APP Corporation Pty Limited  
Phase 1 Environmental Site Assessment

Luddenham Road, Luddenham, NSW

13 December 2013  
42811-55312  
JBS&G

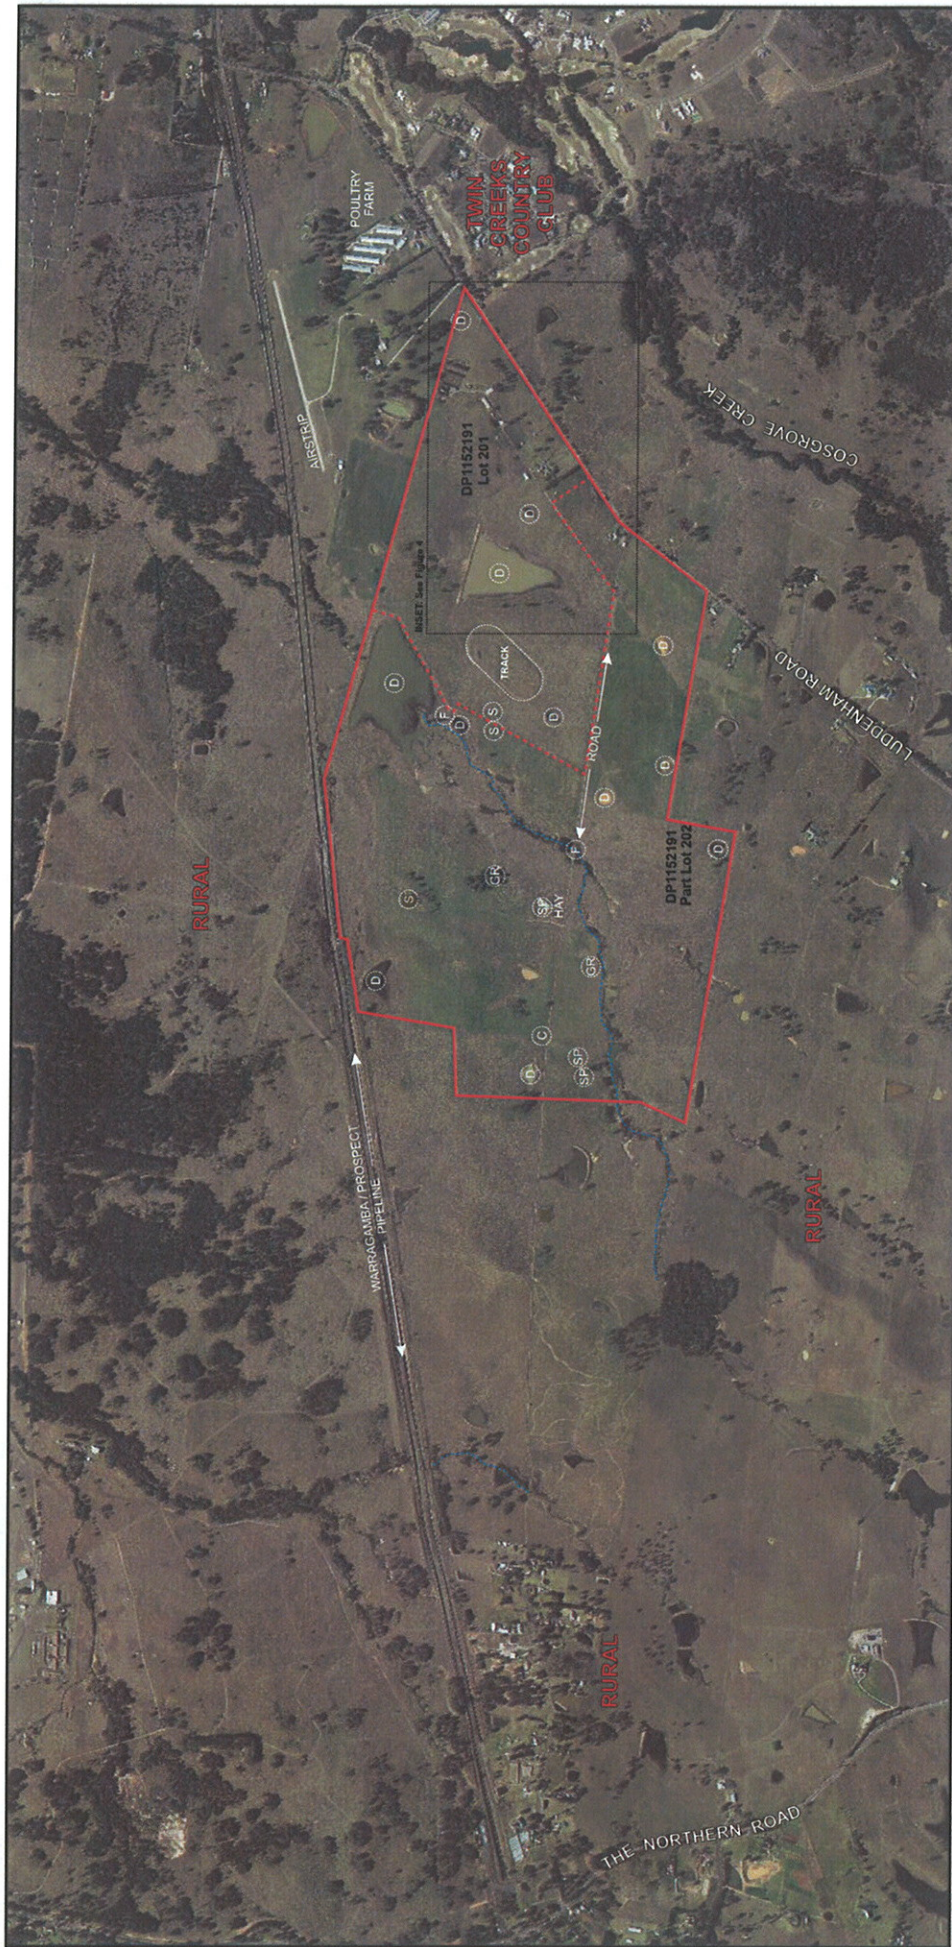
File Name: 42811\_03

| Area of Environmental Concern | Contaminants of Potential Concern |
|---|---|
| Hazardous material storage, within maintenance area/workshops with associated oil storage, staining, surface debris, stockpiles and burn pits. | Heavy metals, TPH/BTEX, PAHs, OCPs and asbestos. |

The site is dominated by rural areas with little or no potential for contamination. The areas where there was potential for contamination to be present included residential occupancies, sheds, workshops, livestock stables and storage areas all located in the eastern portion of the site. Small areas of fill material and stockpiles were also observed in a scattering of locations throughout the site.

ACM was observed on-site used in the construction of a number of buildings on site and in drainage pipes throughout the site and there is evidence of further asbestos contamination on-site such as fill areas and causeways.

It is considered unlikely that the AECs identified will have impacted the land to a degree that would prevent planning and development of the land for the intended use(s). It is recommended that a Detailed Site Investigation (DSI) be completed to assess the extent of contamination prior to future development.

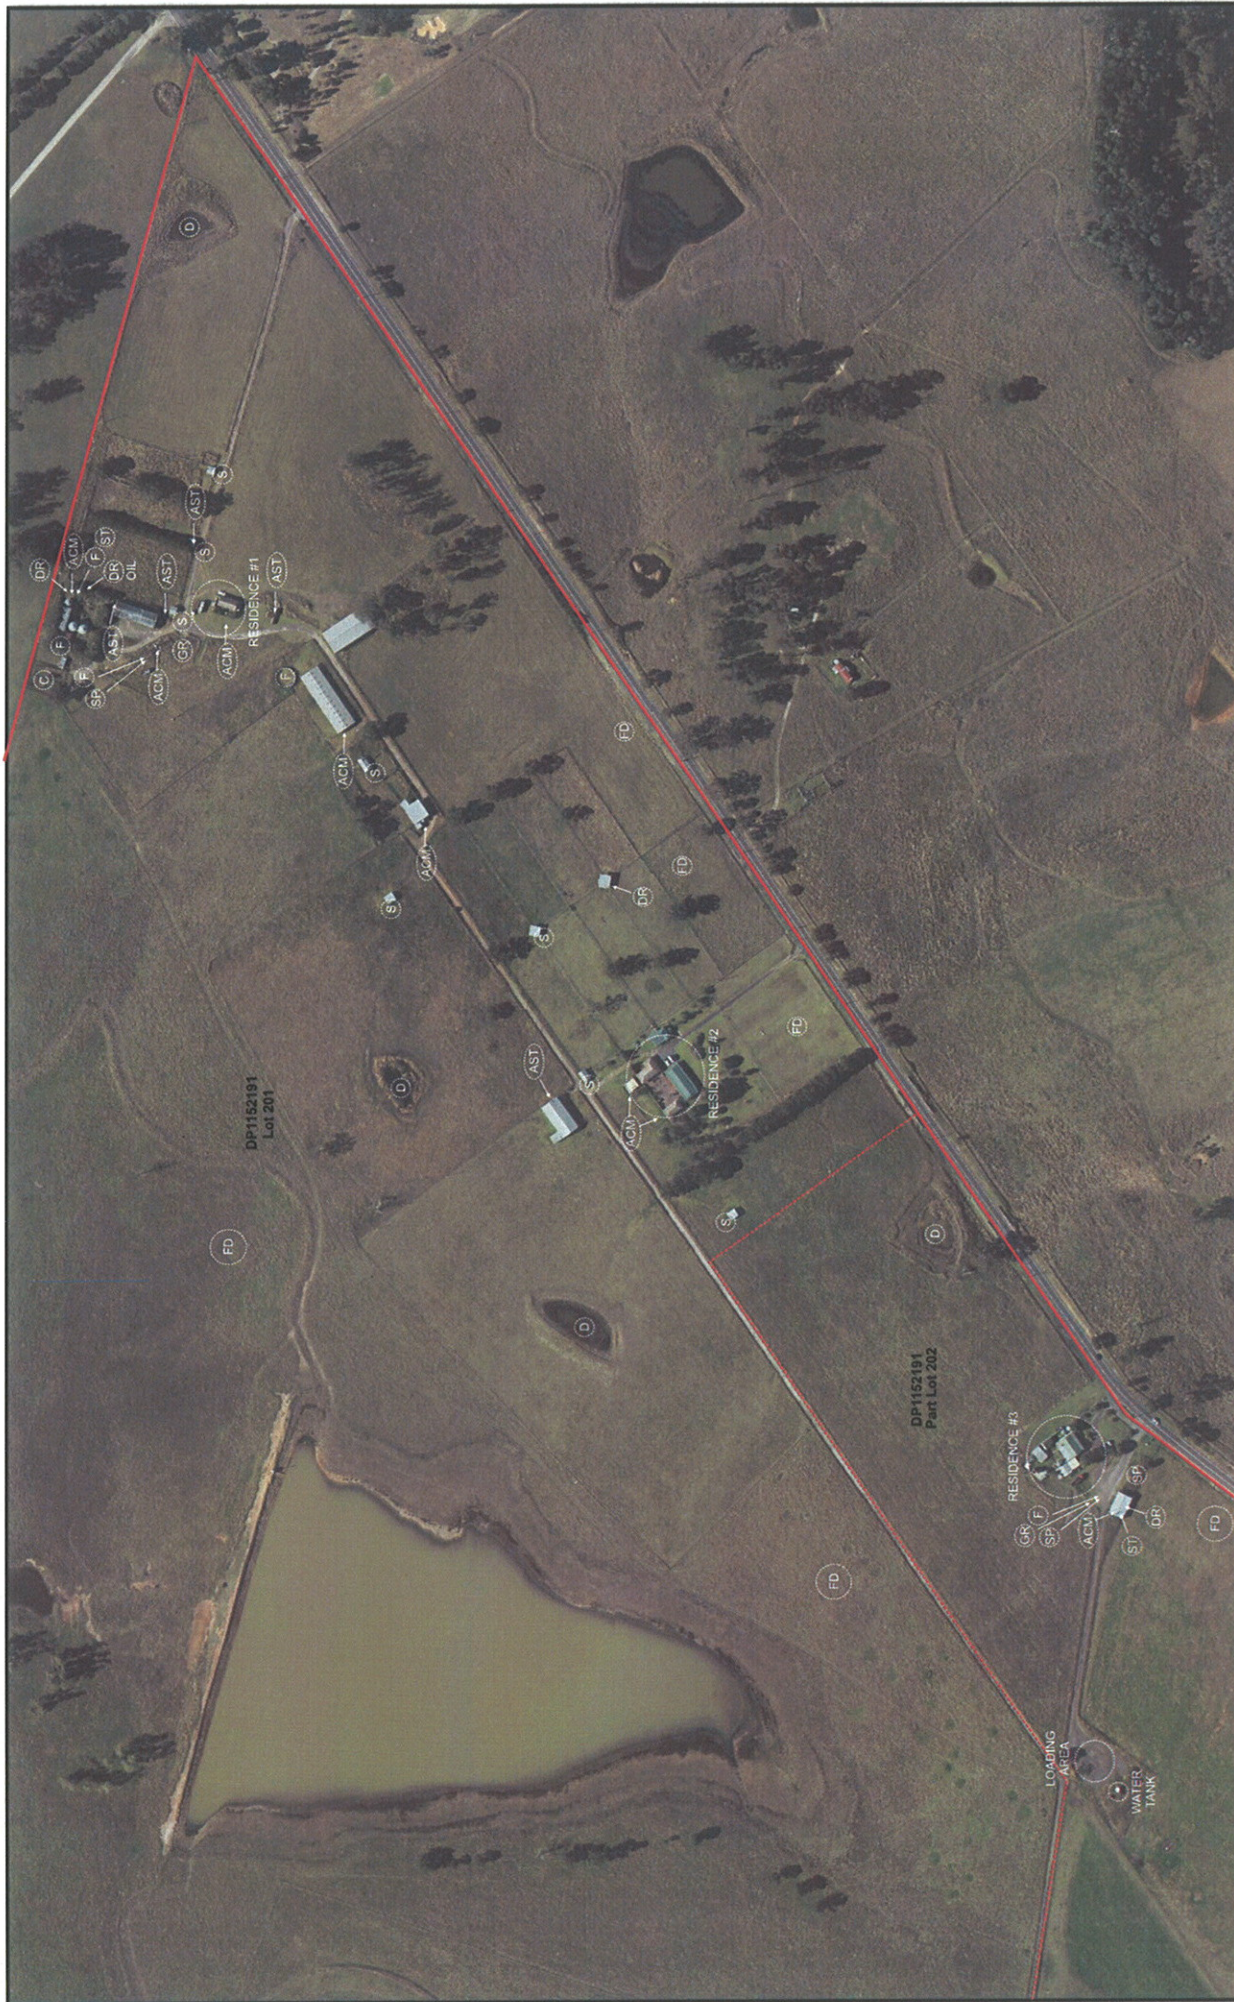
ST = STAINING  
 DR = DRUMS  
 GR = GENERAL RUBBISH  
 ACM = ASBESTOS CEMENT MATERIAL  
 AST = ABOVE GROUND STORAGE TANK

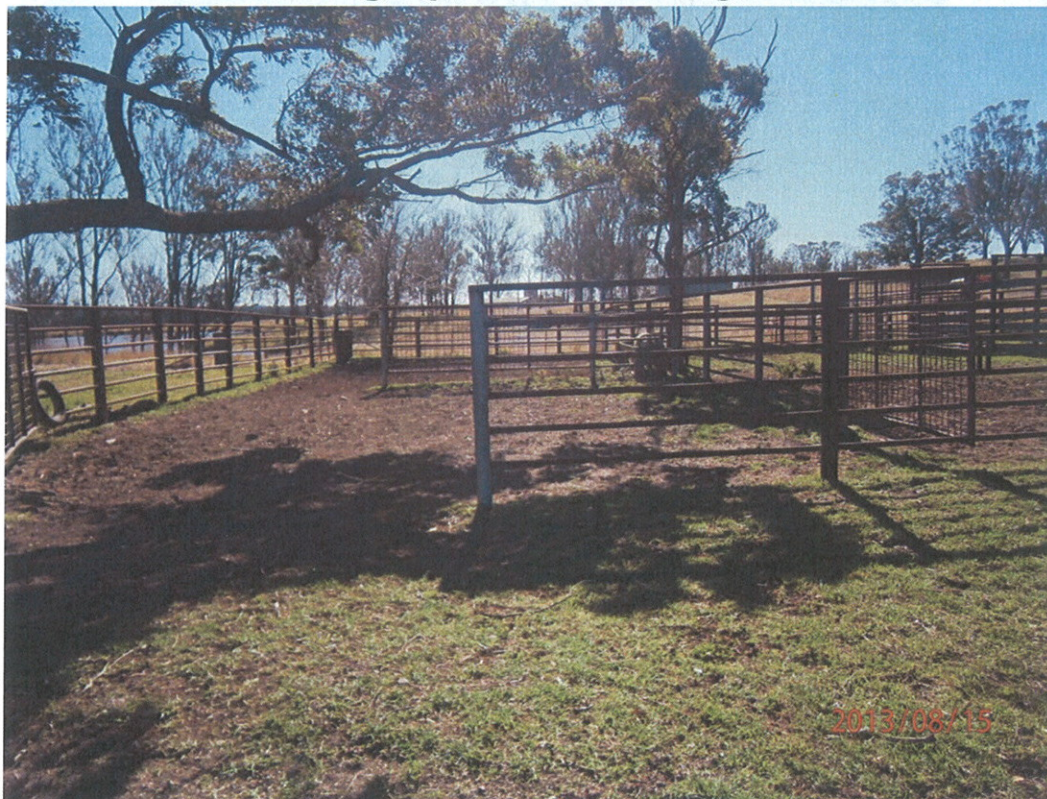
**Photograph 1** – View of the cattle yard in Lot 201 looking north.

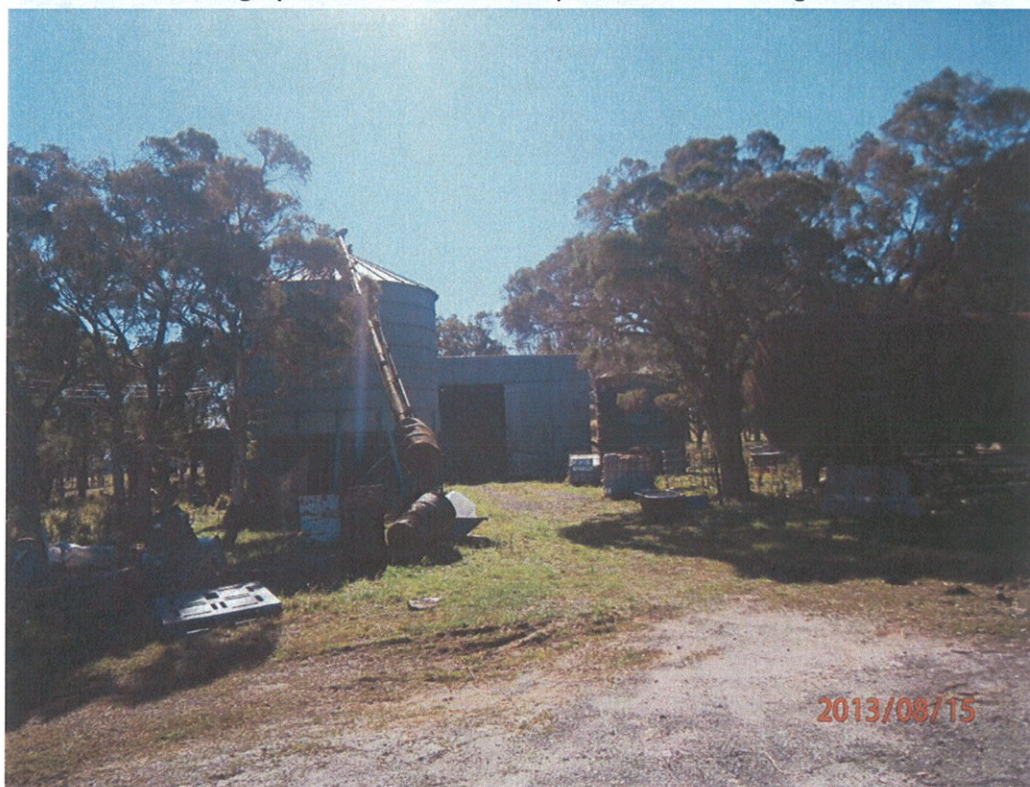
**Photograph 2** – View of the work area of Lot 201 looking north

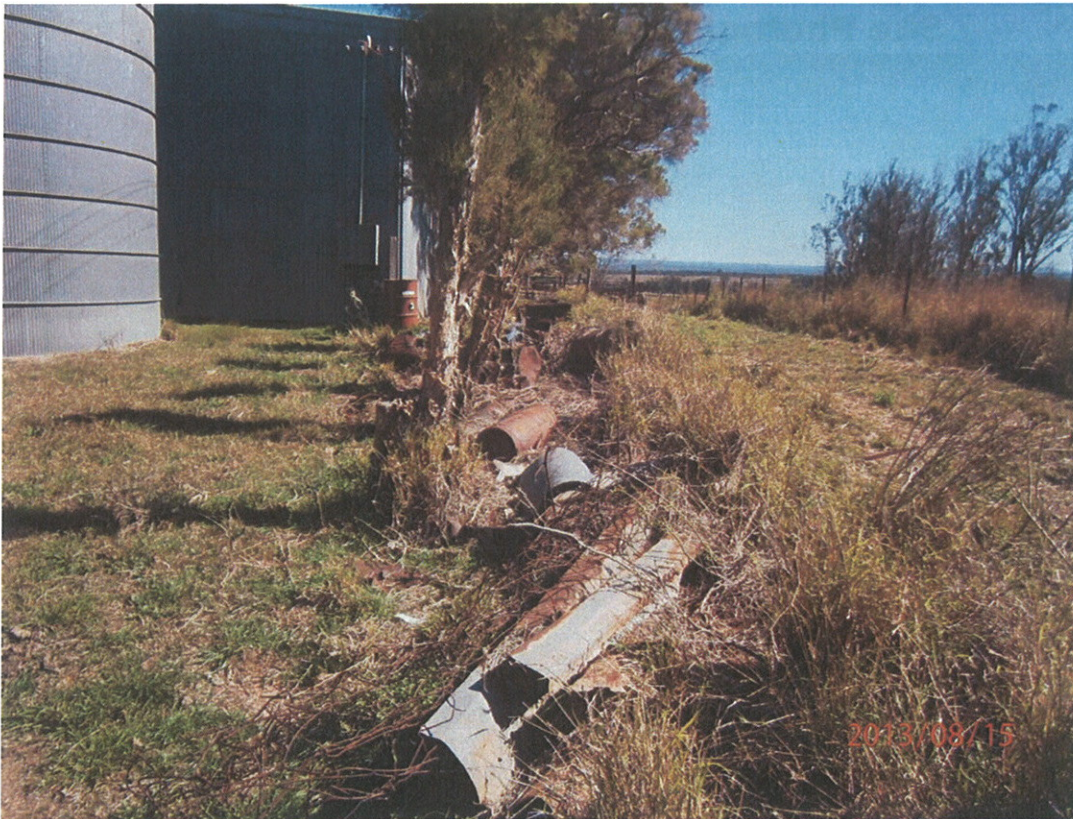
**Photograph 3** – Discarded material such as steel and old oil drums, looking west

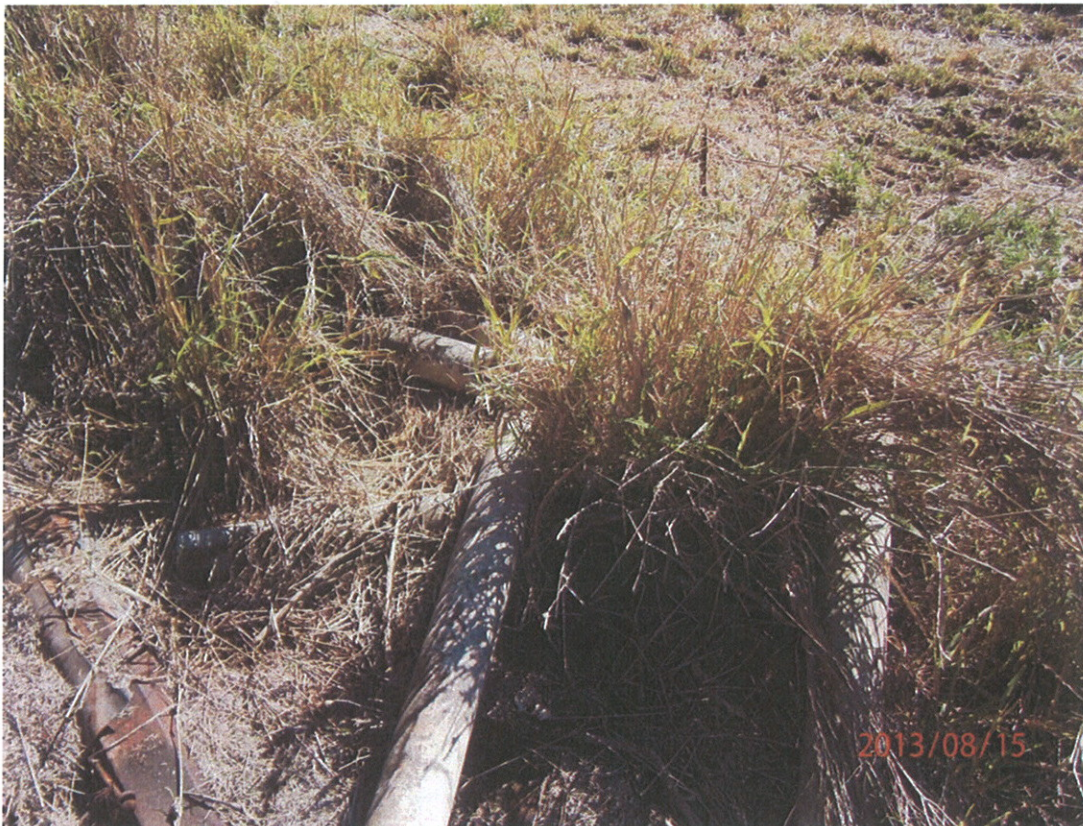
**Photograph 4** – Suspected asbestos containing material (ACM) pipe
