**Preliminary Environmental Site Assessment, prepared  
by JBS Environmental Pty Ltd, October 2009**

# **Preliminary Environmental Site Assessment**

Jacaranda Ponds  
Lot 75 DP214752, Lot 44 DP214755, Lot 1  
DP784300, Lot 2 DP784300, Lot 3 DP784300, Lot 20  
DP214753, Lot 50 DP751637, Lot 3 DP230943, Lot  
52 DP1104504 and Lot 2 DP533402  
Spinks Road  
Glossodia NSW

October 2009  
JBS 40946-14016  
JBS Environmental Pty Ltd

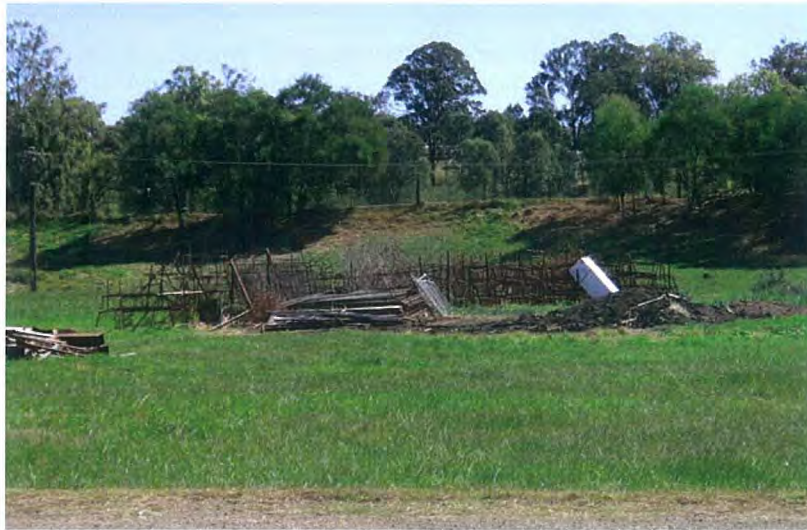
Access to Lots 1, 2 and 3 in DP784300 was off Kurmond Road via a private road, which entered the site at the southern end of Lot 2. To the east of the entrance a concrete rubble stockpile with a volume of approximately 4 m<sup>3</sup> was observed, approximately 5 m north of tree 216 (T216). Mr John Vassallo of Diverse Property Solutions indicated that the nineteen large sheds, located in two groups in the southern half of Lots 2 and 3, were used to hatch and rear chicks that were either used for egg production at the site or sold on to other chicken farms for egg or meat production. Two rows of seven sheds making up one group were located in Lot 2 with a group of five sheds located in Lot 3. The area around the sheds was not accessible as it was quarantined to protect the chicks from disease. A stockpile of unidentified metal frames and an area that appeared to be used for burning waste materials was observed between the two groups of sheds as shown in Photograph 1.

Photograph 1: Pile of burnt material and unidentified metal frames.

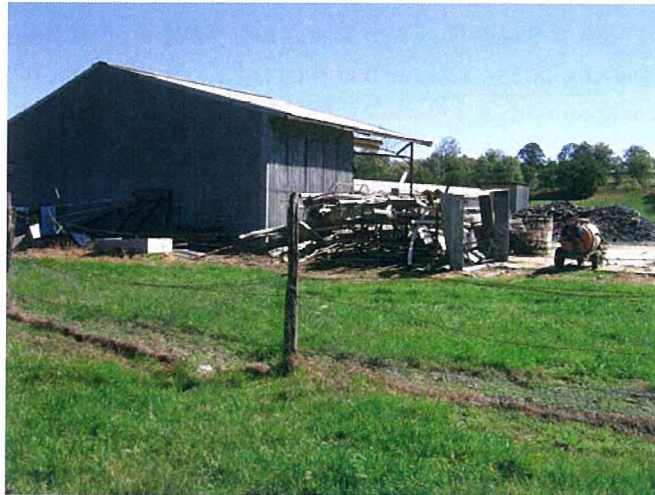
Stockpiles of waste material were observed next to a corrugated iron-clad storage shed located between the two groups of chick rearing sheds. A smaller corrugated iron storage shed was located to the north of the shed and stockpiled materials. The material in the stockpiles could not be closely inspected due as it was in the quarantine area, but appeared to comprise building demolition rubble, soil, asphalt and concrete. The contents of the storage sheds could not be seen from outside the quarantine area fence, however, dead vegetation was noted in the area immediately surrounding the larger shed that may indicate the use of herbicides in this area.

Photograph 2: Dead vegetation around the shed, and stockpiled waste material, shown in the background centre right of the photograph.

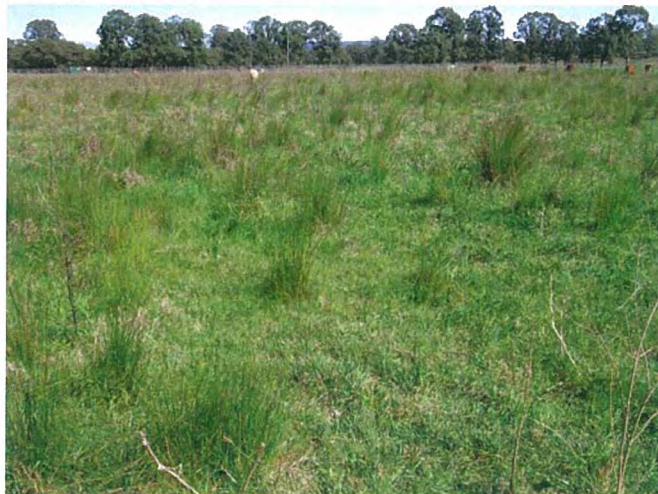
Salinity indicator plants (spiny rush), shown in Photograph 2, were observed in the area between the chick rearing sheds and Currency Creek.

Photograph 3: Salinity indicator plants observed in the southern portion of the site.

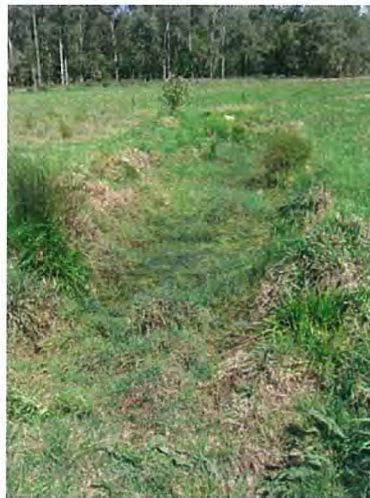
Salinity indicator plants were also observed in the southeastern corner of Lot 3 in an area where trenches were observed as shown in Photograph 2.

Photograph 4: Water in trench and salinity indicator plants

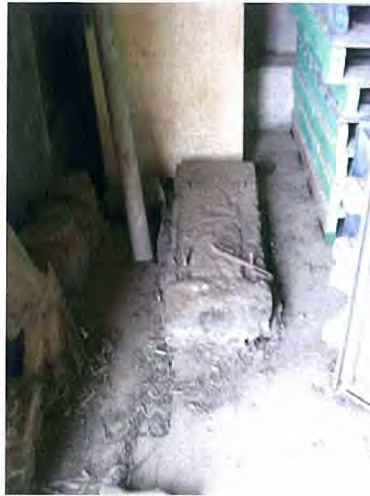
A concrete pad with protruding bolts was observed in a storage building located in proximity to T69. The pad may have been used to seat a piece of machinery, potentially an electrical generator. The shed was being used to house three tractors and some timber pallets although most of the space in the building was vacant. A residential dwelling was located to the west of the storage building.

Photograph 5: Concrete pad with protruding bolts.

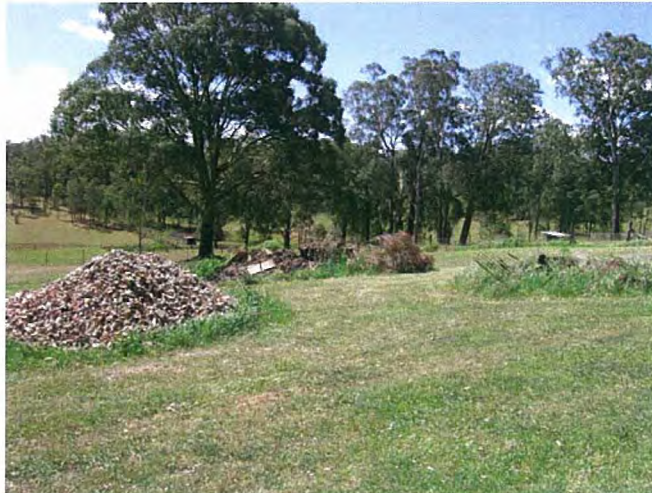
Three cars had been abandoned, to the northeast of the egg storage shed, adjacent to T506. Three stockpiles of material were located approximately 50 m north of the egg storage shed. One stockpile comprised clean, crushed concrete and bricks, one stockpile comprised bent metal fencing and other waste materials, with the third stockpile comprising soil, rock and timber, with the presence of ash indicating that some of the materials had been burnt.

Photograph 6: Materials stockpiled to northeast of the egg storage building.

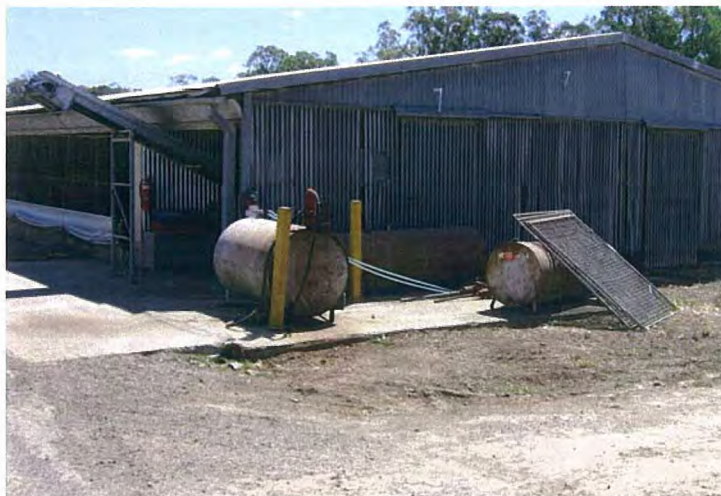
Three ASTs were observed located on a concrete slab adjoining the southeast corner of shed 4. Two of the ASTs (each approximately 1500 L in volume), which were labelled lead replacement or unleaded petrol, appeared to be no longer in use as the hand pumps had been removed from the tanks and were laying on the concrete slab. The third AST was labelled diesel and appeared to be still in use. There was staining observed on the slab immediately beneath and around the tank. The staining indicated that some of the spilt diesel had runoff the concrete slab onto the surrounding soil.

Photograph 7: ASTs located adjacent to shed 4. Diesel staining is visible on the underlying concrete slab.

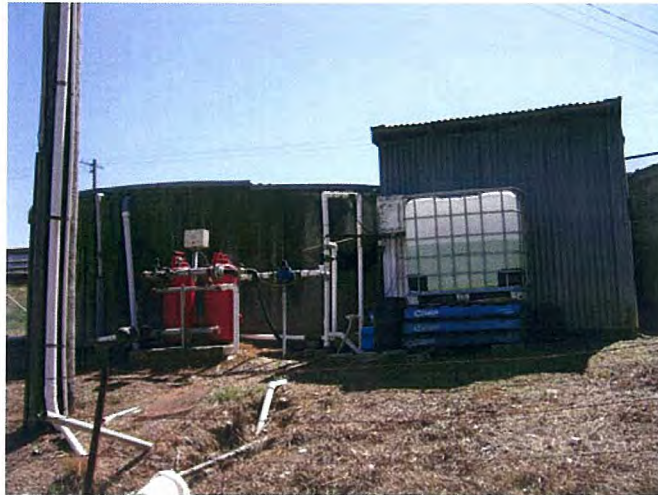
Two concrete tanks and a plastic tank were located approximately 20 m south of the gap between sheds 7 and 8. A shed constructed of corrugated iron was located adjacent to the tanks. A half-filled 1000 L plastic container, labelled sodium hypochlorite solution, commonly known as bleach, was located at the rear, southern side, of the shed. Two 200 L plastic drums also containing bleach were located adjacent to the plastic tank. The site manager indicated that the tanks, storage shed and bleach were used for storage of water pumped from Currency Creek that was treated, via sand filters and addition of chlorine to provide drinking water for the chickens.

Photograph 8: Concrete storage tank, shed and 1000 L plastic container containing bleach.

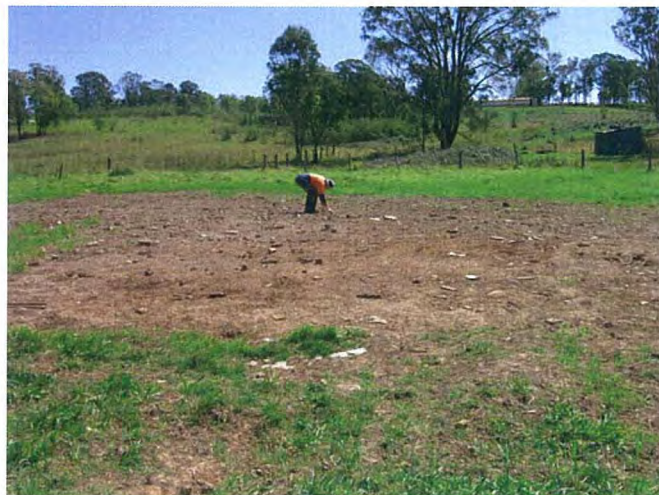
A vegetated stockpile of what appeared to be soil was observed in the southwest corner of Lot 1 in DP784300. A dead cow was observed at the base of the stockpile. Stockpiles of chicken manure were present in the southern third of Lot 1 in DP784300. It appeared that that manure from the chick rearing sheds and egg production sheds was brought to this area, shown on **Figure 2**. Fragments of potential asbestos containing materials were observed in a cleared, bare earth area located approximately 35 m north of the manure stockpiles. A review of the historical aerial photographs indicated there was formerly a structure, possibly a residential dwelling, in this area.

Photograph 9: Area of bare ground, located north of the manure stock, where fragments of potential ACM were observed.

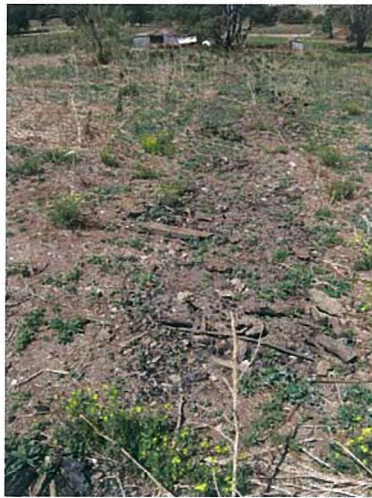
A corrugated iron storage shed was located approximately 50 m northeast of the patch of bare ground. The shed appeared to be used for chicken shed hardware such as lights, and fittings, such as pipes and feed hoppers. Between 5 to 10 kg of a blue crystalline substance, similar in appearance to copper sulphate, was observed on a table in the shed. An area of bare ground and sparse vegetation was observed to the north of the shed as shown in **Figure 2**. The presence of charcoal indicated that material had been burned in a strip of ground within the sparsely vegetated area. A burnt car oil filter was observed mixed in with the charcoal.

Photograph 10: Charcoal observed in a strip of ground in Lot 1 DP 784300.

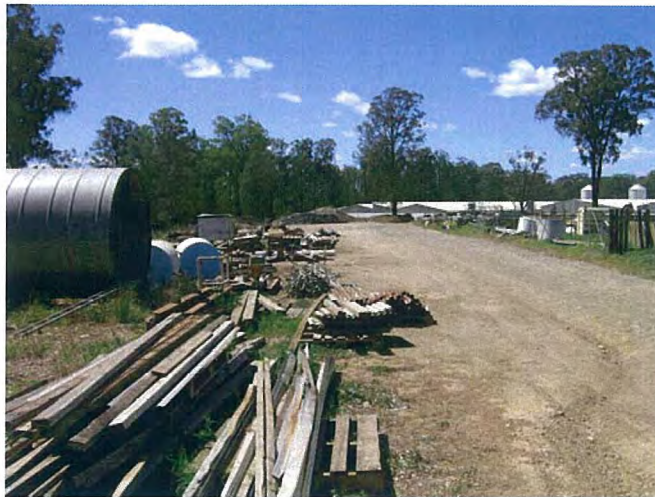
Two surface water dams were located in the centre of Lot 1, with another dam also observed in the northeast corner of the same Lot. Four large vacant sheds, which appeared to have been previously used for egg production, were located in the northern half of Lot 1. Materials were stored on both sides of the access driveway to these sheds. Materials included sheet metal chicken cages, fuse boxes/electrical switchboards, timber, pipes, empty paint cans and stockpiled soil and ripped shale. The electrical switchboards were potentially constructed with Zelemite or Miscolite, trade names for a product that was manufactured from coal tar pitch and asbestos.

Photograph 11: Materials stored along the access driveway to the former chicken sheds in Lot 1.

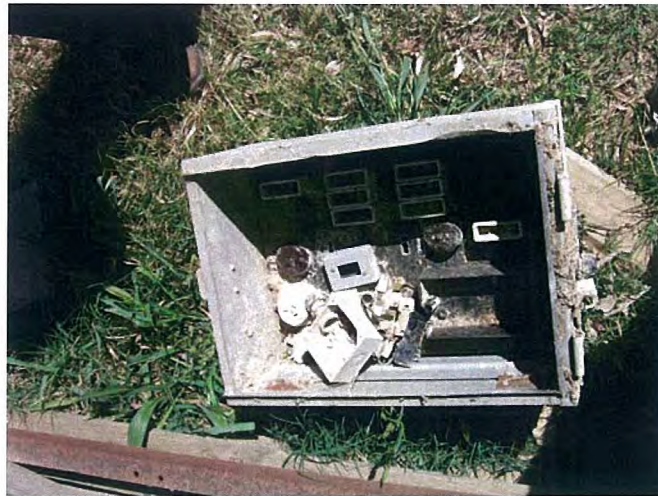
Photograph 12: Switchboard constructed from suspected ACM.

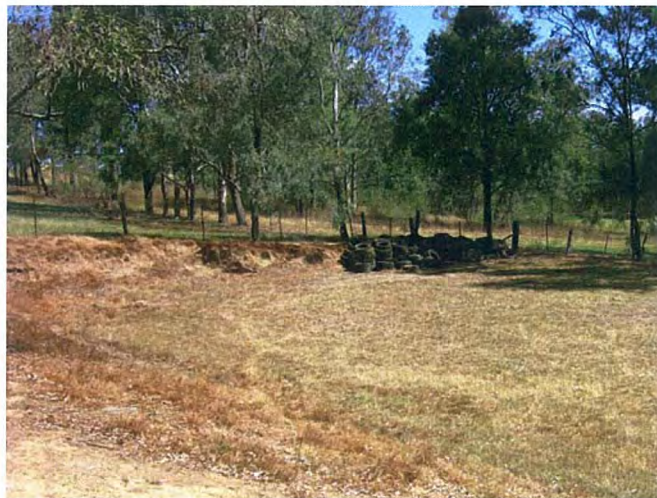
A residential dwelling, which appeared to be vacant, and a separate double garage were observed on Lot 44 located at 3 Derby Place. Two open covered structures constructed of timber and sheet metal were located along the southern boundary of the Lot. Cut and fill had been carried out to level an area west of the house. A tyre stockpile was observed on the levelled area.

Photograph 13: Cut area and tyre stockpile in Lot 44.

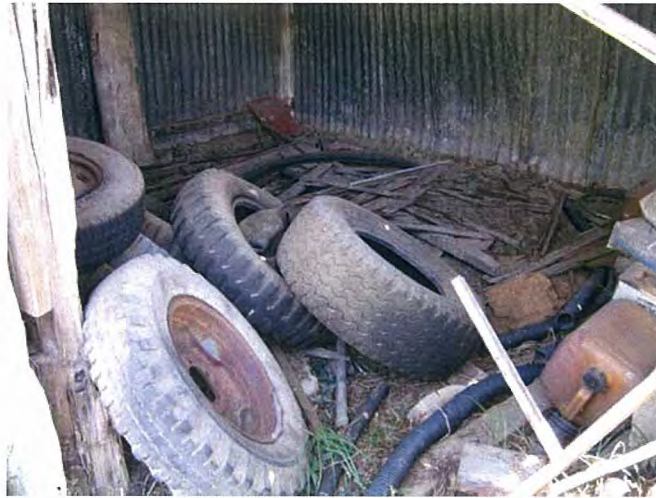
been used as a storage/workshop area and possibly as stables. Tyres, pieces of plastic pipe and bags of concrete or sand and cement mix were observed in one of the sheds. A shack, located between the sheds and the house, had also been vandalised. The shack was constructed of fibre cement sheet, which was suspected to be ACM, and timber.

Photograph 14: Tyres, pieces of plastic pipe and bags of concrete or sand and cement mix observed in one of the sheds on Lot 50.

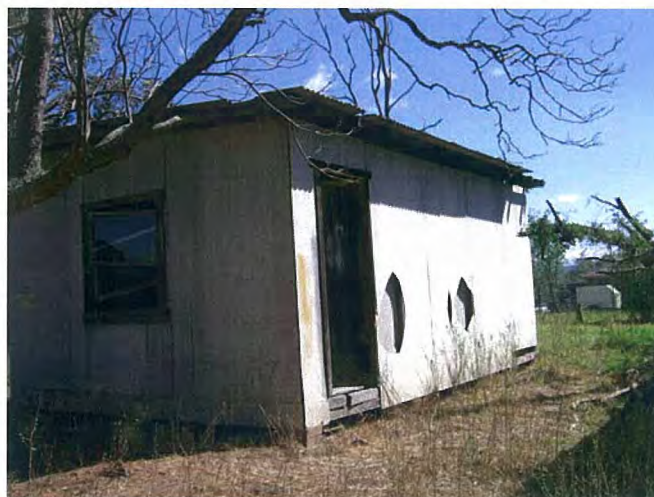
Photograph 15: Shack constructed of suspected ACM.

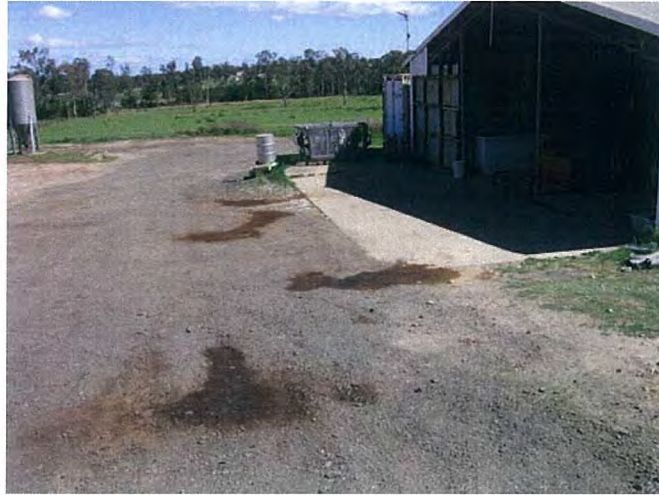
Photograph 16: A 200 L drum located on a concrete block outside a storage shed on Lot 3 in DP230943. Oil staining on the gravel driveway between the storage shed and chicken sheds.

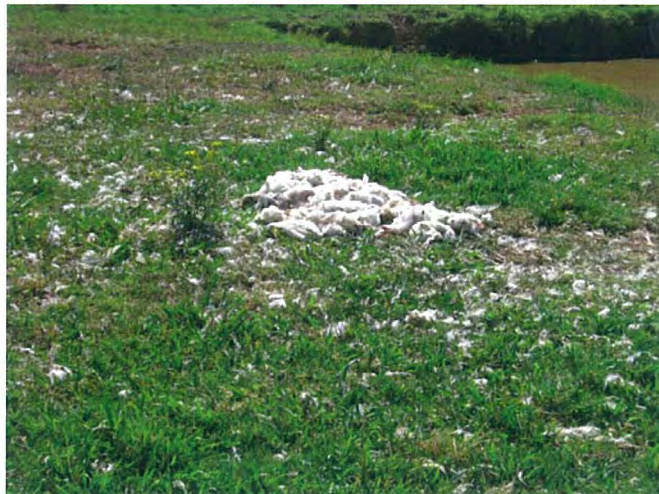
next to the storage shed. A pile of dead chicks had also been discarded on the ground surface adjacent to the dam located to the west of the storage shed. A residential dwelling was located in the east central portion of the site north of the chicken sheds. The house and immediate surroundings were not inspected.

Photograph 17: Dead chicks discarded adjacent to the dam west of the chicken sheds on Lot 3 in DP230943.

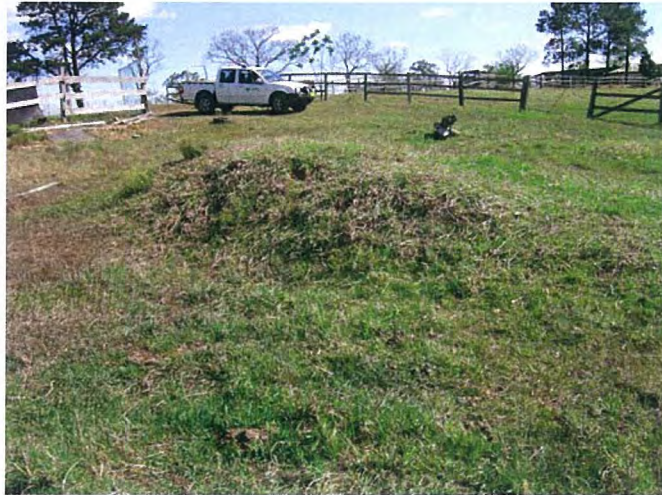
Two dead cows were observed in a depression south of T1342, in the southwest corner of Lot 52. Potential salinity indicator plants were observed in an area, with approximate dimensions of 20 m by 10 m, 10 m west of T1198. Potential salinity indicator plants were also observed around a surface water dam, located immediately south of T1362 in the southern central portion of Lot 52. A residential dwelling and some associated sheds, located in the central portion of Lot 52 were not inspected as there were dogs preventing access to this portion of the property. A stockpile of bitumen and concrete and another stockpile of unknown composition were observed approximately 35 m north of T1377.

Photograph 18: Material stockpiled 35 m north of T1377.

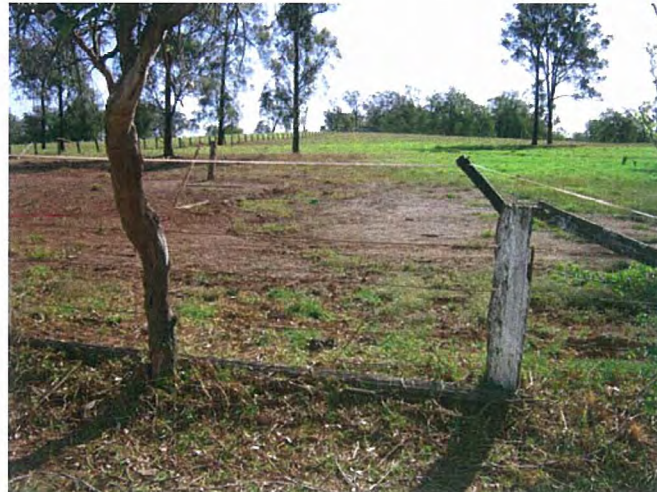
An area of sparse vegetation and bare ground was observed immediately southwest of T1511.

Photograph 19: Area of bare ground and sparse vegetation southwest of T1511.
