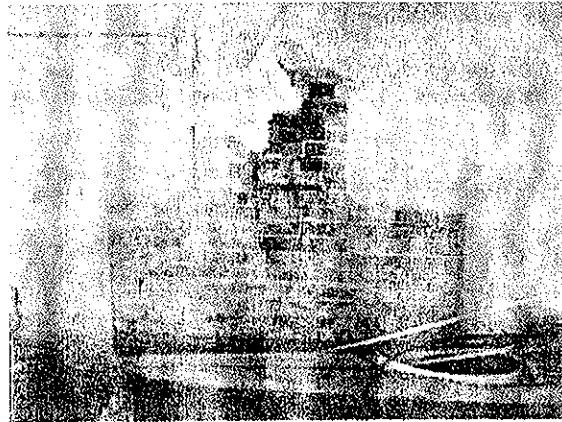
Figure No.100: View of former fireplace and chimney  
stack partly damaged. LG4

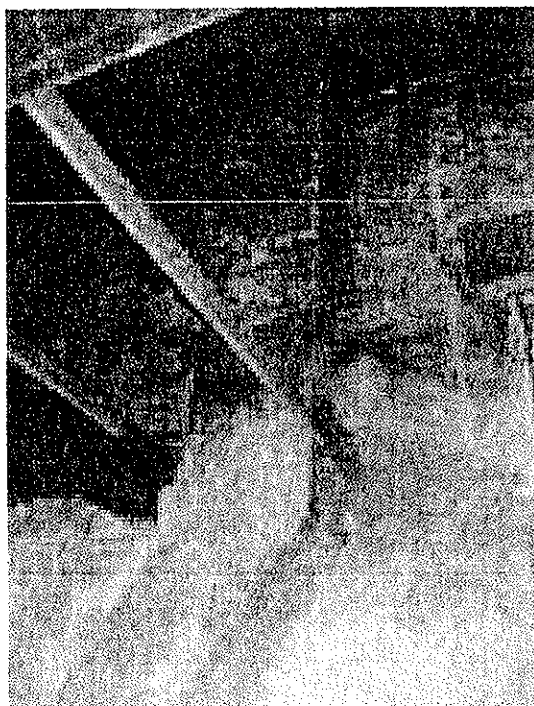
Figure No.101: View of chimney stack partly  
damaged and smoke stained. LG4 to G25

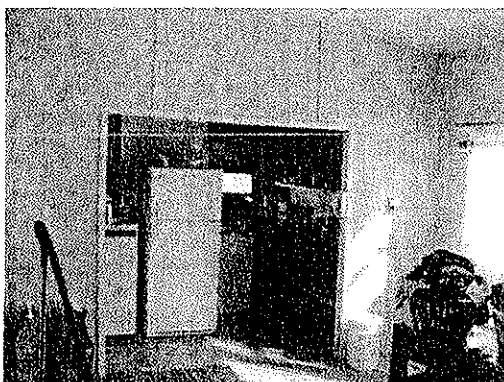
Figure No.103: View of 1940s kitchen filling the early verandah. The wall behind the fridge is thought to be part of the early structure and is now the bathroom. This area formerly accessed the verandah.

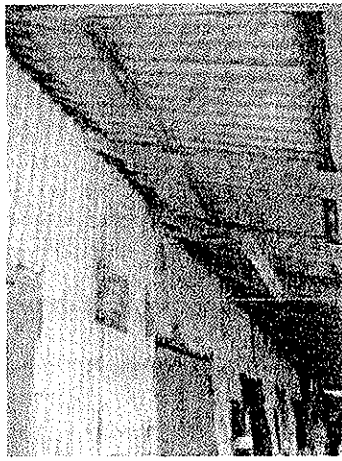
<p>Figure No.110: Covered verandah of large stables in farm complex indicating change in timber roof construction.</p>
<p><b>Current use and condition</b></p> <p>Stables are in fair condition and contain evidence of early and later construction elements. Evidence of early floor elements including early brick paving and concrete slabs extend beyond the perimeters of the current walls. The area is also used a storage space and washing bay.</p>

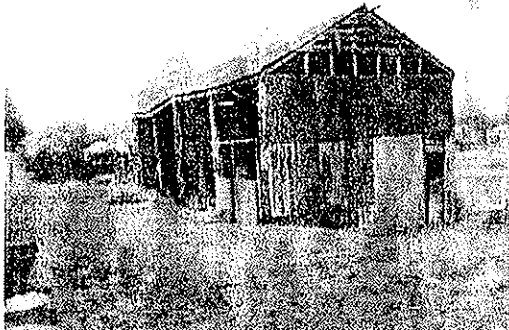
<p>Figure No.111: Small stables in farm complex thought to be an early structure.</p>
<p><b>General Description</b></p> <p>Construction Period: c1930 Design style: Vernacular Adapted: c1950</p> <p><u>Construction materials</u></p> <p>Walls: Timber with metal sheeting Verandah – round timber posts</p> <p>Roof: Timber framed and metal sheeting (later addition)</p> <p>Floors: Compacted earth – evidence of early brick paving</p>	
<p><b>Current use and condition</b></p> <p>The stables are in fair condition with the roof structure sagging in some places. The north façade of the stables has been opened to allow for access and the covered walls are a combination of later and recent corrugated sheeting.</p>

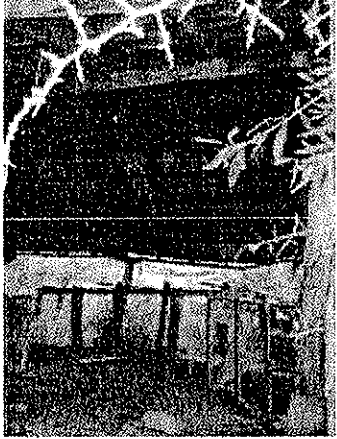
<p>Figure No.113: Early milking shed in farm complex overgrown by the Peppercorn tree.</p>
<p><b>Current use and condition</b></p> <p>This early milking shed is no longer used and in poor condition. The timber structure is supported by the Pepper corn. The structure is in urgent need of repair.</p>
