3.6 Subject buildings

3.6.1 Orielton Homestead (B1)

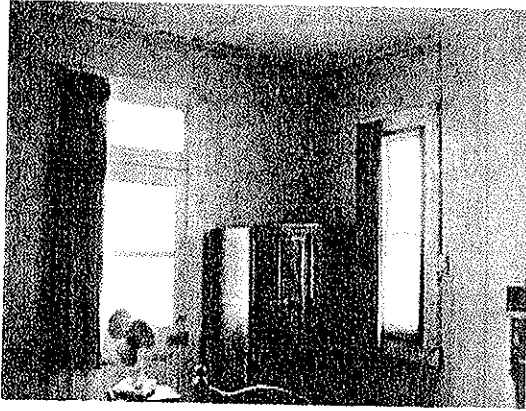
Figure No.61: View of second bedroom G21 with simple detailing and changed French door. No access is possible to outdoor space as only remnants of the original verandah remain

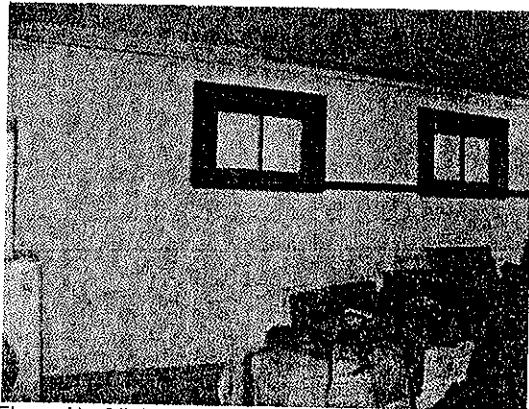
Figure No.65: View of the former teacher's classroom LG7 indicating original windows. The area has significantly deteriorated because of its lack of use.

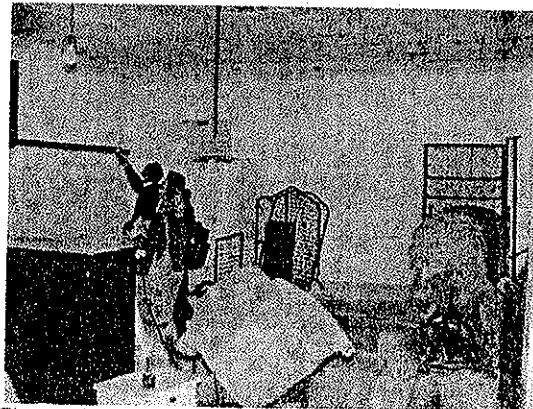
Figure No. 66: View of the teacher's classroom LG7 indicating deteriorated ceiling and early picture rails.

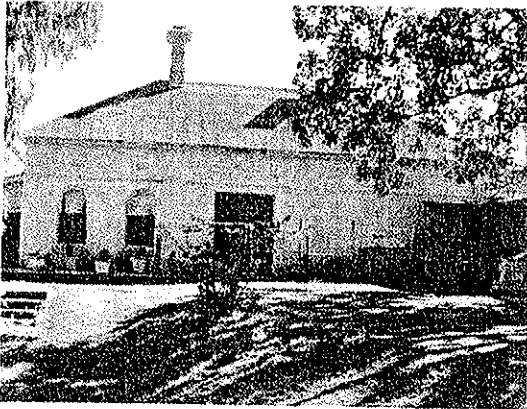
Current use/condition	Unoccupied space – former residence. The area is in poor condition and in urgent need of repair except for G2 which is used as a bedroom/sitting room (also weeping).

Figure No.73: View of area C from east. The area is in urgent need of repair.

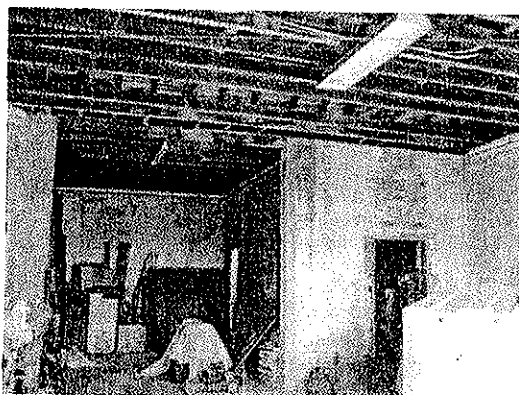
General Description	
Construction periods: late c.1850 Design styles: Georgian, vernacular	
Construction materials	
Walls	Exterior - brickwork rendered with stone coursing Interior - brickwork rendered
Roof	Framing - pit sawn hardwood timber, Corrugated metal sheeting
Floors	Concrete Former timber flooring removed approx. 300mm above existing FL
Joinery/ Features	<p><u>Room G10</u> Lathe and plaster ceiling (hardwood) Roof sheeting imported from England (English stamp located at underside of sheeting) Central fireplace East façade windows square timber framed with shutters</p> <p><u>Room G9</u> Lathe and plaster ceiling with simple ceiling rose Door hardware inscribed with date 1884. Former window – flat arch (west wall)</p> <p><u>Room G8</u> Concrete floor Open space – former lean – to roof.</p>
Current use/condition	Garage, storage space Poor condition in urgent need of repair.

Figure No.83: Area G10. Now used as a garage and storage. Evidence of an early fireplace is visible through attentive analysis

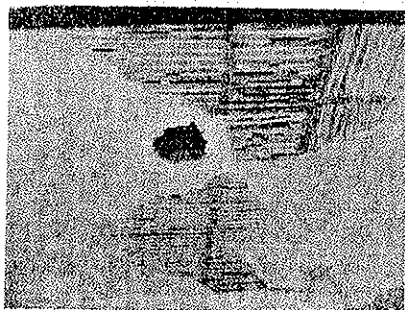
Figure No.85: Area G9. Damaged ceiling rose. This area is now used as a storage farm room

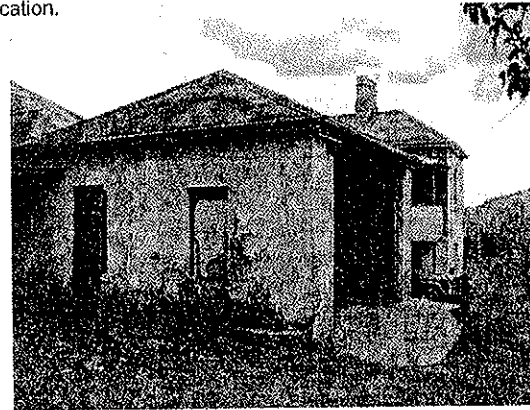
General Description	
Construction periods:	c1880s
Design styles:	Victorian Italianate
Construction materials	
Walls	Exterior - brickwork rendered with stone coursing Interior - brickwork rendered
Roof	Framing – circular sawn Oregon timber
Floors	Concrete Former timber flooring removed approx. 300mm above existing FL
Joinery/ Features	Lathe and plaster ceiling – G11 Roof sheeting imported from England (English stamp located at underside of sheeting) Central fireplace East façade windows square timber framed with shutters Former arched window (west wall) Former door with flat brick arch (west wall)
Current use/condition	Garage, storage space Poor condition in urgent need of repair.

Figure No.89: View of east wall of area E. The north wall was later removed c 1940s and is now used as garage space.

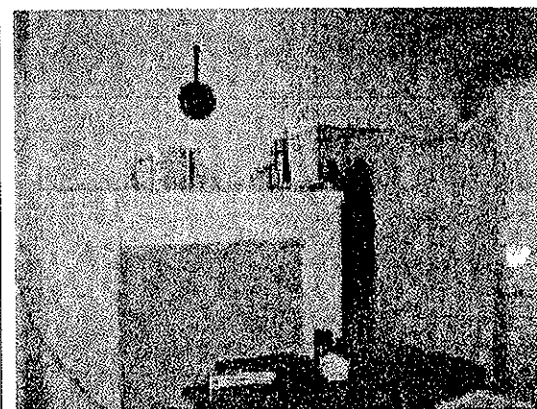
Figure No.93: Internal view of kitchen area in servants building. Evidence of a 1940s addition fireplace exists but is no longer functioning.
