### Structural engineers report (Mott MacDonald)

21<sup>st</sup> January 2016

## **RE: 11-13 Randle Street, Surry Hills – Structural Report**

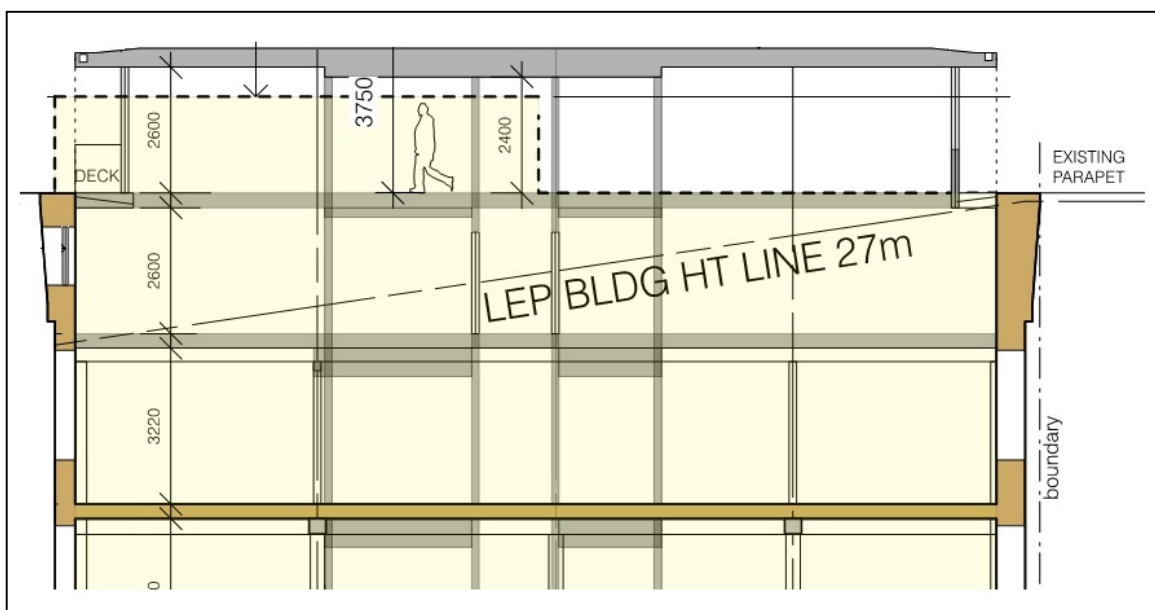
It is expected that the additional storey will be constructed using a lightweight structural steel frame supported at the column locations and perimeter walls of L5 only. We

assume therefore that no additional (false) floor structure will be required at L5. Loads associated with the new floors have been determined to be as follows:

- Design column axial load at L1: 890kN
- Design column axial load at ground floor: 1040kN
- Design column axial load at basement: 1190kN

Based on the column capacities advised in section 3.0 we confirm the columns have sufficient axial capacity to carry the proposed two storey addition.

**FIGURE 1: BUILDING SECTION SHOWING TWO STOREY ADDITION ABOVE LEVEL 5**

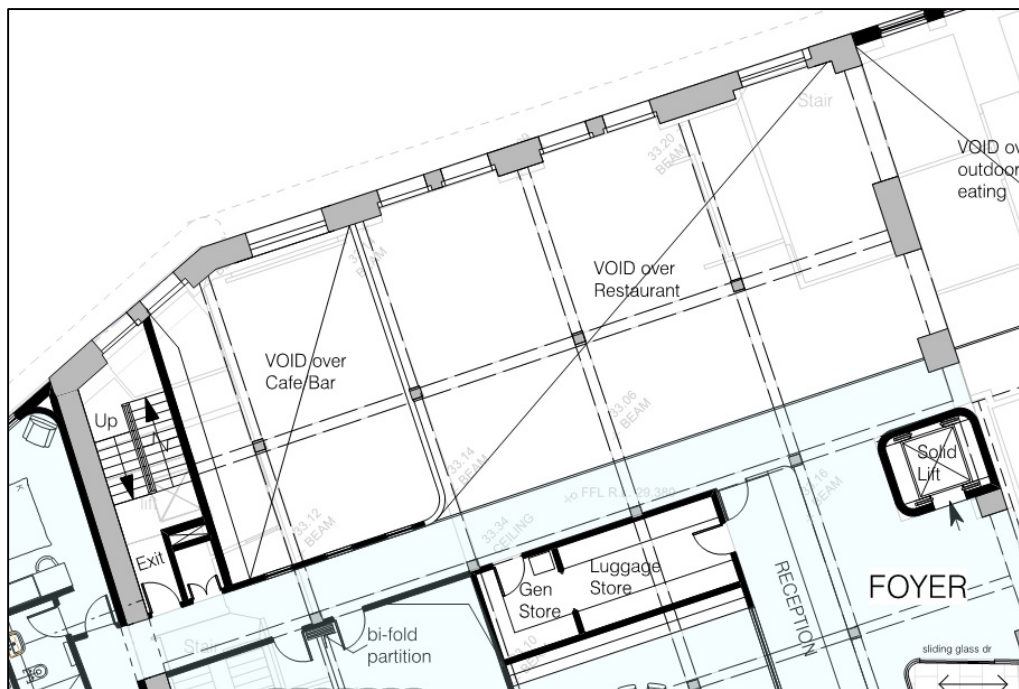
Removal of the ground floor structure to the extent shown on the architect's drawing 1519-DD06 is possible with the following restrictions:

**FIGURE 2: PARTIAL REMOVAL OF THE GROUND FLOOR STRUCTURE**

- Retention of the existing beams in the east-west direction and installation of new bracing beams in the north-south direction are required at each column at the ground floor to provide lateral bracing to the columns, which would previously been provided by the joist and floorboard diaphragm. The new bracing beams shall be connected to a sufficiently robust structure (masonry walls or the remaining floor).
- Some timber or steel trimmers may be required to support joists where half bays are removed.

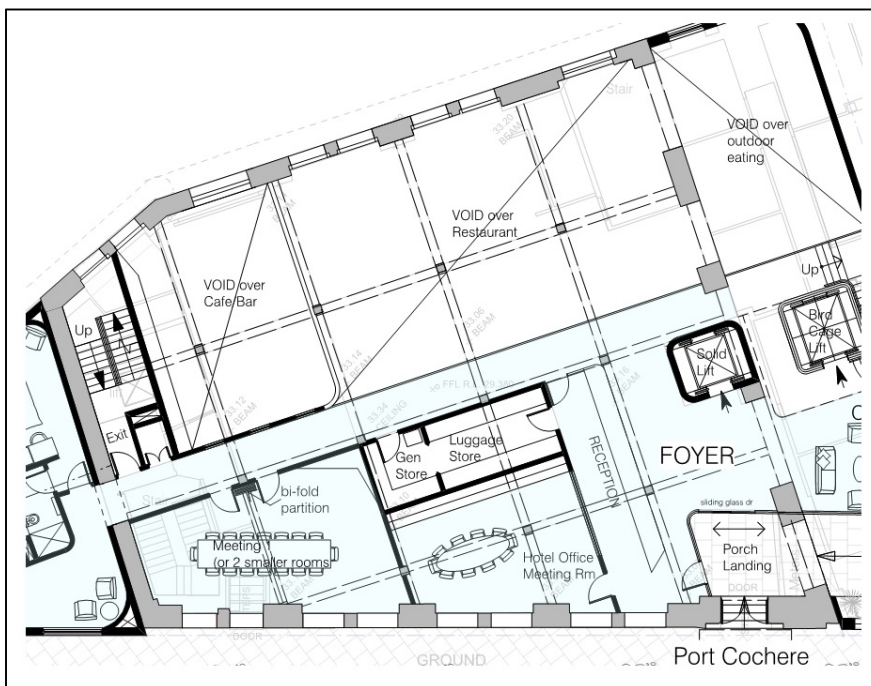
Large openings are proposed through the north and south perimeter walls at all levels to provide a continuous central corridor through the building and for accessing the adjacent buildings. To enable the creation of these openings the masonry above will need to be supported on a new lintel. This is likely to consist of several prestressed concrete lintels stacked across the width of the wall.

At the ground floor the north perimeter wall is shown to be punctured by several large openings, leaving only occasional masonry piers. As this wall is currently a major lateral force resisting element of the building, alternative means of resisting such forces will be required. It is expected that the “solid lift” shown on the line of this wall will act in the new development as a major lateral force resisting element, and will need to be designed as such (see section 7.0 Seismic Strengthening below for details).

**FIGURE 3: REMOVAL OF NORTH AND SOUTH PERIMETER WALLS**

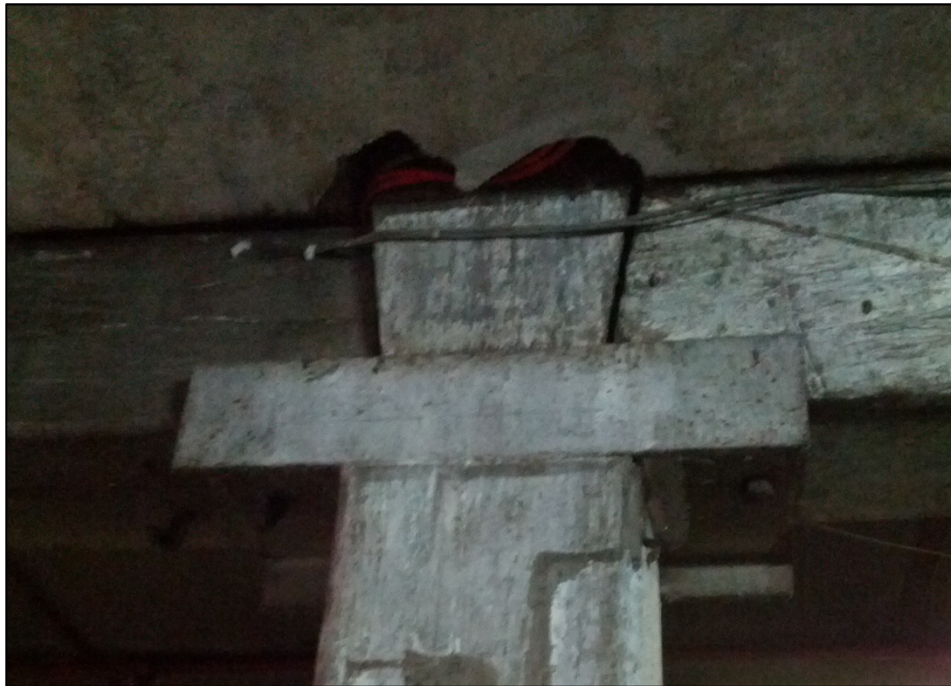
Timber beam to column joints include a structural steel I section laid on its side to form a corbel.

The timber framing structure (beams and columns) are currently exposed to view on all levels. No significant defects were observed in these elements.

**PHOTO 1: BASEMENT COLUMN TO BEAM CONNECTION**

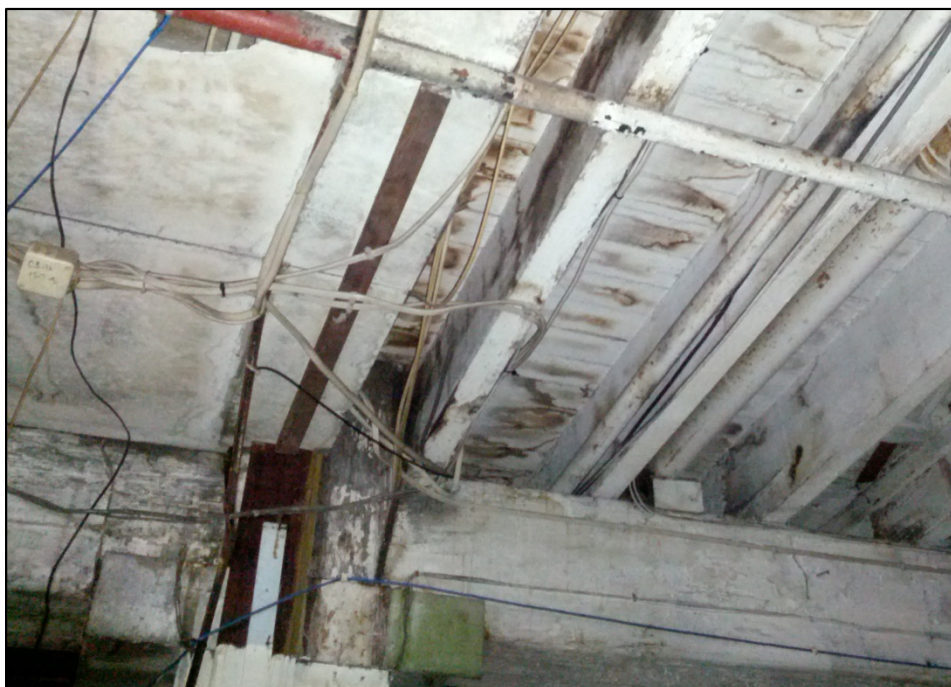
The ground floor joists are mostly exposed to view in the basement level. While some staining of the joists has occurred, there is no obvious evidence of termite damage or decay and therefore the joists are expected to remain in serviceable condition.

**PHOTO 2: GROUND FLOOR JOISTS AND FLOORBOARDS**

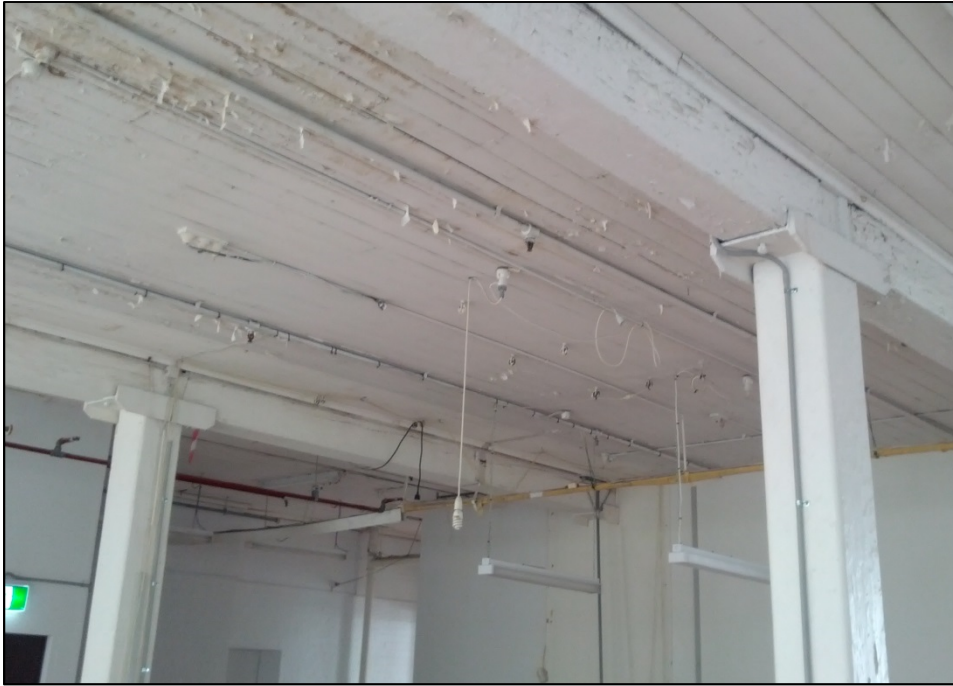
**PHOTO 3: GROUND FLOOR COLUMN, BEAM AND CEILING CONSTRUCTION**

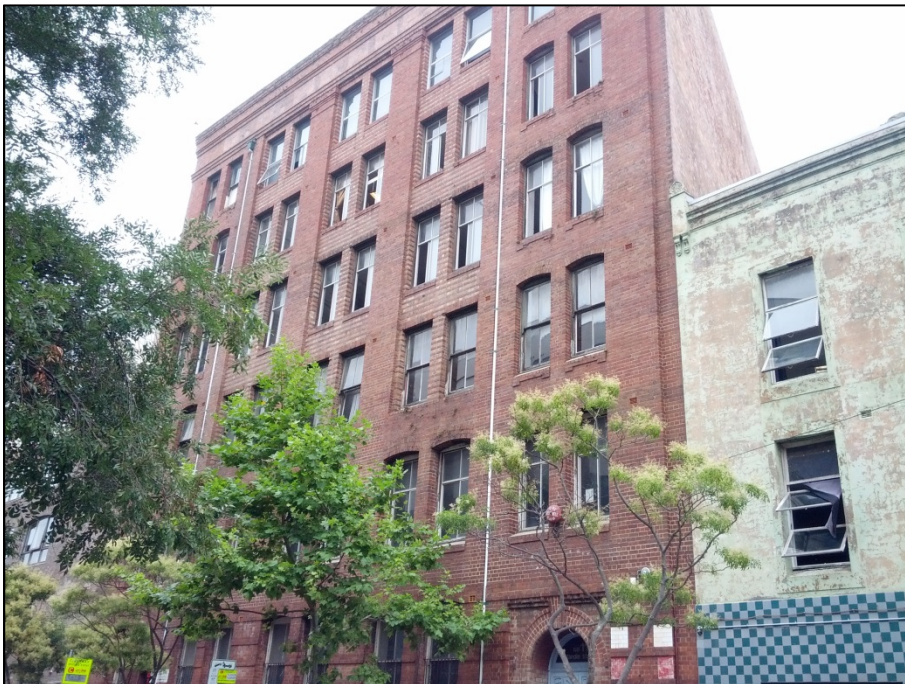
- Corrosion of steel lintels over window openings, common across the Randle Street façade. Some spalling brickwork due to expansive corrosion of the lintels.
- Vegetation growth at parapet level along Randle Street.
- Damaged brick sills common at window openings along Randle Lane.
- Corrosion of embedded steel sections (from the old external fire stairs – now removed) on the Randle Lane facade. Some minor associated brick damage.
- Minor cracking in beams over the southern windows on the Randle Lane façade.
- Some dropped arches at window openings on the Randle Lane façade, with cracked brick spandrels above.

**PHOTO 4: RANDLE STREET FACADE**

It is expected that these defects will be addressed during construction of the proposed development. It is likely that a full height scaffold will be required on both Randle Street and Randle Lane to carry out remedial works to the facades.

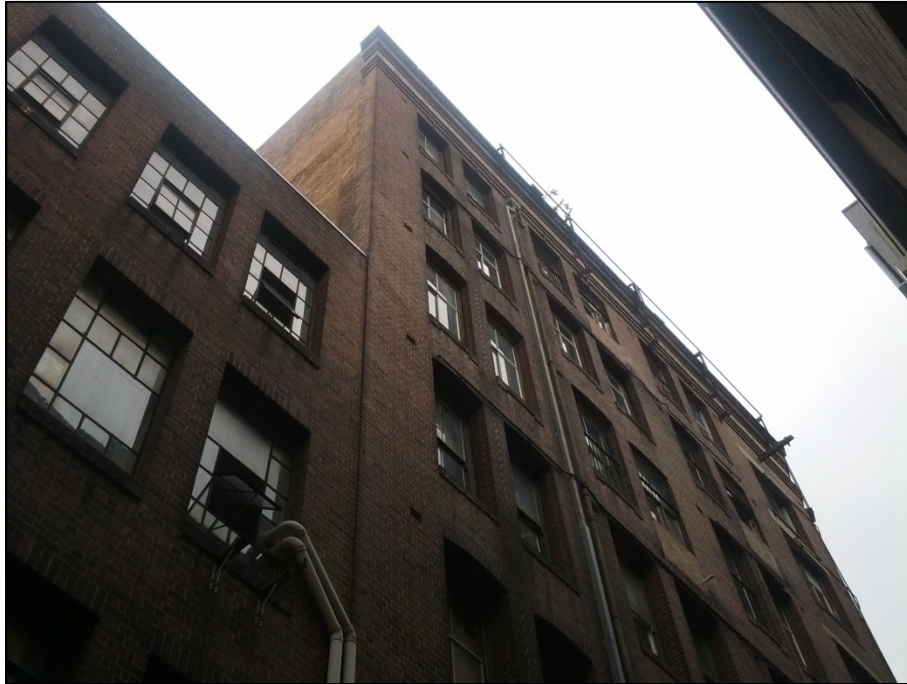
- Some vertical cracks in the parapet on Randle Lane.

**PHOTO 5: RANDLE LANE FAÇADE**
