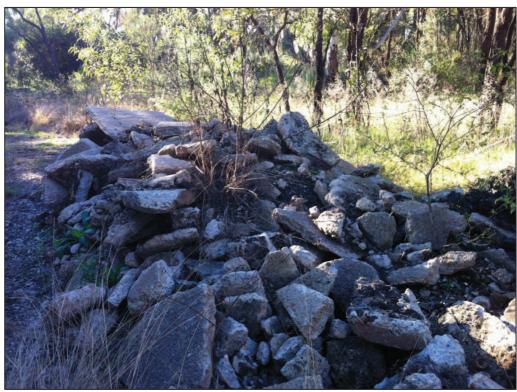
Plate 2 – Broken concrete piled adjacent to the eastern boundary of the site.

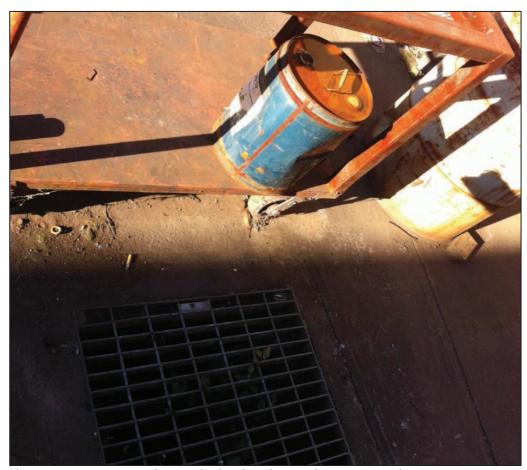
Plate 5 – Location 11 with a 20L hydraulic oil tin and stormwater drain.

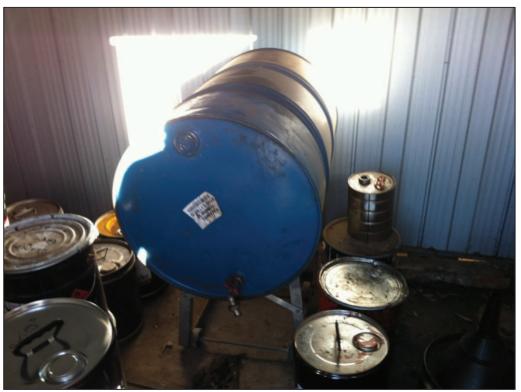
Plate 7 – 200L paint thinner AST (AST 1) inside the flammables shed.

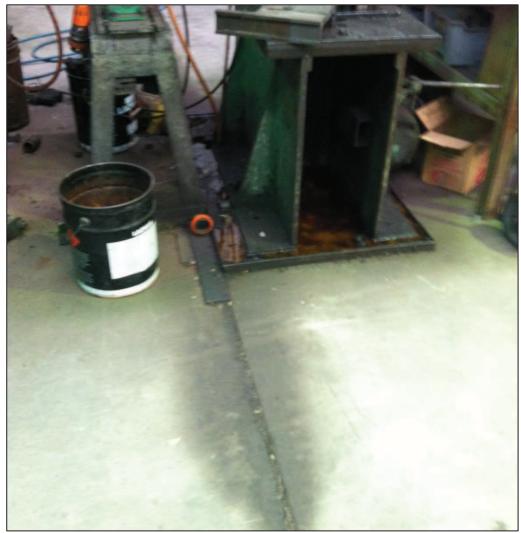
Plate 8 – Dark staining around machinery inside the Leaf Springs Shed.

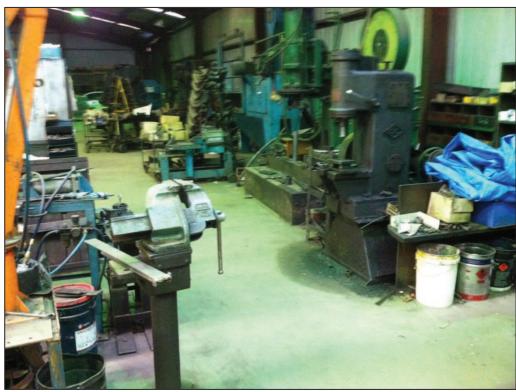
Plate 10 – Dark staining around machinery inside the Leaf Springs Shed.

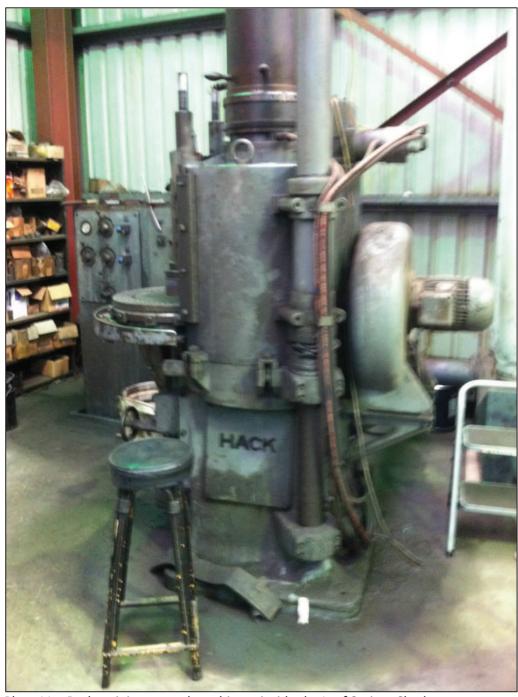
Plate 11 – Dark staining around machinery inside the Leaf Springs Shed.

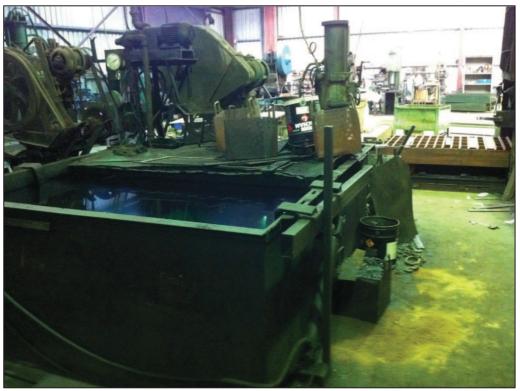
Plate 12 – Open tank filled with approximately 1,000L of tempering oil at Location 15, in the central portion of the Leaf Springs Shed

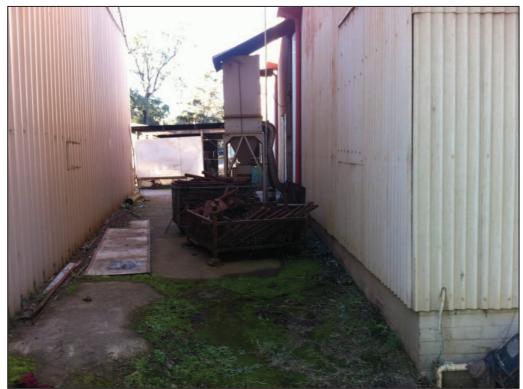
Plate 13 – Locations 16 and 17, scrap metal and a hopper (part of air extraction system for Coils Factory) between the Leaf Springs Shed and Coils Factory on the southern portion of the site.

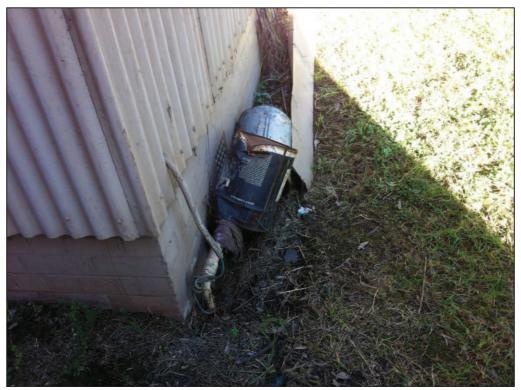
Plate 14 – Empty paint tins adjacent to the western corner of the Coils Factory.

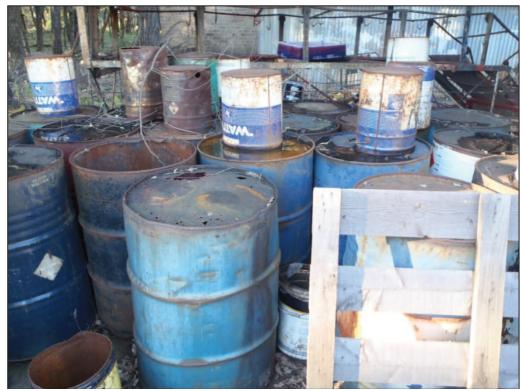
Plate 18 – Drums west of the painting shed.

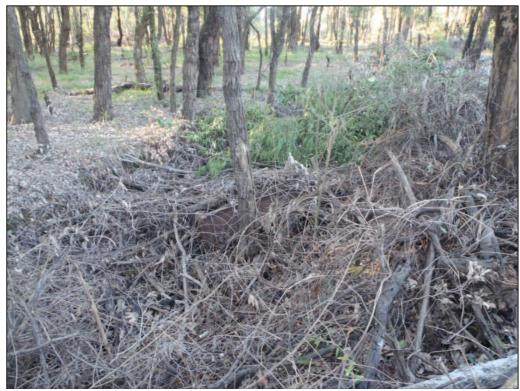
Plate 20 – Metallic items in the dry drainage channel north of the bunkers.

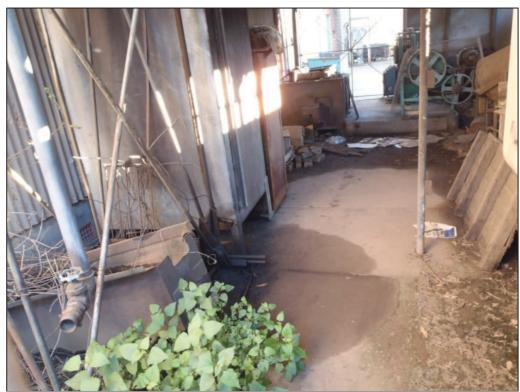
Plate 23 – Dark staining underneath AST 3 in Location 27.

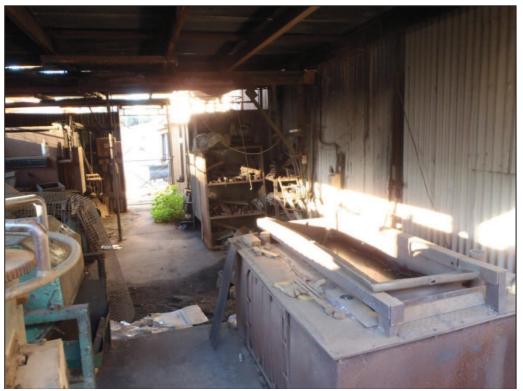
Plate 25 – Old salt bath in Location 28, adjacent to the southern wall.

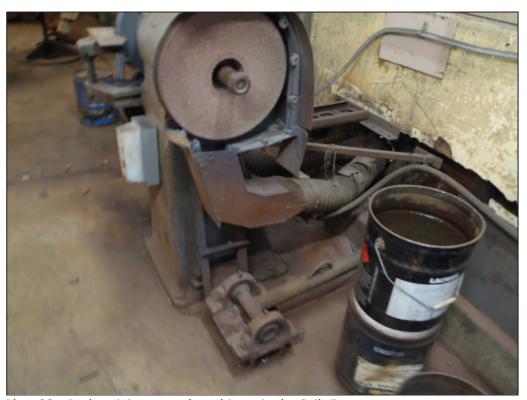
Plate 28 – Dark staining around machinery in the Coils Factory.

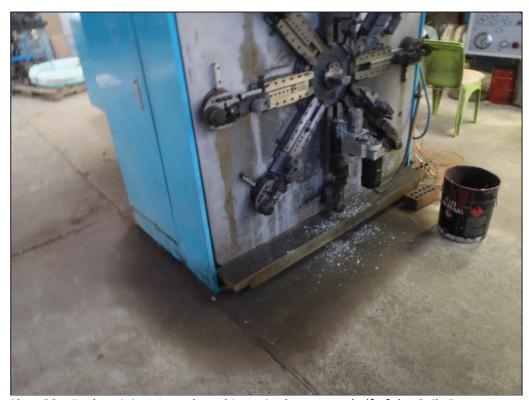
Plate 30 – Dark staining around machinery in the eastern half of the Coils Factory.

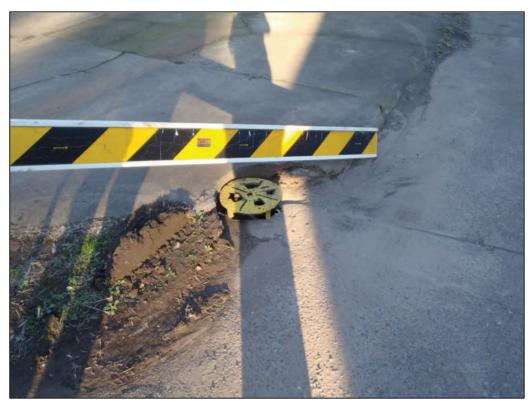
Plate 31 – Broken drain east of the Coils Factory.
