Silo Condition Assessment

Menangle Park

Prepared for: Dahua Group Sydney Project 3 Pty Ltd

Reference No: 300178115.00

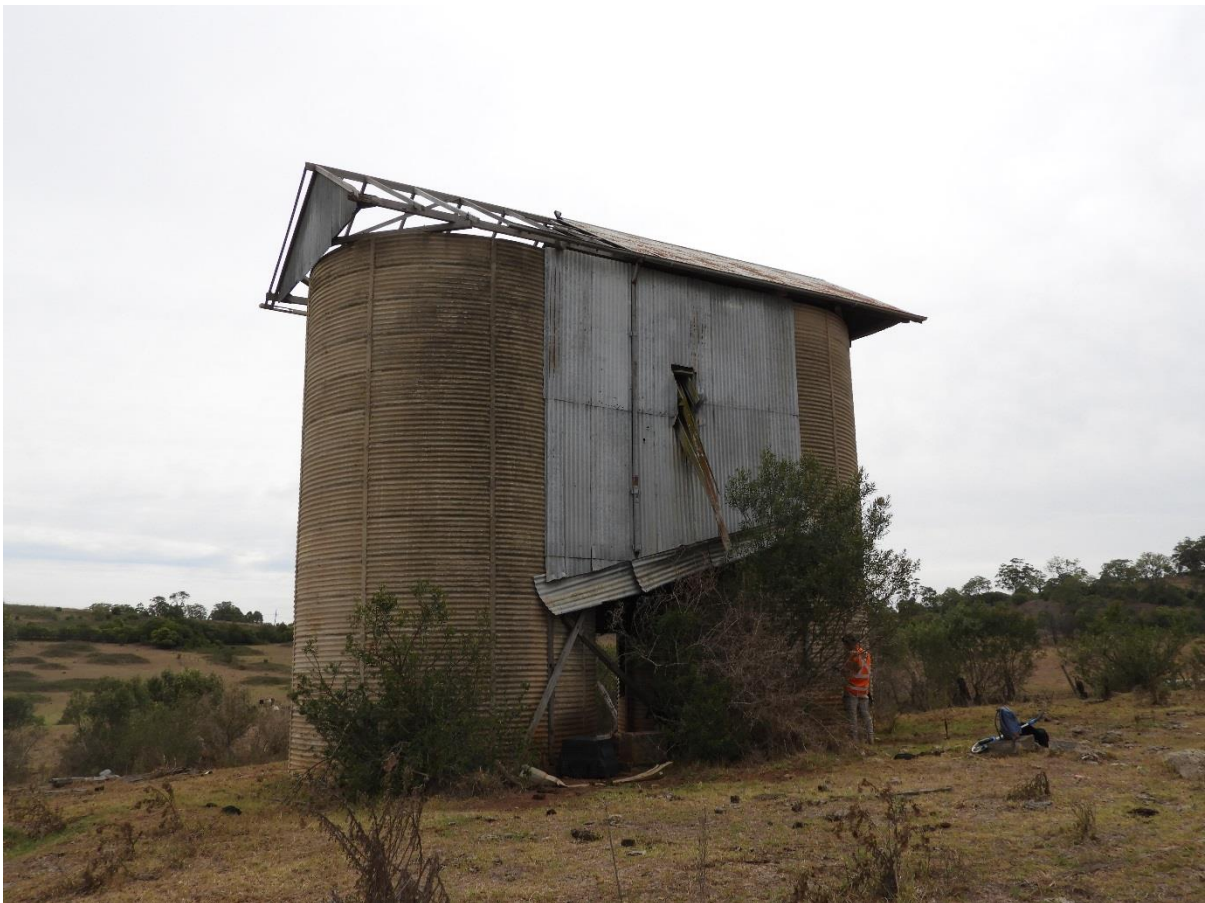
Photograph 2: South elevation of the silos.

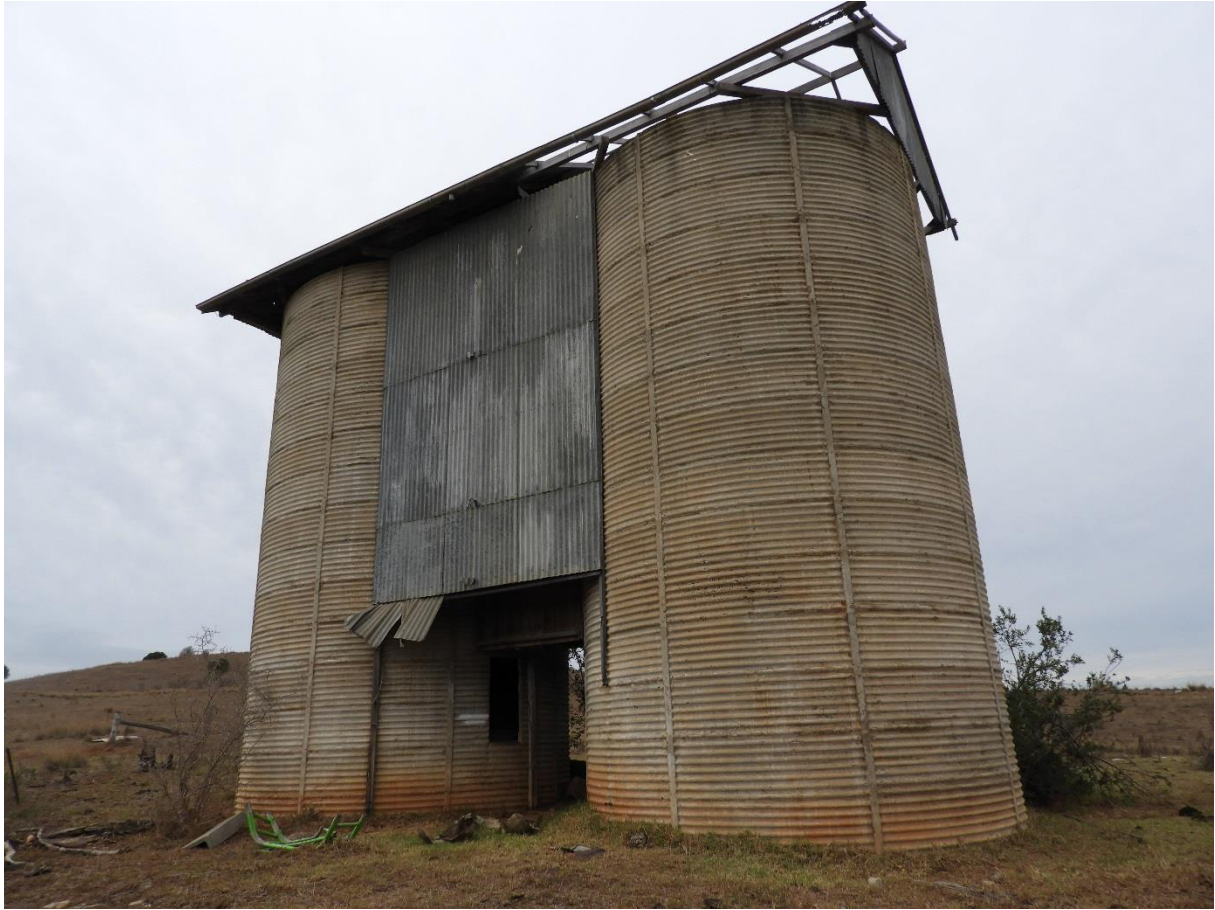
Photograph 3: North elevation of the silos.

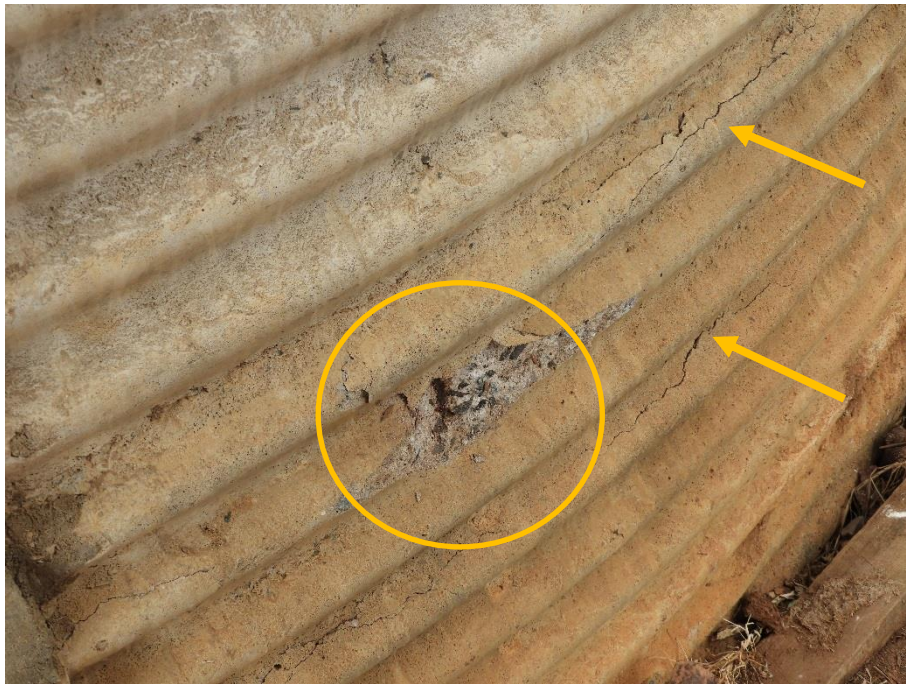
Without the benefit of chemical testing, the concrete elements appear to be in poor condition. Several areas of spalling on the external faces is apparent, particularly on the lower sections of the silos. Photograph 4 and Photograph 5 show spalled sections of concrete, and surrounding cracking indicating the commencement of spalling. Cover over the reinforcement, as seen from spalls and exposed reinforcement, appears to be minimal throughout the structure and as low as 4 mm in some locations, but up to 25 mm in others. Furthermore, some honeycombing was noted on the surface of the concrete which is potentially allowing an easy path for water to penetrate to the steel and initiate corrosion.

Photograph 4: Spalled section of concrete, and surrounding cracking indicating the commencement of spalling.

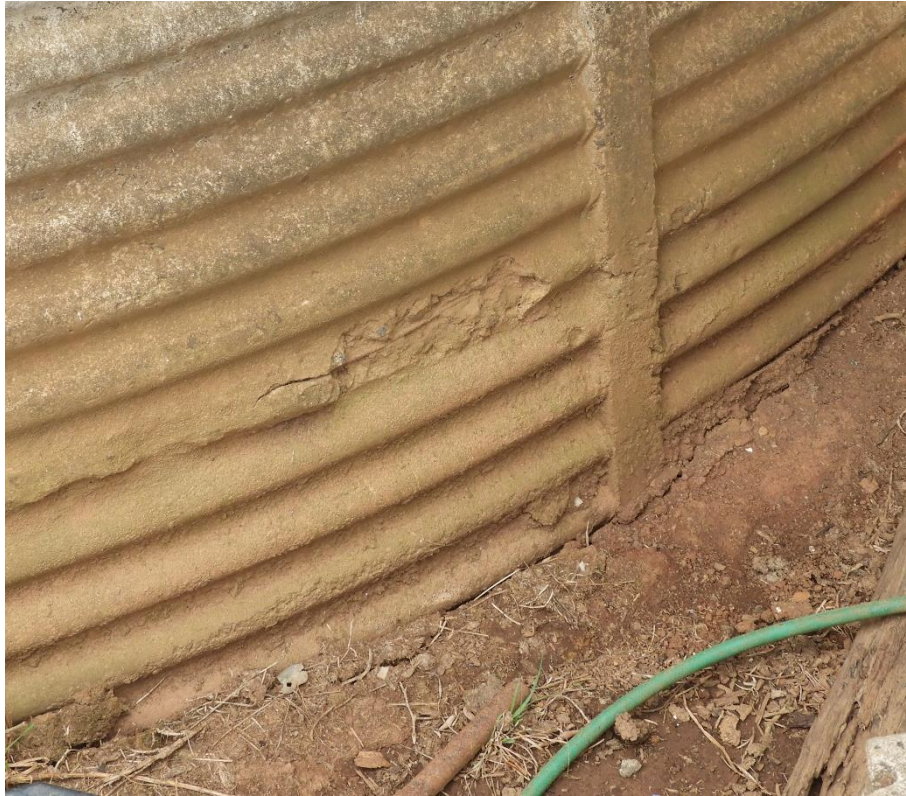
Photograph 5: Spalled section of concrete, with exposed reinforcement.

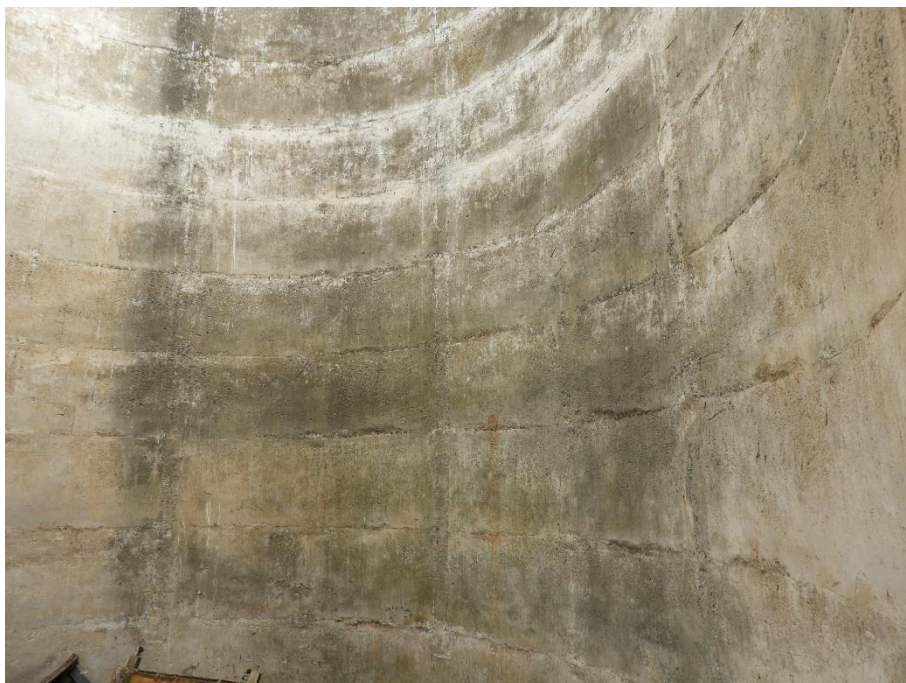
The internal faces of both concrete silos are in fair . Minor vertical shrinkage cracks up to 0.75 mm wide were noted in 2 locations.

Figure 6: Inside of western silo. Concrete is in fair to good condition.

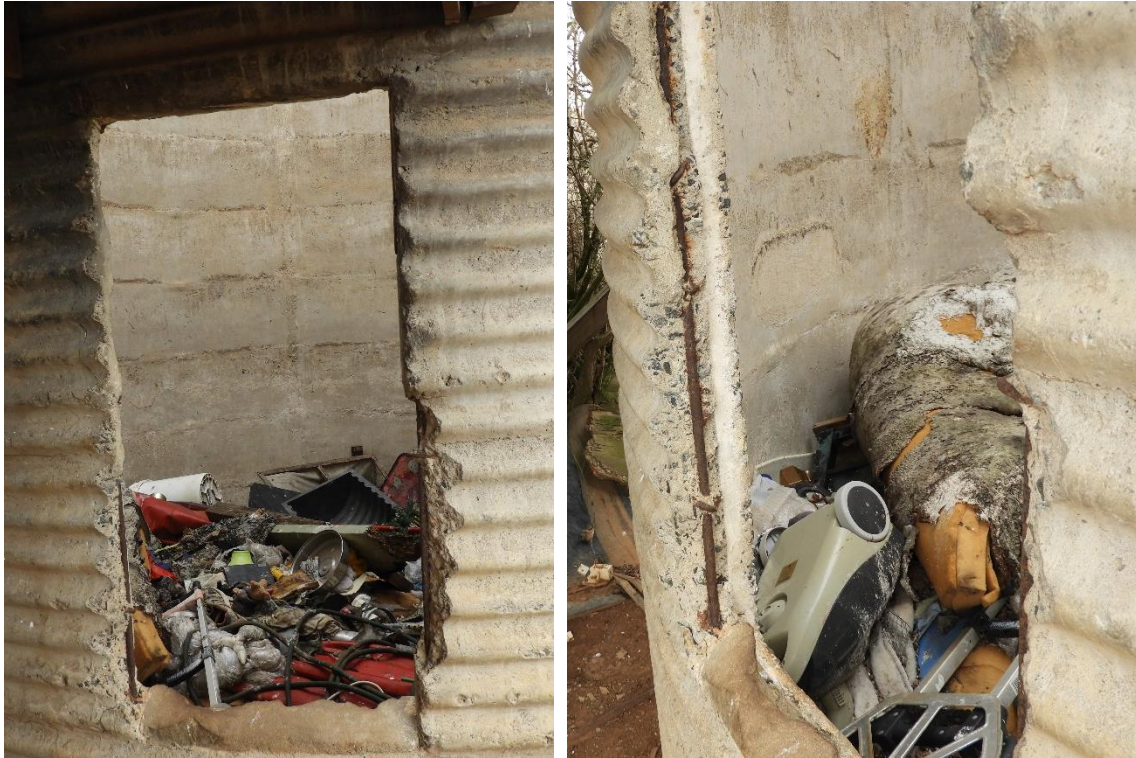
Concrete spalling and exposed and corroding reinforcement was noted around the edges of the lowest access opening of both silos. Refer Photograph 7. The openings for the upper levels did not show similar signs of deterioration. Refer Photograph 8.

Photograph 7: Spalling and exposed reinforcement around lowest opening of western silo.

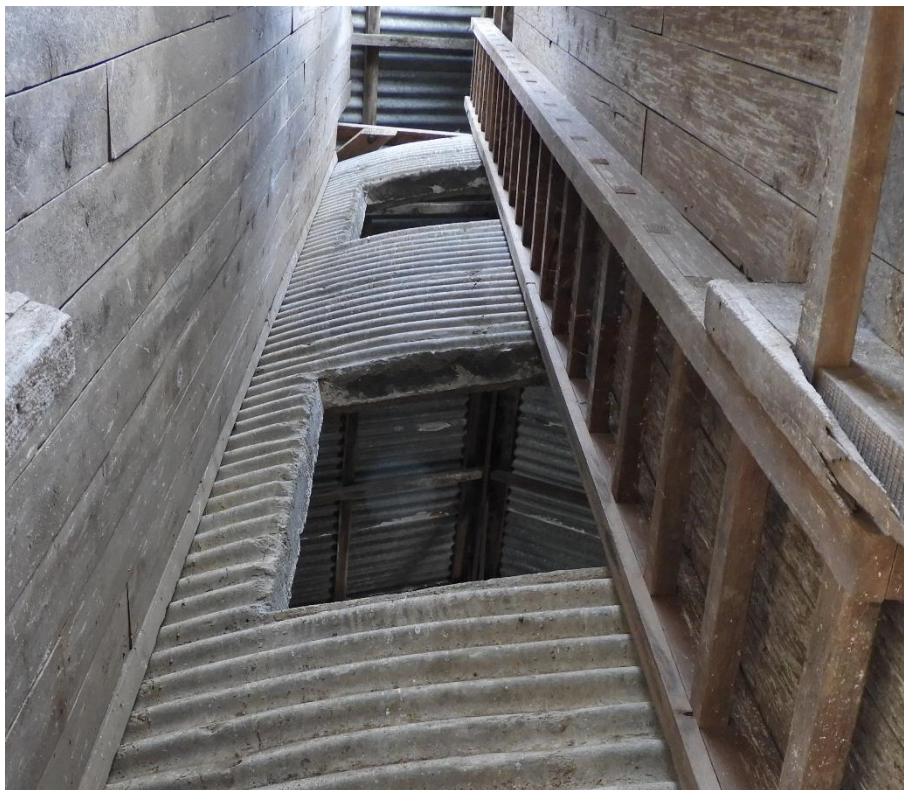
*Photograph 8: Upper openings did not show the same signs of deterioration as lowest openings.
Image of eastern silo.*

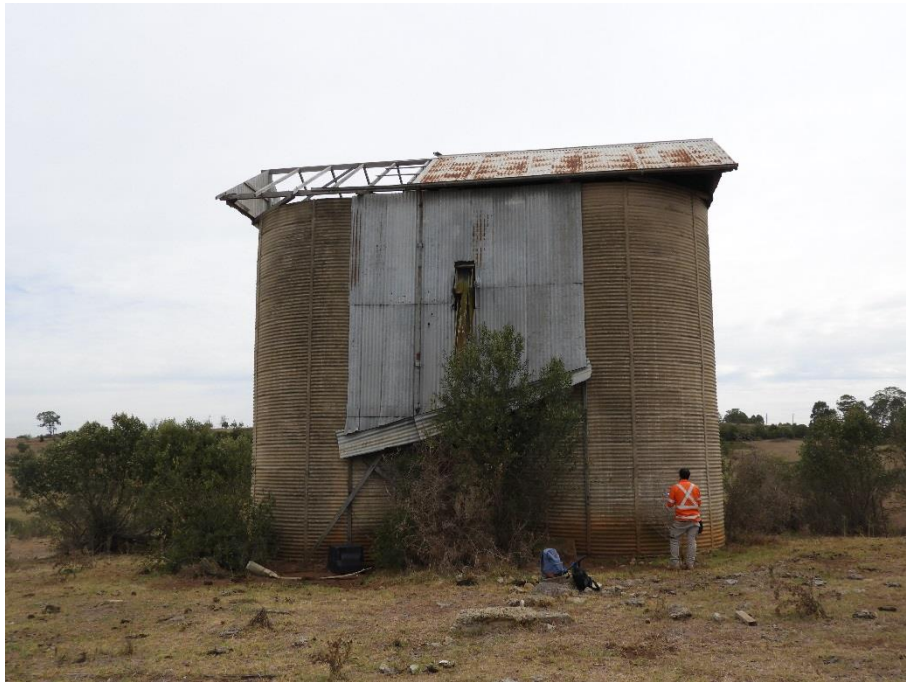
The corrugated iron roof cladding has been completely displaced from the western side of the roof which appears to be a result of failure of the battens (refer Photograph 9). Consequently, significant weathering and deterioration of the roof frame has occurred in this location (refer Photograph 10).

Photograph 9: Missing roof cladding on western side of silos.

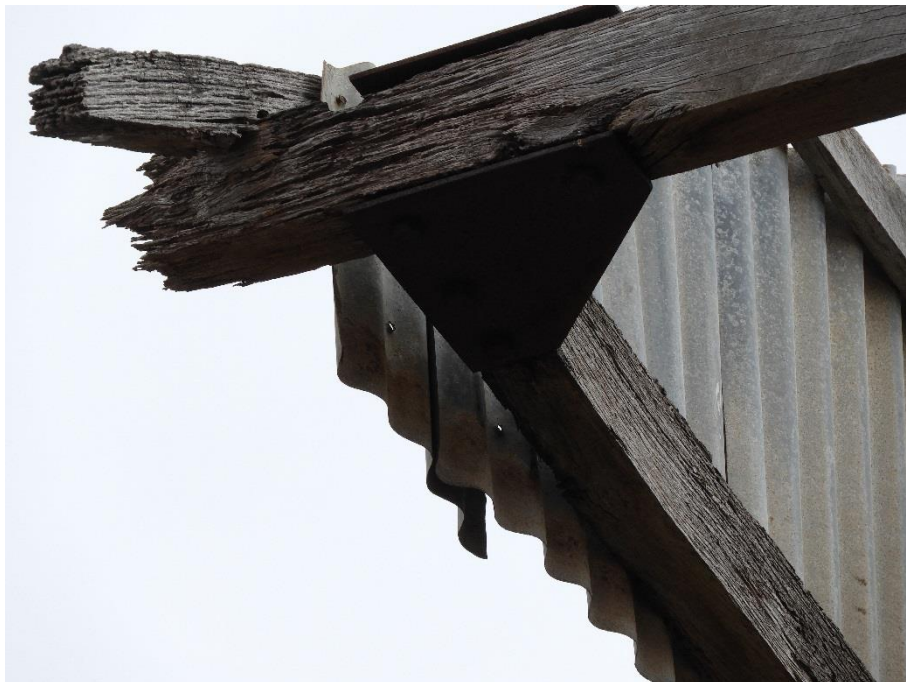
Photograph 10: Extensive weathering of exposed timber beams and rafters.

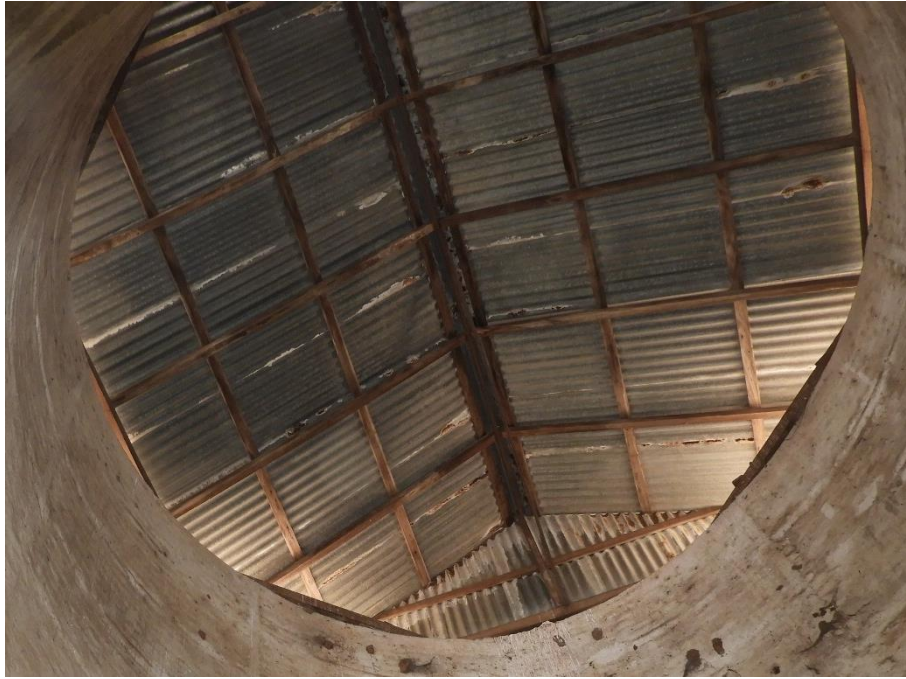
The remaining metal roof cladding is in poor condition with widespread corrosion. Refer to Photograph 9 and Photograph 11. The structural timber sections of the roof that have remained sheltered by the cladding are in fair condition – refer to Photograph 11, Photograph 12 and Photograph 13. The steel plates at the connections are also in acceptable condition, with surface corrosion noted only – refer to Photograph 12 and Photograph 13.

Photograph 11: Steel cladding and timber structural members are in good condition on eastern side of silos. Photo looking up through east silo.

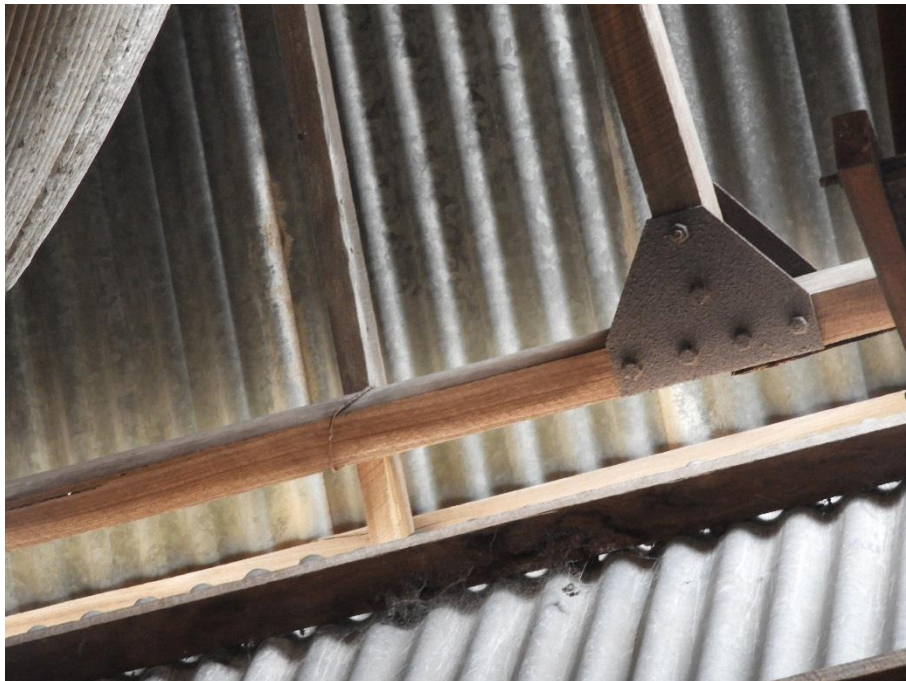
Photograph 12: Steel plates at connections are in acceptable condition. The timber beams and rafters undercover have remained in good condition.

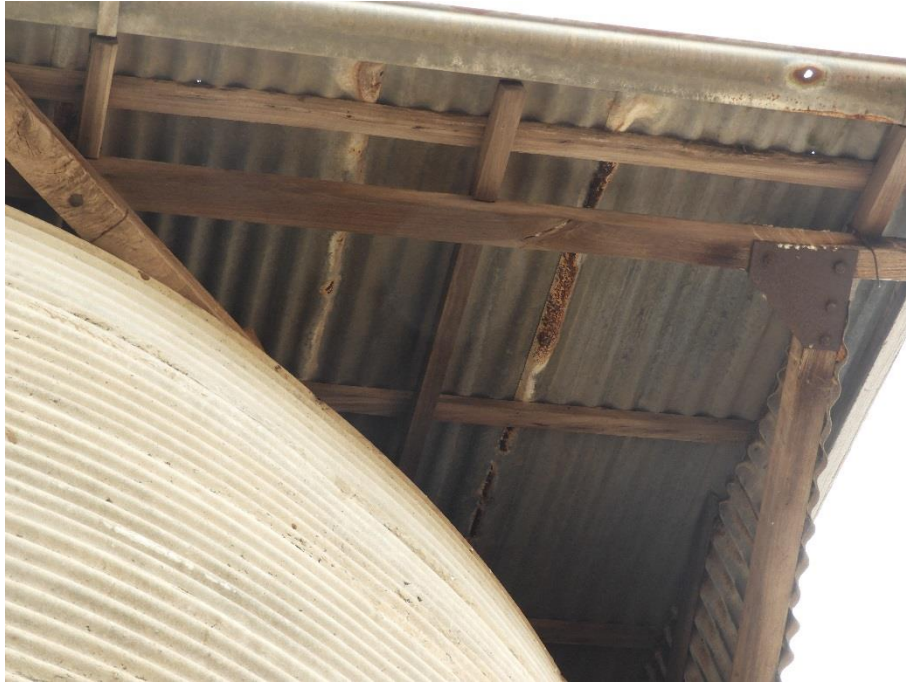
Photograph 13: Steel plates at connections are in acceptable condition. The timber beams and rafters under cover have remained in good condition. Corrosion on the underside of the roof cladding.

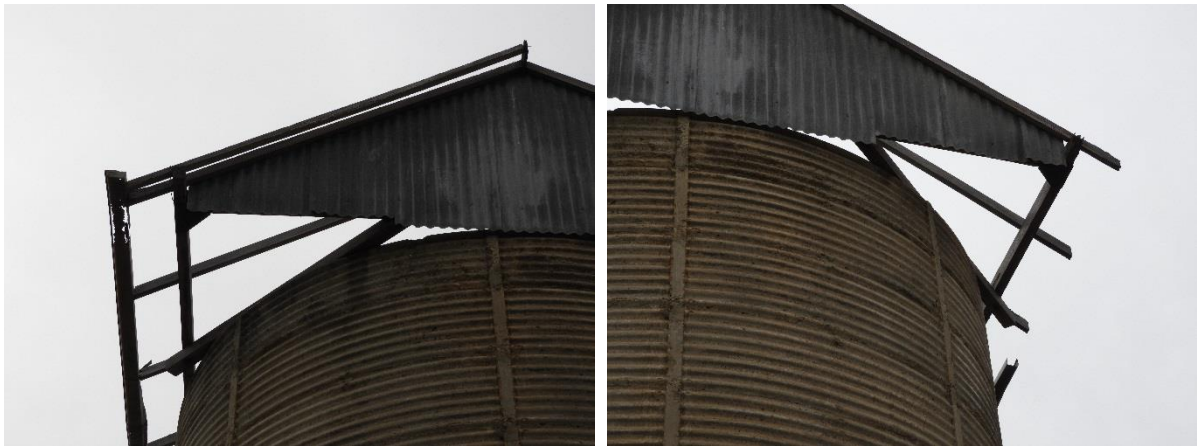
The gutters show significant corrosion throughout, and is perforated as a result. A section of gutter on the south-western side is missing (refer to Photograph 14).

Photograph 14: Corrosion of gutter on north western side (left), and gutter missing on south western side (right).

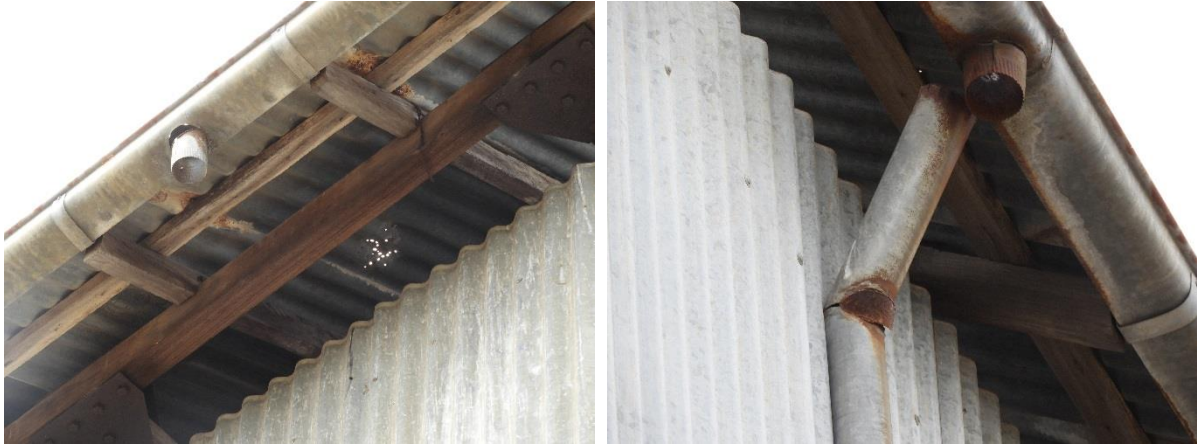
The downpipe is missing on the north face of the silos, and the downpipe on the south face is not connected to the gutter. Significant corrosion of the downpipe is occurring (refer to Photograph 15).

Photograph 15: Downpipe missing on north face (left), and downpipe not connected on south face (right).

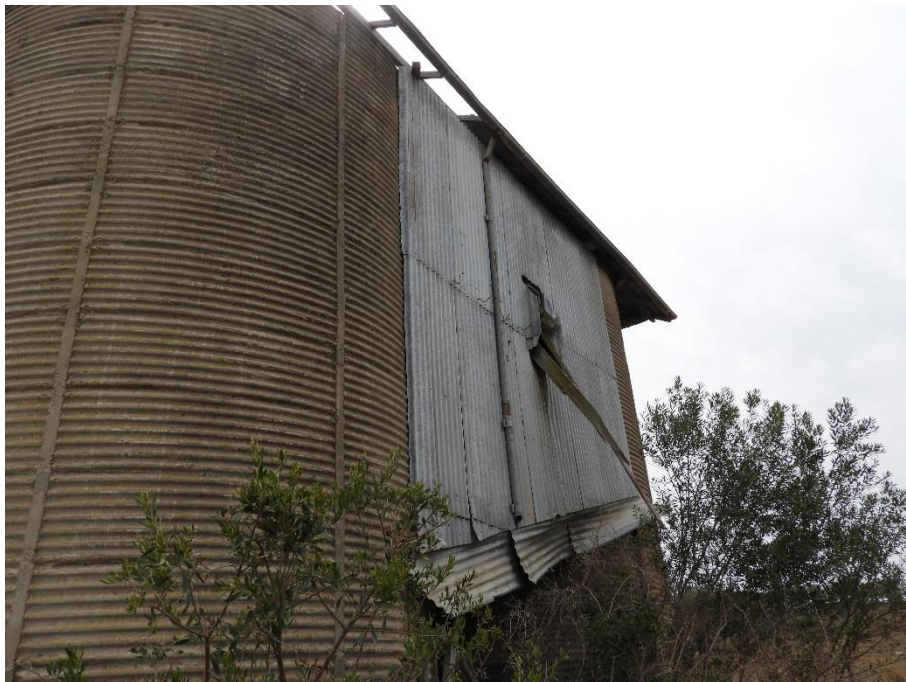
The corrugated iron façade is deteriorated, deformed and displaced on both the north and south elevations (refer to Photograph 16 and Photograph 17). However, the sheeting still provides some level of protection to the timber access structure.

Photograph 16: Façade on southern elevation.

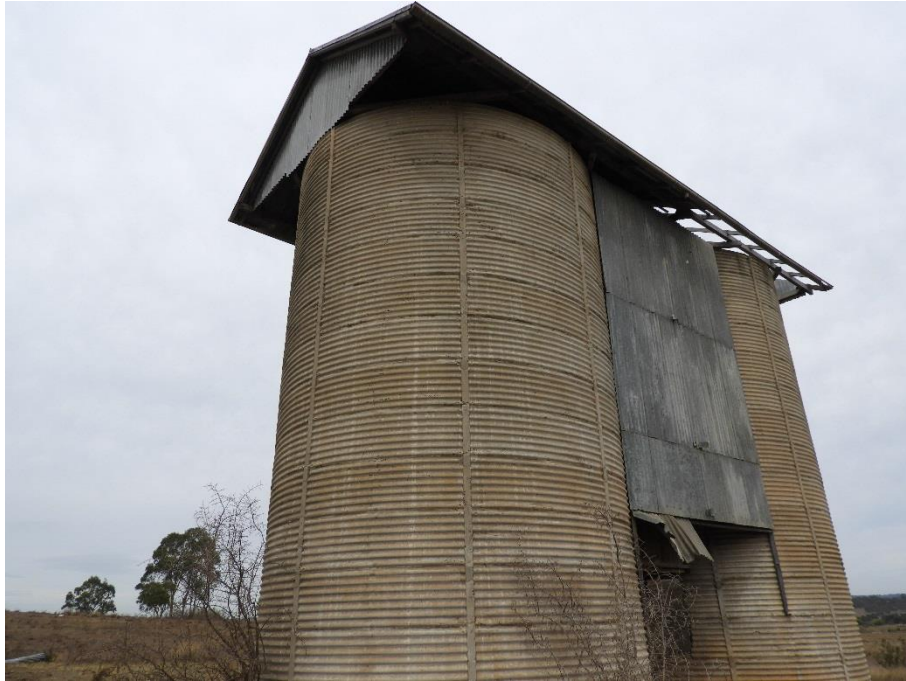
Photograph 17: Façade on northern elevation.

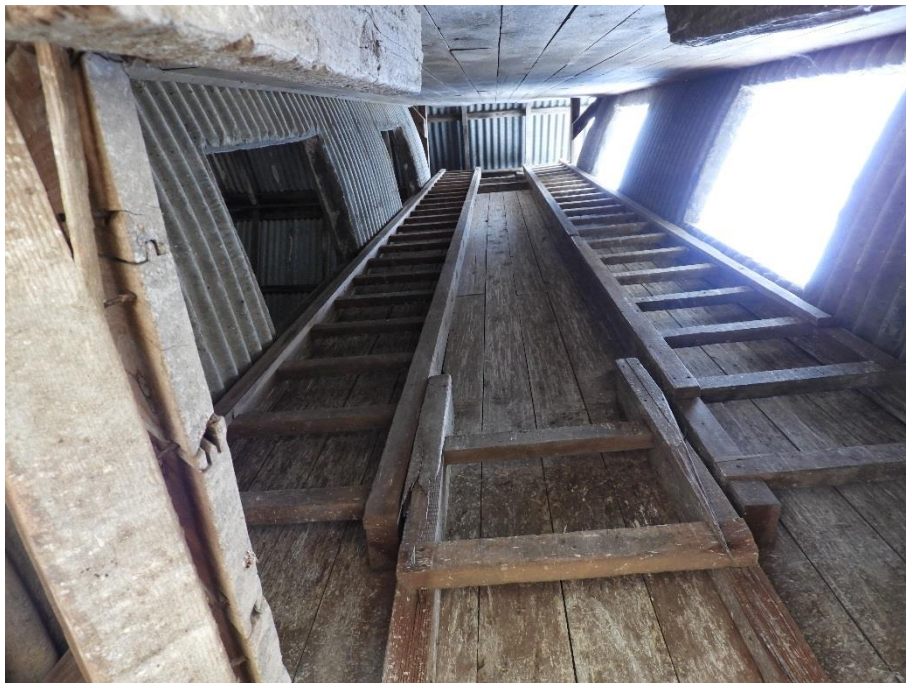
Photograph 18: Internal ladder on north side of silo. Deterioration of the lowest section can be seen at the bottom left of the image.

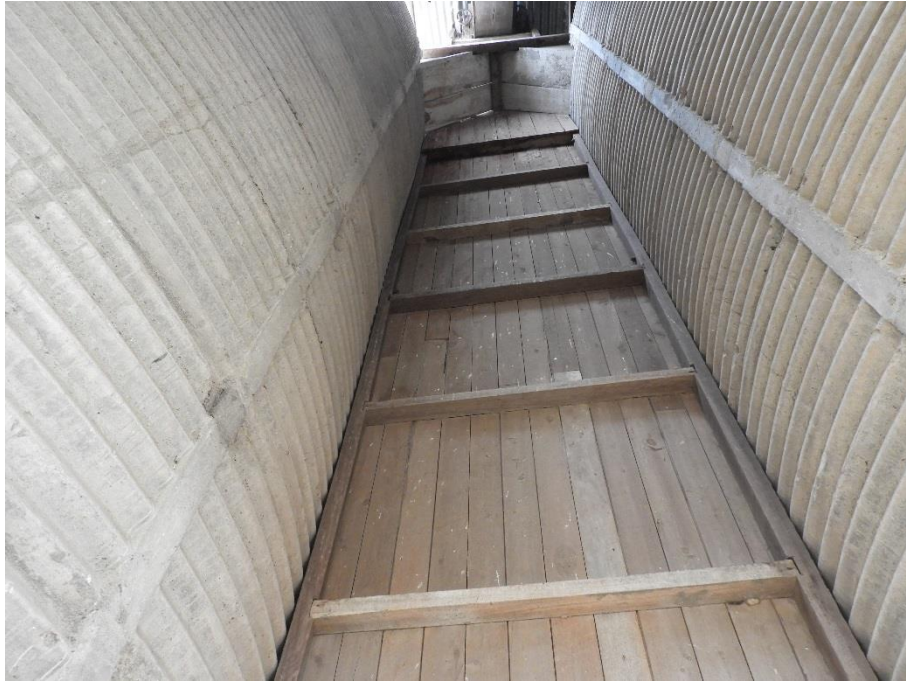
Photograph 19: Internal structure on south side of silos.

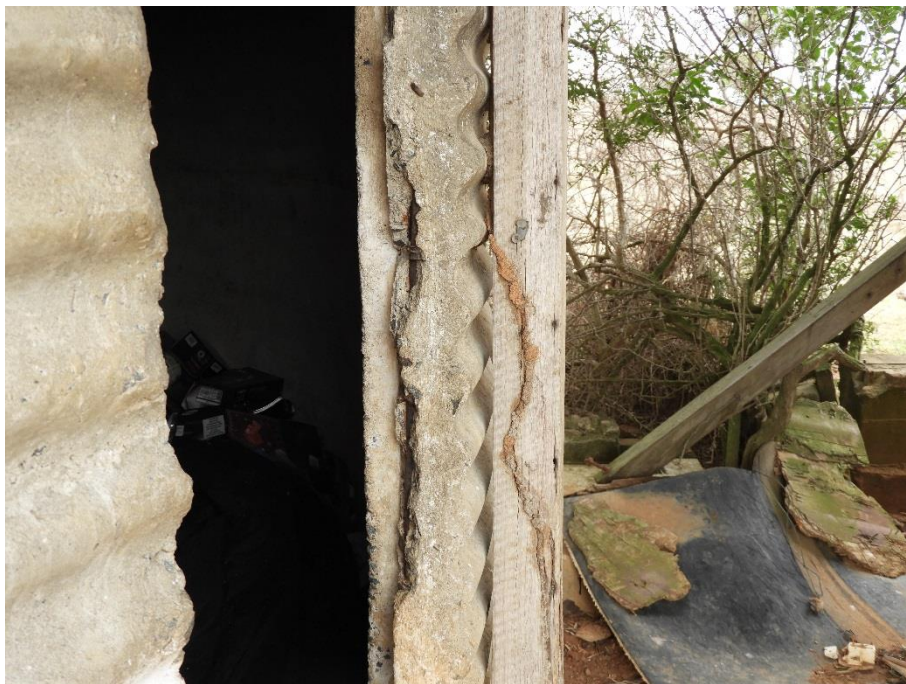
The façade is supported by a timber frame spanning between the silos which also supports a timber ladder providing access to the top of the silos. The timber structure appears to be affected by termites or borers which has compromised the structural integrity of the frame (refer Photograph 20). For this reason, access was not possible to undertake a thorough assessment and determine the extent of the infestation.

Photograph 20: Evidence of termites or borers in timber frame.

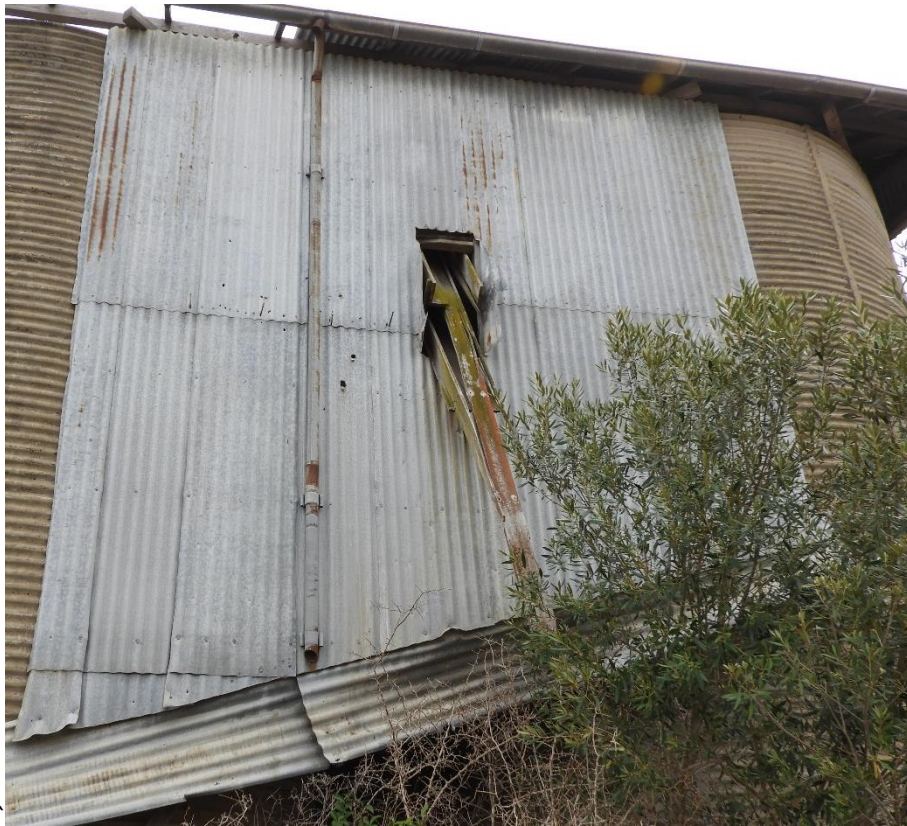
A grain chute extends through the southern face of the façade and is in a state of disrepair. The exposed structure has failed and splintered sections hang through the opening (refer to Photograph 21).

Photograph 21: Exposed section of grain chute on southern elevation has failed.

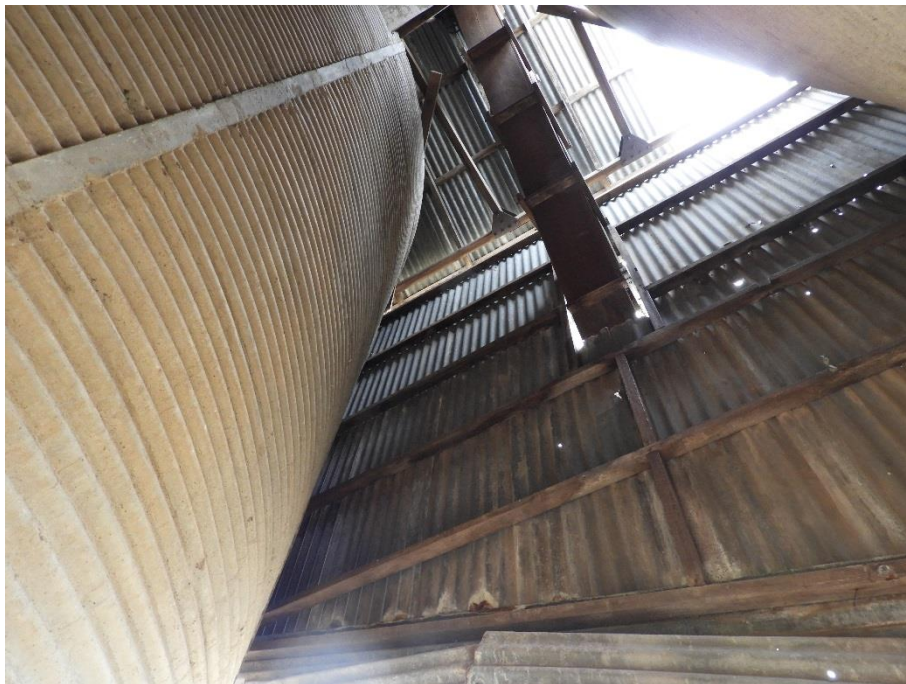
Photograph 22: Internal section of grain chute.

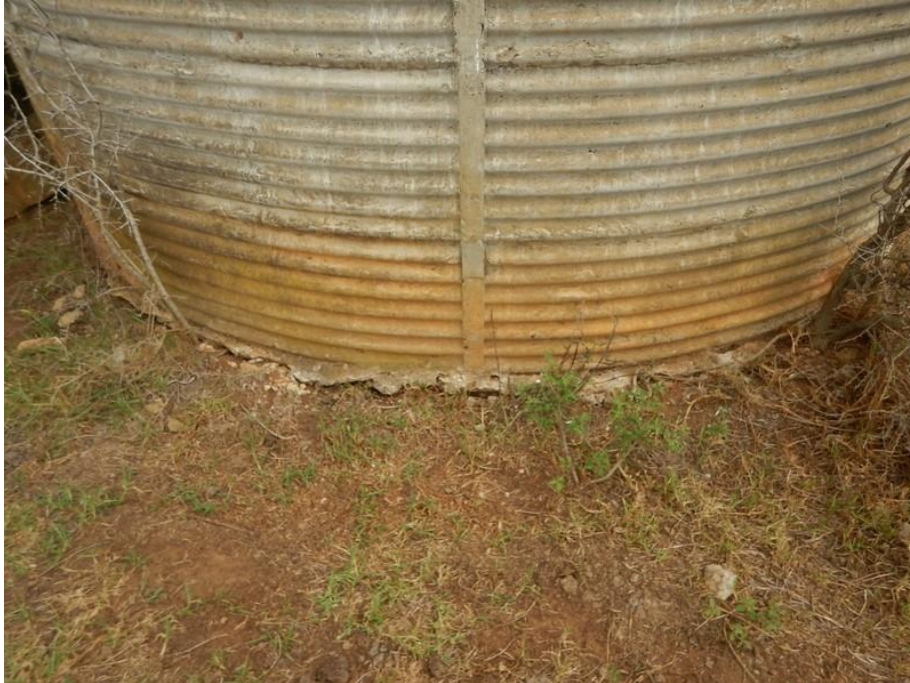
Ground subsidence in the clay foundations was evident around the footings of the silos (refer to *Photograph 23: Ground subsidence evident around the base of the silos.*). This does not appear to be having any consequence on the structure at this stage but will undermine the structure in future if unaddressed.

Photograph 23: Ground subsidence evident around the base of the silos.

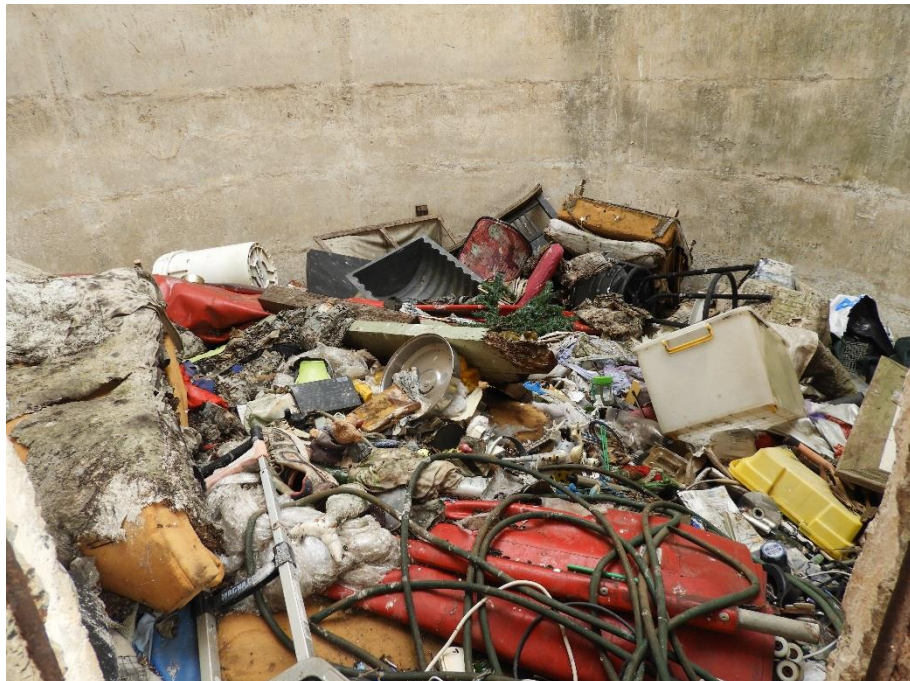
Both silos currently have a large amount of rubbish inside which is holding moisture and will impact on the durability of the silos (refer to Photograph 24).

Photograph 24: Large amount of rubbish can be found inside both silos

In its current state, the silo is not considered to be safe and suitable for a residential environment. There is a substantial amount of rubbish that has accumulated within the silos that is required to be tipped.

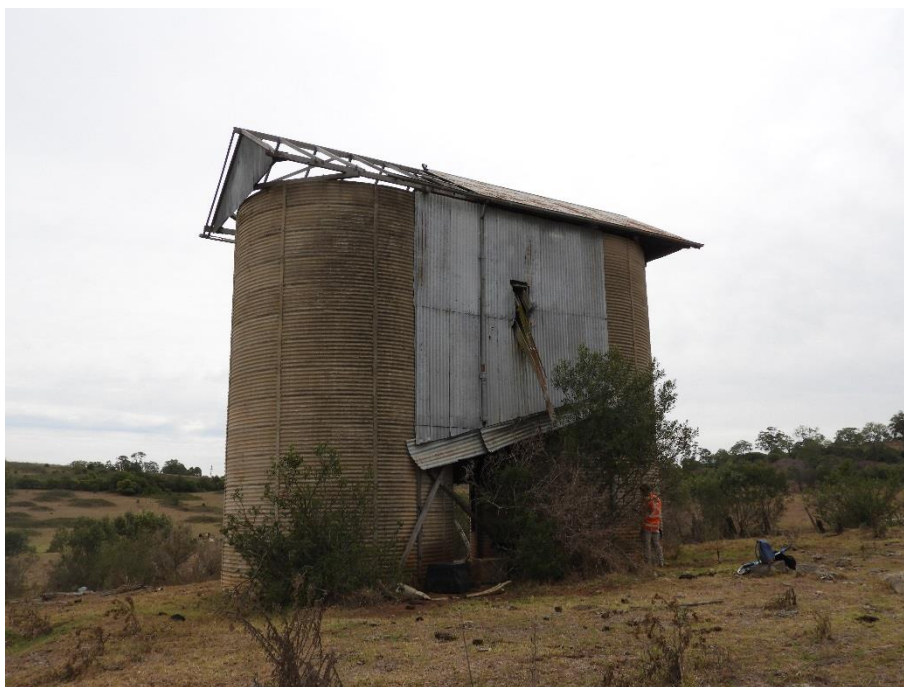
Overgrown vegetation is present around both silos, particularly on the south face of the silos (refer to Photograph 25).

Photograph 25: Overgrown vegetation on south side of silos
