### Memo

| Our Ref: | 16-0095 |
| Subject: | Sydney Polo Club – Heritage Advice |

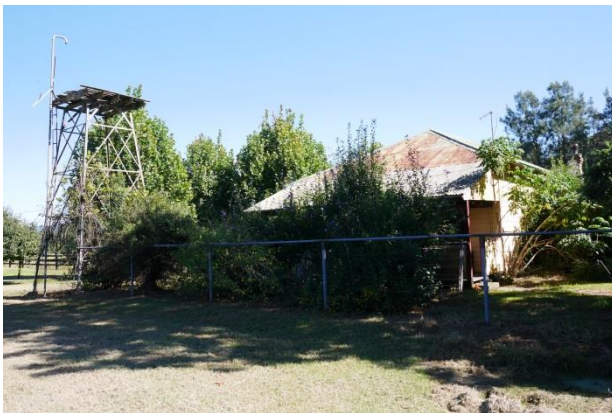
A farm building constructed c1900-1910s was identified approximately 60m west of the Polo Barn Function Centre and an exterior visual inspection of the building was conducted. The building is single storey, raised on brick piers with a rectangular footprint measuring approximately 17 by 8m. It consists of a weatherboard and fibrous cement façade, corrugated metal roof and 2m wide timber awnings supported by timber posts on both the northern and southern elevations. The building has a brick chimney on the western elevation with timber box framed windows and an outdoor toilet and laundry extension to the rear of the building. The farm building appears to be heavily altered and in dilapidated condition. It suffers extensive cracking and damage to the facade, as well as roof corrosion and possible termite infestation. An interior inspection was not conducted for the purpose of this study.

**Figure 2** Southern elevation of farm building, remnant water tower and metal fence

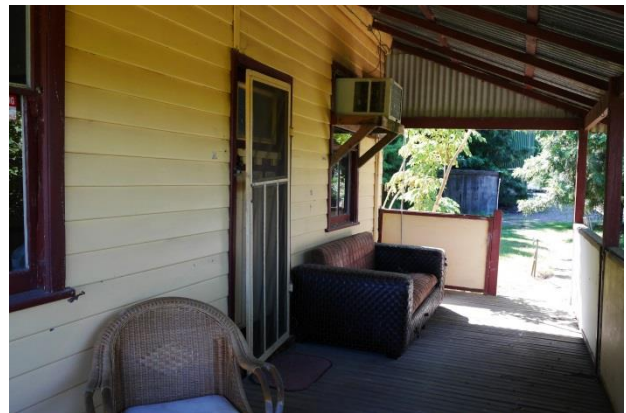
**Figure 3** Corrugated metal verandah on northern façade, supported by timber posts, with hardwood flooring.

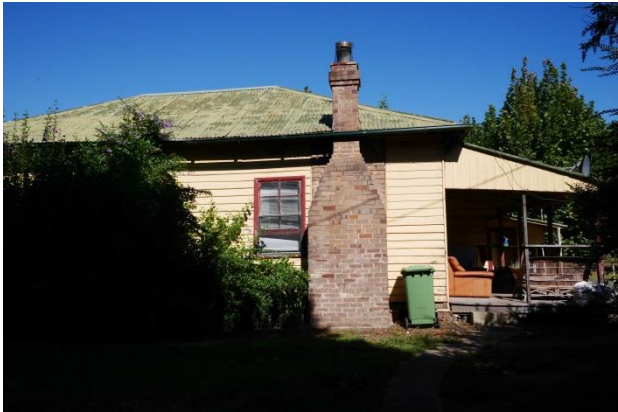
**Figure 4** Western elevation of farm building (Source: GML 2016)

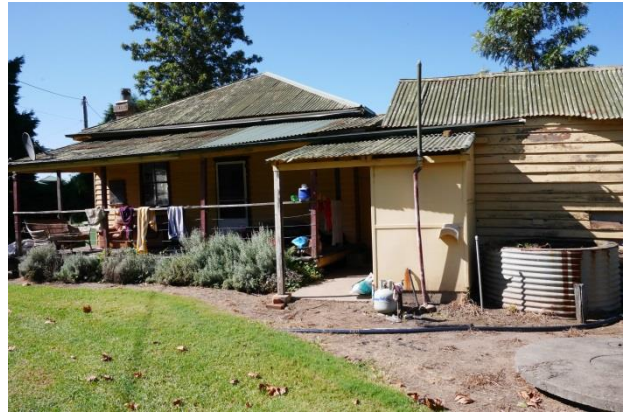
**Figure 5** Northern elevation of farm building showing toilet/laundry extension (Source: GML 2016)

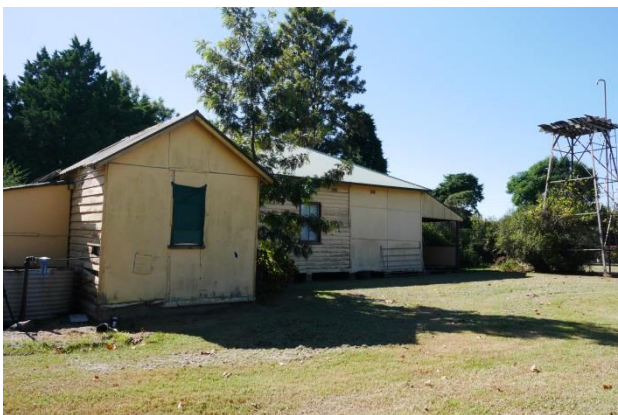
**Figure 6** Eastern elevation of farm building (Source: GML 2016)

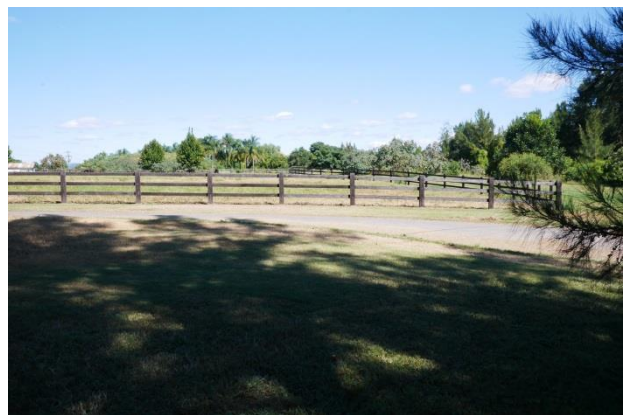
The site contains a timber fence approximately 20m to the south-west of the farm building; however it is unclear whether this is the fence identified as part of the SREP listing, or a modern addition. The fence encloses a grazing pasture, and is a simple agricultural style fence with timber rails connected by timber posts. There is no timber fence in the immediate vicinity or directly associated with the farm building, nor is there any evidence of a previously removed fence.

**Figure 7** Adjacent grazing pasture and timber post fence (Source GML 2016)

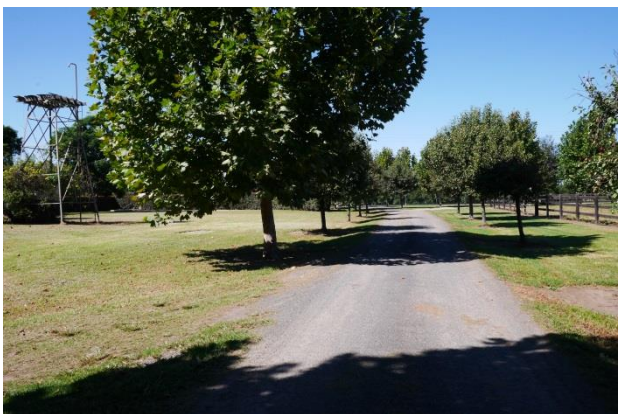
**Figure 8** Laneway between farm building and grazing pasture. Timber fence visible to the far right of image (Source: GML 2016)

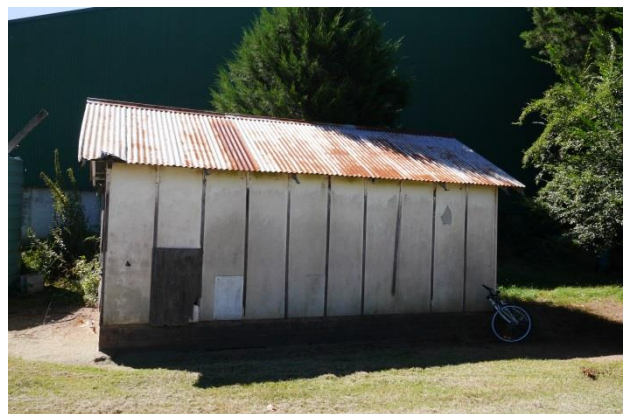
**Figure 9** Storage shed (Source: GML 2016)
