## **ARBORICULTURAL IMPACT ASSESSMENT REPORT**

**58 – 76 Stanmore Road  
Stanmore**

**Cyprus Club**

**10<sup>th</sup> December 2016**

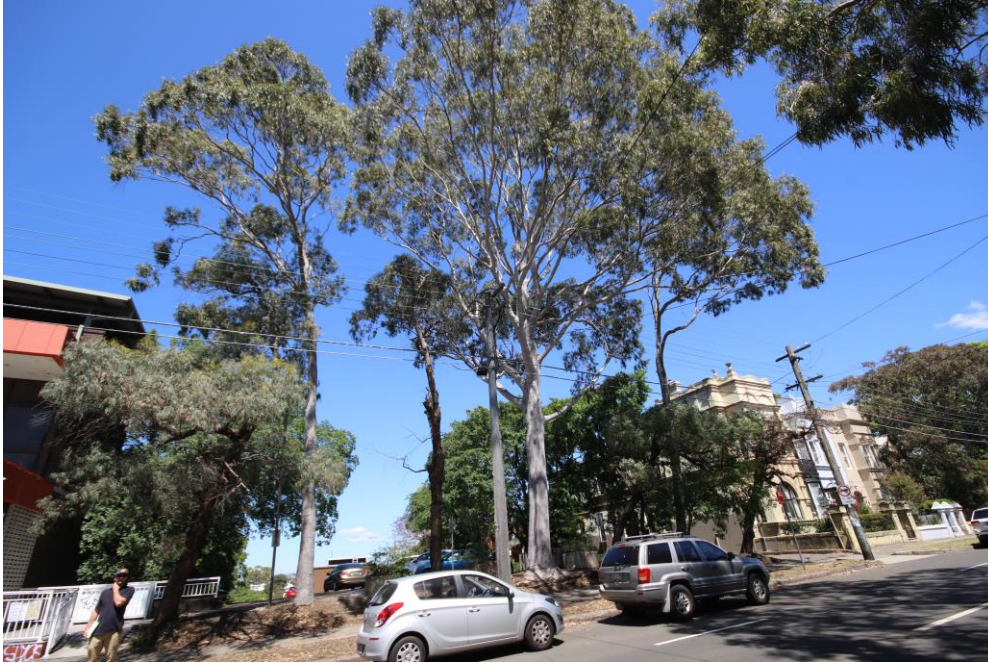
4. The following site trees can be retained as the development works have less than 10% encroachment within their TPZ: Tree 7 *Corymbia citriodora* (good vitality), tree 9 *Corymbia citriodora* (good vitality) and tree 11 *Corymbia citriodora* (good vitality) – refer plate 1;

Plate 1 showing trees 11, 9 & 7

- c. Retain the following trees on site: Trees 7, 9 & 11;
- d. Retain the following street tree: Trees 21;
- e. Tree removal work shall be carried out by an experienced tree surgeon in accordance with NSW WorkCover Code of Practice for Amenity Tree Industry (2007);

- g. Trunk protection shall consist of a padding material such as hessian or thick carpet underlay wrapped around the trunk. Hardwood planks (50mm x 100mm or similar) shall be placed over the padding and around the trunk of the tree at 150mm centres. The planks shall be secured with 8 gauge wire or hoop steel at 300mm spacing. Trunk protection shall extend a minimum height of 2 metres or to the maximum possible length permitted by the first branches on Trees 7, 9 & 11 – refer Annexure D;

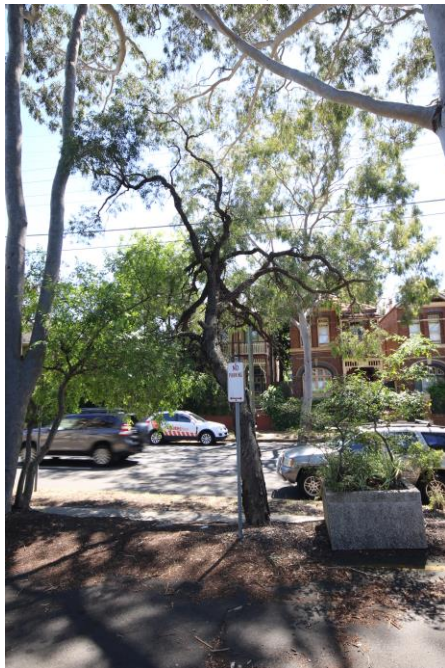
5. The following trees are not impacted by the development works, however their form and lack of vitality warrants removal to provide space for replacement planting: Tree 8 *Eucalyptus nicholii* (stunted and poor vitality) – refer plate 2 and tree 12 *Eucalyptus nicholii* (fair vitality but stunted form) – refer plate 3. Note these trees for removal in the TMP;

Plate 2 – tree 8

- a. Remove the following Exempt trees on site: Trees 3, 6, 10, 15A, 19 & 20;
- b. Remove the following trees on site: Trees 1, 2, 4, 5, 8, 12, 14, 15, 18, 18A, 20A & 20B;

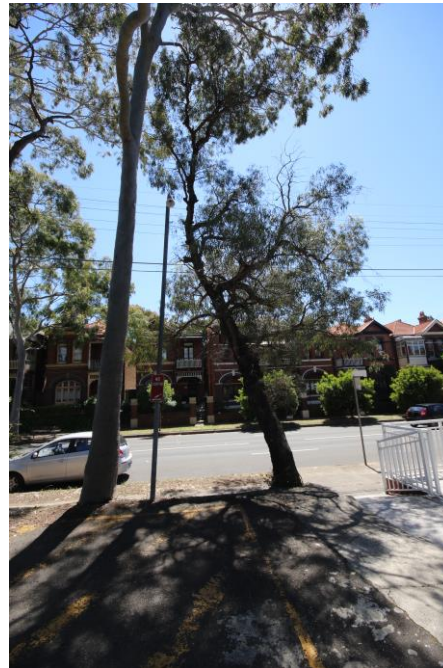
Plate 3 – tree 12
