31 May 2016

**SUBJECT: Preliminary Contamination Investigation**

**SITE: 8 Narabang Way, Belrose NSW**

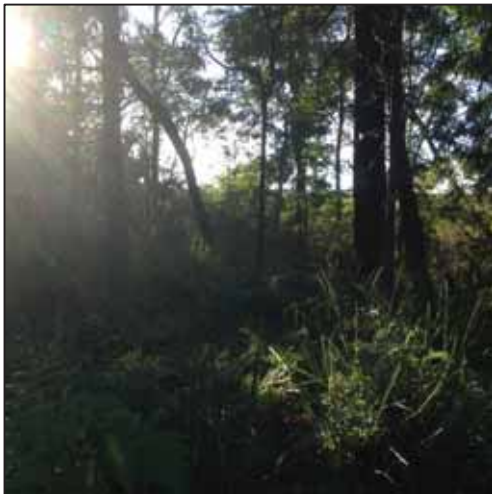
Plate 1 – View east towards neighbouring commercial property.

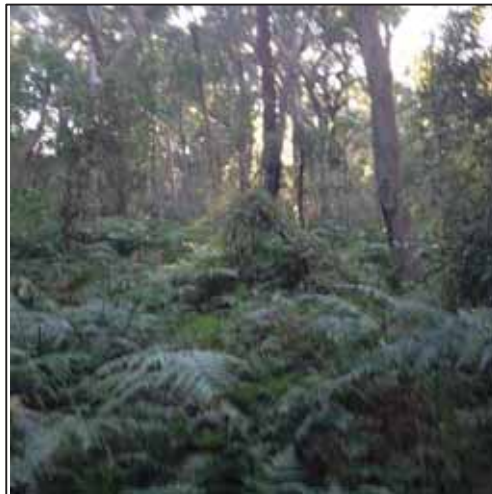
The site slopes down towards the southeast and is densely vegetated by mature native trees, understory shrubs and some weed species. No signs of surface contamination, dumped waste materials or potentially contaminating activities at the site and surrounds were observed during the inspection.

Plate 2 – View north from the southern portion of the lot.

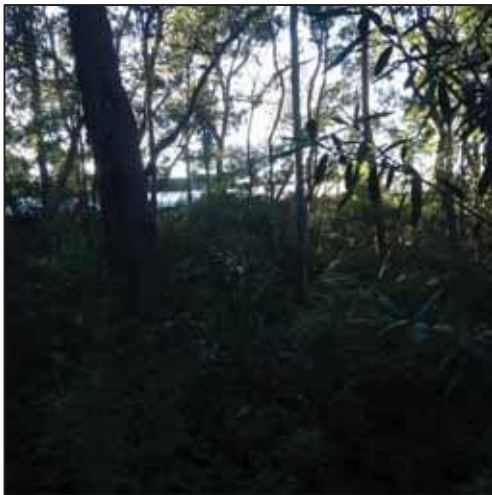
Plate 3 – View west towards neighbouring commercial property.

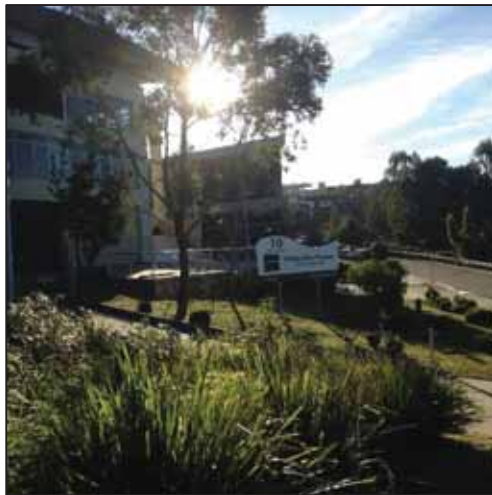
Plate 4 – Neighbouring property to the east.

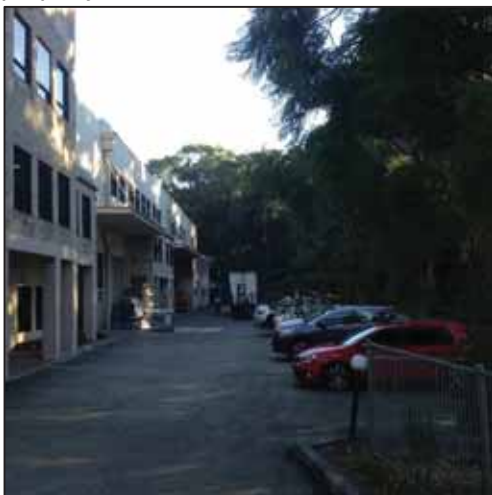
Plate 5 – Neighbouring property to the west.

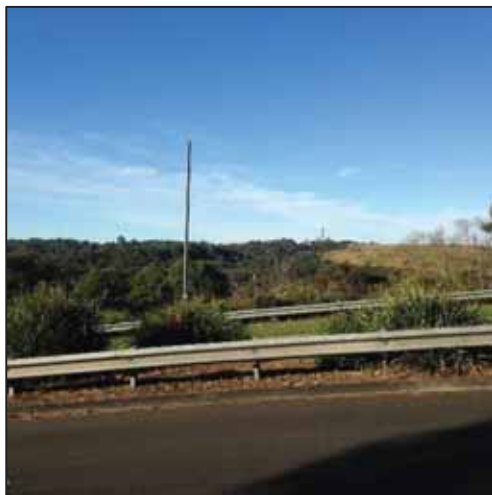
Plate 6 – View across Narabang Way to the south.

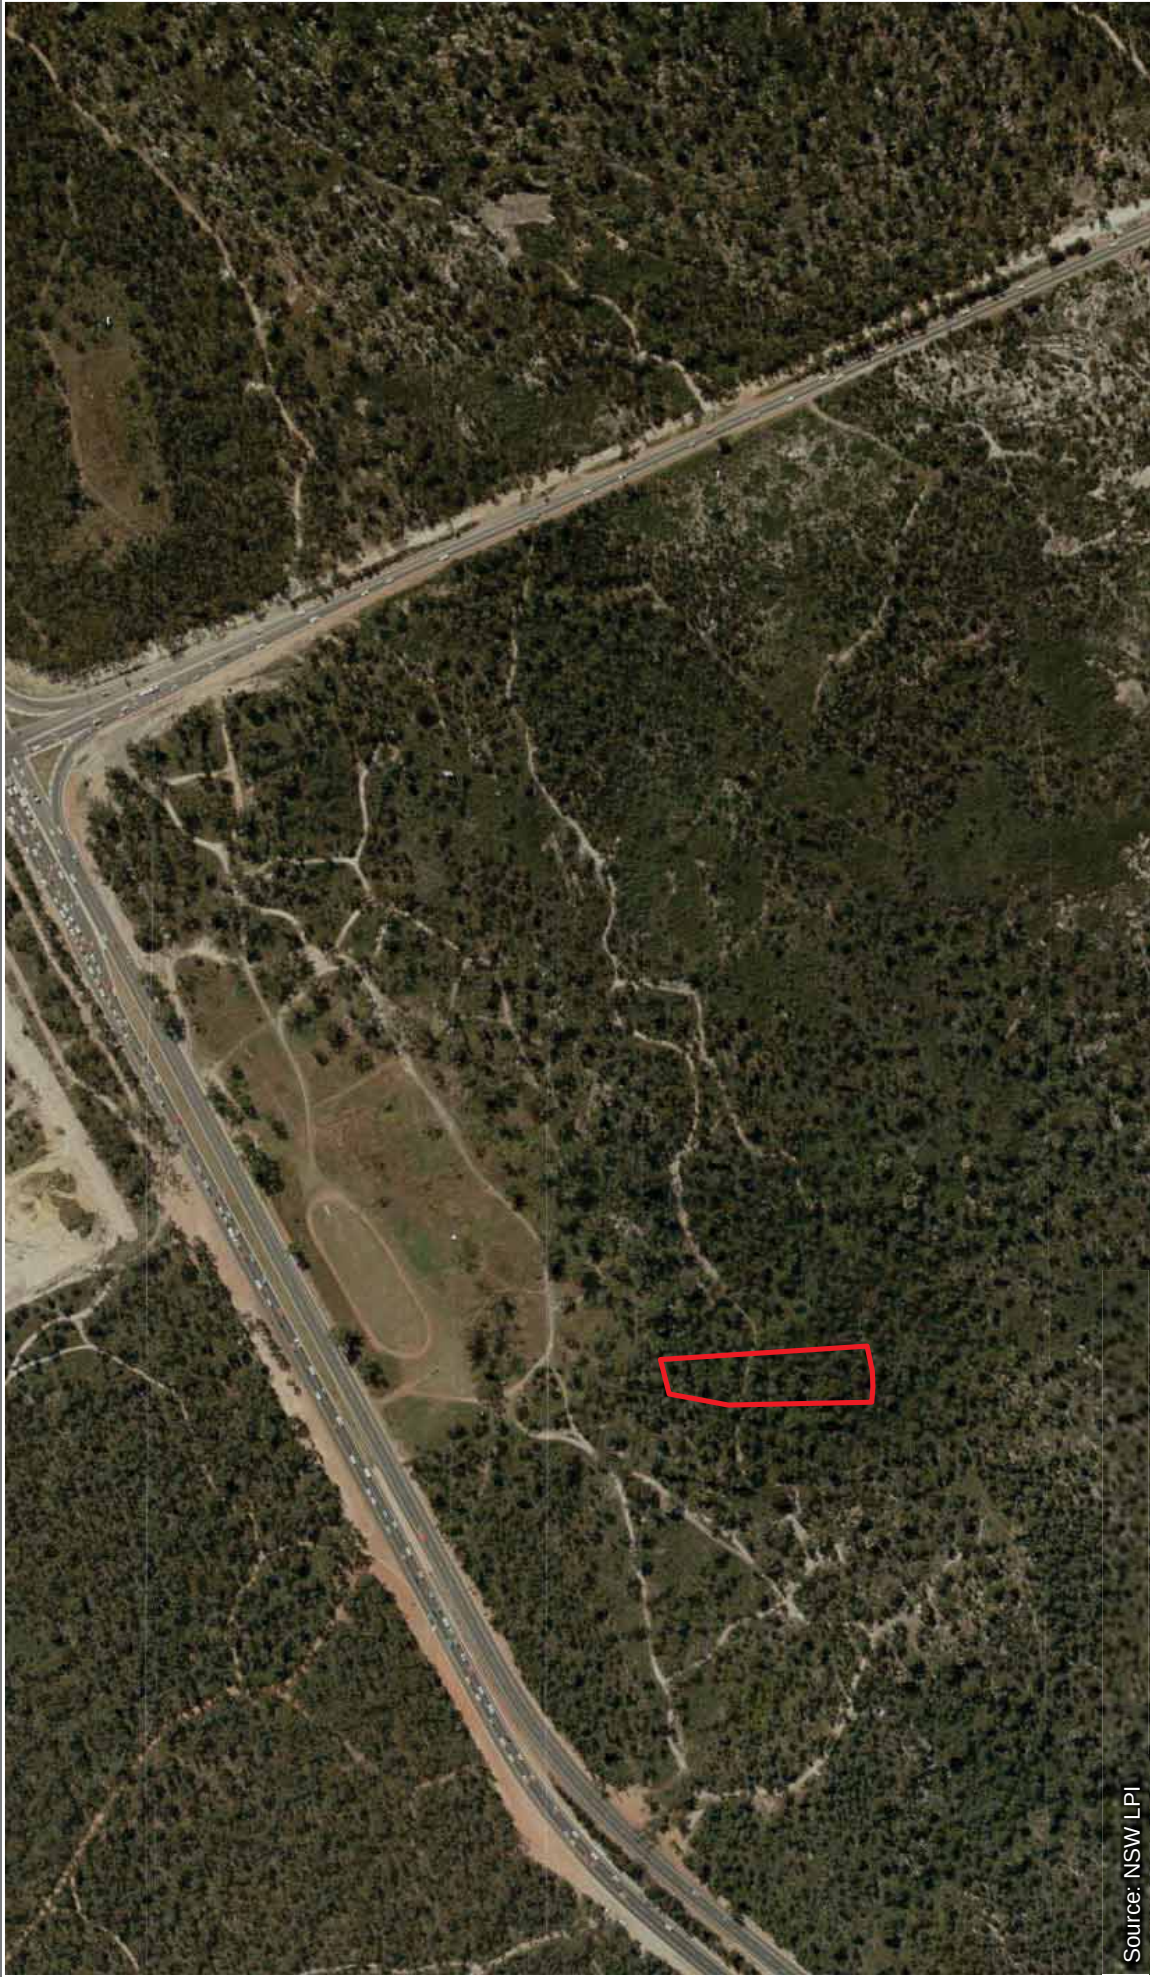
Aerial Photograph – 1982

| Area | Description |
|---|---|
| Site | Site appears unchanged from the previous image. |
| Surroundings | Surrounding land use appears unchanged from the previous image. |

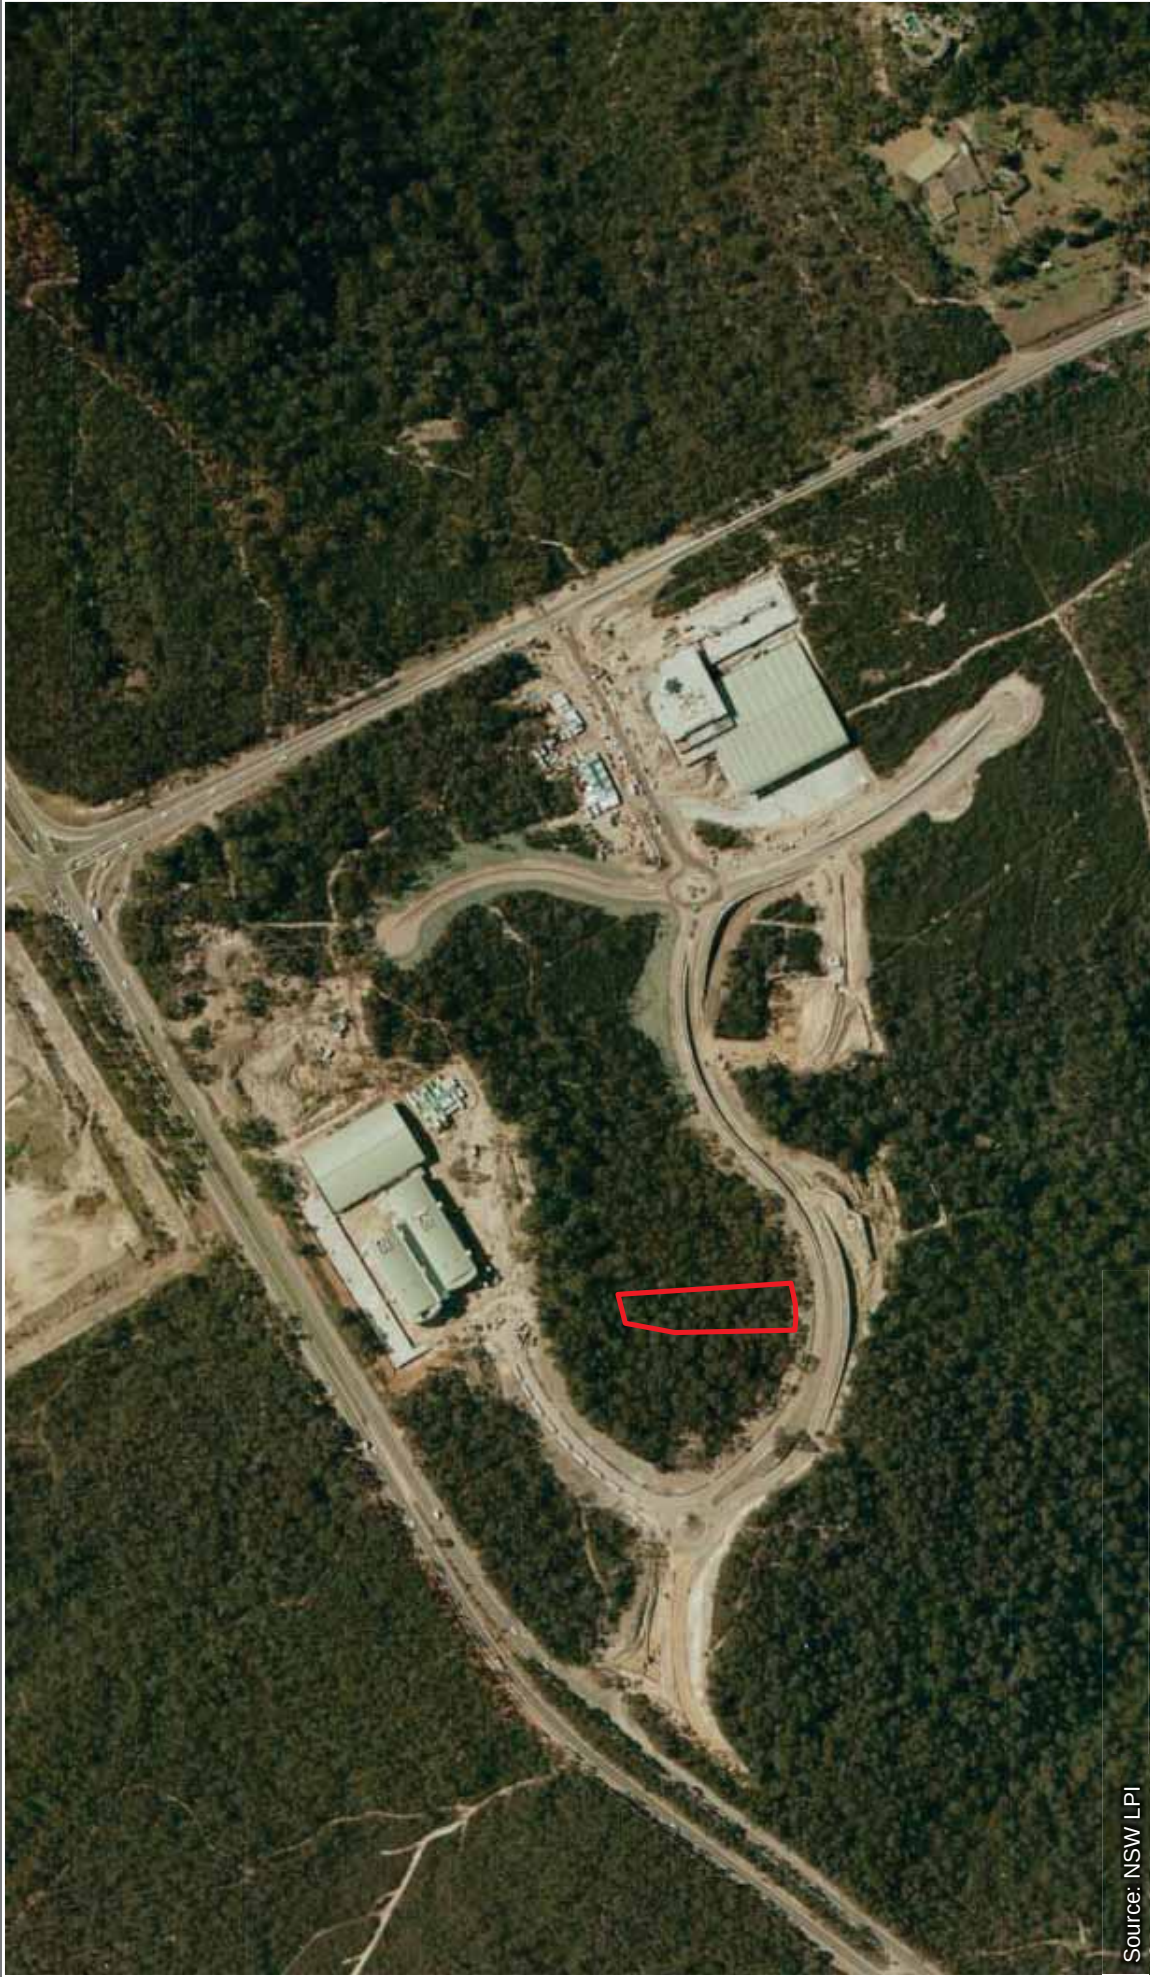
Aerial Photograph – 1991

| Area | Description |
|---|---|
| Site | Site appears similar to the previous image. |
| Surroundings | The current road network is under construction with two large commercial / industrial properties constructed to the north and east. |

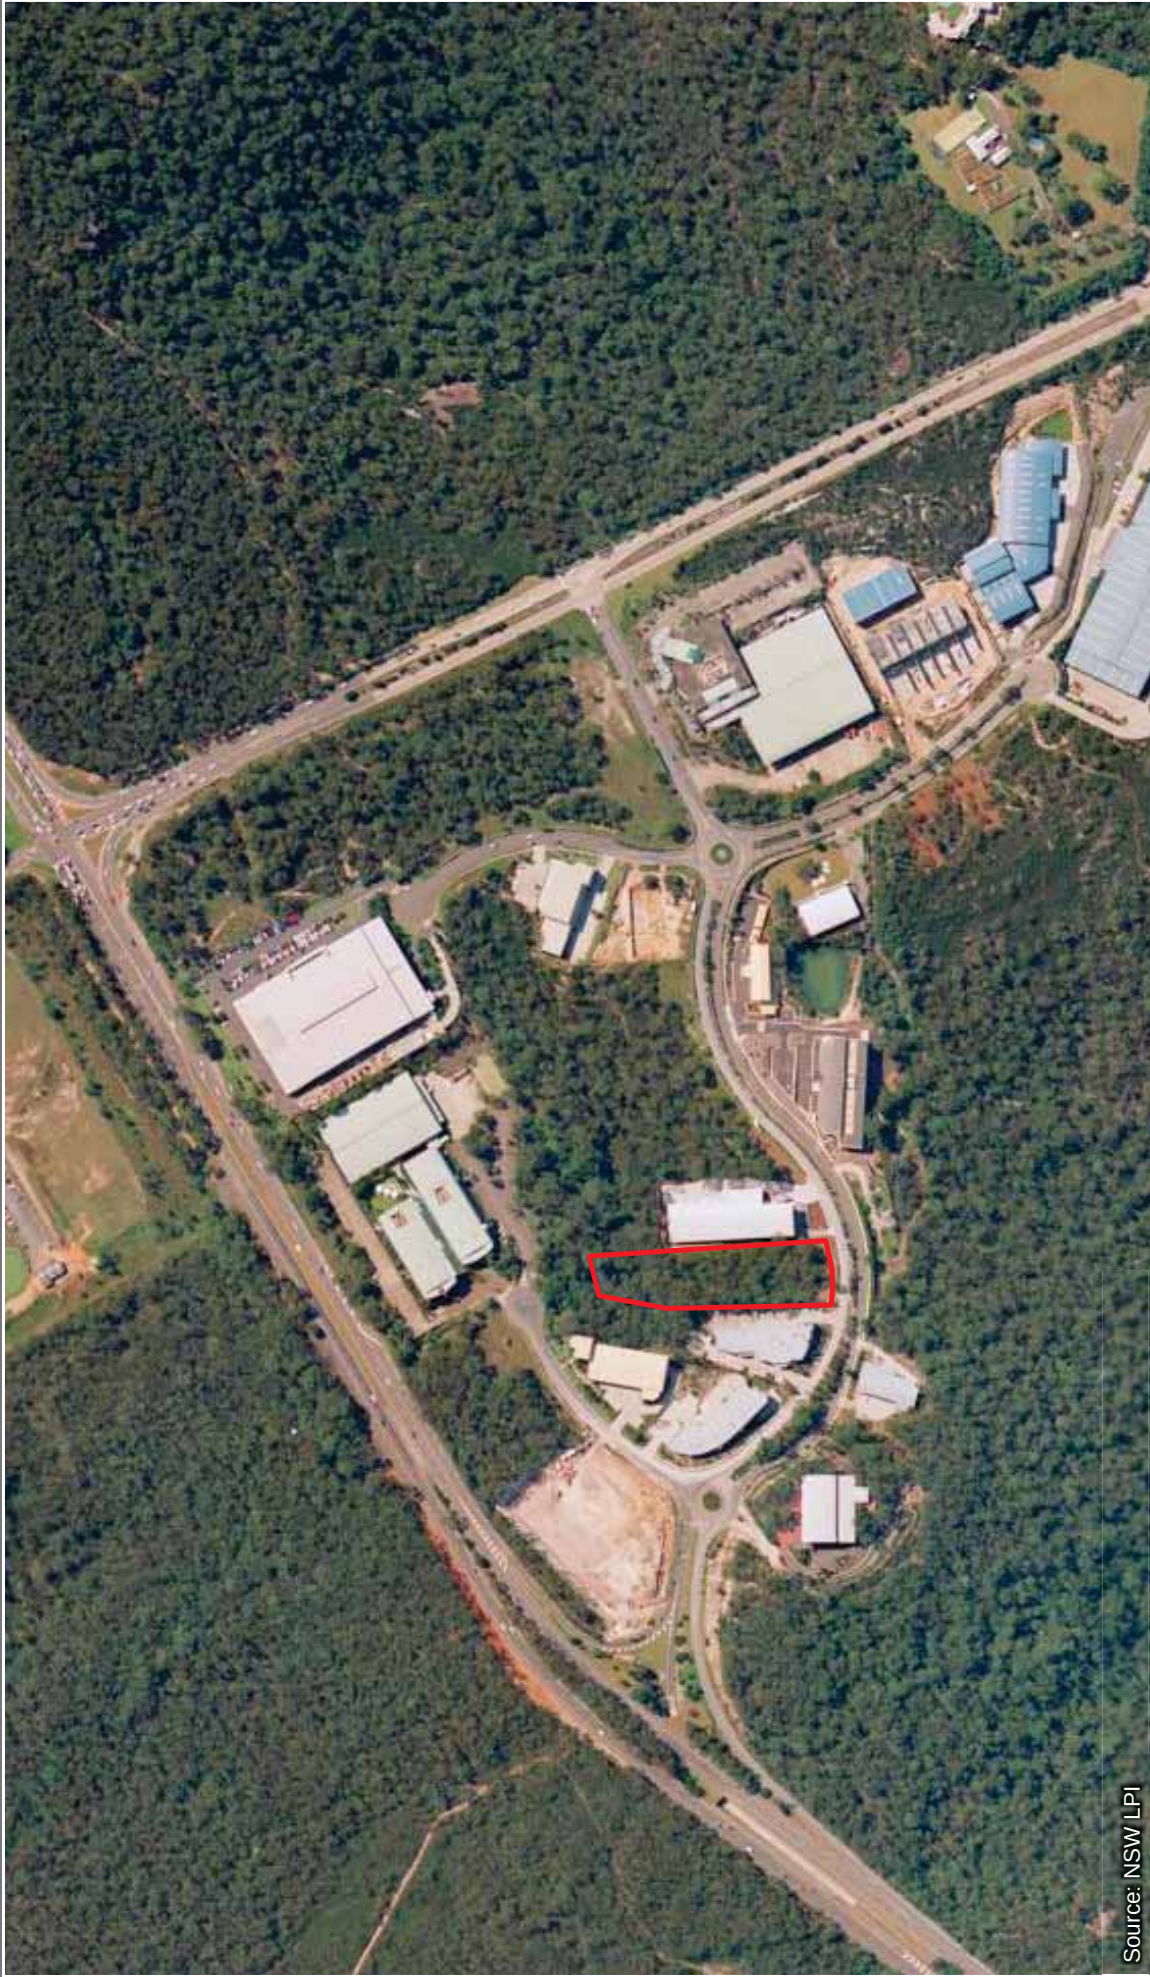
Aerial Photograph – 2002

| Area | Description |
|---|---|
| Site | Site appears similar to the previous image and remains undeveloped bush land. |
| Surroundings | The two current commercial industrial buildings to the east and west of the site have been constructed. |

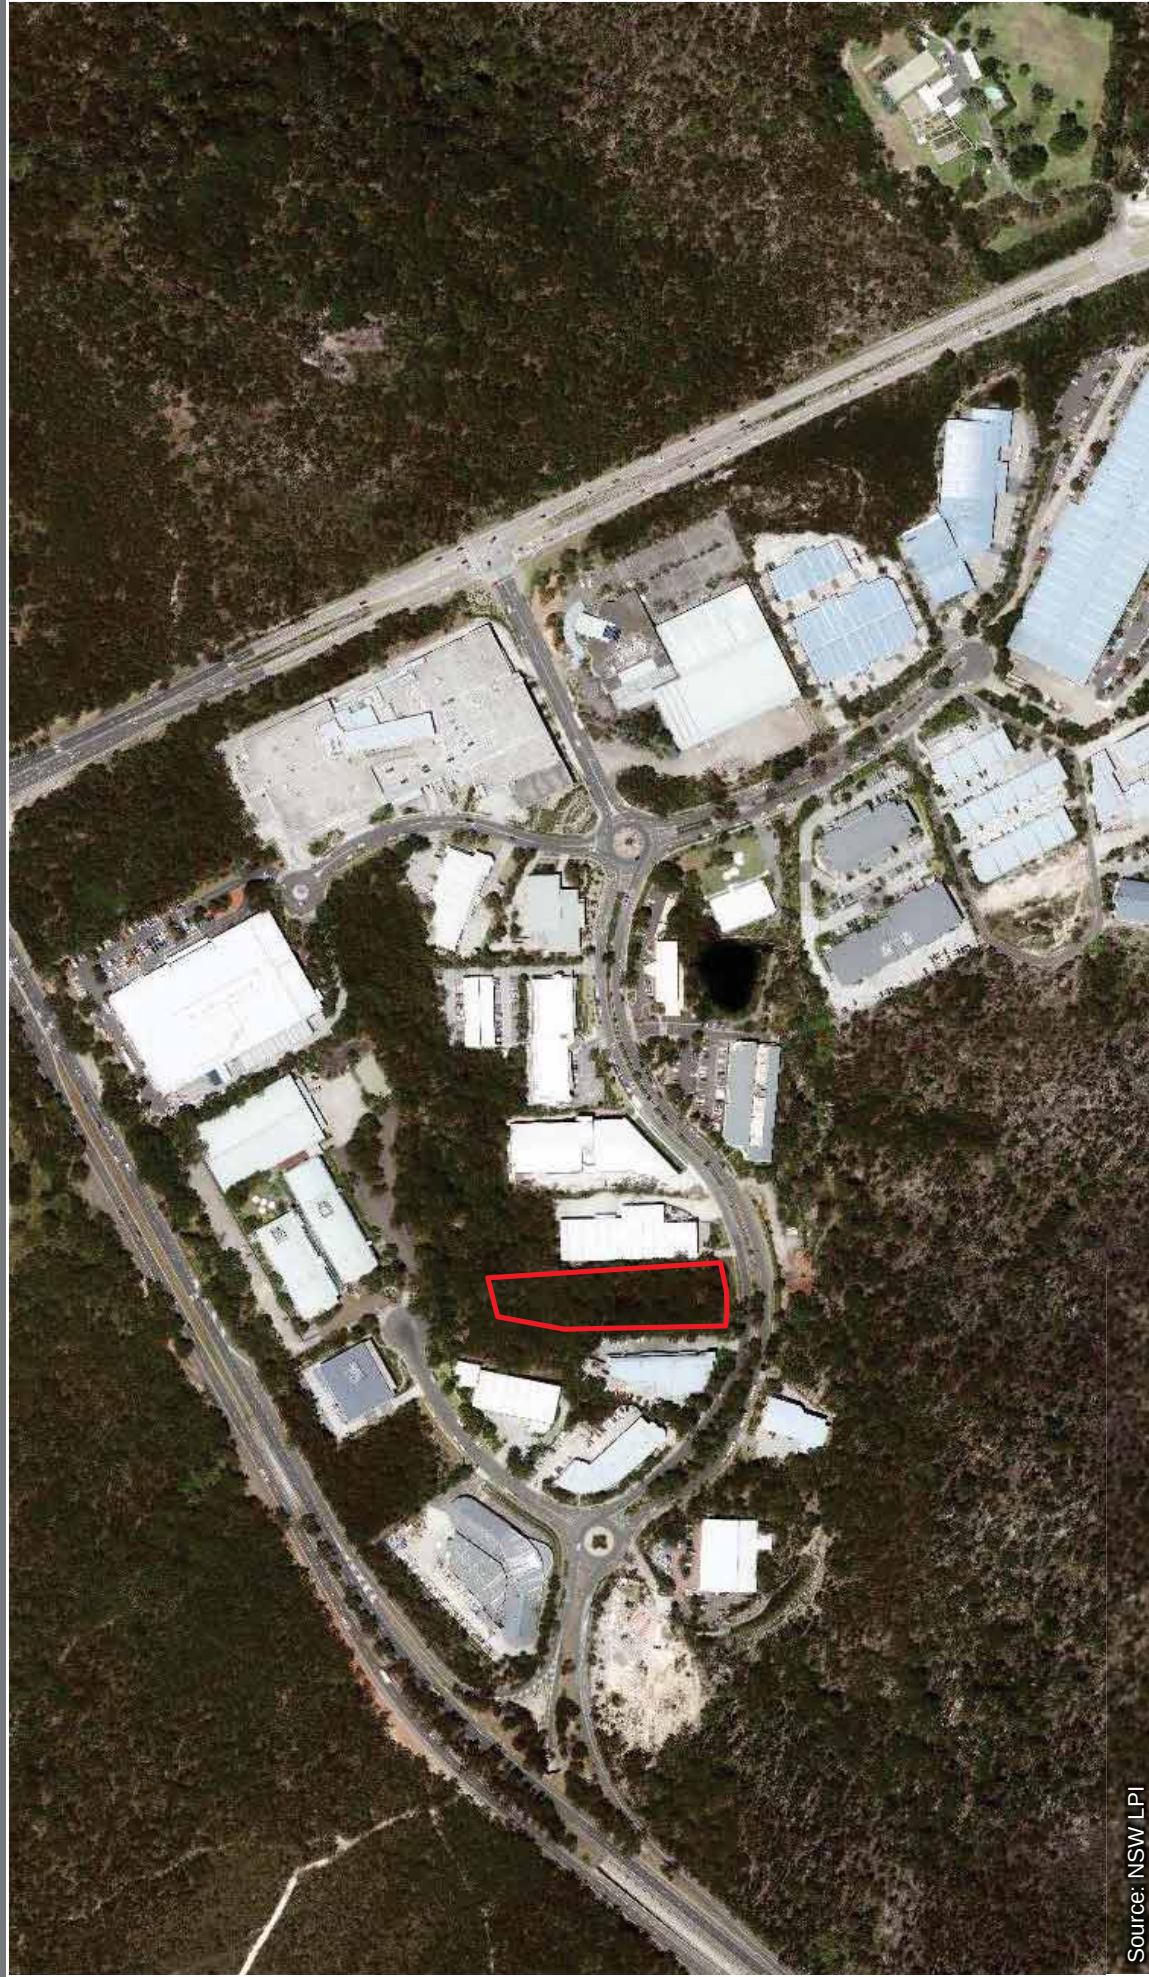
Aerial Photograph – 2016  
**PRELIMINARY CONTAMINATION INVESTIGATION**  
8 Narabang Way, Belrose NSW

| Area | Description |
|---|---|
| Site | Site appears similar to the previous image. |
| Surroundings | Surrounding land use appears unchanged from the previous image. |
