**GEOENVIRONMENTAL  
PRELIMINARY SITE INVESTIGATION  
FOR A PROPOSED DEVELOPMENT AT**

**26 MERCEDES ROAD,  
INGLEBURN**

**CAMPBELLTOWN CITY COUNCIL LOCAL GOVERNMENT  
AREA**

Job number: 2318

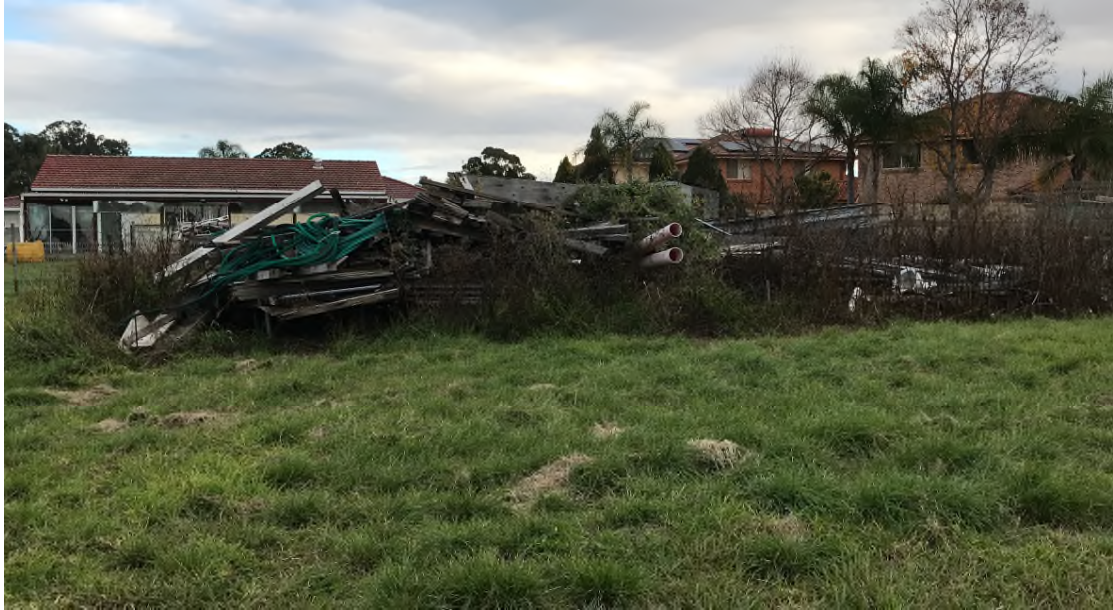
| Land Contamination Signs | Presence of contamination and location | Description and condition |
|--|---|---|
| <b>Property conditions or previous activities undertaken which could potentially cause contamination</b> | None likely, some building materials previously stored but not a major risk | Some timber present neatly piled up but no signs of potential contaminating materials |

| <b>Land Contamination Signs</b> | <b>Presence of contamination and location</b> | <b>Description and condition</b> |
|--|---|--|
| <b>Condition of materials storage and handling facilities and any solid or liquid waste disposal areas</b> | None present | Building materials typical of normal materials with no suspected contamination present |

**Photograph A3.1: Pile of accumulated building materials**

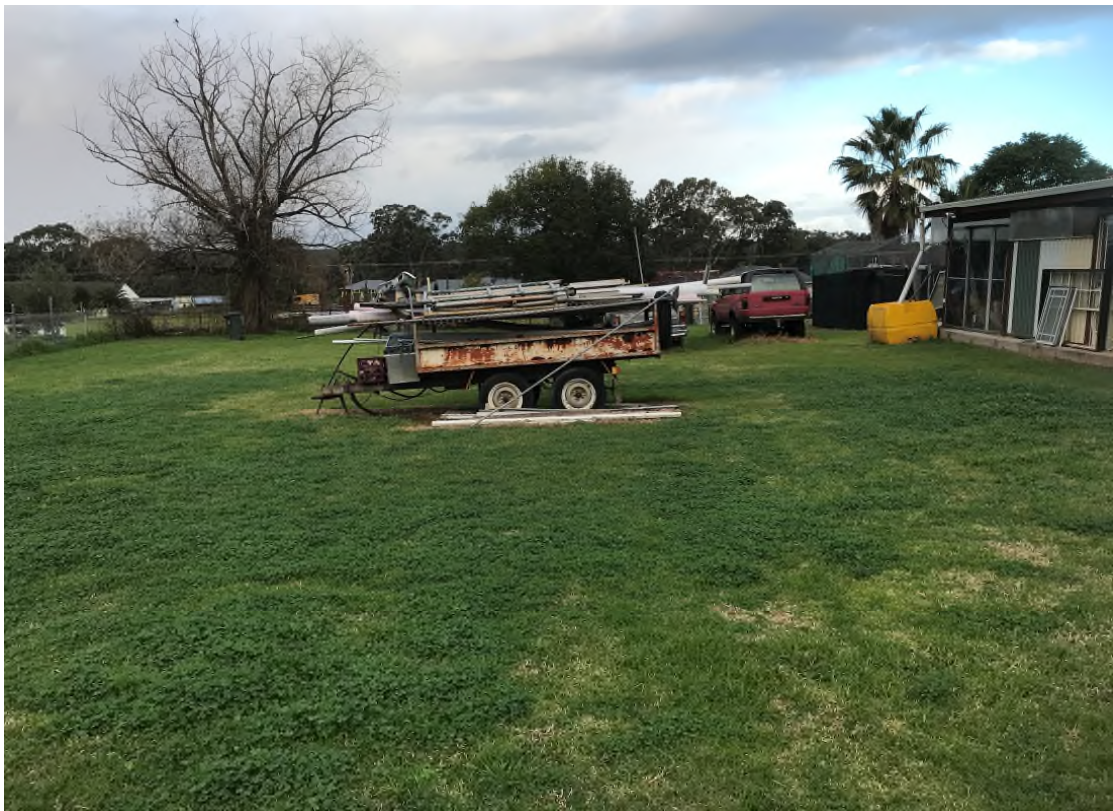
**Photograph A3.2: Stored Trailer and Vehicle at back of hours**
