## Attachment 1 – Watercourses Investigation

Our Reference: 150715  
23 November 2015

**Re: 11 Westminster Place, Razorback**

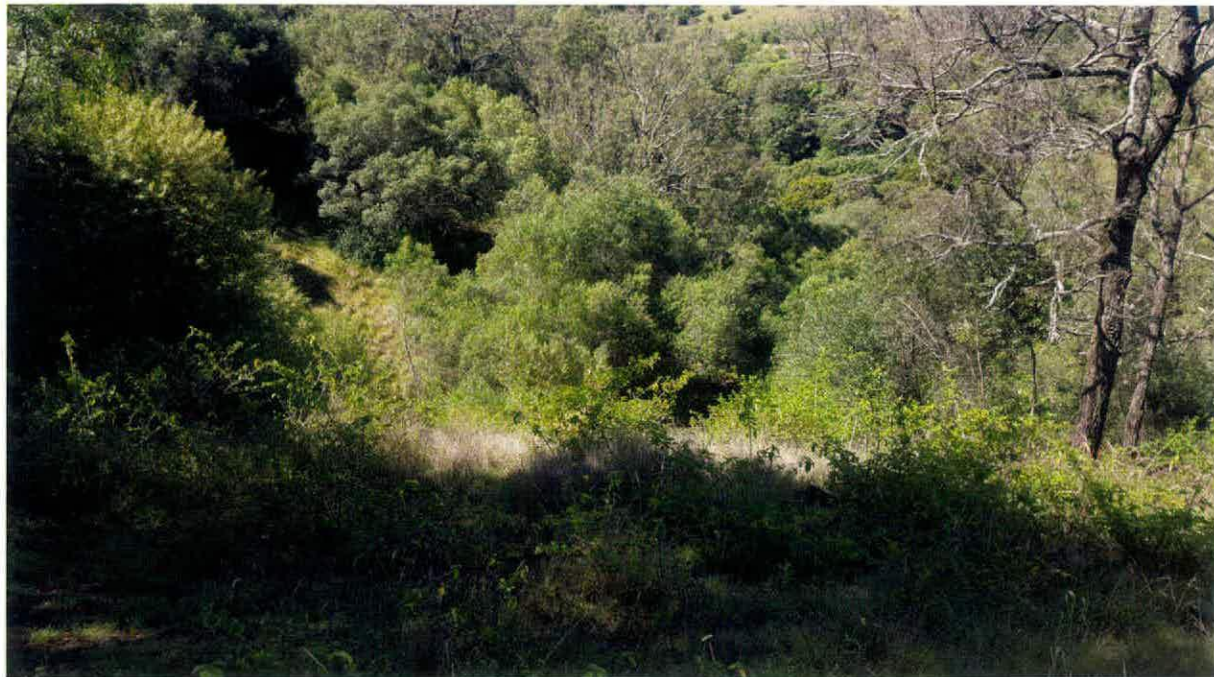
### Creek "A"

Whilst mapped as a creek, an investigation on site has found that no watercourse exists in this location. The site is dominated by a steep gully. Fencing and steep embankments prevent the passage of people and live stock in this area. The site contains no evidence of a creek bank or bed, typical of a watercourse and certainly is not a permanent watercourse.

An upstream dam, located on Lots 4 & 5 DP 1128635 ensures that water is prevented from entering the gully. The gully would generally only convey overland flow of surface water captured within the gully itself.

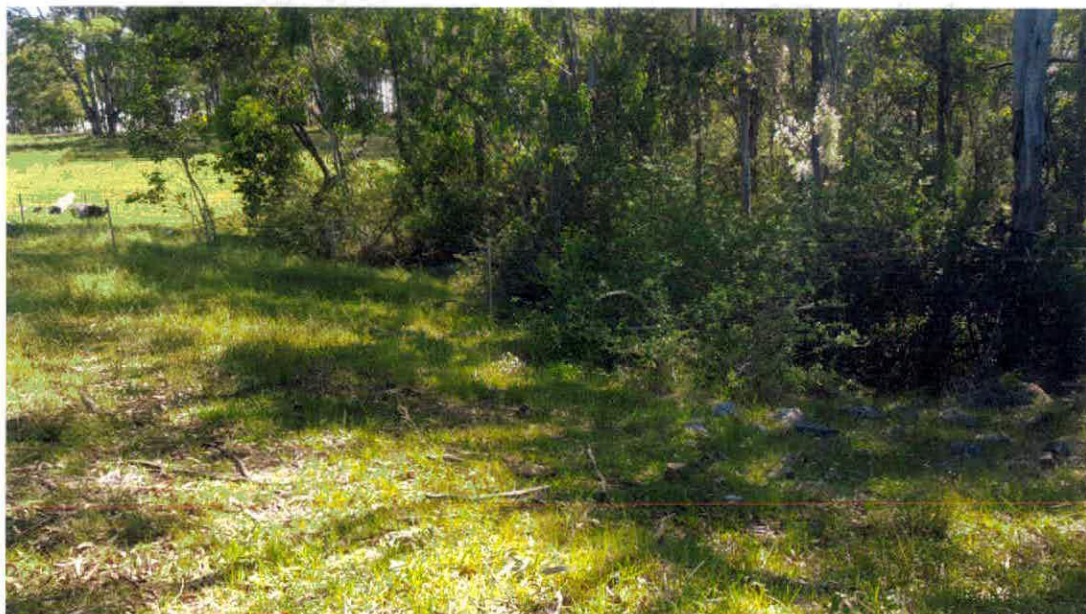
### Creek "B"

Whilst mapped as a creek, an investigation on site has found that no watercourse exists in this location. The site is dominated by a small path of fenced off vegetation and a gully of gentle grade. The site contains no evidence of a creek bank or bed, typical of a watercourse and certainly is not a permanent watercourse.

An upstream dam, located on Lots 8 & 9 DP 1128635 ensures that water is prevented from entering the gully. The gully would generally only convey overland flow of surface water captured within the gully itself.

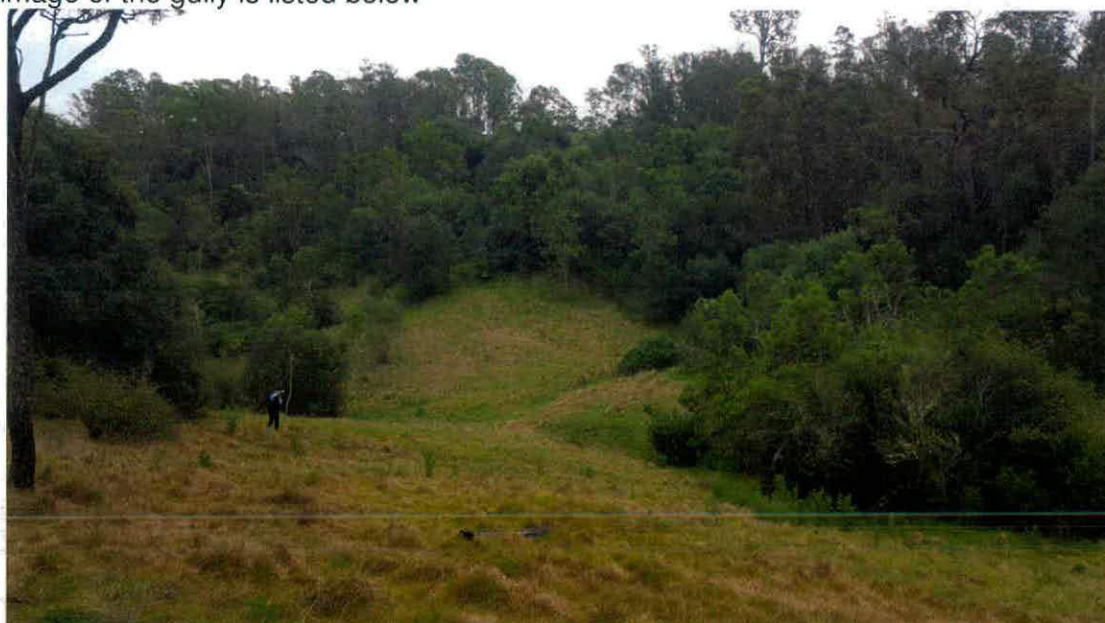
### Creek "C"

Whilst mapped as a creek, an investigation on site has found that no watercourse exists in this location. The site is dominated by a gully of steep grade and is vegetated by trees grasses. The area is fenced off from the actively used portion of the site and is not grazed by animals. The site contains no evidence of a creek bank or bed, typical of a watercourse and certainly is not a permanent watercourse.

Two upstream dams, located on Lot 6 DP 1128635 ensure that water is prevented from entering the gully. The gully would generally only convey overland flow of surface water captured within the gully itself.

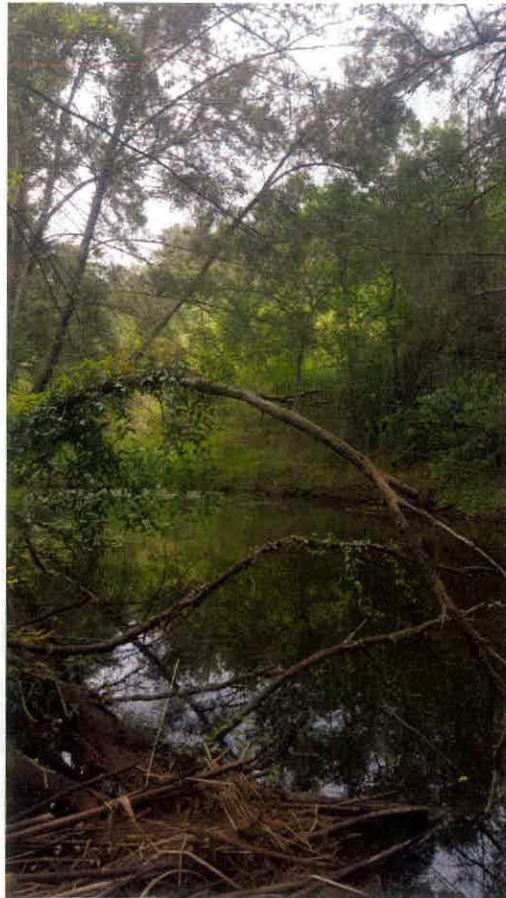
**Racecourse Creek**

Investigation on site has found an existing and permanent watercourse exists in this location. Survey has found that the location of the creek is generally mapped in the correct location. The site is dominated by a more open valley at the base of the escarpment and is vegetated by trees grasses with high weed infestation. The area is fenced off from the actively used portion of the site and is not grazed by animals. The site is a permanent flowing watercourse and displays characteristics of a creek bank or bed.

The site is quite removed and isolated from the proposed development site.
