**REPORT  
on  
PRELIMINARY GEOTECHNICAL ASSESSMENT**

**OATLEY BOWLING CLUB  
RIVER STREET, OATLEY**

**Prepared for  
HURSTVILLE CITY COUNCIL**

**Project 44456  
December 2006**

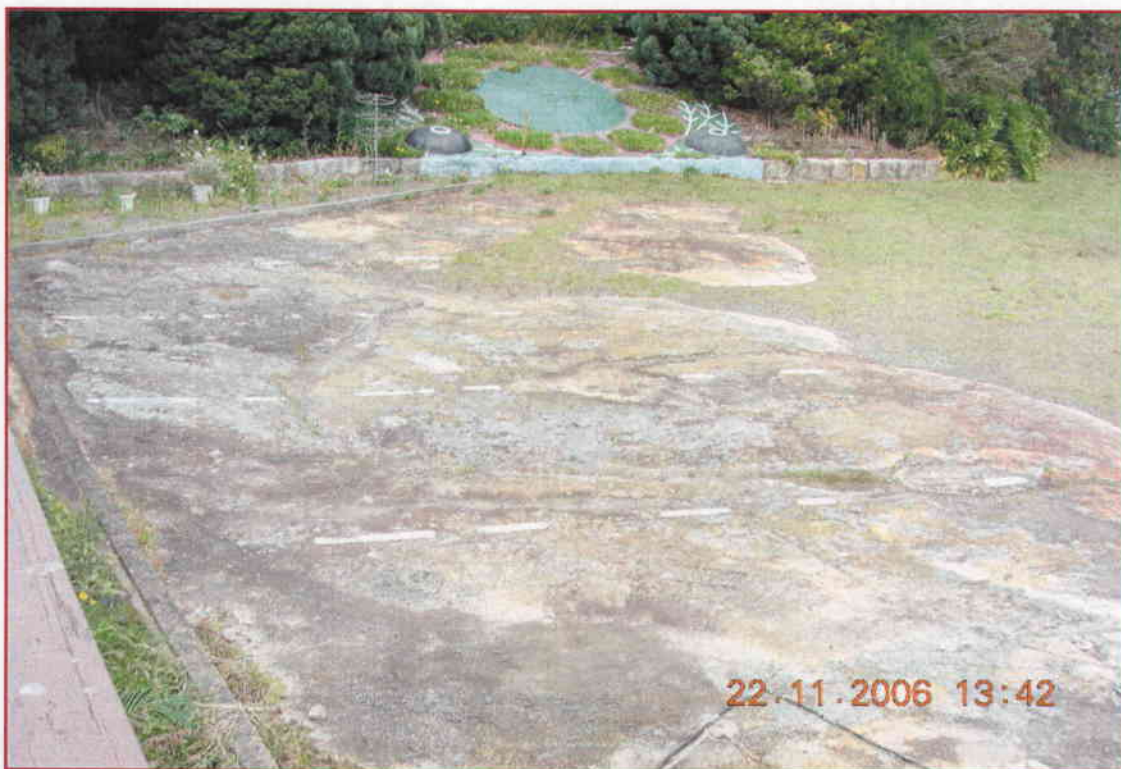
Sandstone bedrock is exposed on the large flat area in front of the club house and under the shed on the western side of the site. Sandstone bedrock is also present behind the club house. See Photos 1, 2 and 3 in Appendix B.

PHOTO 1: Exposed rock in front of club house

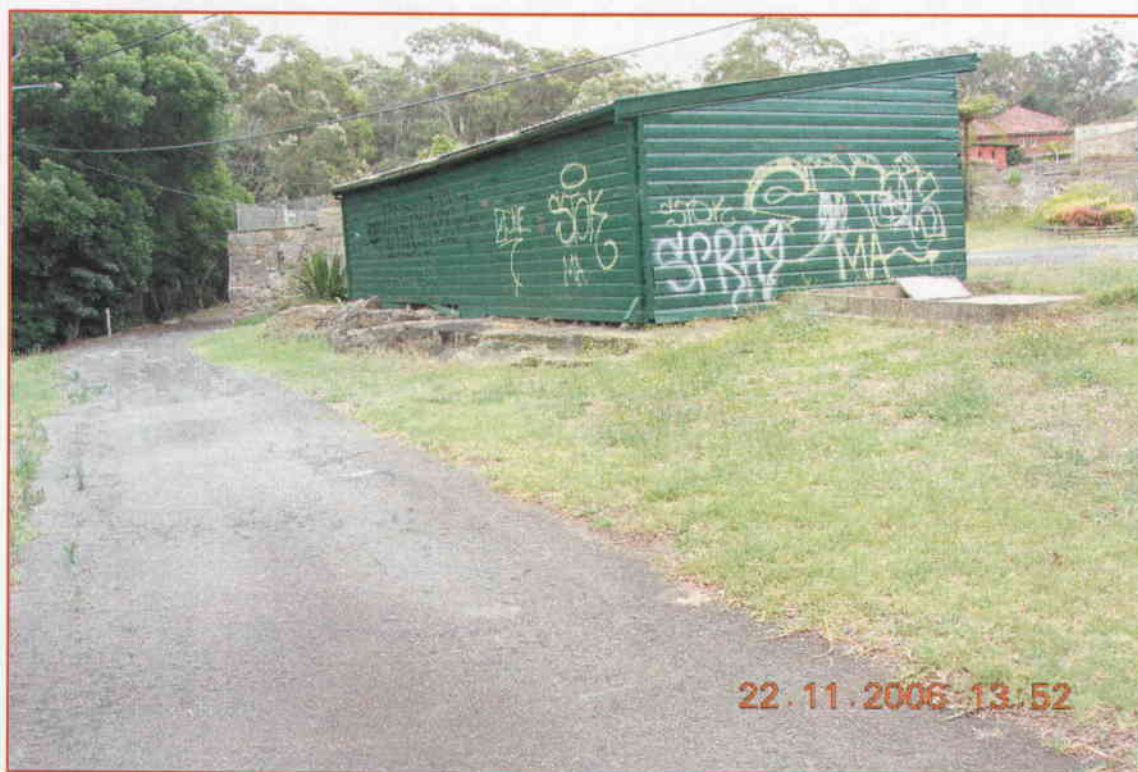
PHOTO 2: Exposed rock under shed

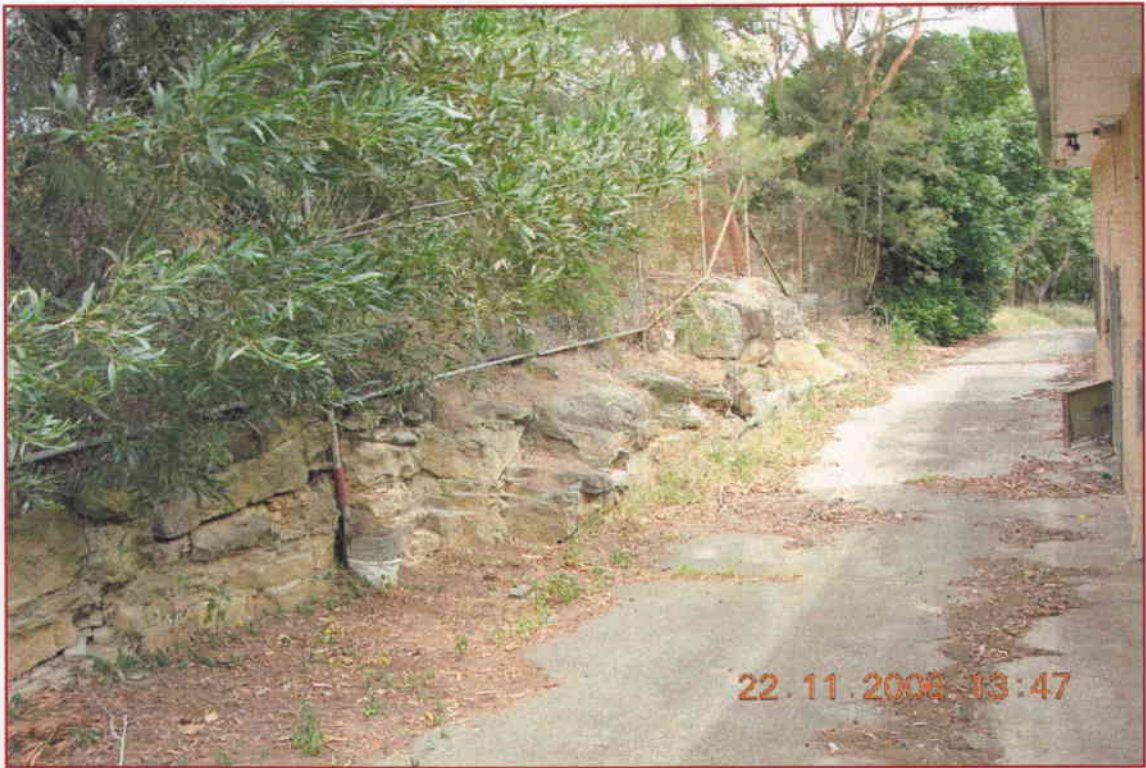
**PHOTO 3: Exposed rock behind club house**

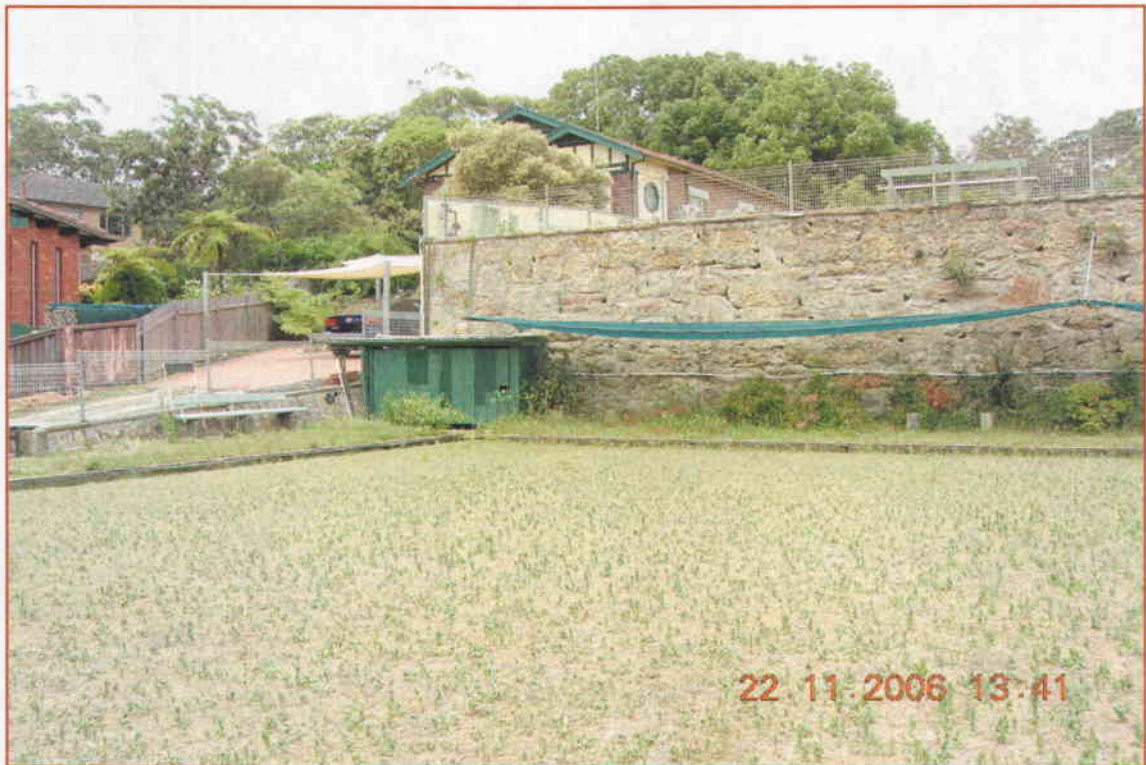
The sandstone block retaining walls, up to about 4 m height, supporting the greens have many cracks in the mortar and show signs of minor movement. No bulging of the walls was obvious. See Photos 4 and 5.

**PHOTO 4: Retaining wall between greens**

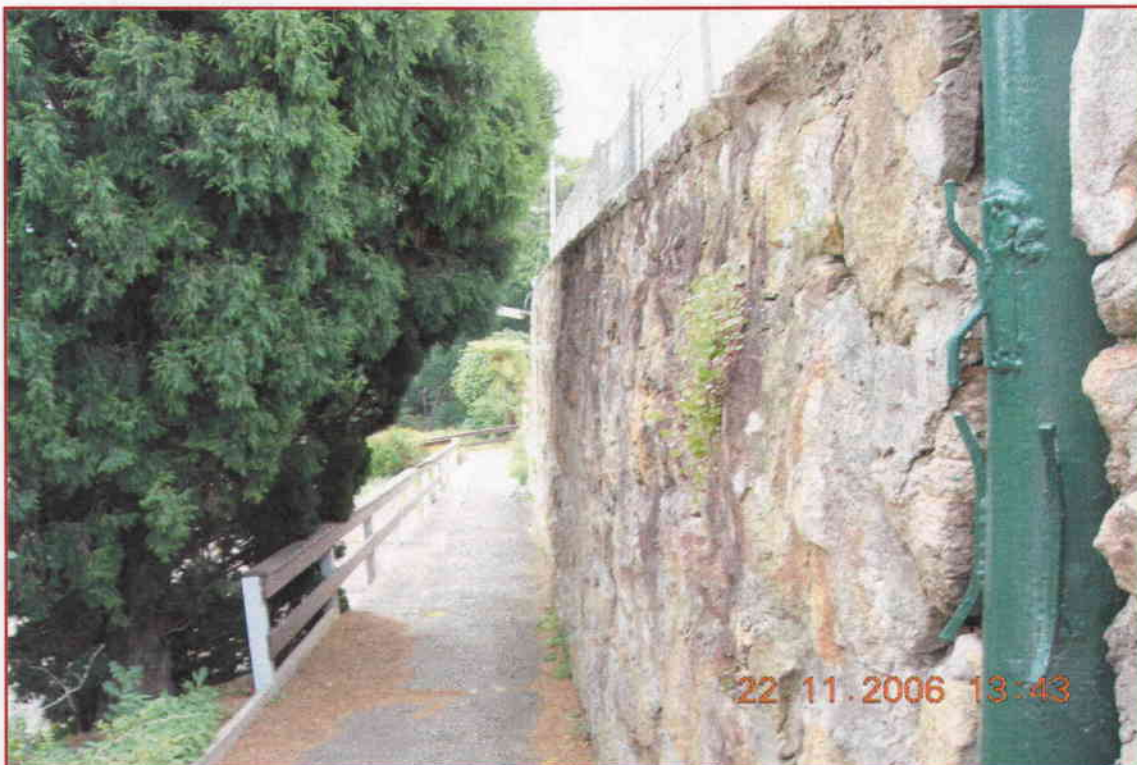
**PHOTO 5: Retaining wall supporting lower green**

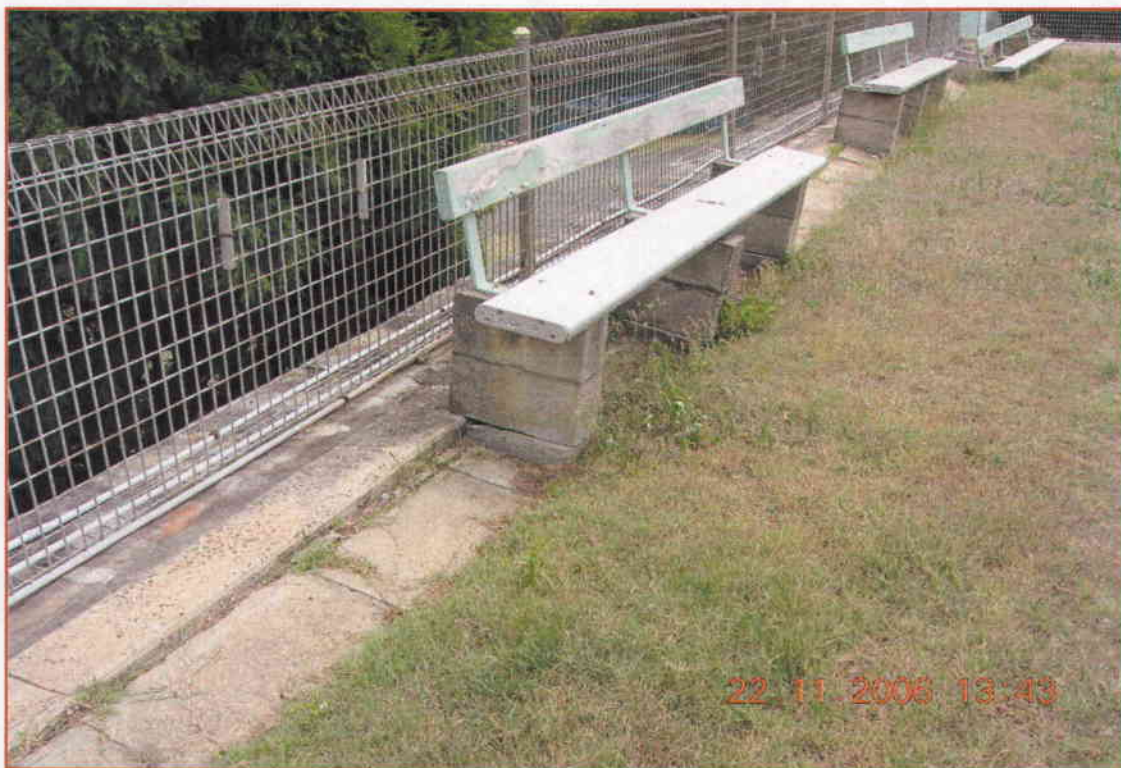
The bowling greens have been built on filling and there is evidence of the filling settling, especially in the area between the actual greens and the retaining walls where the seats are located. Seats in the area have been adjusted by up to the order of 100 mm. See Photos 6 and 7.

**PHOTO 6: Settlement of filling**

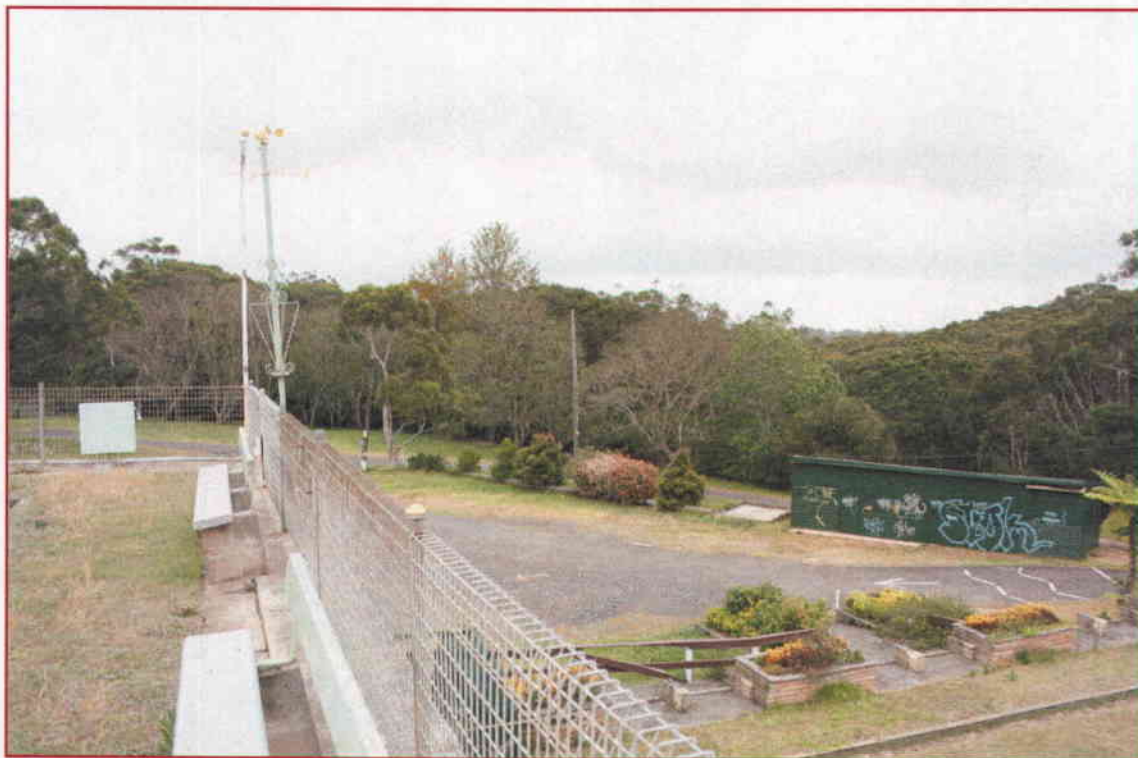
**PHOTO 7: Leaning seat indicating settlement**

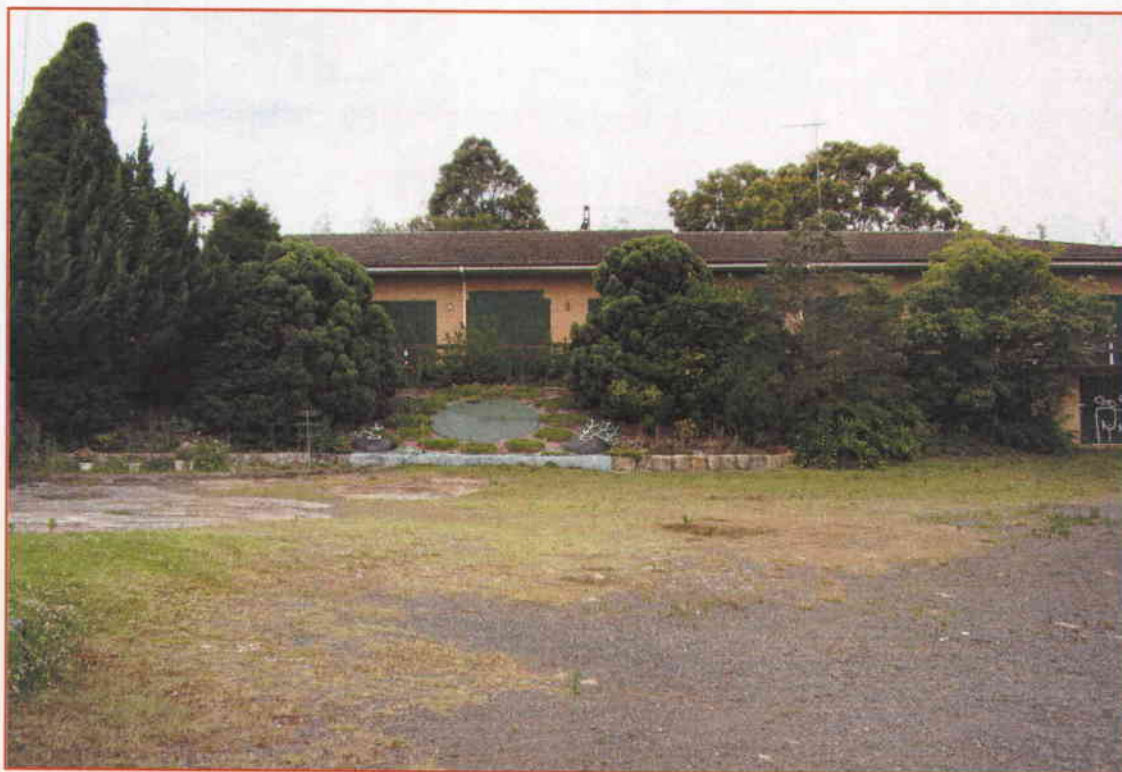
The club house is in relatively good condition as it is probably founded on rock. See Photo 8.

**PHOTO 8: The Club House**

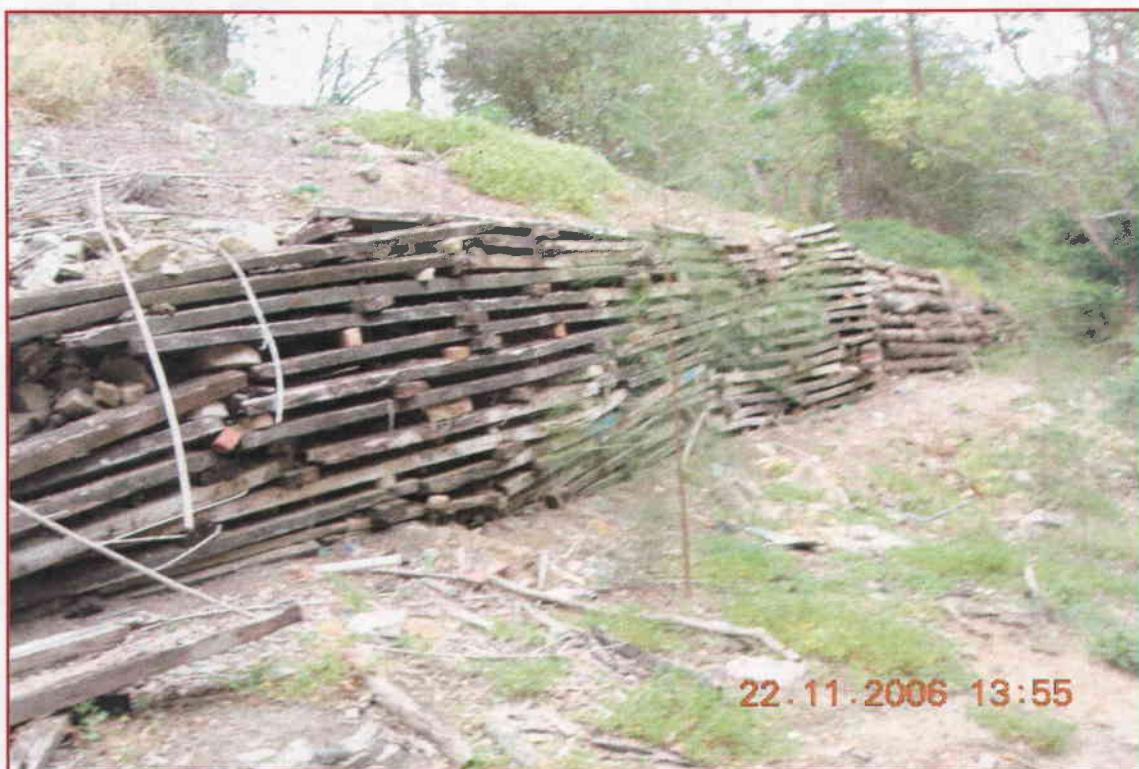
In the southern western corner of the site, the timber crib walls supporting the embankments are in poor condition with many incidences of collapses, washing out of fines and rotting timber. See Photos 9 and 10. Also observed on the embankments was unsuitable material including pipes, large pieces of rock and concrete, steel pieces, plastic and rubbish.

PHOTO 9: Timber crib wall

The embankments in the south-western corners of the site are in a poor condition. It is considered that the embankments and any retaining walls should be totally rebuilt as they cannot be relied upon to provide support for a development at the top of the embankments.

This would involve removal of any remaining retaining walls and the material for some distance behind the faces and could be undertaken in conjunction with the reworking of the uncontrolled filling on the site. There was plenty of unsuitable material exposed in the embankment which should not be reused in the reconstruction of the embankment.

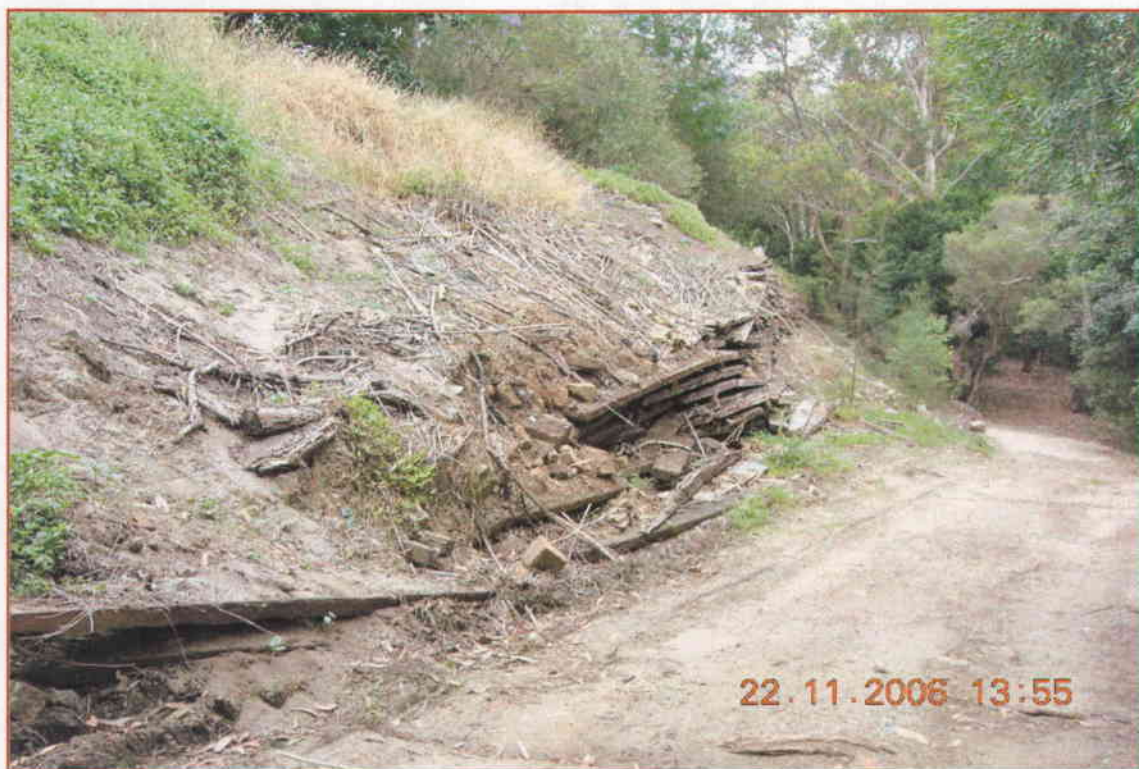
PHOTO 10: Failed crib wall
