Report on  
Updated Preliminary Site Investigation

Former Oatley Bowling Club  
River Road, Oatley

Prepared for  
Hurstville City Council

Project 73308.01  
January 2016

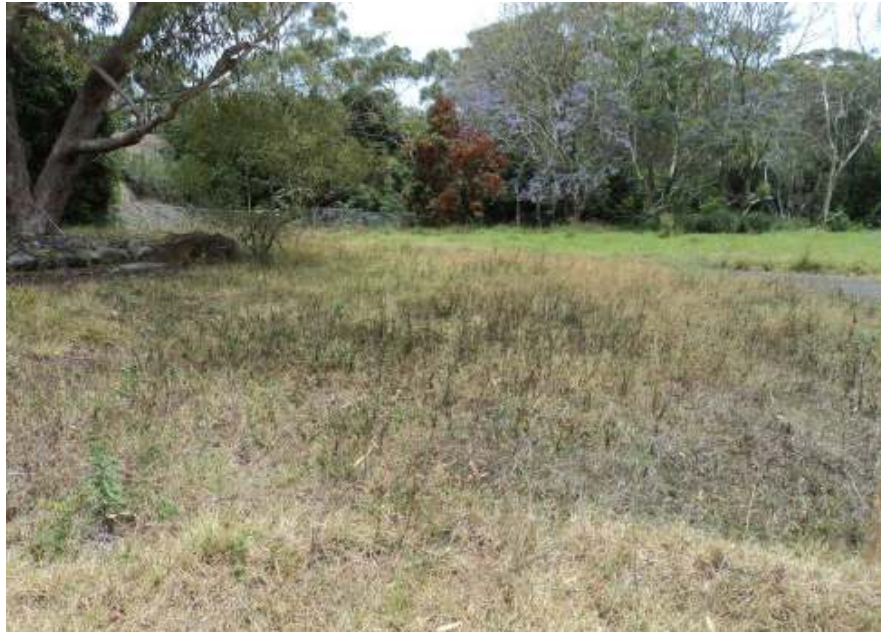
- The former single storey brick club building, garage and timber/metal shed at the site had been demolished. Inspection of the footprint of the former clubhouse buildings found that fibrous cement materials were present on the ground surface;

Photo 3 – Footprint of former bowling club building

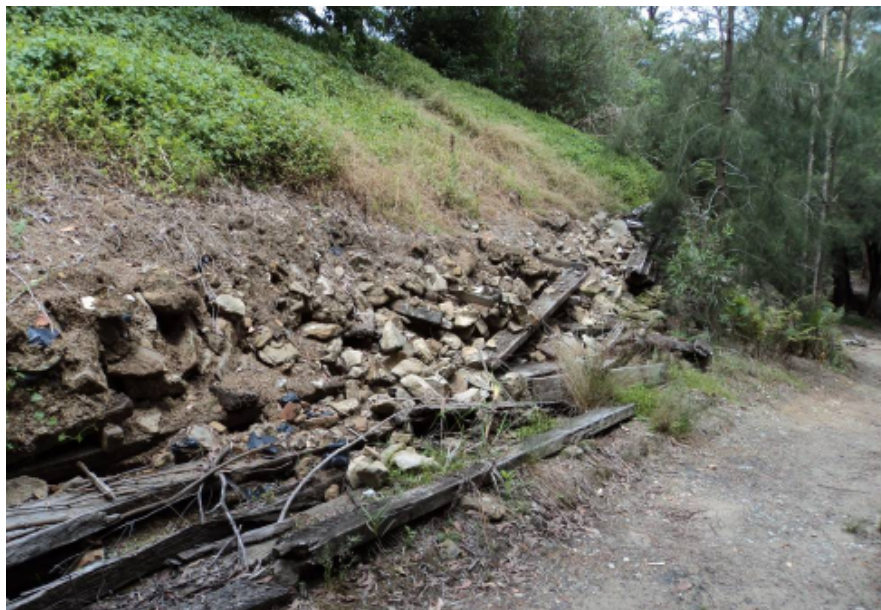
- The telephone line above River Street had been damaged and hung close to the road surface; and
- The timber crib retaining walls used to support the embankment at the west of the site were in a poor state of repair.

Photo 4 – Damaged timber retaining structures

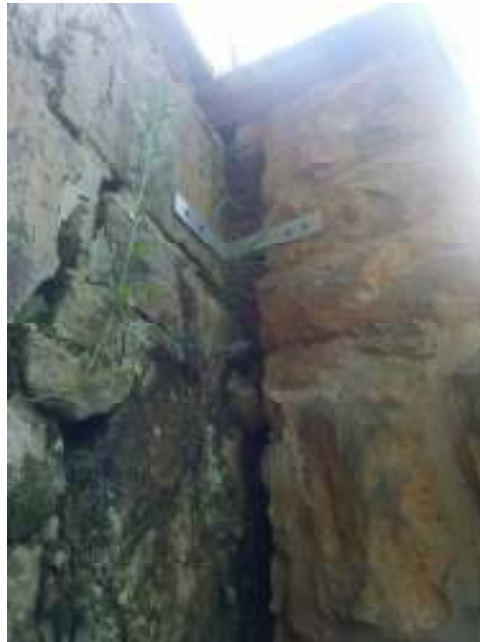
- The two bowling greens were still present and remained overgrown with weeds. On the upper and lower green an electrical box in the south east corner of the green was present. The greens were still supported by sandstone block retaining walls, however these appeared to be failing and one section had been braced to maintain structural integrity;

Photo 5 – Failing retaining wall for bowling greens (note metal brace)

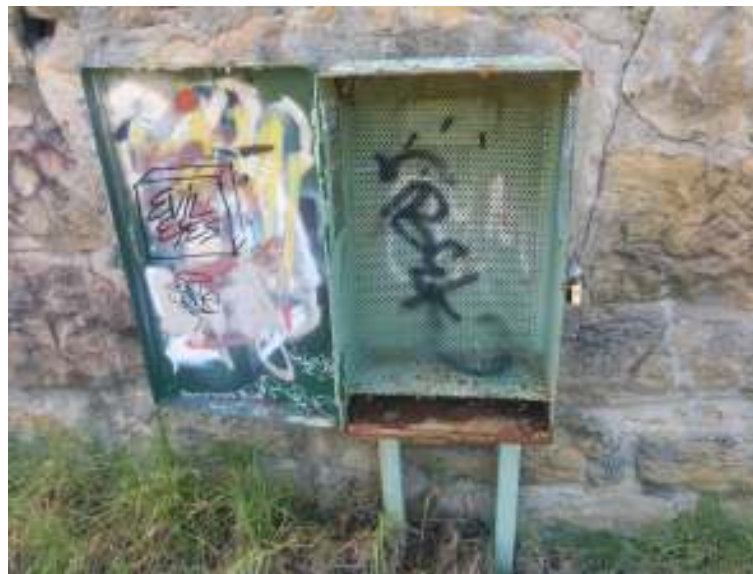
Photo 6 – Electrical box on lower bowling green

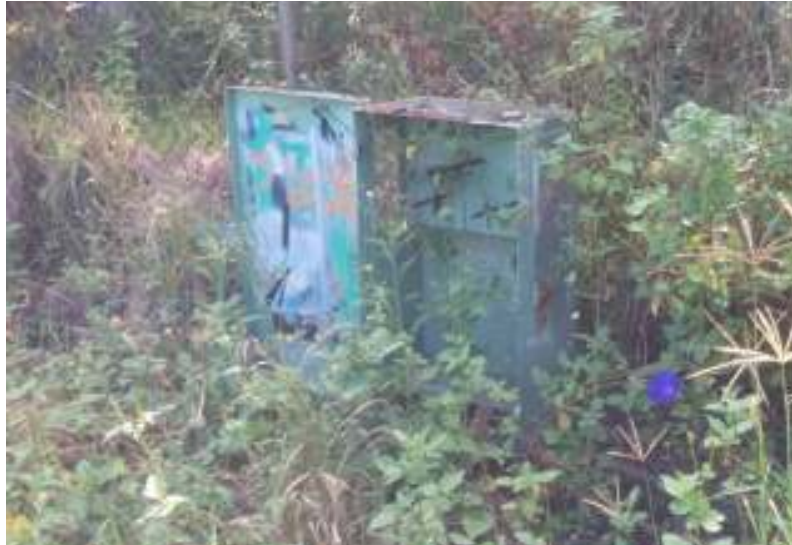
- Potential application of pesticides and herbicides on the bowling greens;
- Potential PCBs associated with the electrical box found on the upper bowling green;
- Application of the uncontrolled filling to form/ level the site especially the bowling greens;
- Potential presence of hazardous building material remaining after the demolition of the former bowling club building; and
- Contamination associated with fly tipping and the small filling stockpiles present at the site.

Photo 7 – Electrical box on upper bowling green

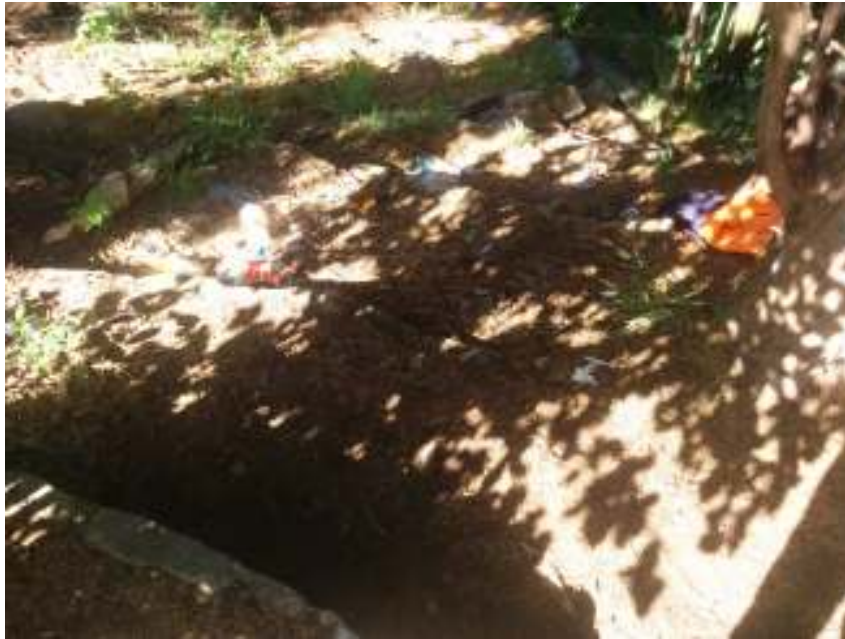
- Fly tipping, littering and graffiti were seen to affect the site;
- There were many semi-mature trees and shrubs growing at the site and former landscaped areas were overgrown and poorly maintained;

Photo 9 – Littering to the south of the bowling greens

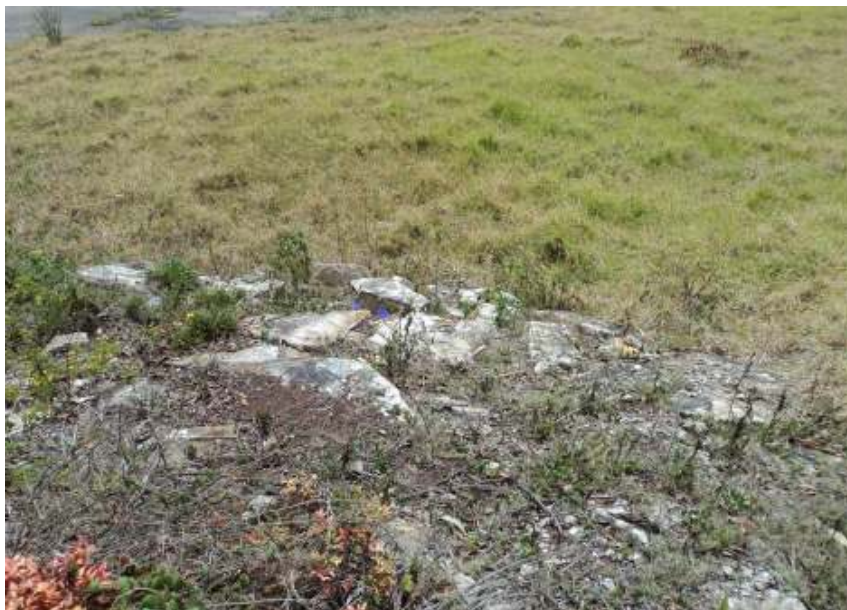
- There was a metal shed in the north-eastern corner of each green;
- Some small stockpiles of filling were noted, possibly associated with the demolition works;

Photo 10 – Rubble Stockpile

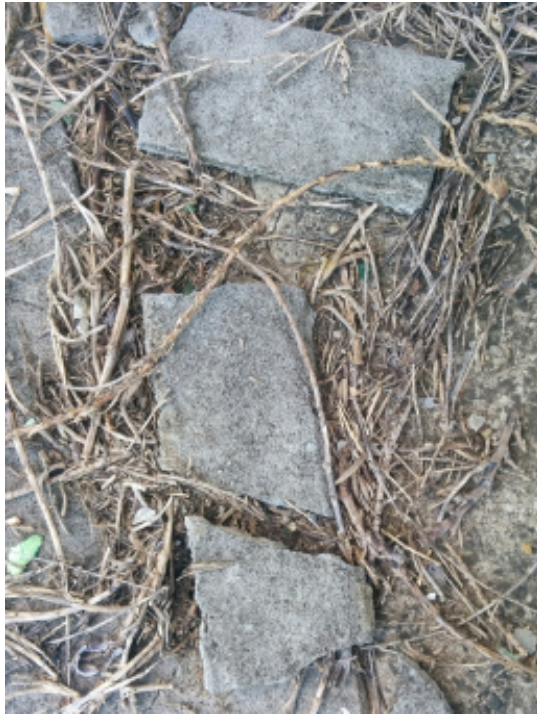
Photo 11 – Potential Asbestos Containing Material

It should be noted that as no intrusive sampling was undertaken as part of this current or the previous two assessments, no detailed comments can be made with regard to the actual levels of subsoil contamination. It is recommended, similarly to the 2012 recommendation, that subsurface sampling be undertaken as part of the proposed development to verify the nature, with respect to contamination, of the filling and natural material on-site. A waste classification in accordance with relevant NSW EPA guidelines should also be undertaken for any material that is to be exported from the site.

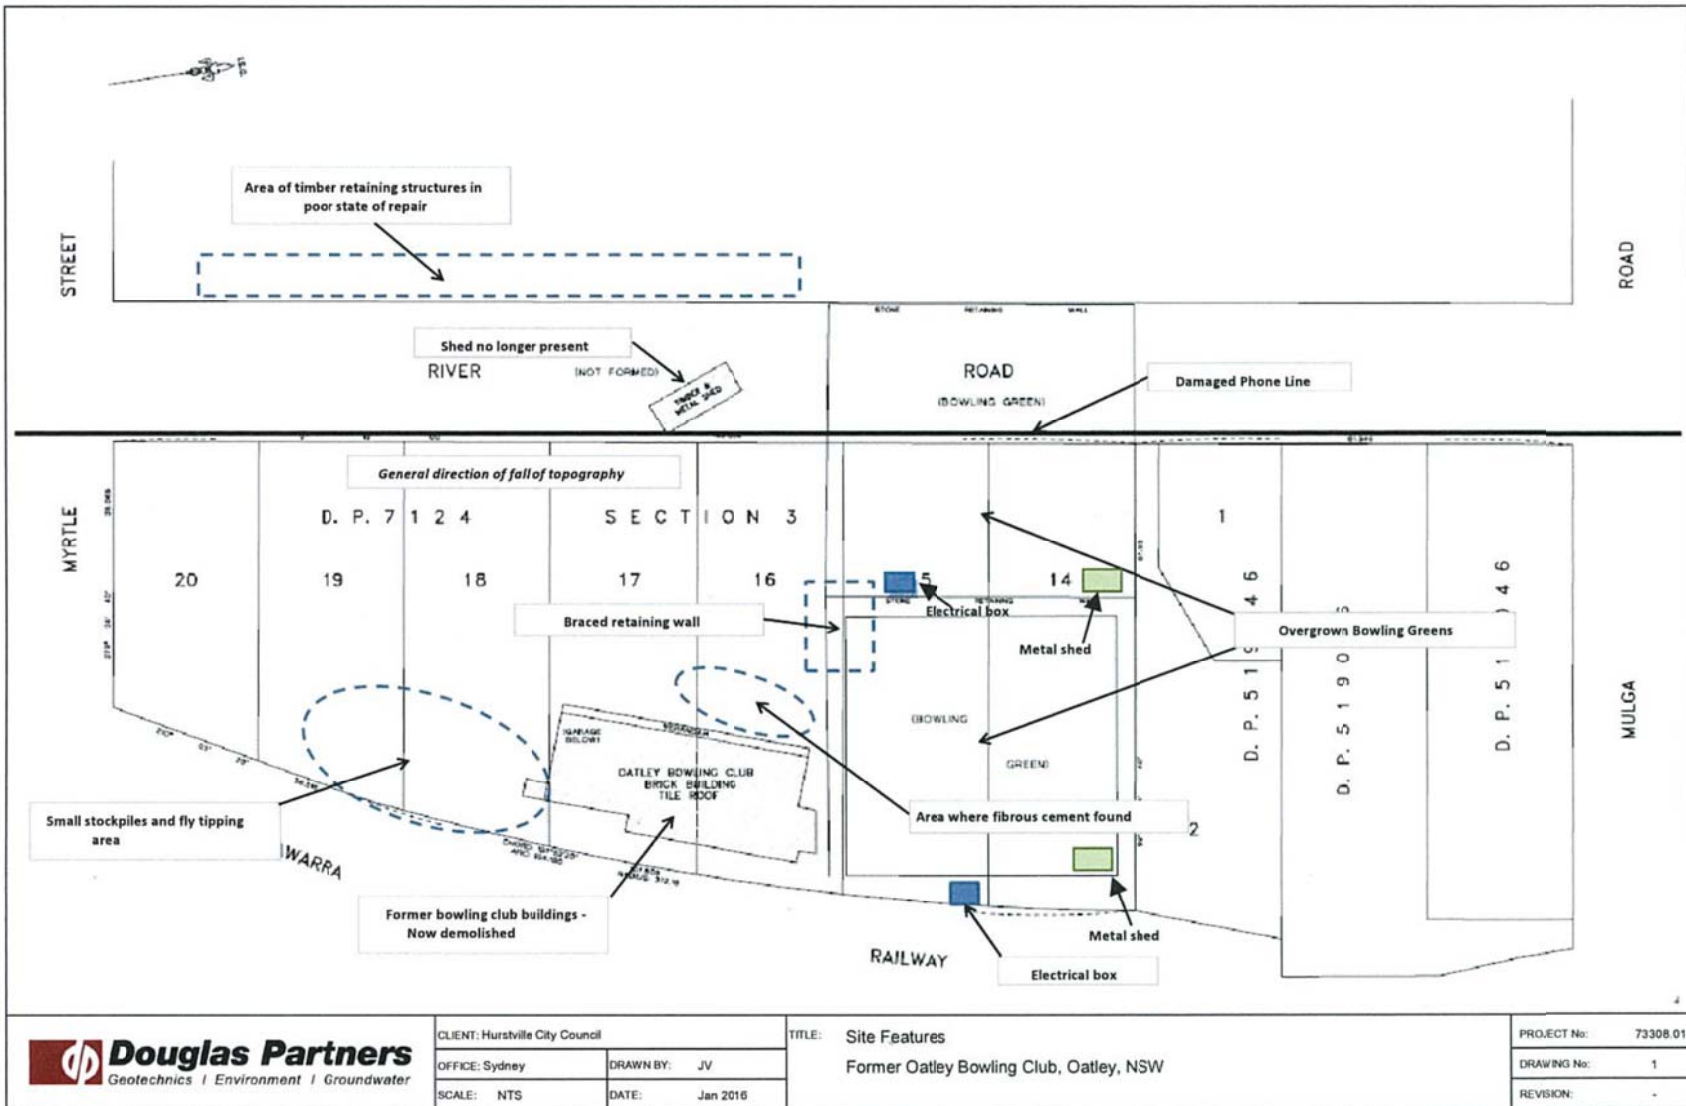
TITLE: Site Features  
 Former Oatley Bowling Club, Oatley, NSW

A drawing showing key site features observed during the inspection (Drawing 1) is included in Appendix C, with a photographic record included in Appendix B.

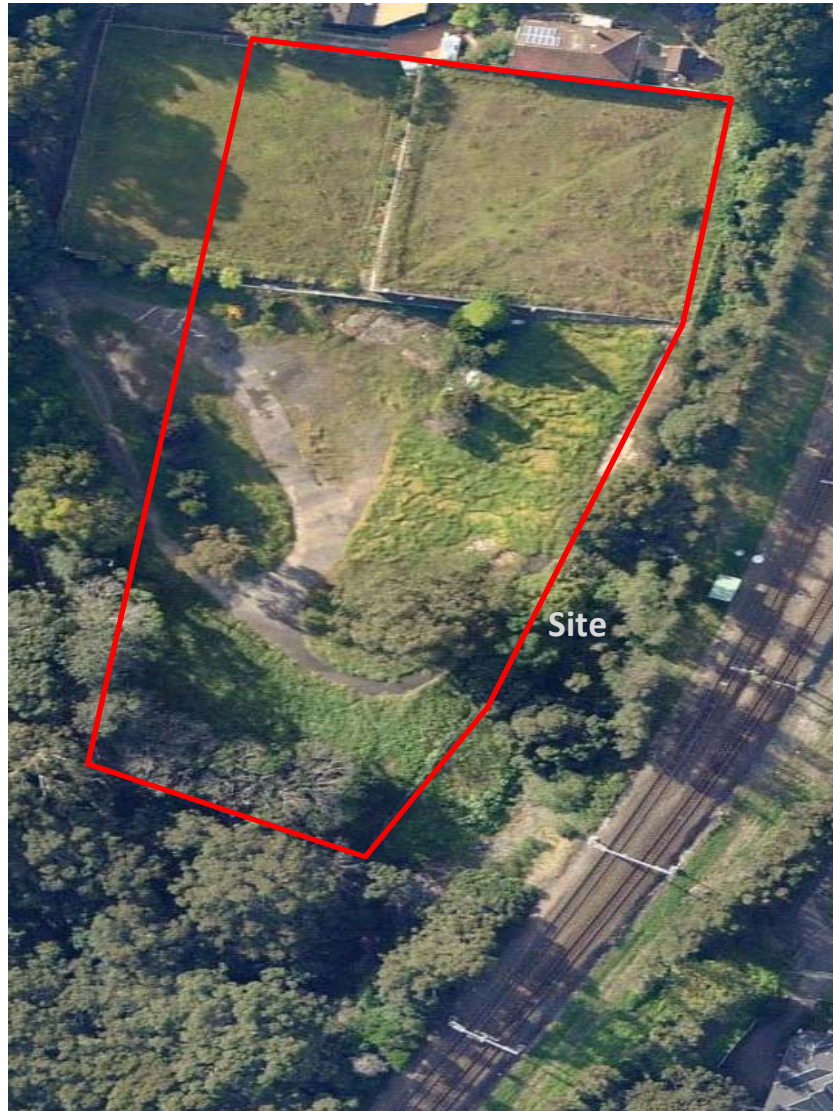
**Historical Photograph- 2012**  
**Preliminary Site Investigation**  
**Former Oatley Bowling Club**

The 2012 image indicates that there are no buildings on site and the former bowling greens are covered in grass in the northern part of the site. The rest of the site is characterised by sporadic vegetation, grass and a former asphaltic roadway is present. The site is predominately surrounded by bushland from the Myles Dunphy Bushland Reserve on the south-western boundary. Residential properties lie to the north of the site and the eastern boundary is adjacent to the rail line which connects to Oatley Station along the Illawarra Line.

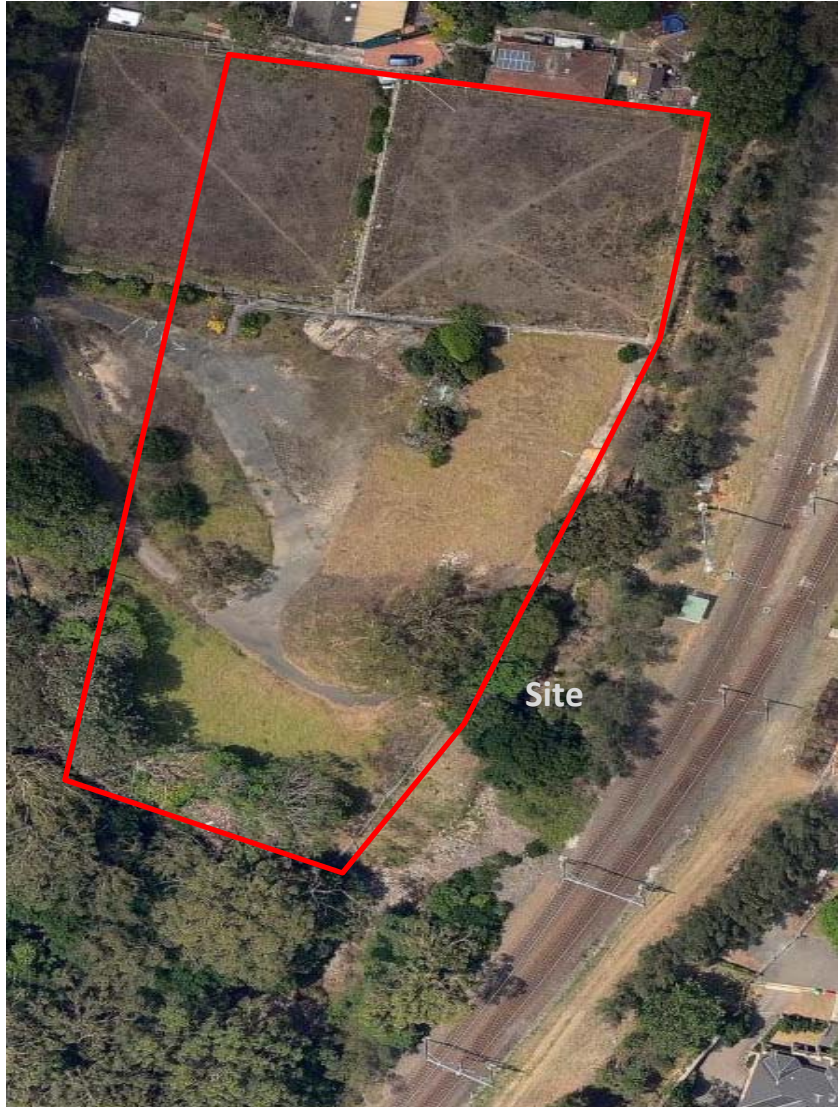
**Historical Photograph- 2013**

The site and surrounding area appear relatively unchanged since 2012.

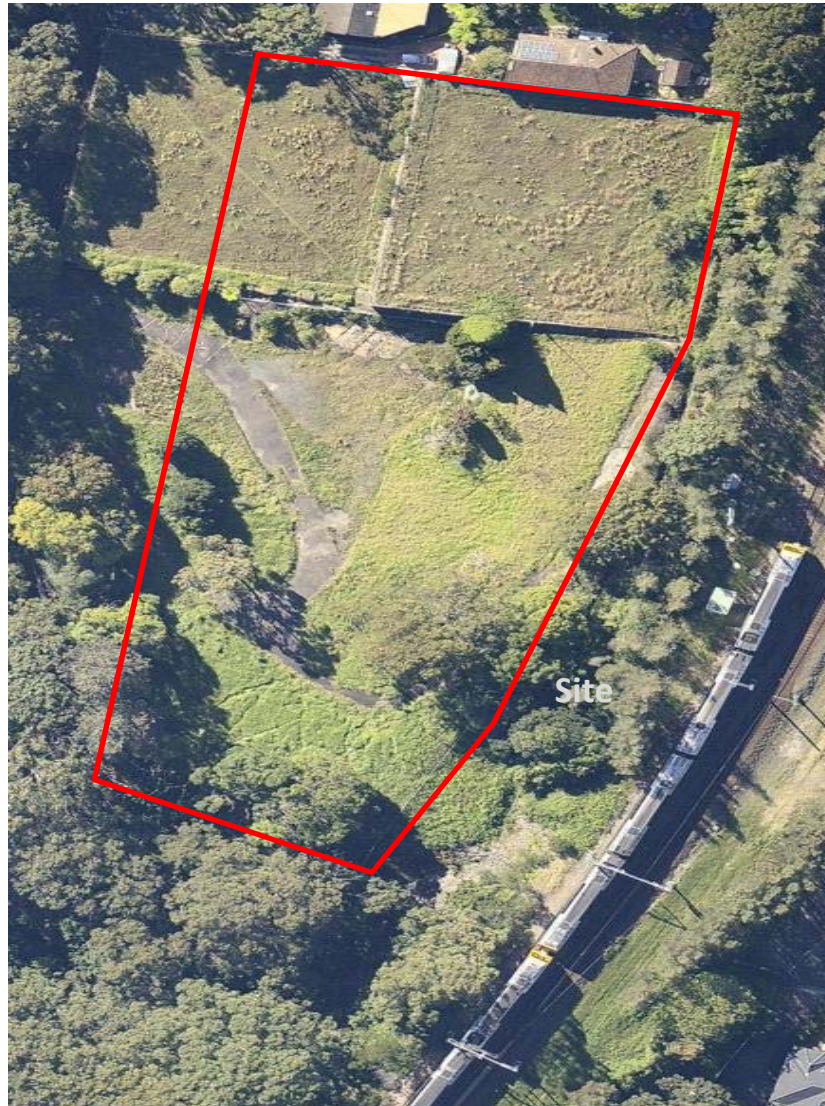
**Historical Photograph- 2014**

The site and surrounding area appear relatively unchanged since 2013.

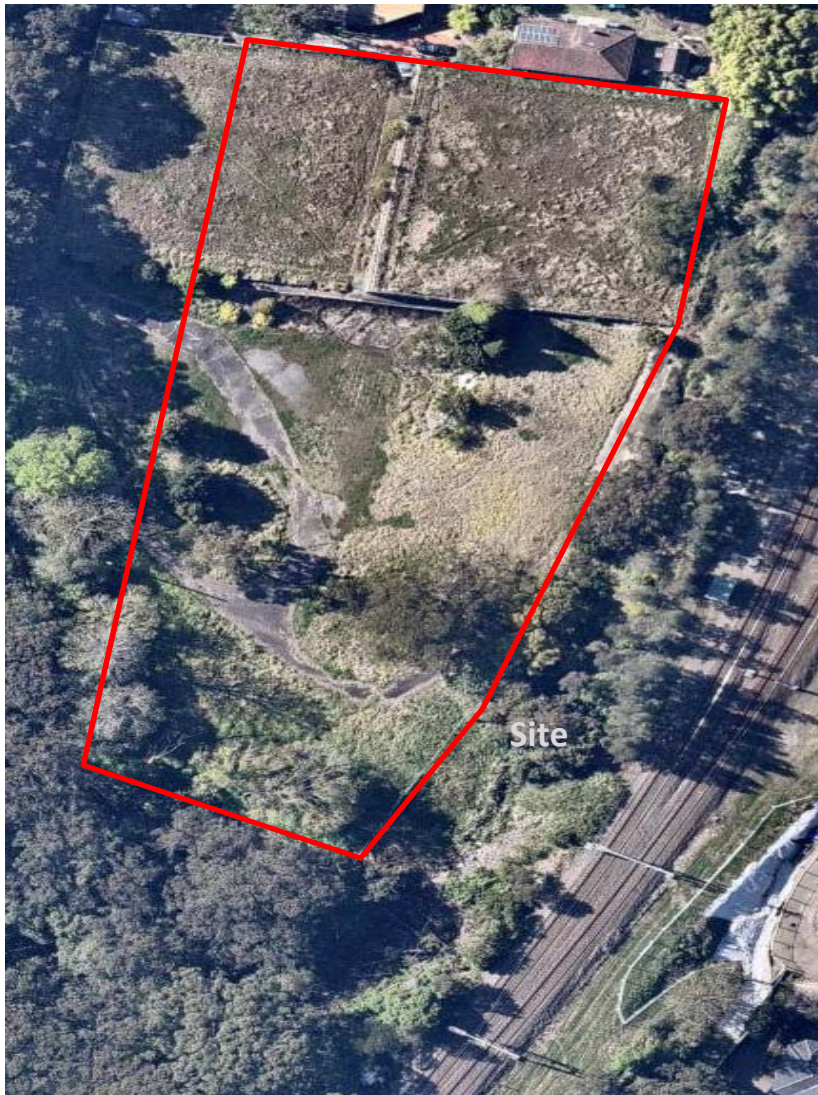
**Historical Photograph- 2015**  
**Preliminary Site Investigation**  
**Former Oatley Bowling Club**

The site and surrounding area appear relatively unchanged since 2014.
