## **48 Dudley Street Coogee**

### **Heritage Assessment**

Report prepared for Randwick City Council

January 2017

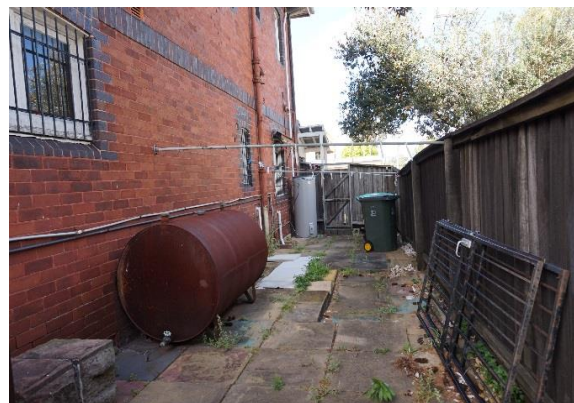
heating system (as well as its later replacements). At the rear (south) end of the east elevation, the window to the kitchen and projecting skillion roofed awning (added to the west end of the entry porch over the rear [south] entry to the kitchen) confirm the service functions of this part of the residence. This awning also provides weather protection for a timber-framed access ramp from the street (added over the original concrete and masonry steps), these elements upgrading the accessibility of the residence to meet changing requirements. A timber paling fence along the Mount Street boundary together with timber and modern profiled steel cross-fences (at the south and north ends of the residence) enclose and screen the service yard area from view from both the public domain and within the site. (Figures 3.17 and 3.18)

**Figure 3.18** Service yard along east elevation of residence looking south with old fuel tank and modern fittings. (Source: GML, 2016)

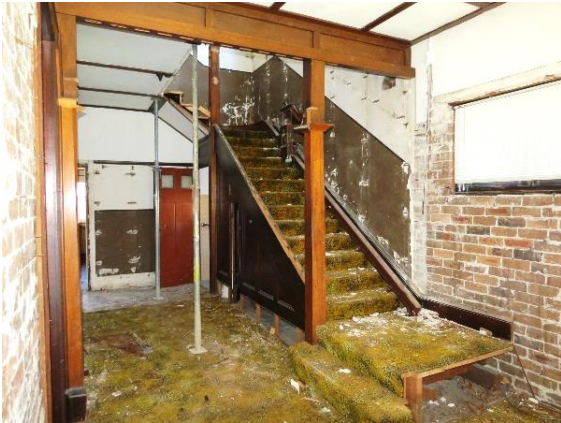
The stained timber wainscoating that previously lined the walls of the entry hall and stairways has also been removed together with the stained timber battening on the walls of the main ground floor rooms (Figures 2.13 to 2.15 and 3.27 and 3.35 to 3.39). Removal of the wainscoating has, however, exposed an earlier painted finish (including a dark green dado) on the original wall plaster of the stair hall (from ground to first floor), showing it to be an early, and sympathetic addition rather than original to, these areas. No earlier finish on the internal brickwork, however, remains on the north, east and west walls of the entry hall which are unplastered up to the height of the previous wainscoating (Figures 3.35 and 3.36).

**Figure 3.27** Entry and stair hall from main entry door showing extent of removed and retained fabric. (Source: GML, 2016)

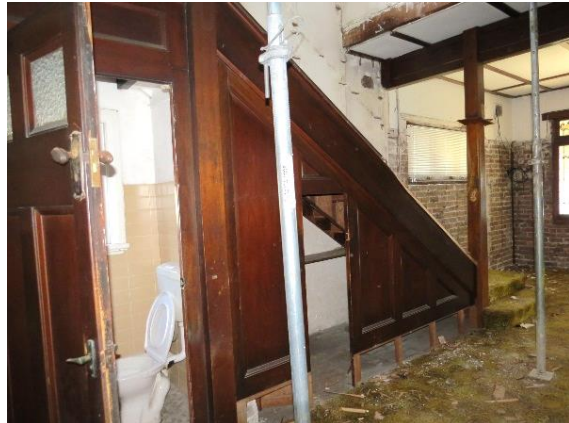
**Figure 3.28** Panelled timber lining under main stair with ground floor lavatory. Props to stair structure with recent works. (Source: GML, 2016)

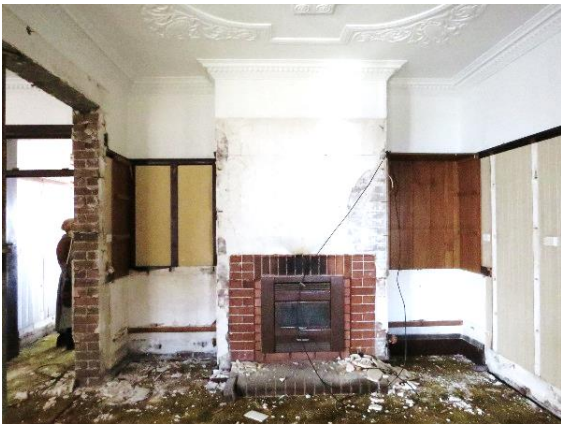
**Figure 3.29** View of living room with original and recently removed components and fabric. (Source: GML, 2016)

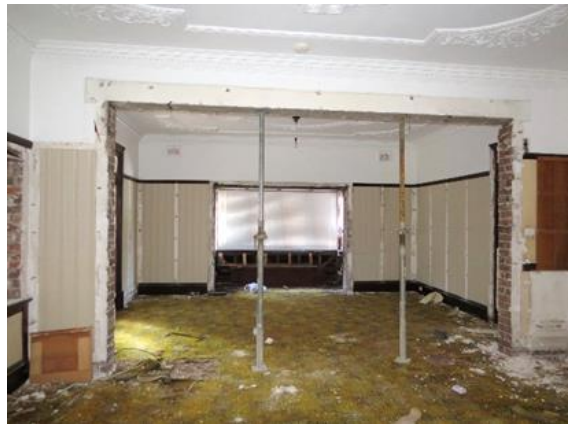
**Figure 3.30** View across living room to sitting room with props under original archway following removal of timber framing. (Source: GML, 2016)

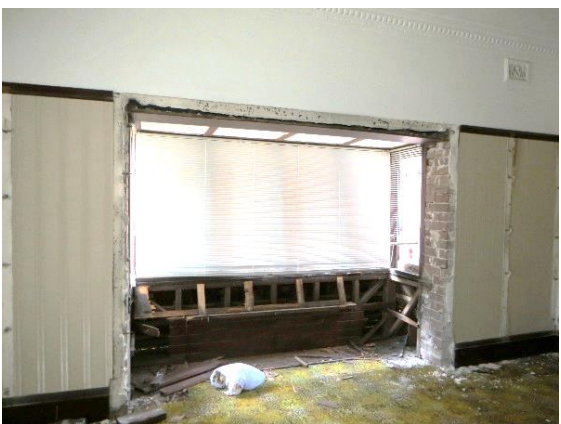
With the recent removal of and/or damage to fittings and finishes within the main ground floor spaces and stairs, however, the building's interior character and level of integrity have been notably altered. Key elements removed as part of these recent works include the original stained timber post enclosure and frieze over the main stair, the architraves and balustrade to the original archway between the living and sitting rooms (Figures 3.29 and 3.30), the two timber over-mantles to the living and dining room fireplaces (Figures 3.29 and 3.32), the built-in bookshelves either side of the living room fireplace (Figure 3.29) and the timber panelling/framework from the sitting room window seat (Figures 3.31 and 3.33).

**Figure 3.31** East wall of sitting room with original bay window with remains of removed wall linings and window seat. (Source: GML, 2016)

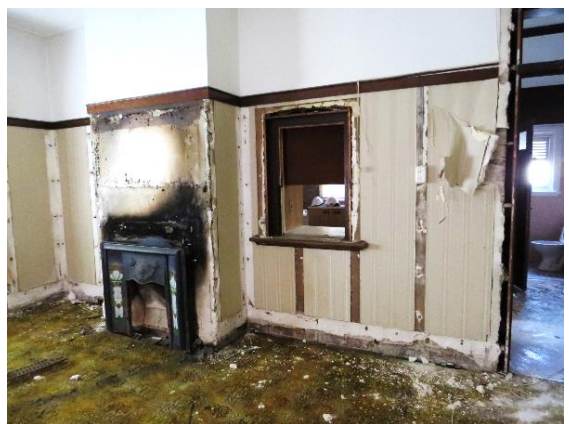
**Figure 3.32** South wall of sitting room with cast iron fireplace and servery window and door to kitchen following removal of overmantle, window and door joinery. (Source: GML, 2016)

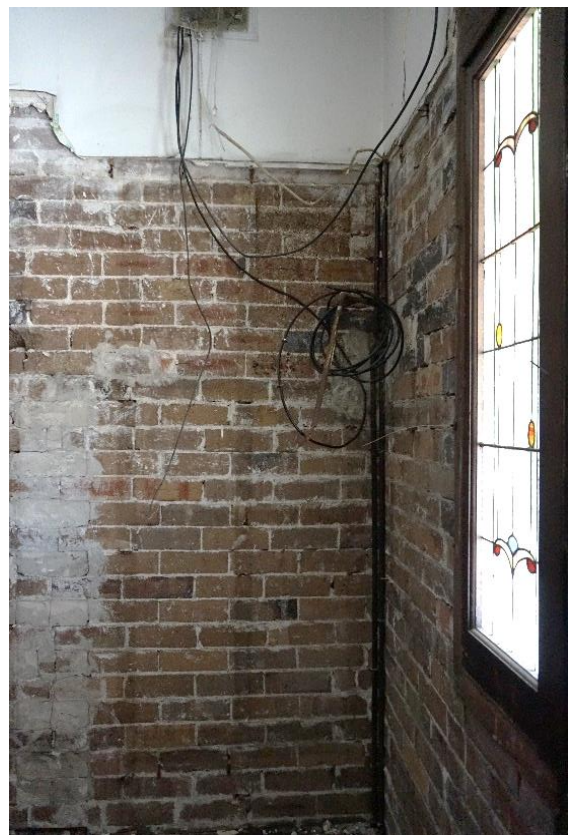
**Figure 3.36** Northwest corner of front hall with exposed brick after removal of wainscoting and plaster finish above. (Source: GML, 2016)

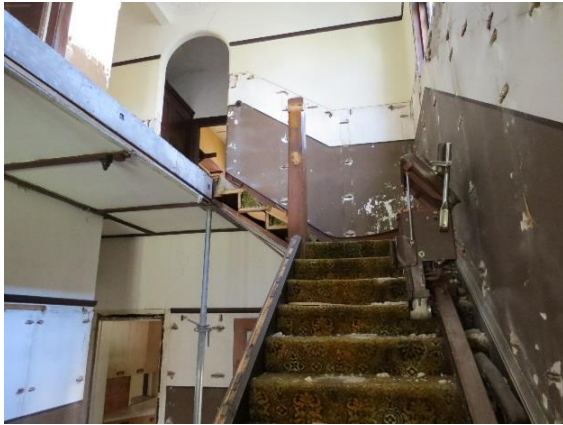
**Figure 3.37** Main staircase from ground to first floor landing after removal of balustrade and wall linings. (Source: GML, 2016)

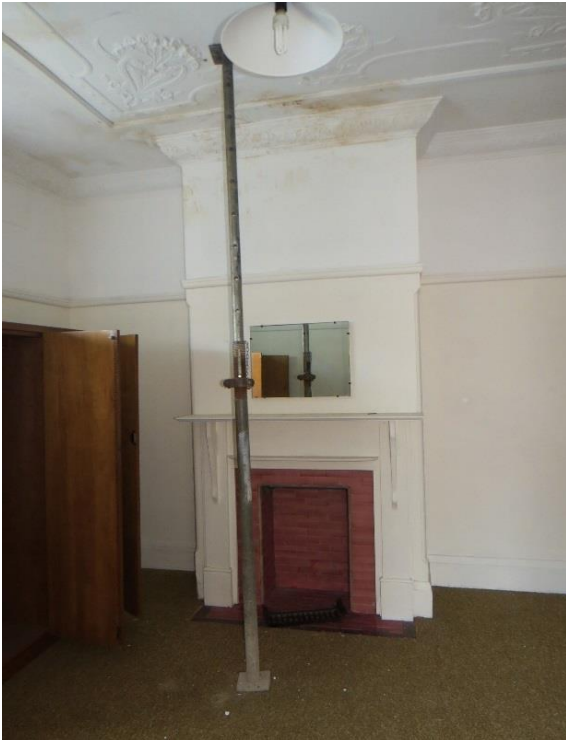
balcony and the staining and dropping of the fibrous plaster ceiling in one of the first floor bedrooms.

**Figure 3.47** West wall of main (south) bedroom with original fireplace showing water damage to plaster ceiling around chimney (with propping to sagging section). (Source: GML, 2016)

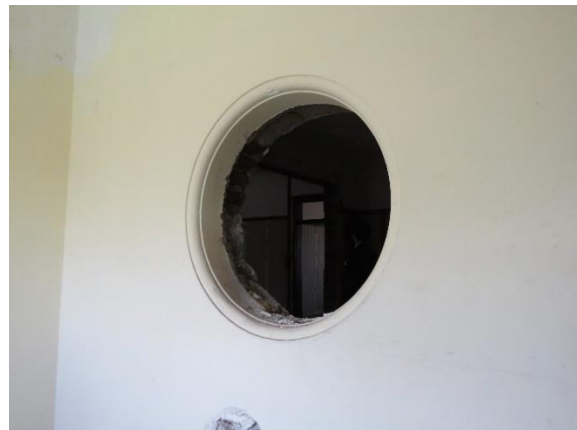
**Figure 3.54** Round window opening in south wall above service stair to provide light from north windows to living room (window glass and frame removed). (GML 2016)

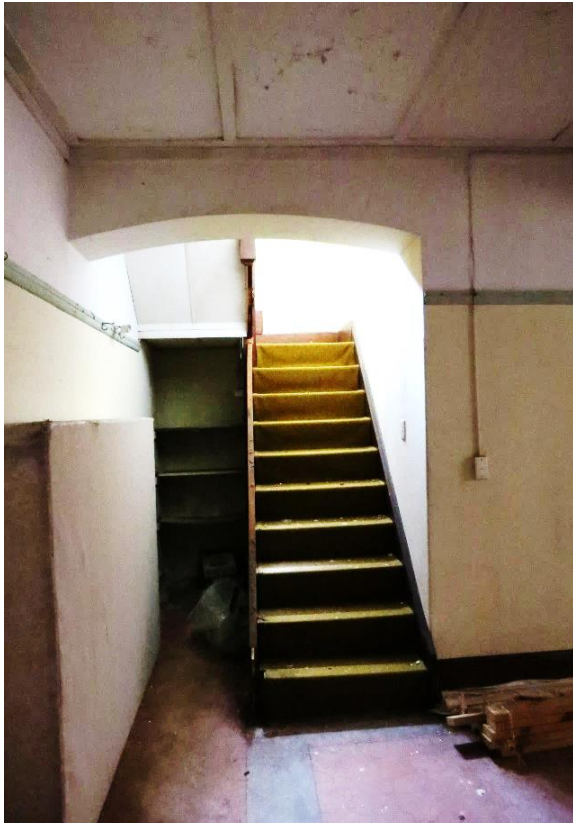
**Figure 3.55** Service stair to basement with original stair (balustrade recently removed) lit by window in front elevation. (GML 2016)

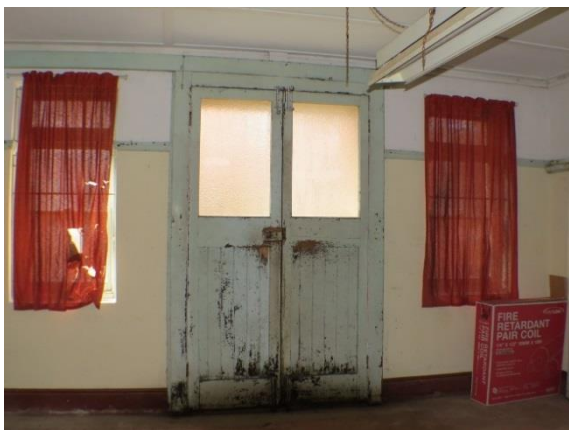
**Figure 3.57** Boarded timber and half-glazed doors and flaking timber sash windows to east wall of basement. (GML 2016)
