Our Ref: 1817702cRE 1-11 Oxford St Paddington- Development Proposal Structural Report Peer Review

## STRUCTURAL PEER REVIEW OF THE CONCEPT DESIGN SUPPORTING PLANNING PROPOSAL AT 1-11 OXFORD STREET, PADDINGTON

## 2. OBSERVATIONS

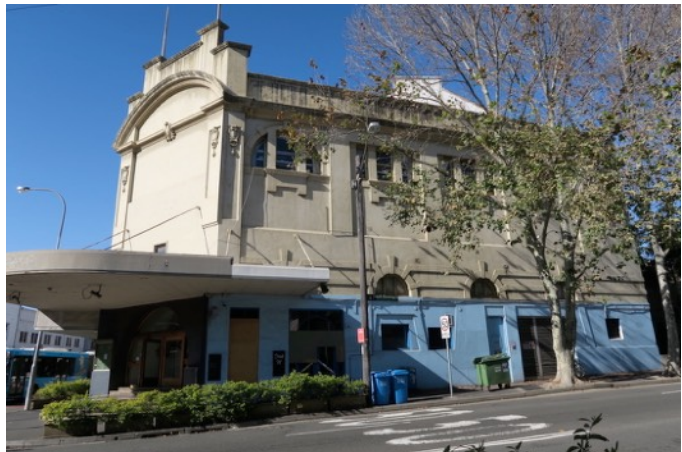
### 2.1.

A general view of the site as seen from South Dowling St.

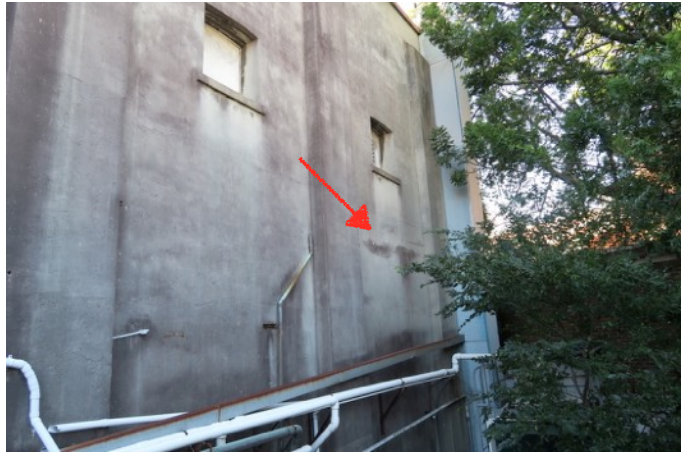
## 2.2.

On the southern facade of the building, the render is seen to be cracking in a regular pattern. The cause of this cracking is not identified, but could have potential implications on the stability or retention of the facade.

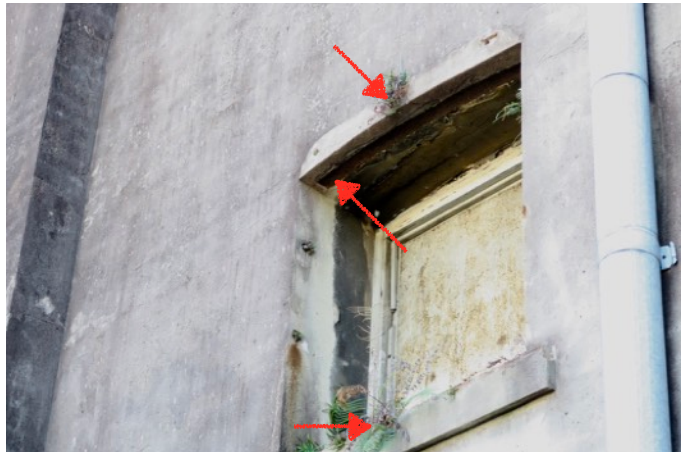
### 2.2.1.

On the southern facade, the lintels to the window are corroding. There is also the presence of vegetation growing within the facade.

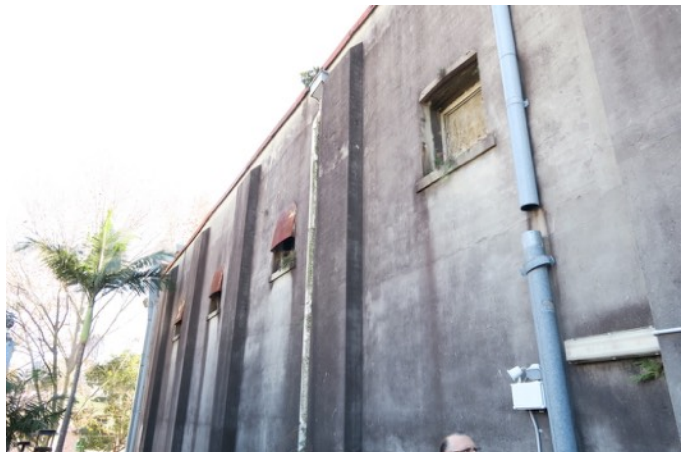
## 2.3.

A general view of the southern facade, looking towards South Dowling Street to the west.

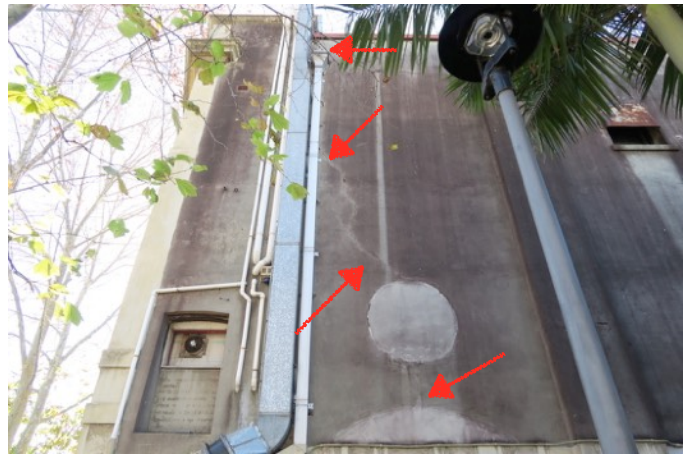
2.4.

The junction of the facade on the south west corner has a vertical crack present running from the upper level of the facade down to ground level.

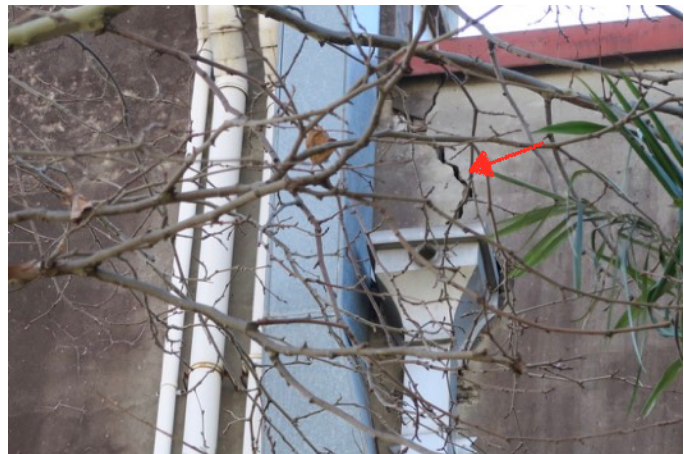
2.5.

A detail view of the cracking at the rain head on the facade. The cracking is of significant size.

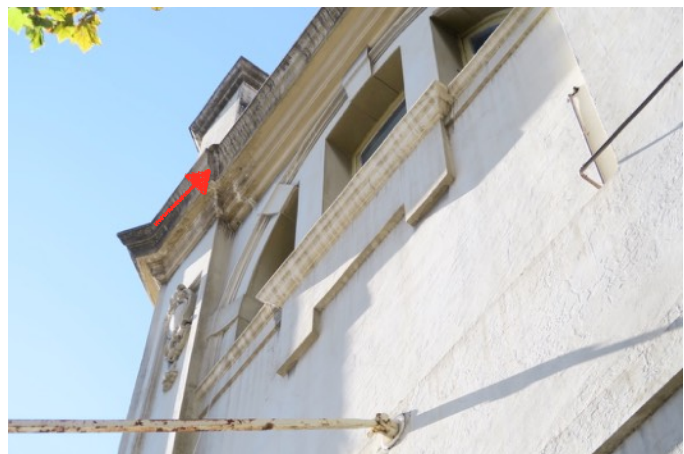
2.5.1.

When viewed from street level, the upper cornice of the facade appears to have a missing section of cornice, along with signs of other cracks present.

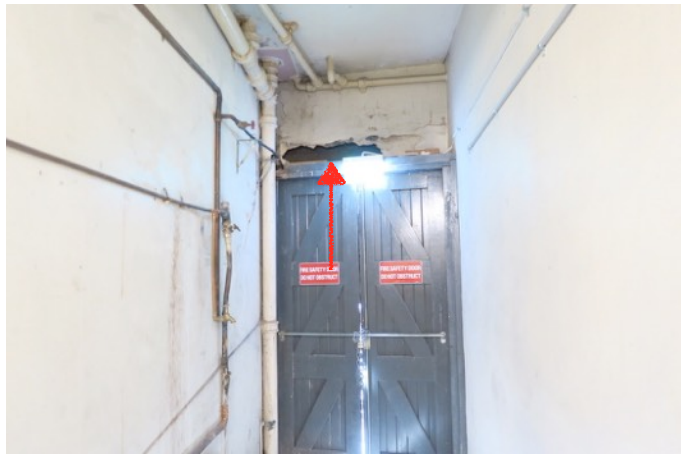
## 2.5.2.

Internally, the fire stairs opening out to Oxford St has a damaged lintel present, along with visible water damage to the building's interior render.

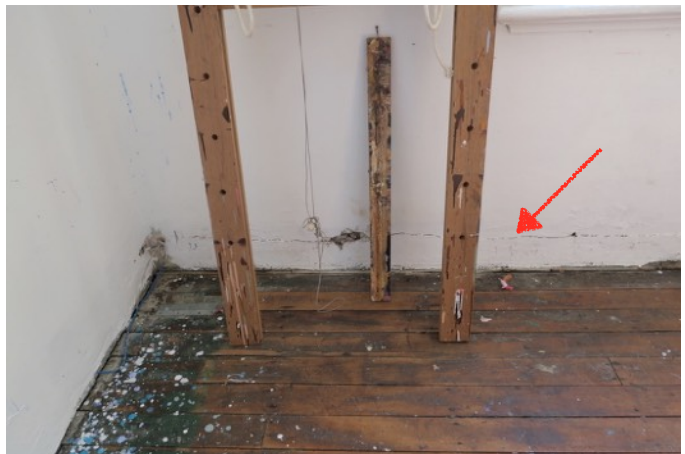
## 2.5.3.

Within one of the first floor art spaces, a regular linear crack is present at a lower level.

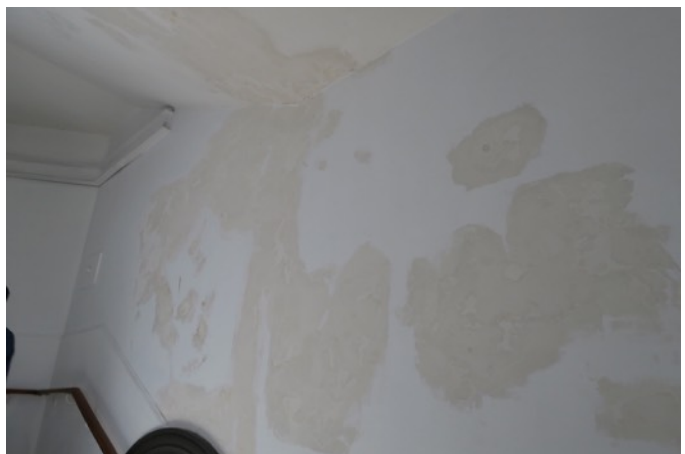
## 2.6.

Internally there are areas of the external facade which show signs of repair to the render to the internal face of brickwork.

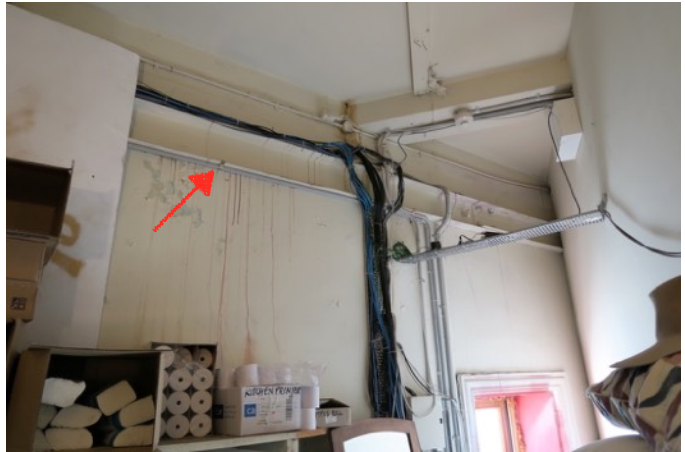
## 2.6.1.

At the north west corner of the building adjacent to the front awning, a steel beam is present to assist in the fixing of the canopy tie rods.

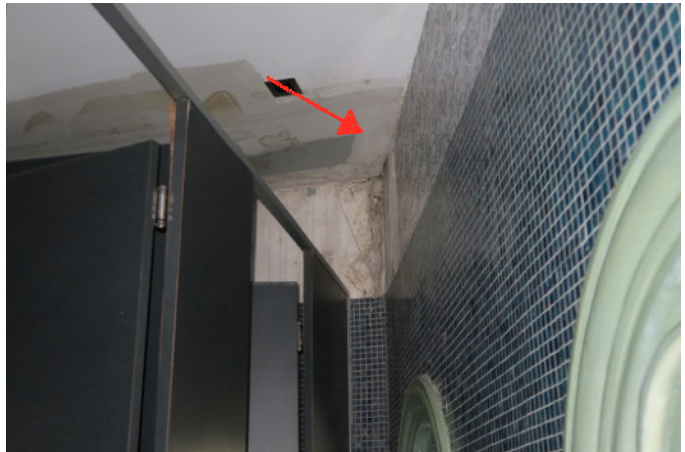
## 2.7.

Water damage visible to the internal wall on the second floor toilets, at the location of the cracking identified previously to the south western corner of the building.

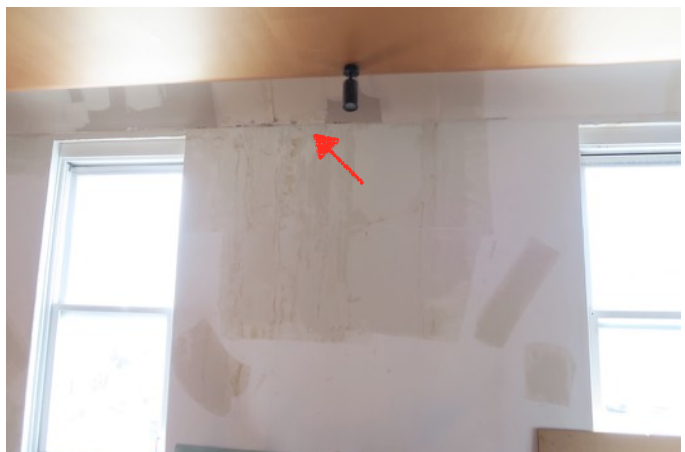
## 2.8.

Water damage to the internal render, as seen along the Oxford St facade, at the 2nd floor level.

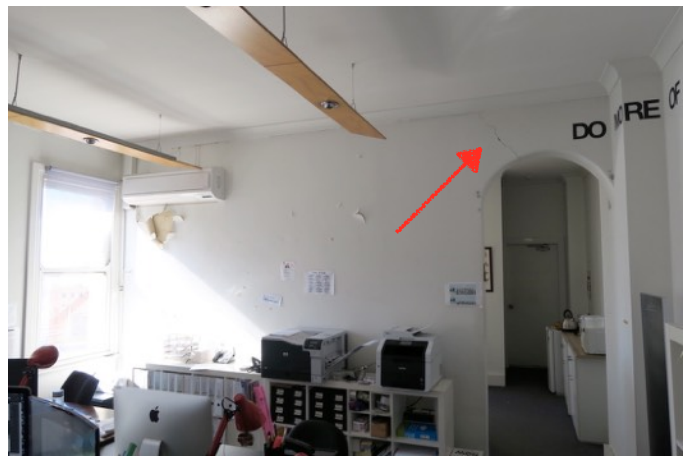
2.9.

Cracking present in the archway at the eastern corner of the property on Oxford St, within the arched opening. This is a through crack in the brickwork.
