Phase 2 Environmental Site Assessment, Parcel 9

Prepared for: Hydro Aluminium Kurri Kurri Pty Ltd

Prepared by: ENVIRON Australia Pty Ltd

Date: April 2015

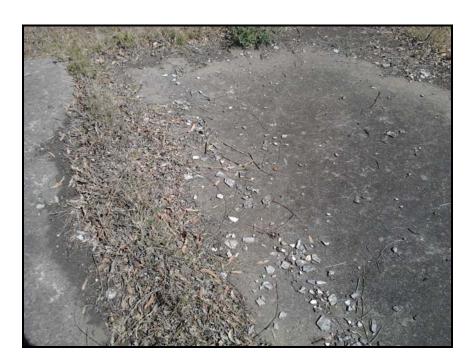
Photo 1: 9/10/13 Photograph of ACM fragments scattered across the concrete slab of the former building on Lot 448.

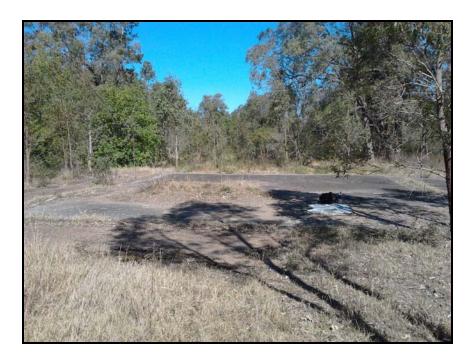
Photo 2: 9/10/13 Photograph of the concrete slab of the former building on Lot 448.

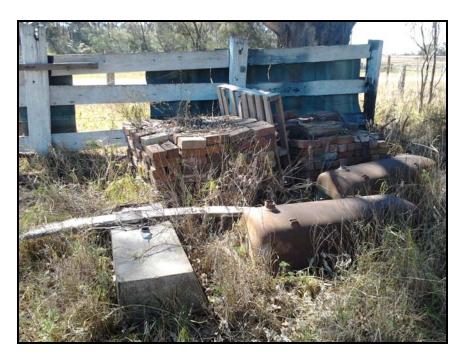
Photo 3: 9/10/13 Photograph showing the stock fences and old material stockpiles at the front of Lot 448.

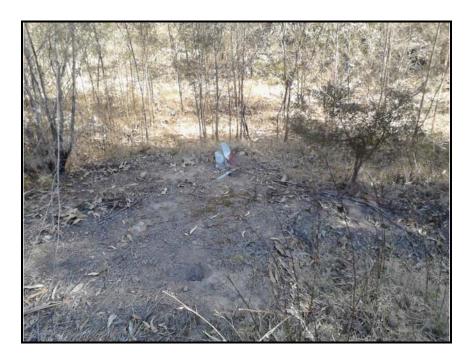
Photo 4: 9/10/13 Photograph of a fill mound at the back of Lot 448.

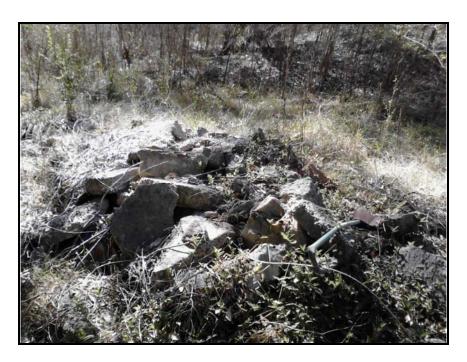
Photo 5: 9/10/13 Photograph of a fill mound with broken concrete pieces visible at the back of Lot 448.

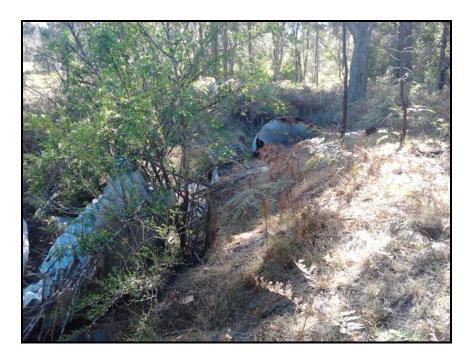
Photo 6: 10/10/13 Photograph of a fill mound and surface debris including old metal sheeting and a water tank on the middle portion of Lot 449.

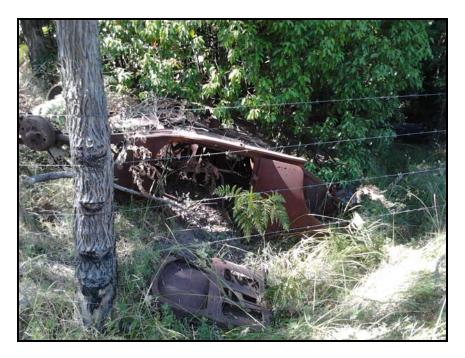
Photo 7: 10/10/13 Photograph of an old car body in a gully near the creek at the rear of Lot 449.

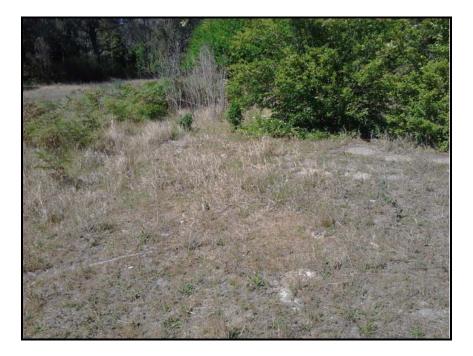
Photo 8: Photograph of concrete pavers in what appears to be a garden area of the former residential dwelling at the front of Lot 449.

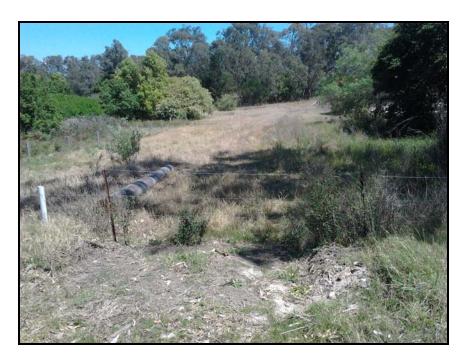
Photo 9: 10/10/13 Photograph of the front of Lot 449 where 2 ACM fragments were found on the area likely to be the former residential building footprint.

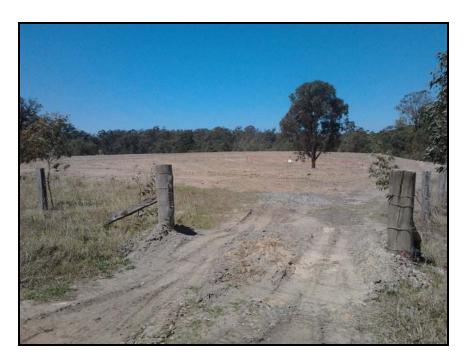
As VENM, the presence of this material on Parcel 9, Lots 15 and 447 does not compromise the environmental condition of the Lots for the proposed land use.

Photo 11: 9/10/13 Photograph of the front of Lot 447 where fill from adjacent construction of the Hunter Expressway has been placed on the Lot.

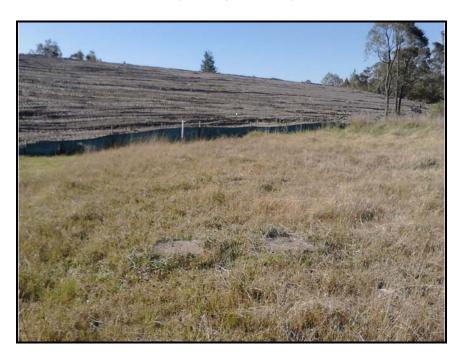
Photo 12: 9/10/13 Photograph taken at the rear of Lot 447 looking at small concrete building footings (foreground) and the fill that has been placed on the front of the Lot (background).

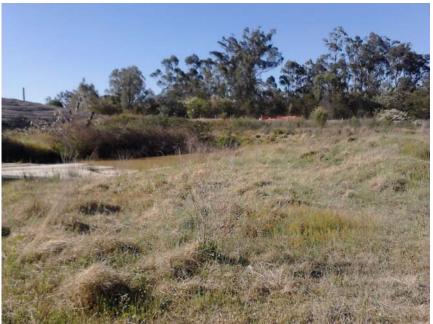
Photo 13: 9/10/13 Photograph of pooled water and grassed covered fill mounds at the rear of Lot 447.

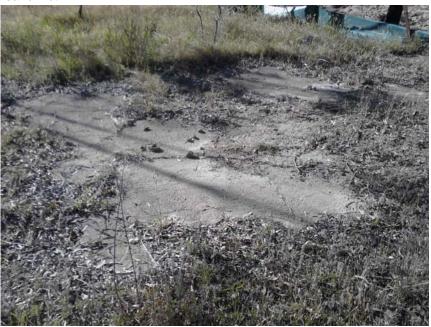
Photo 14: 9/10/13 Photograph of a concrete slab for a former building at the rear of Lot 448 on the eastern boundary fenceline.

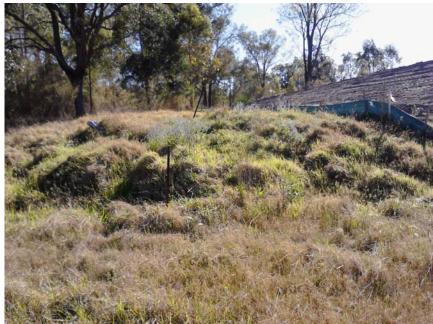
Photo 15: 9/10/13 Photograph of a large grassed over fill mound at the rear of Lot 447.

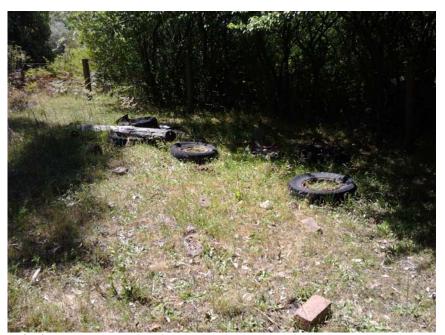
Photo 16: 10/10/13 Photograph of surface debris at the rear of Lot 438.

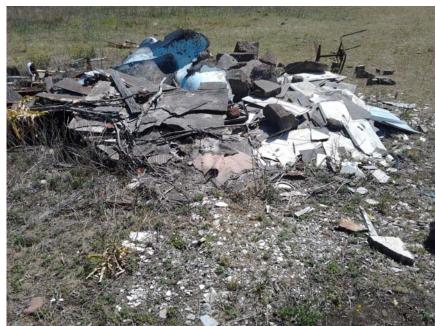
More recent demolition of existing structures occurred on Lots 20 and 439 in 2012 / 2013. This has resulted in the dispersion of ACM fragments across the ground surface of both these properties and asbestos fines were found to be present in the soil stockpiles on Lot 439.

Photo 17: 10/10/13 Photograph of building rubble including ACM sheeting and fragments on Lot 439.

As discussed above it is considered that the current condition of the former residential areas of Lots 20 and 439 are not suitable for the current land use and are also considered to be a potential risk to human health in their current condition. As an interim measure these areas should be securely fenced to prevent public access (and any illegal dumping).

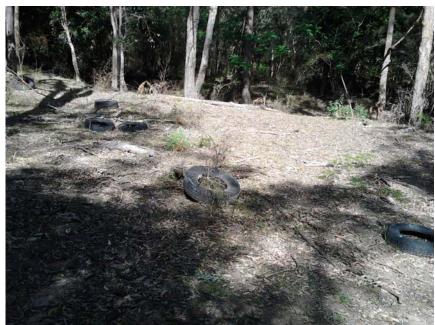
Photo 19: 11/10/13 Photograph of old tyres from suspected flooding of the creek at the rear of Lot 436.

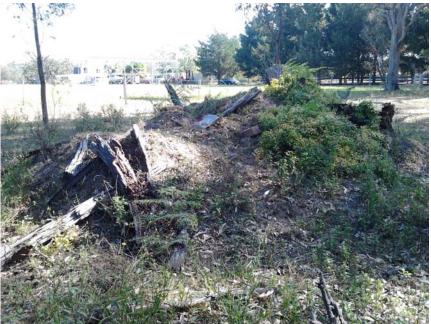
Photo 20: 11/10/13 Photograph of old timber and bricks in a fill mound at the front of Lot 437.

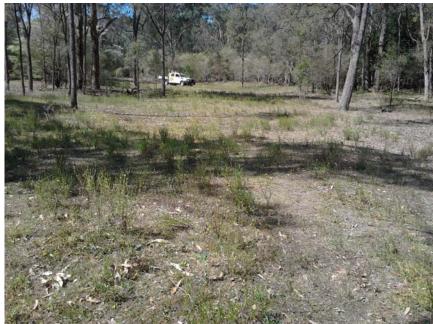
Photo 21: 11/10/13 Photograph of the extent of hummocky ground (extending to the vehicle in the background) on Lot 436 at the suspected location of the former municipal landfill.

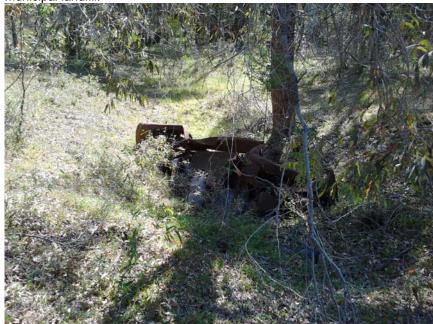
Photo 22: 11/10/13 Photograph of an old car body in a gully on Lot 436.

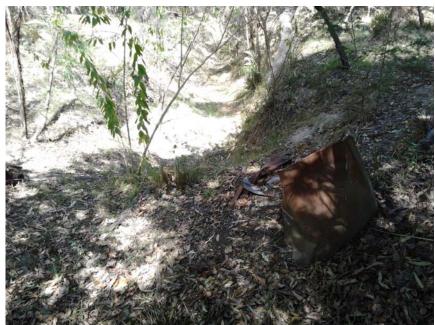
Photo 23: 11/10/13 Photograph of metal scrap in a gully on Lot 436.

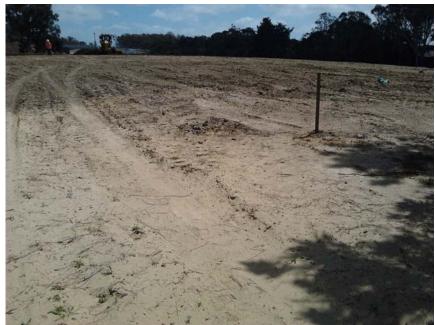
Photo 24: 11/10/13 Photograph of the front of Lot 15 where fill from adjacent construction of the Hunter Expressway has been placed.

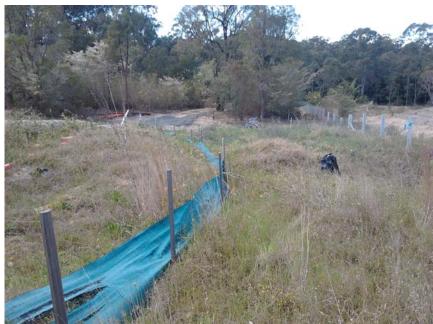
Photo 25: 11/10/13 Photograph of the middle portion of Lot 15 where grassed over hummocky ground is evident.

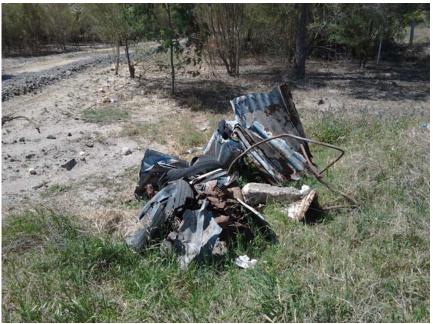
Photo 27: 11/10/13 Photograph of surface debris on the front of Lot 21.

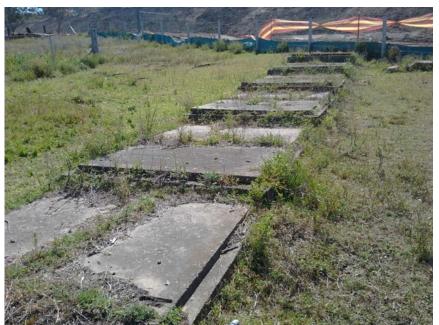
Photo 28: 10/10/13 Photograph of concrete slabs of suspected former kennels on the front of Lot 22.

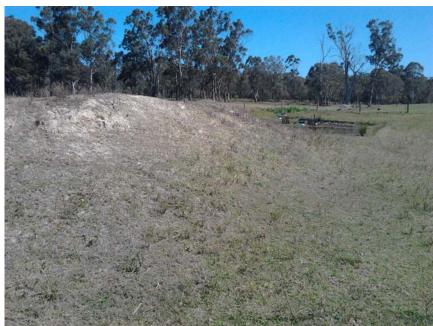
Photo 29: 10/10/13 Photograph of a grassed over fill mound on the front of Lot 22.

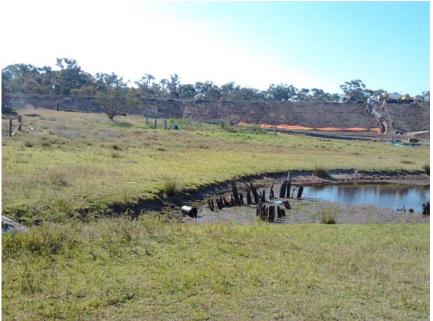
Photo 30: 10/10/13 Photograph from the suspected former building footprint looking towards the front of Lot 22.One ACM fragment was found on the building footprint.

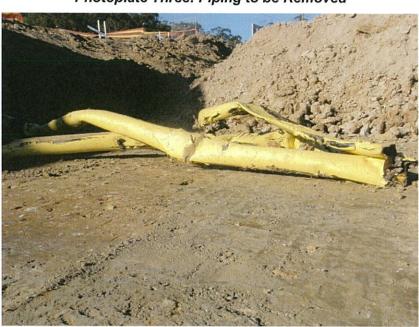
Photoplate Three: Piping to be Removed

There was plastic gas piping found on the area, see Photoplate 3.
