## **Stage 1: Contamination Assessment**

### **Part Lot 20, Old Saddleback Road, Kiama NSW**

Mark Passfield  
SEEC Reference 13000047-CA-01

Date: 5<sup>th</sup> April 2013

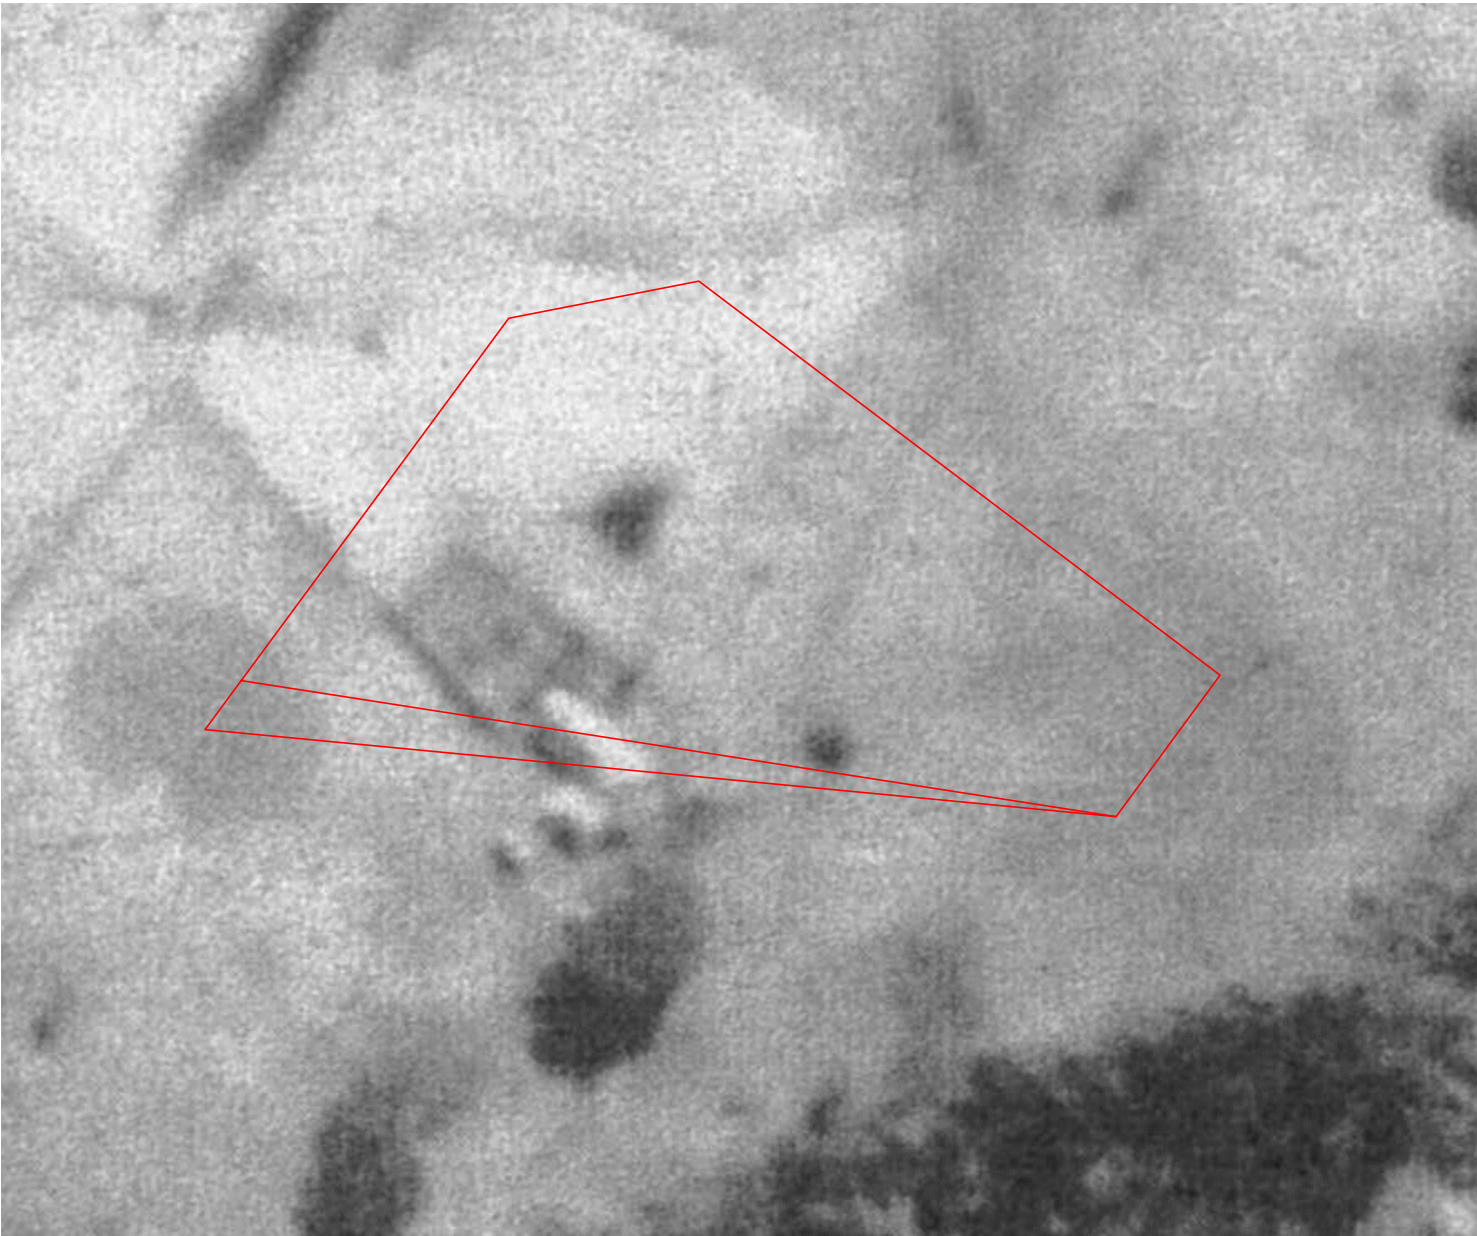
- 1949 – A cottage on the site with two outbuildings on land immediately to the south. The land use of the subject site and the immediate surrounds appears rural.

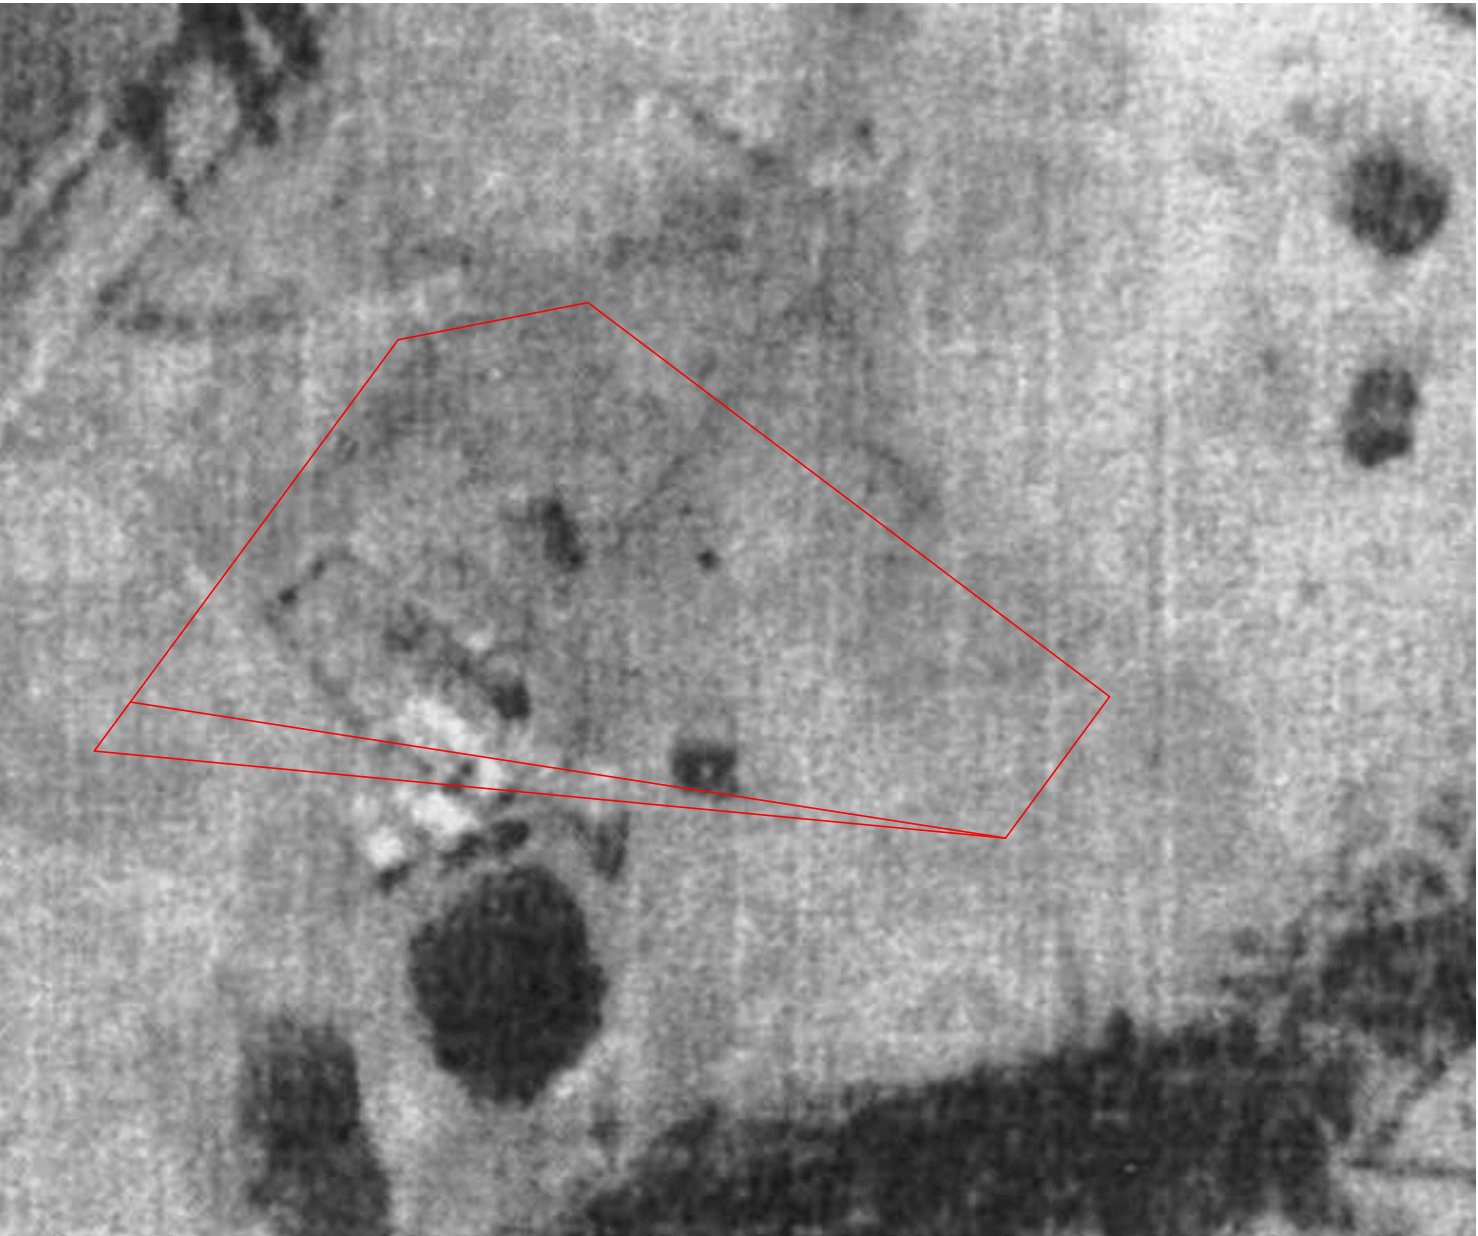
- 1963 – The cottage and outbuildings remain and appear unchanged. The land use of the subject site and immediate surrounds appears unchanged.
- 1974 – The cottage remains but one of the outbuildings appears to have been removed. The land use of the subject site and immediate surrounds appears unchanged.

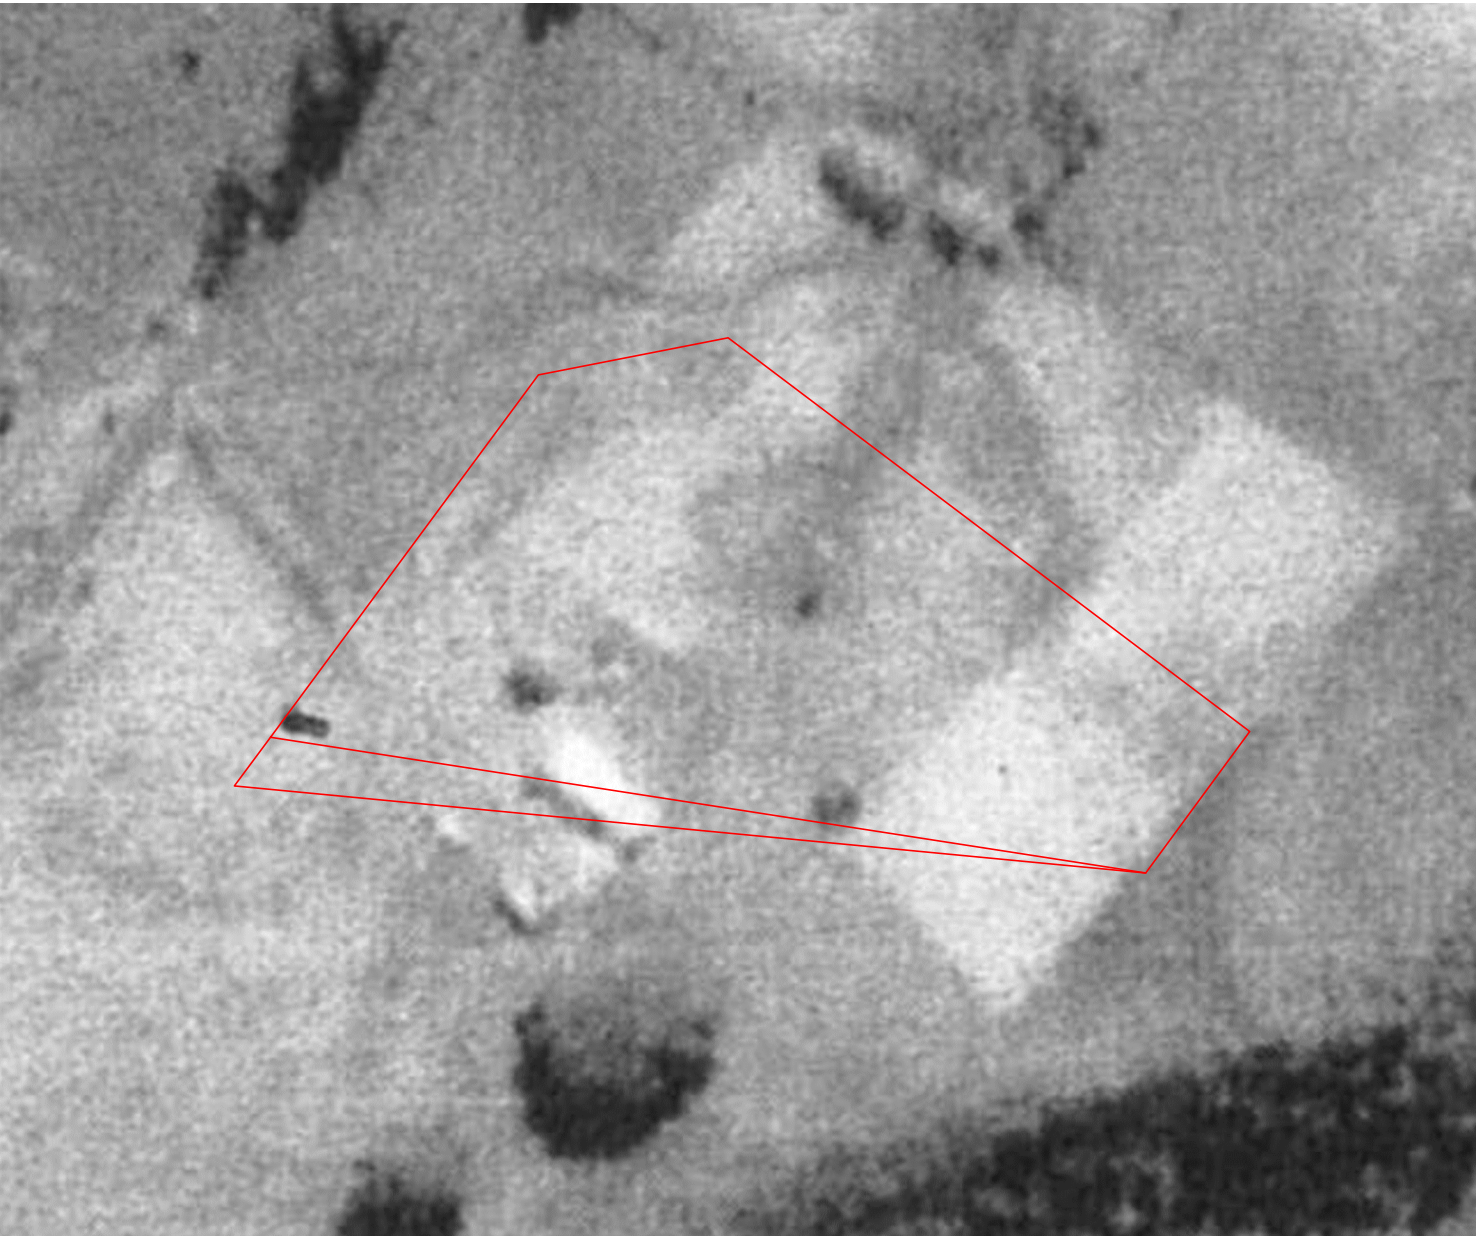
- 1984 – The cottage and the outbuilding remain. The land use of the subject site and immediate surrounds appears unchanged.
- 1997 – The cottage and the outbuilding remain. A new shed is on adjoining land immediately to the northwest. The land use of the subject site and immediate surrounds appears unchanged.

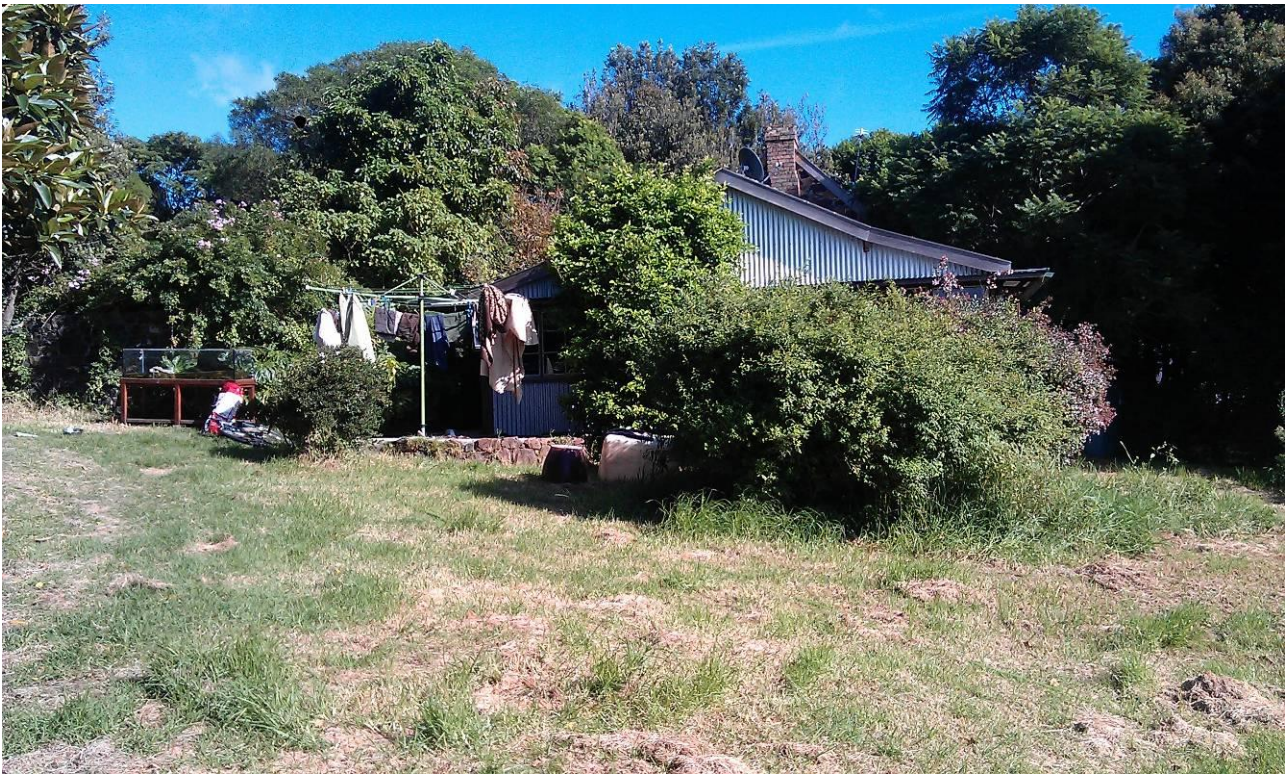
At the time of inspection (25<sup>th</sup> March 2012) the subject site was occupied by part of a cottage (Figures 5 and 7) and a small part of the footings of a previous cottage. It is thought (from the aerial photos) that the original cottage was demolished and used to build the new one sometime between 1963 and 1974. The septic tank serving the cottage and part of an unsealed driveway are also on the subject land (Figure 7). The remainder of the subject land is undeveloped.

Figure 5 – View west over cottage. Septic tank in shrubs in foreground.

There are no indications that the subject site has had potentially contamination activities on it, although it is possible that the under floor area of the cottage could have been sprayed for termites sometime in the past.

We conclude the risk of contamination is very low and the issue of contamination would not preclude re-zoning. However, there is a risk that the under-floor area of the dwelling has been sprayed for termites. When the home is demolished we recommend the exposed under-floor area is tested for Organochlorine and Organophosphate pesticides at the surface and at a depth of 300 mm. If pesticides are present a remedial action plan would be required to address remediation or removal of the contaminated soil.

There is a septic tank on the land that would require decommissioning and removal before any future residential development.

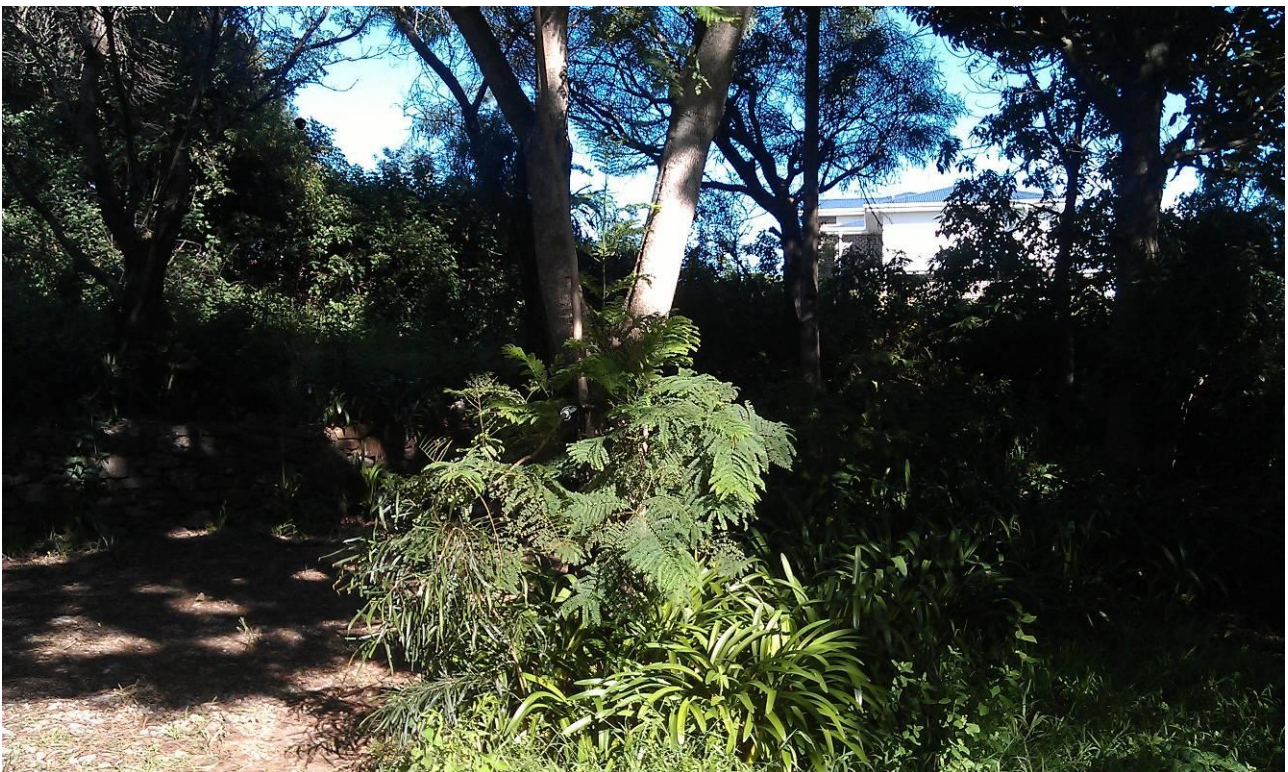
Figure 6 – Looking west towards Old Saddleback Road. Driveway in foreground.

There were no obvious signs of fill material; although minor earthworks (e.g. to form the drive) has occurred in the past.
