Burnett Trees Arborist Report

**39 Macquarie Street, Jamberoo
Lot 1, DP 710456**

Prepared by Andrew Burnett of Burnett Trees, 22 October 2014

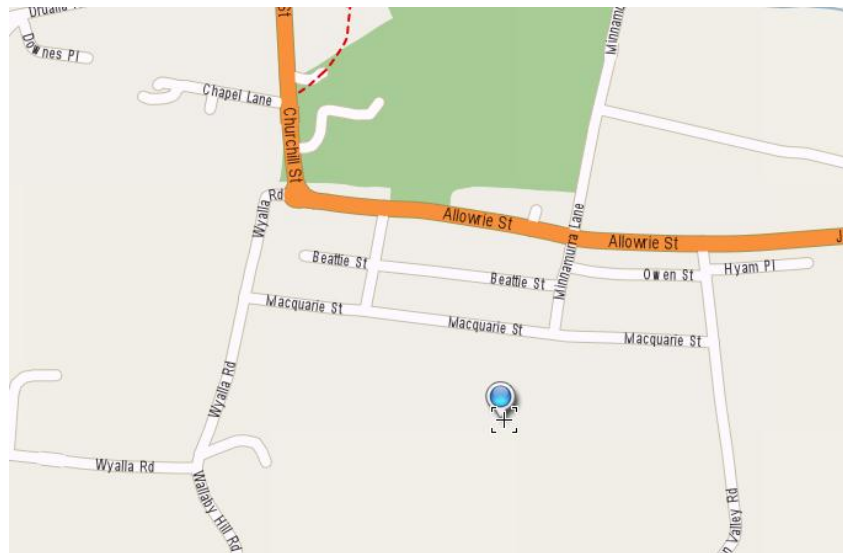
Approximate location of the assessed trees.

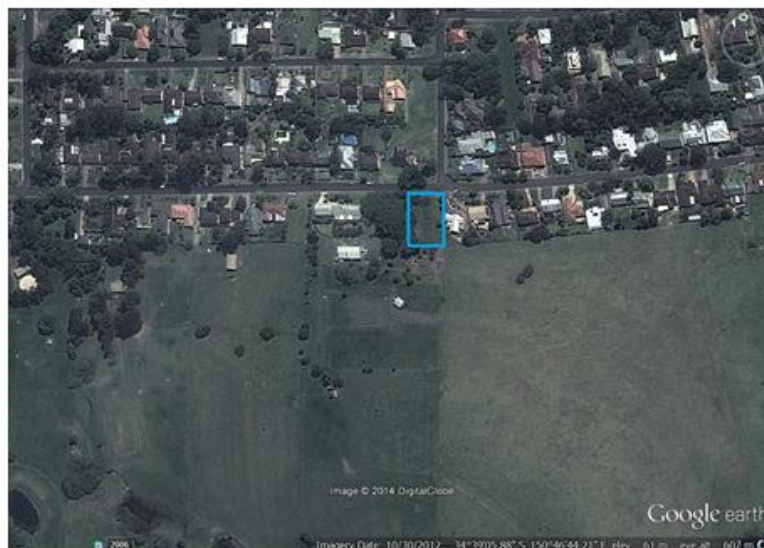
Area to be rezoned. 20m street frontage width x approx 40m depth.

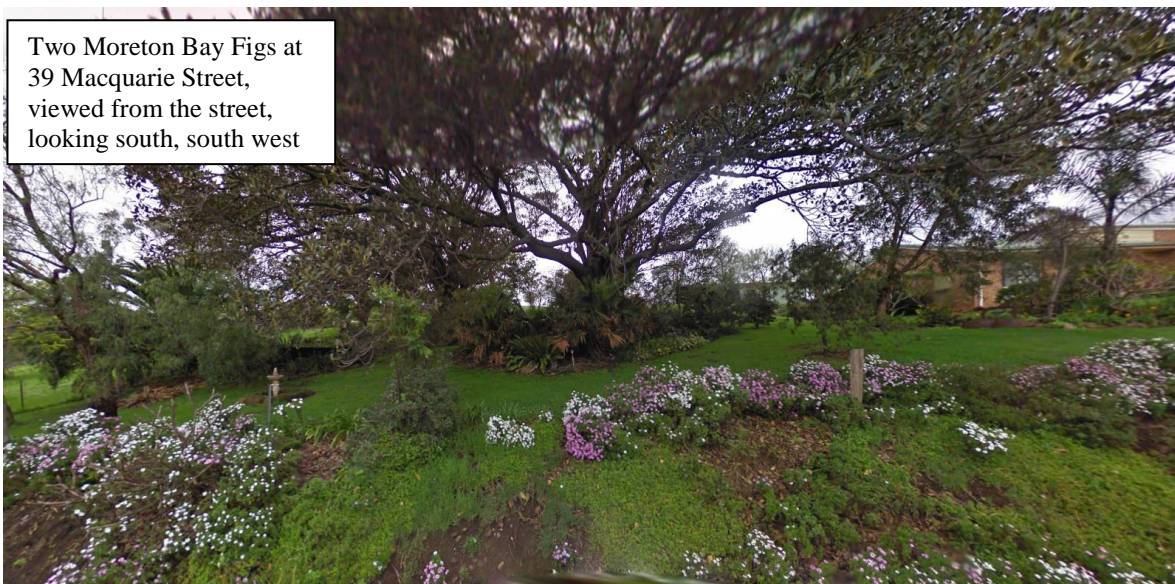
The most considerable trees on the property are two Moreton Bay Figs (*Ficus macrophylla*). The first fig, furthest south from the road and 36m from the current eastern property boundary, was assessed as having a Diameter at Breast Height (DBH) of 2m, growing to a height of approximately 16m and having both Good Health and Good Structure. The tree is Mature in Age. Its SULE rating was assessed as 1a, being a tree “that appeared to be retainable at the time of assessment for more than 40 years with an acceptable level of risk and is structurally sound trees located in positions that can accommodate future growth.”

This tree has a Crown Spread which extends 15m to the north, 16m to the east and 7m to the west. The tree’s canopy currently extends 8 metres over an existing fenceline on the property and is estimated to extend to only 5 metres from the western boundary of the proposed new boundary line which would be 21 metres from the tree’s trunk.

- **Both Moreton Bay Figs (*Ficus macrophylla*) located on the property are recommended for special efforts for retention.**
- **Proposed subdivision is not expected to significantly adversely affect the two Moreton Bay Figs or other tree species.**
- **Boundary fencing on any subdivided property should be erected prior to any excavation or construction works in order to provide a permanent Tree Protection Zone. No building materials or machinery should be permitted to be stored or placed under either Fig tree.**
- **Construction techniques for boundary fencing should use minimum impact techniques to avoid potential root damage, ideally hand-dug pier technique. No strip footing methods should be employed which could sever roots.**
