Appendix 3 – Preliminary Contamination and Groundwater Assessment Report – 16-20 Princess Street

PRELIMINARY CONTAMINATION & GROUNDWATER ASSESSMENT

16-20 PRINCESS STREET, BRIGHTON-LE-SANDS NSW

Job No: MPG 2038

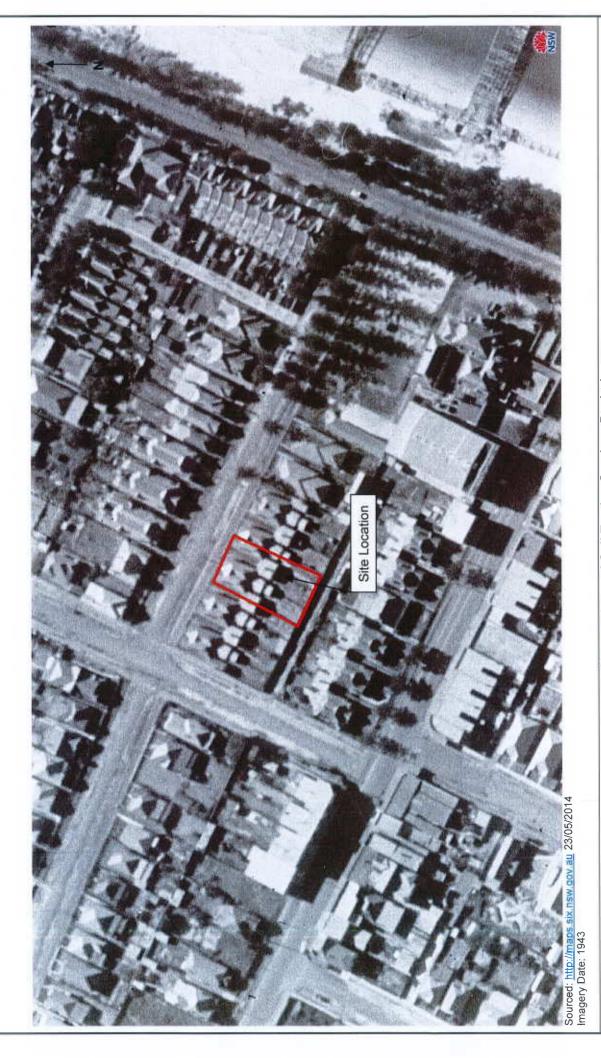
1943 Aerial Photograph 16-20 Princess Street Brighton-Le-Sands, NSW

The site and immediately surrounding area appears to contain duplex dwellings. Princess Street and an access laneway are present to the North and South respectively. A large tall building (possibly factory or office building), approximately 50m South-east of the site is observed. The general area appears to consist of residential properties.

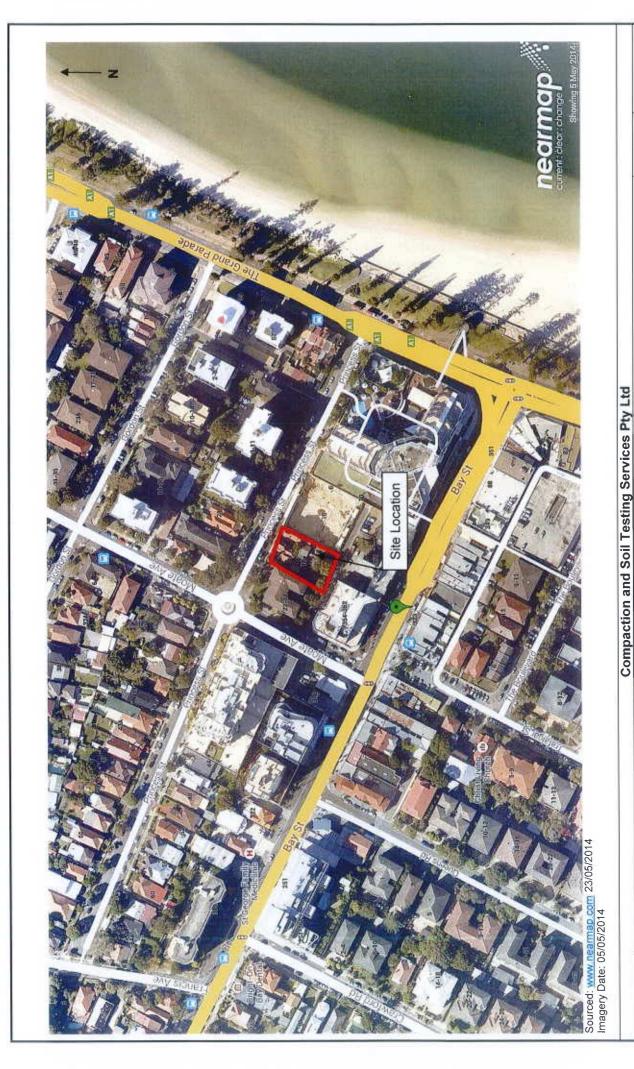
2014 Aerial Photograph 16-20 Princess Street Brighton-Le-Sands, NSW

The site appears relatively unchanged since the 1943 imagery. The neighbouring properties have been redeveloped into apartments, with the property immediately east in the process of development. The general area appears to have undergone significant redevelopment into high-rise residential properties with commercial developments included. A large hotel (Novotel) is observed approximately 80m east of the site.
