Annex A

## Archival Photographs

| Project: | Incitec Pivot Remediation and Demolition HA | | |

Annex B

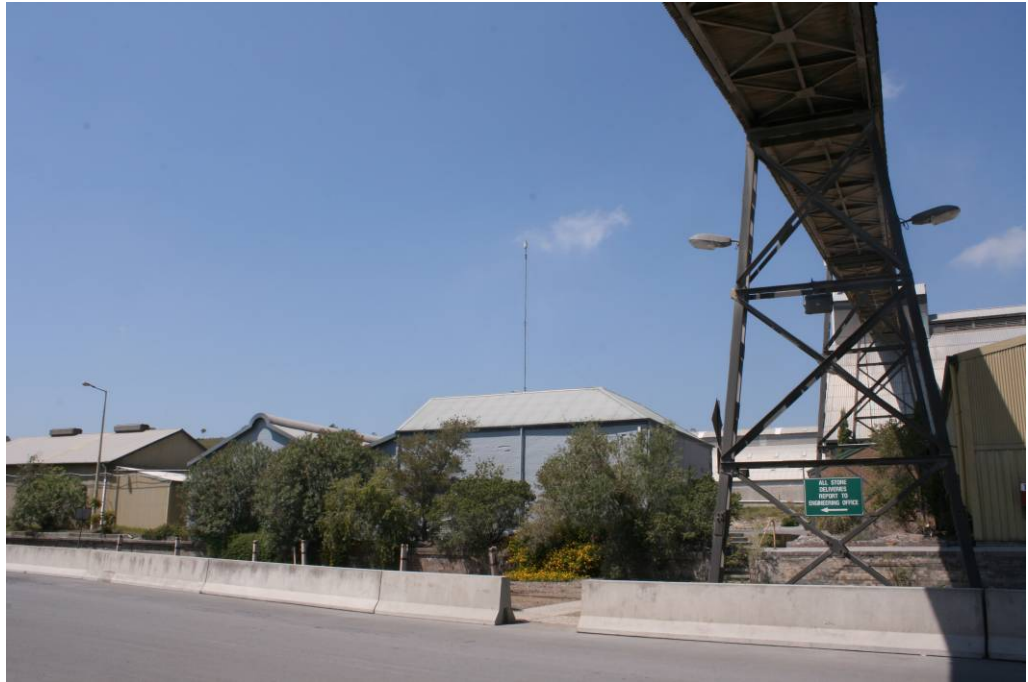
*Photograph A.3 Sandstone and brick building and gantry overhead*

| Photo | Easting | Northing | Bearing | Description |
|---|---|---|---|---|
| 1327 | 0371888 | 6353721 | East | Rear of brick/sandstone building showing southern extent modifications and Gantry running overhead. |

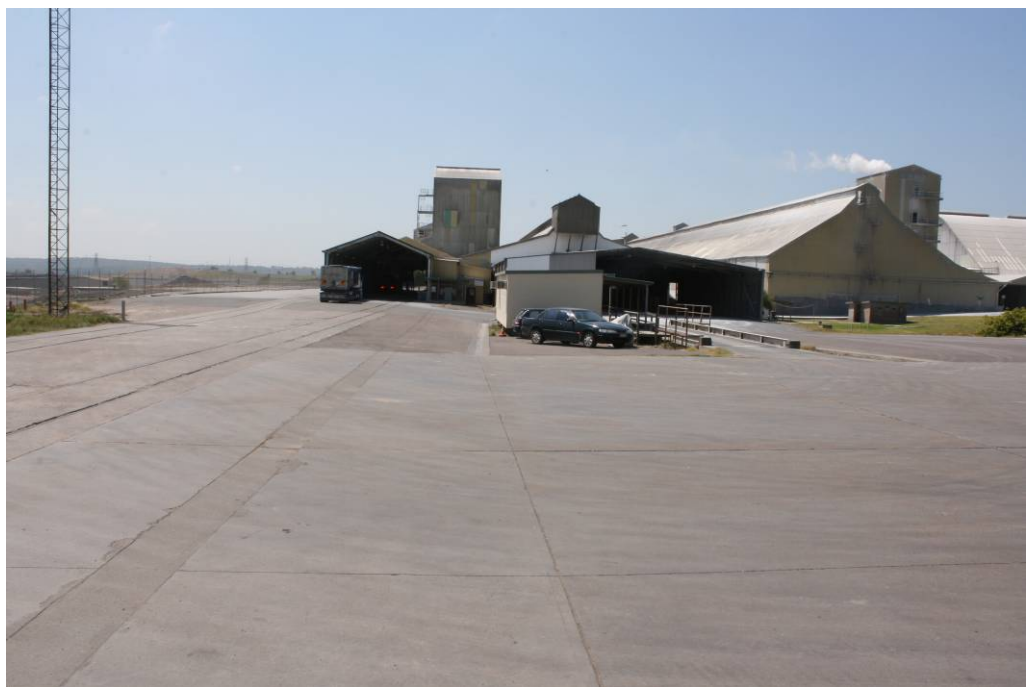
*Photograph A.6    Shed 1, showing the railway line*

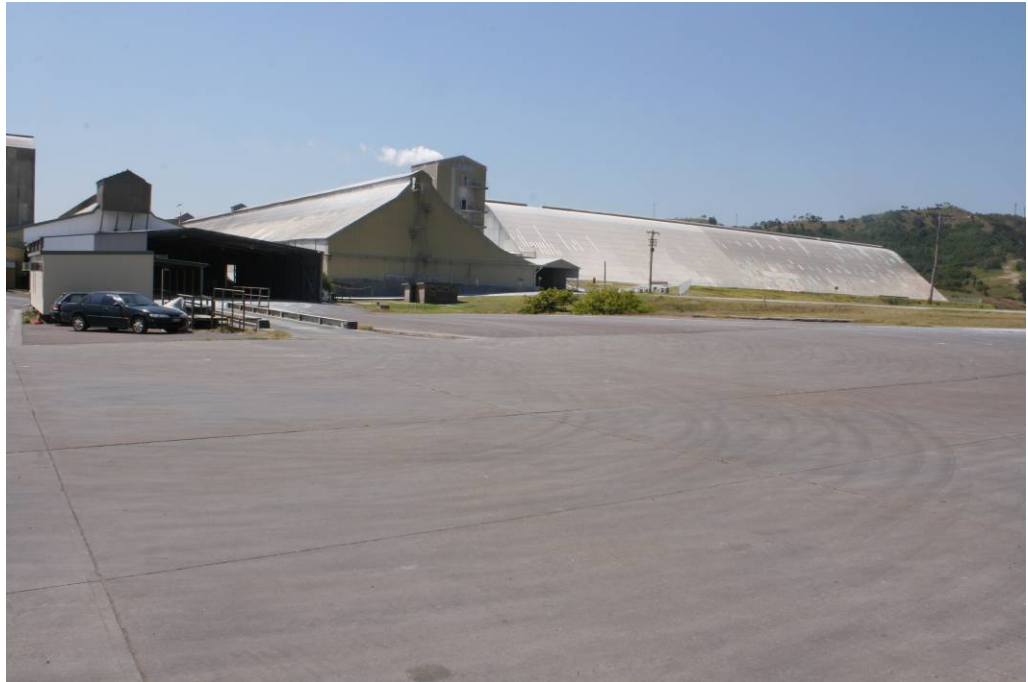
*Photograph A.7 Shed 1, 2 and 3*

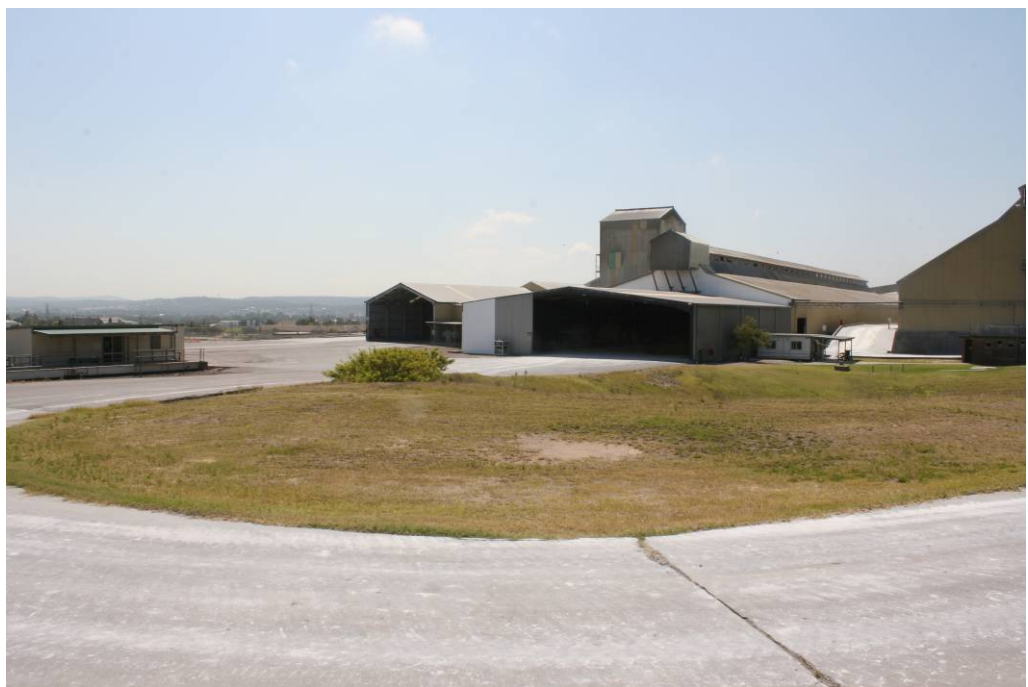
*Photograph A.8 Shed 1 and 2*

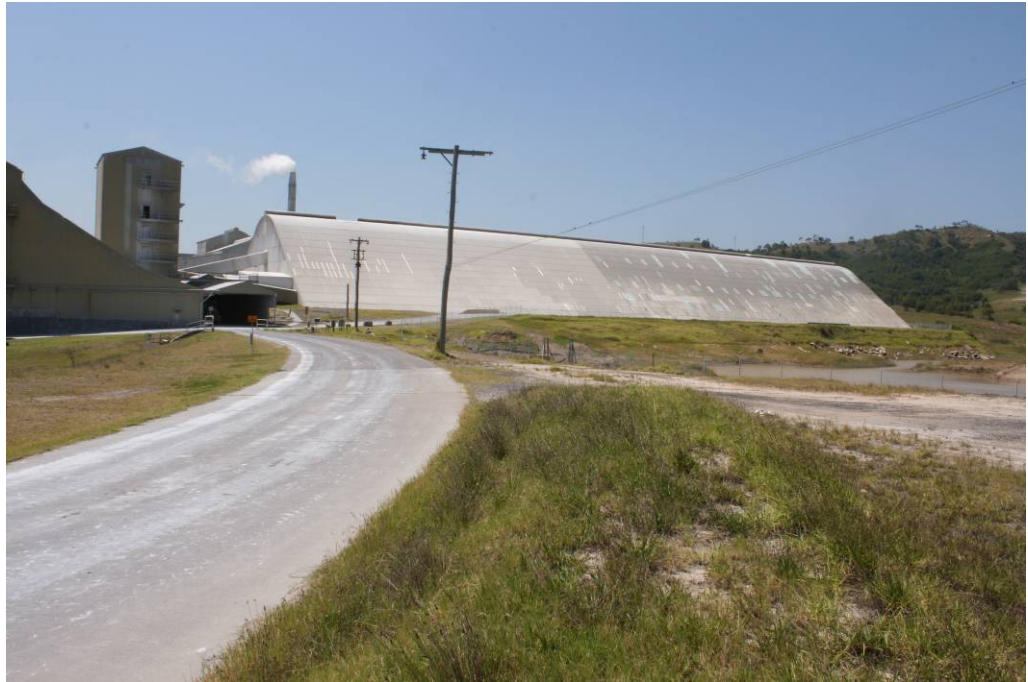
*Photograph A.9 Shed 2 and 3*

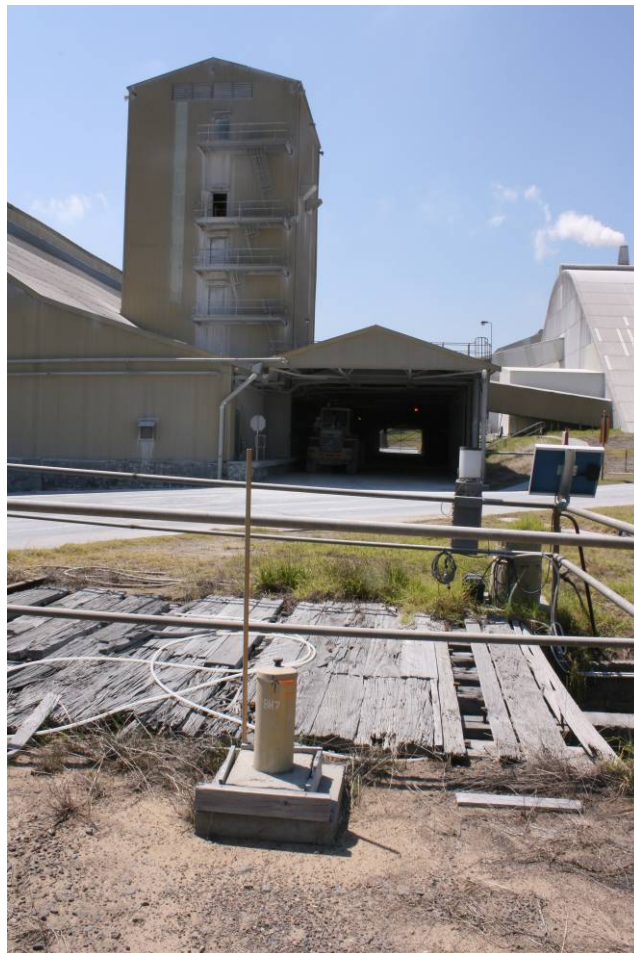
*Photograph A.10 Shed 2 and 3 with pipe covering in foreground*

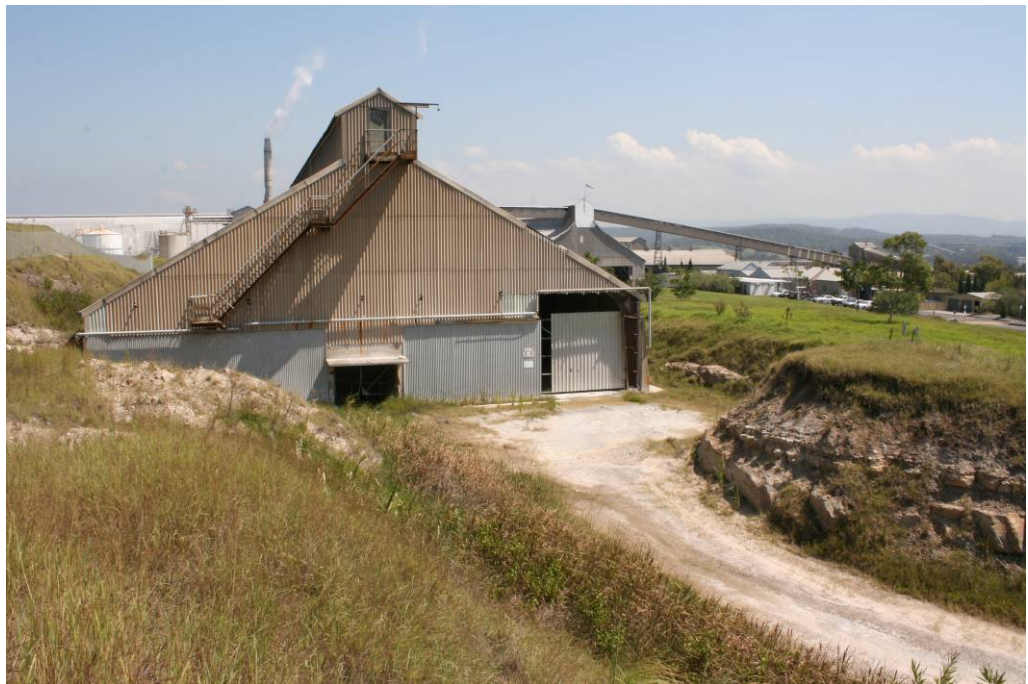
*Photograph A.18 Rear of shed 4 and view of looking to Pasmenco site.*

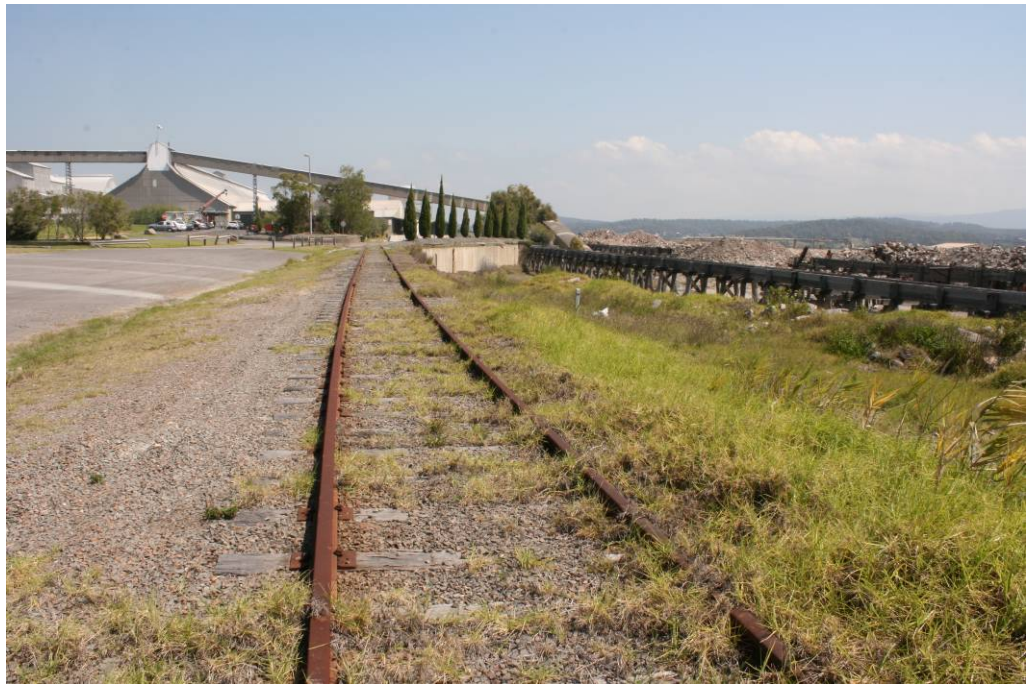
*Photograph A.23 View of railway line on IFL site with shed 1 at rear*

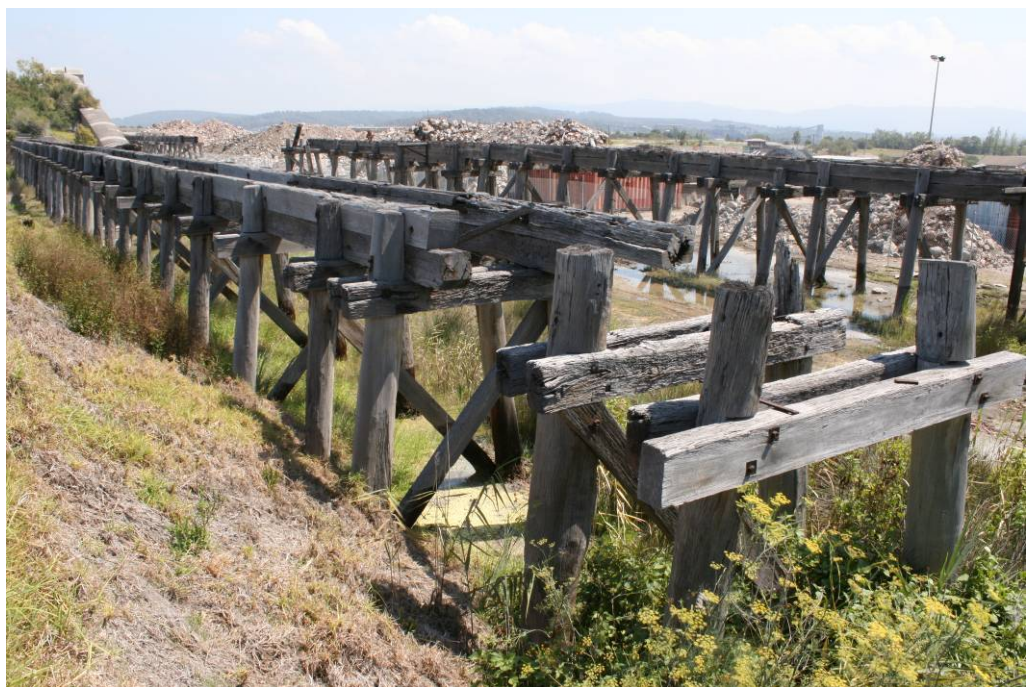
*Photograph A.24 Wooden A frame gantry on site*

| Photo | Easting | Northing | Bearing | Description |
|---|---|---|---|---|
| 1348 | 0372046 | 635854 | South West | Gantry. The Gantry is in a dilapidated state. It consists of a wooden A frame gantry with steel pegs and support pegs. Circular upright poles with rectangular horizontal beams. Railway lines run through the middle. The entire structure is elevated to approximately 2.5-3metres in height. |

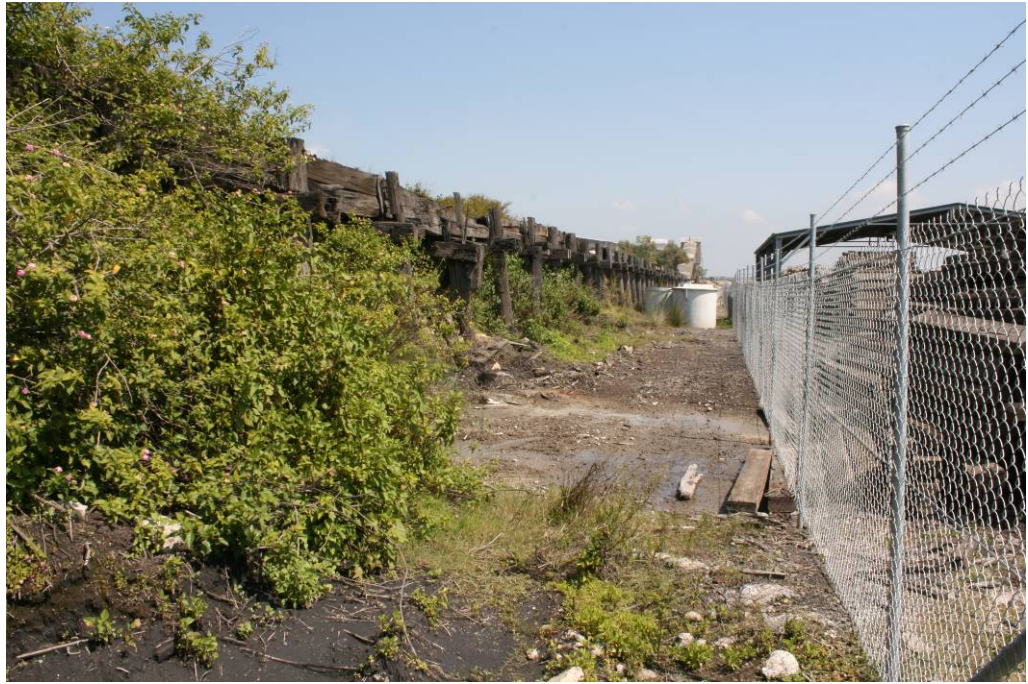
*Photograph A.27 Western boundary of IFL site with Pasminco, gantry running south*
