17 October 2013

**Re: 62 HARROW ROAD, BEXLEY — HERITAGE ADVICE FOLLOWING A FIRE**

**62-82 HARROW ROAD, BEXLEY NSW  
FIRE DAMAGED STRUCTURE INSPECTION REPORT**

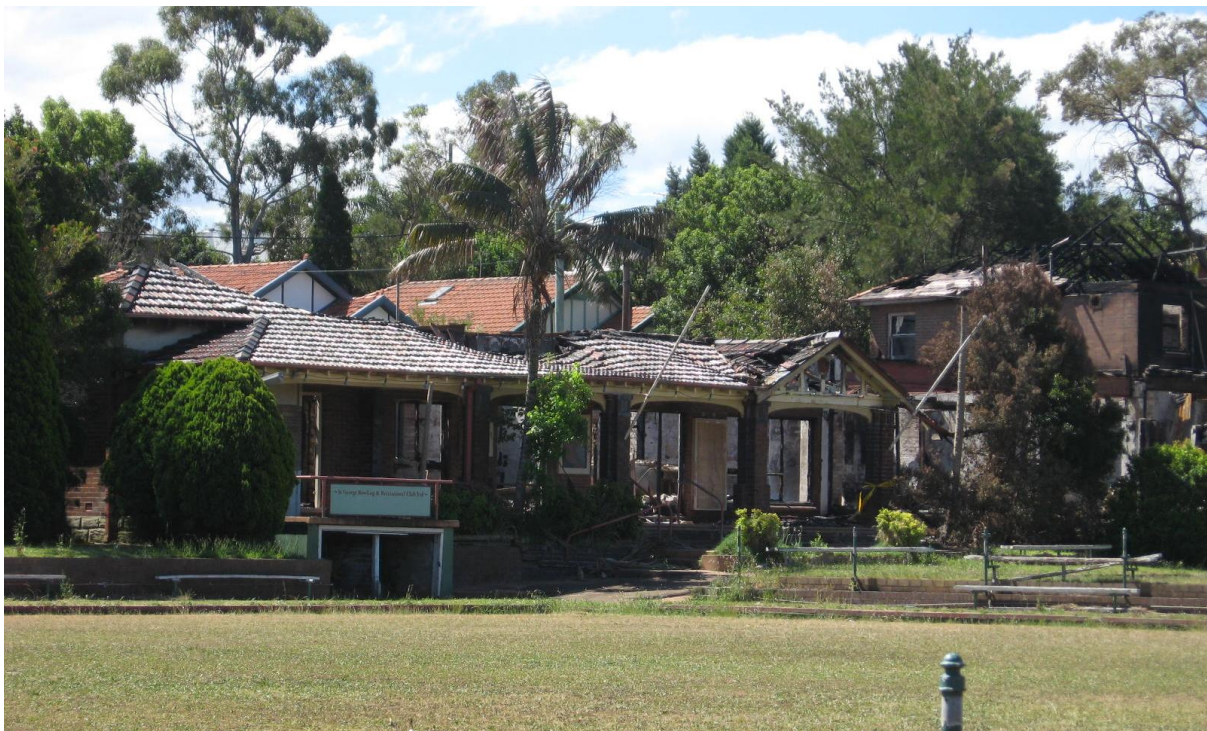
The fire was so severe that approximately 95% of the roofing timbers under the main hip roof were burnt out and collapsed with their roof tiles onto the floor. The fire brigade were able to put the fire out in time for only a minority of the southern veranda to be retained in a very fragile and unsustainable condition. All of the original fenestration and joinery in the clubhouse is burnt out. All of the original ceilings have collapsed. Some brick walls have collapsed. There is nothing from the original section of the clubhouse that can be salvaged. The north-east and south-western ends of the building were severely damaged by the fire, and have some walls standing at the time of inspection on 14 October 2013. These later sections of the former clubhouse had Moderate heritage significance, and these remains do not have sufficient heritage significance to justify conservation.

*Figure 1 — northwards view showing fire damage including a burnt-out roof.*

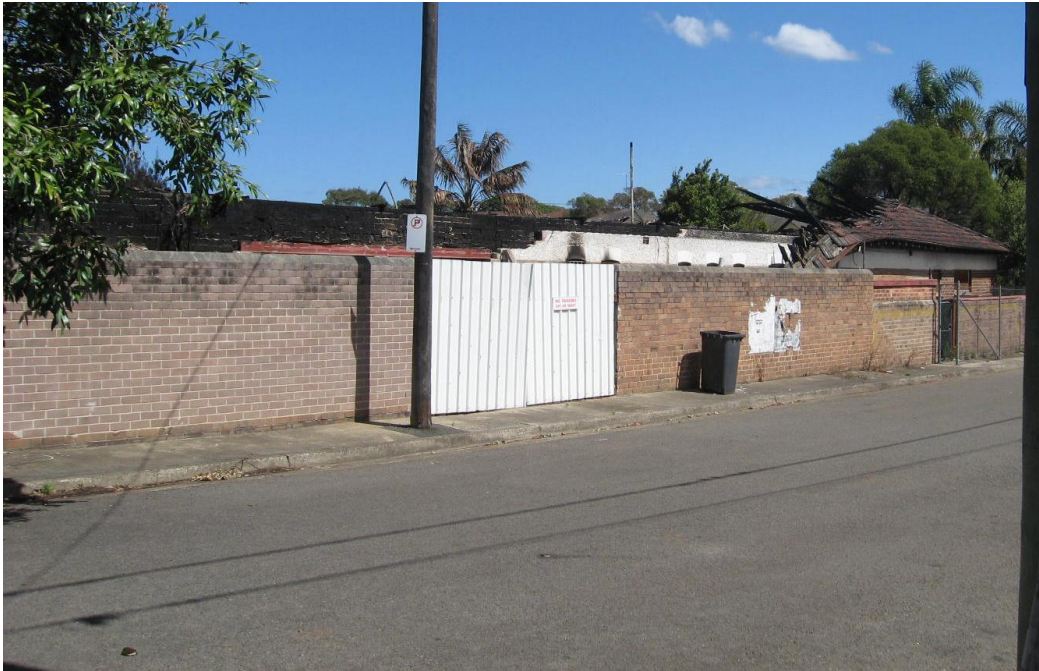
*Figure 2 — southwards view from Bowlers Avenue showing destroyed roof.*

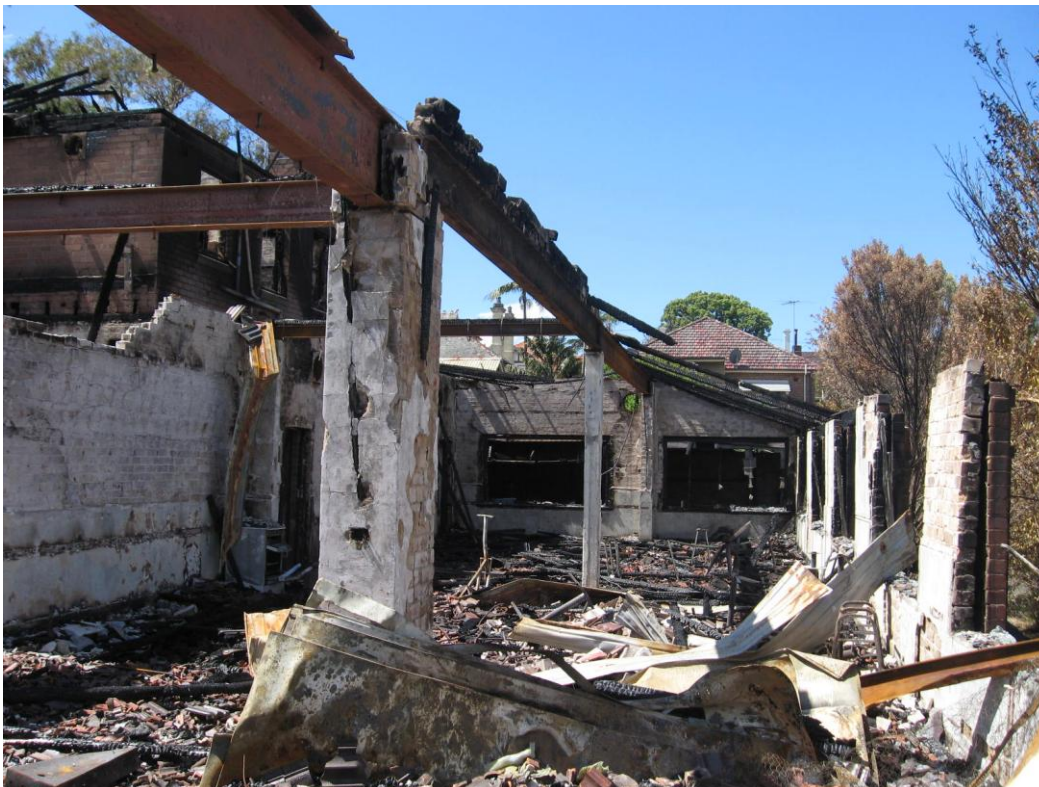
The fire did reveal how extensive the alterations were in the bar and lounge area, where many steel beams replaced original brick walls. We had suspicions that there may have been a decorative ceiling above a more recent decorative ceiling in the Ladies' boudoir. From scant remains of a cornice in this room, it appears that there was such a ceiling until the fire.

*Figure 3 — north-east view along the former dining room (Rooms 14 and 15) revealing the steel beams from a phase of alteration.*

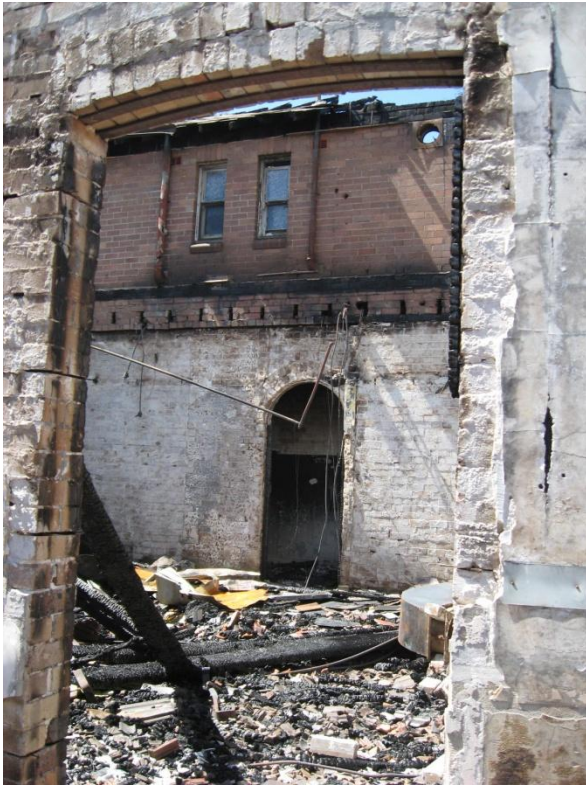
*Figure 4 — north-east view across the original locker room (Room 16). This was one of the most intact rooms with timber panelling.*

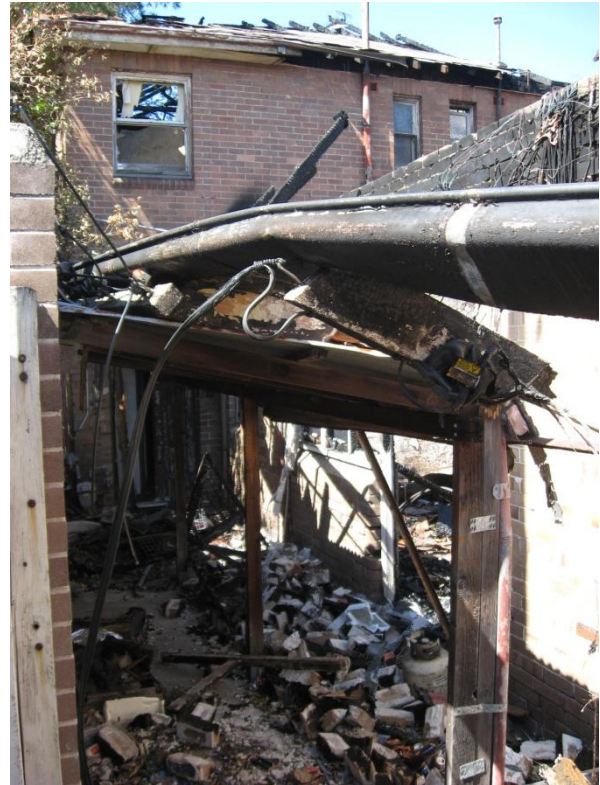
*Figure 5 — north-east view between Bowlers Avenue store room (now collapsed) and the outside of Room 16.*

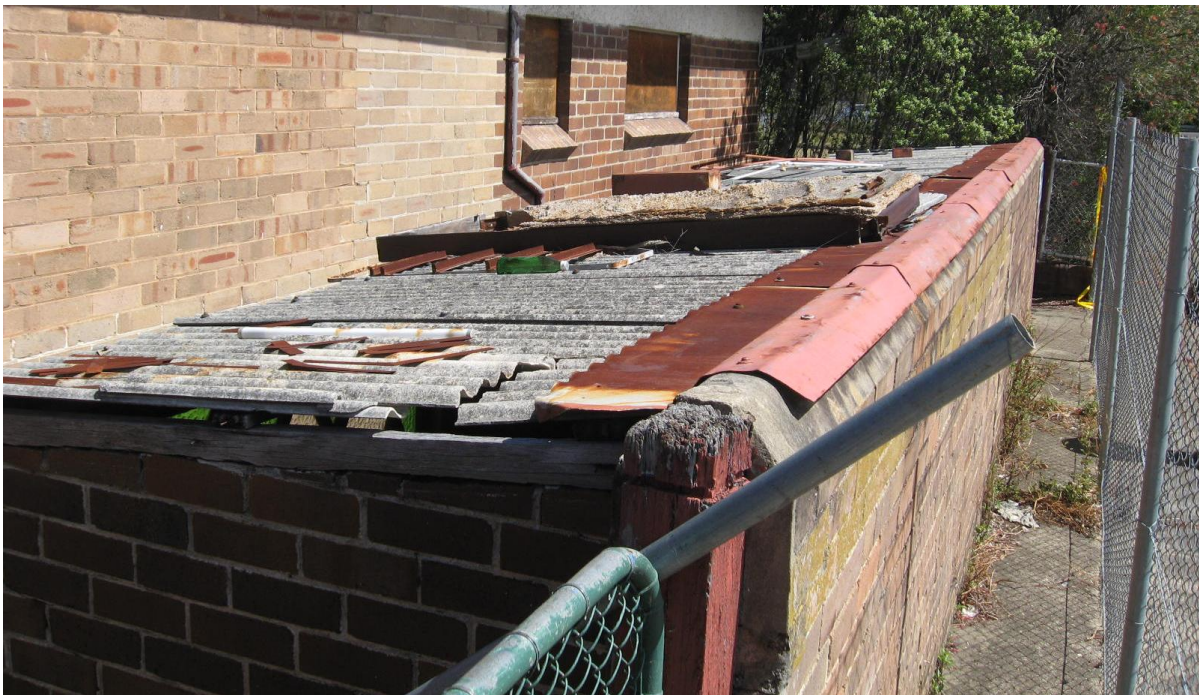
The storage sheds along the Bowlers Avenue boundary may be intact after the fire, but could not be inspected due to safety concerns. These sheds were found to be of high significance as early / original fabric. These sheds are, however, quite shoddily built, but include high-quality original timber-framed windows with a diamond pattern. It is possible that these windows were added to the sheds when alterations to the clubhouse caused their removal. Without the clubhouse, these sheds do not have sufficient heritage value to justify retention. If the two timber-framed windows with a diamond pattern are intact after the fire, they could be salvaged and used in an interpretation strategy in the new aged care development. There is no other original fabric that can be salvaged from the buildings on site.

*Figure 6 — this store room outside Room 11 facing Bowlers Avenue may be intact. Perhaps the timber-framed coloured glass windows could be salvaged for an interpretation, but the shed does not have sufficient significance to justify retention.*

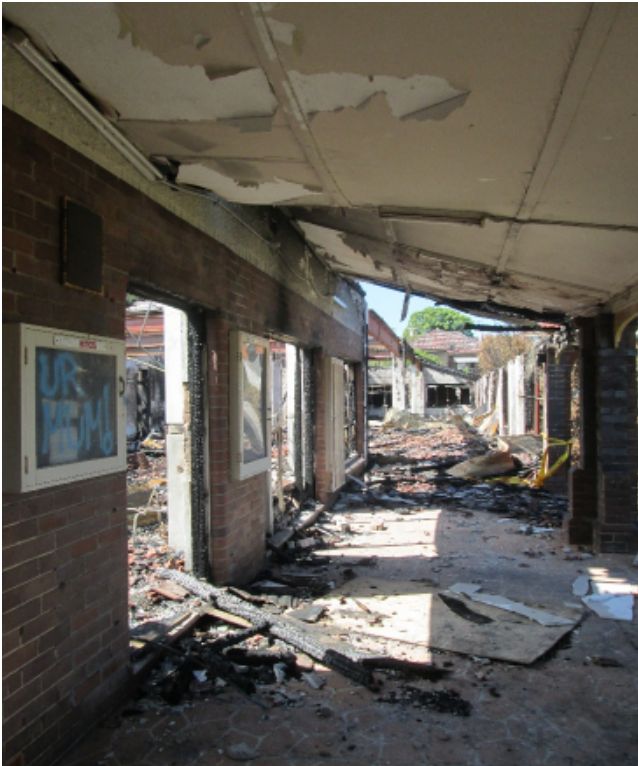
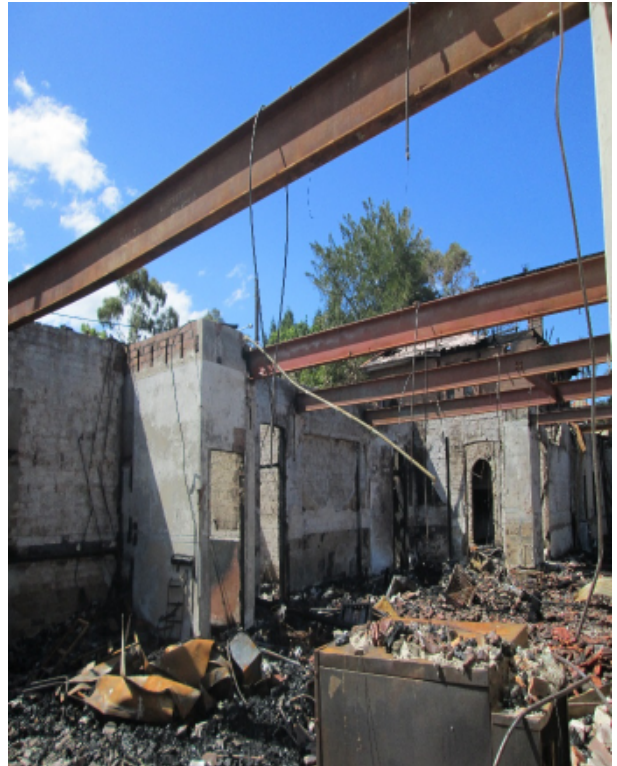
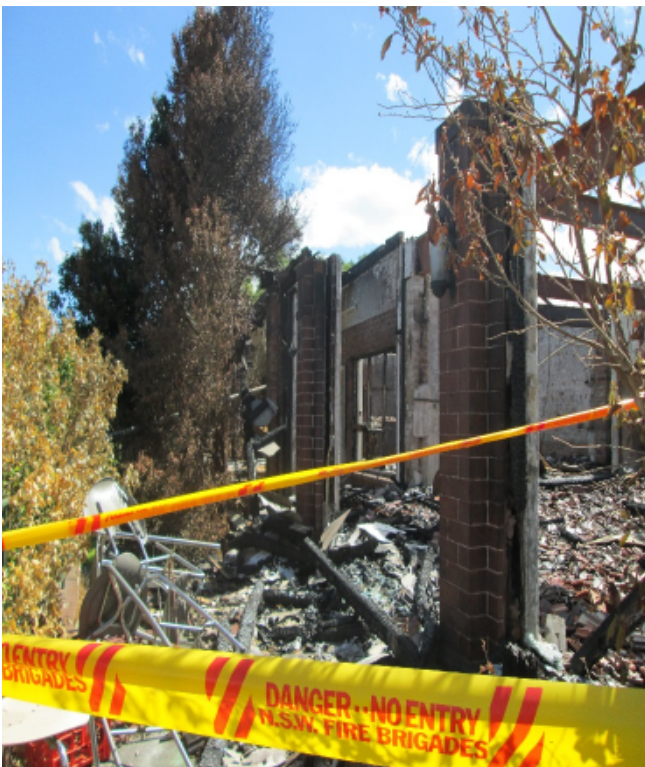
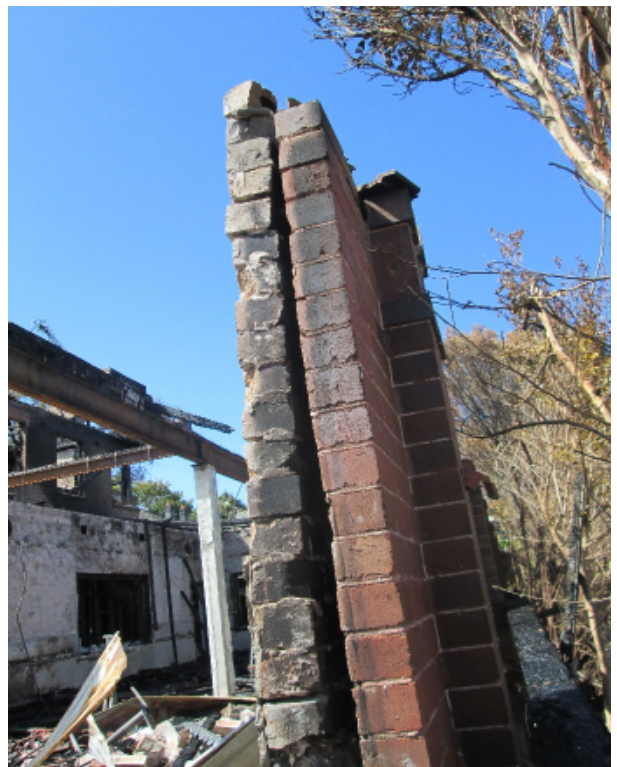
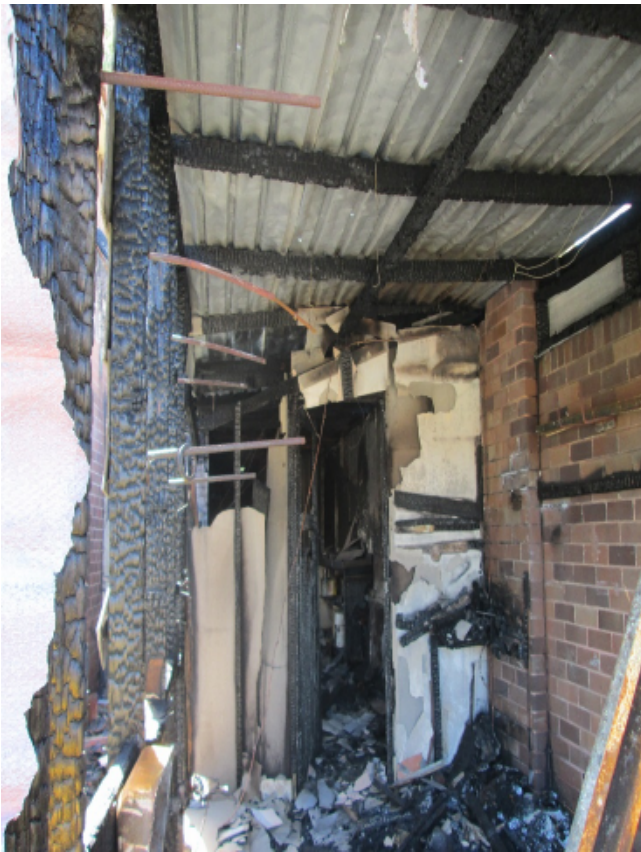
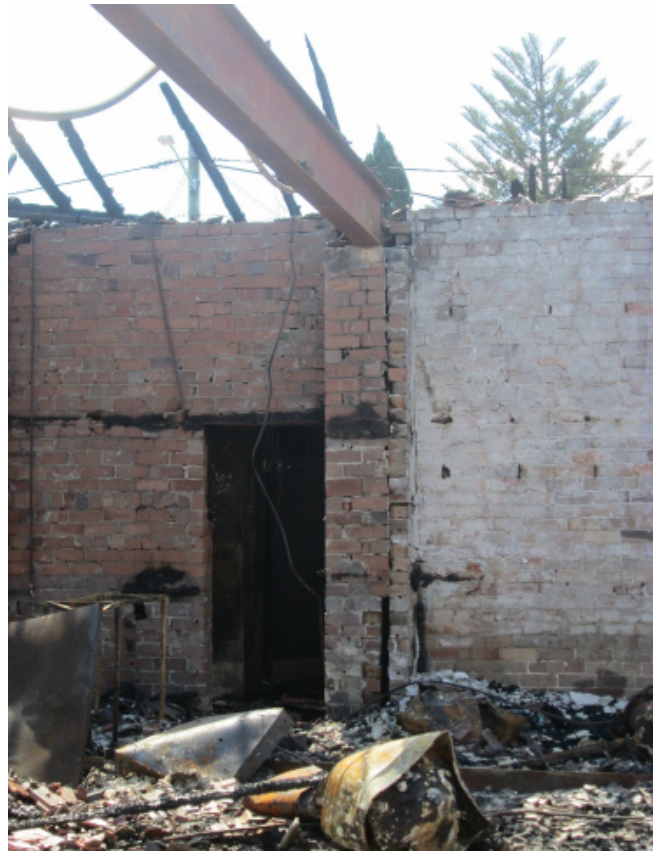
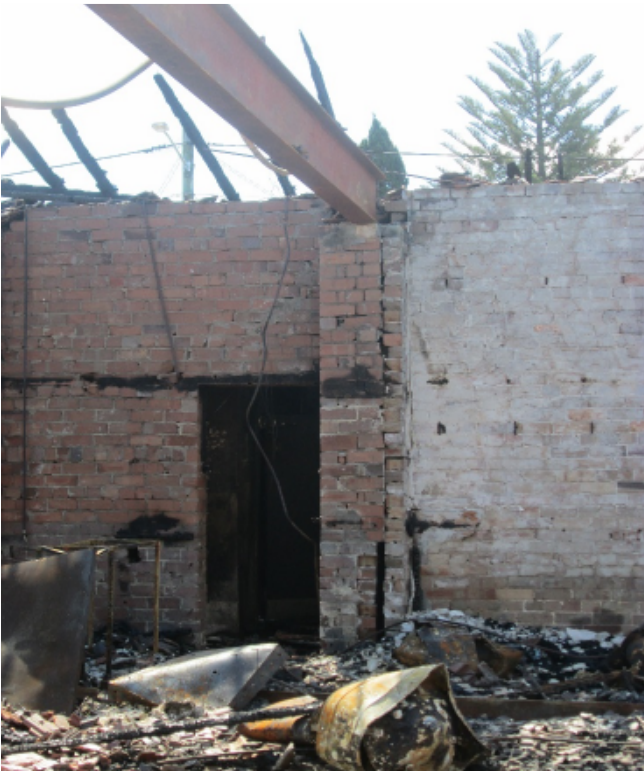
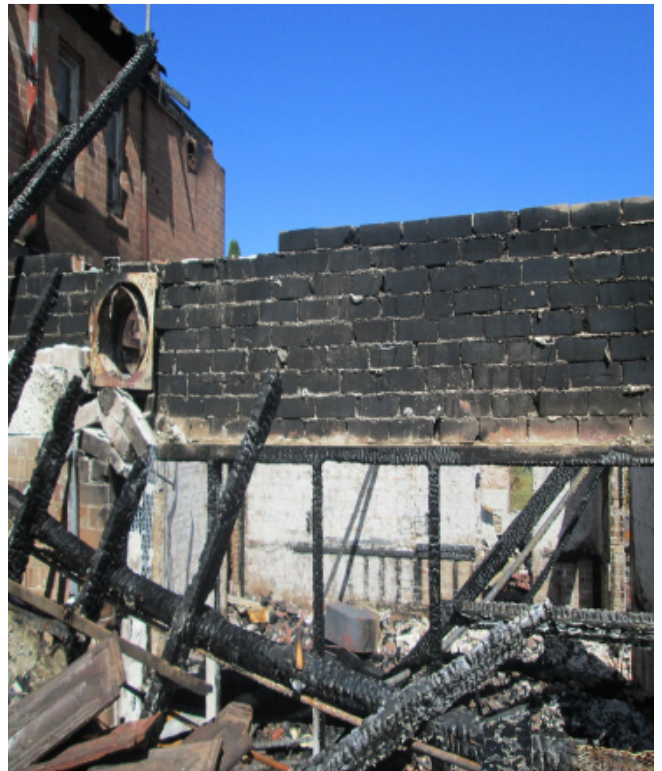
## Photographic Record

- The timber roof framing structure has either been entirely destroyed and/or severely charred by fire to the point that it is no longer structurally adequate.
- The remaining masonry walls are now unbraced due to the fire destroying the roof framing structure posing a risk of further collapse under wind loads.
- Some of the remaining masonry walls appear to have already partially collapsed and many walls appear to be significantly charred due to fire exposure. The structural capacity of these masonry walls is unknown following several hours of heat/fire exposure.
- The remaining roof steel beams appear to have been warped due to the heat/fire exposure and now remain unrestrained posing a risk of collapse under wind loads. The structural capacity of these beams is also unknown following several hours of heat/fire exposure.
- Appended are some photographs taken at the time of inspection.

Based on the above observations I would conclude that the structure is unsafe and that further collapse may occur due to wind loads on unrestrained parts of the structure.
