## **PRELIMINARY CONTAMINATION ASSESSMENT**

**Lot 42 & 1012  
Mount Vincent Road, East Maitland**

**GS ref: 1435-003/0**

**December 2012**

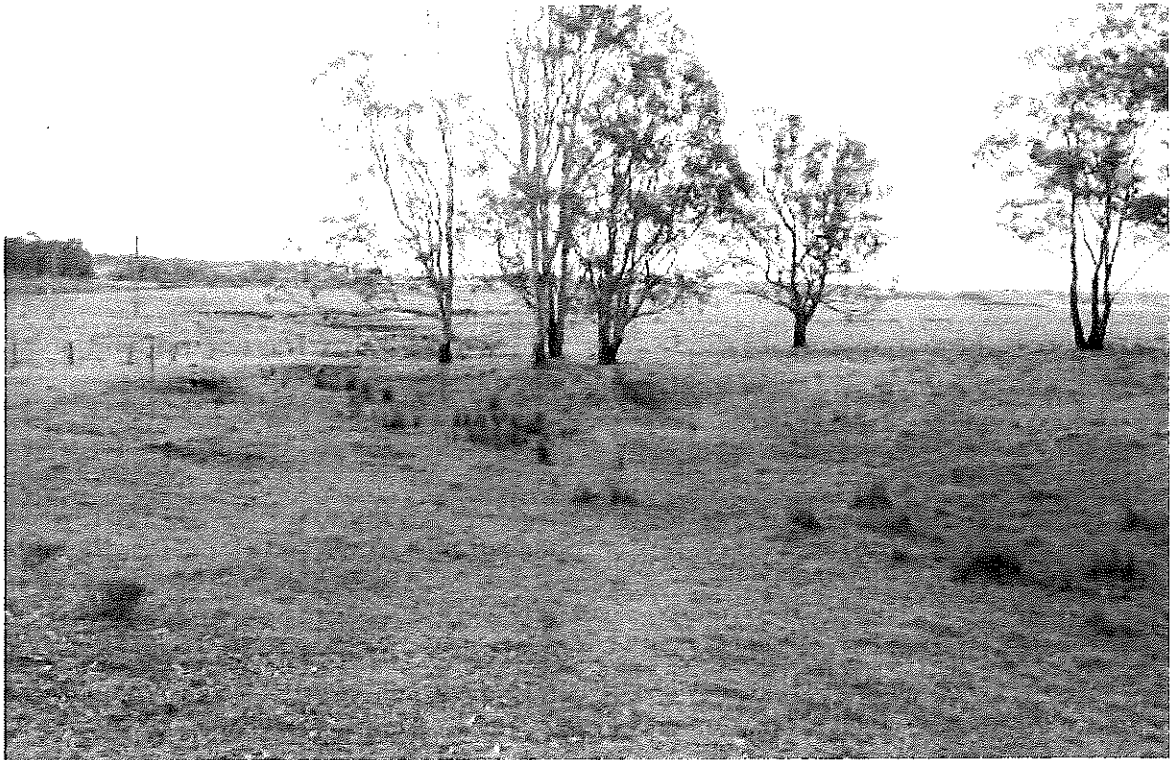
- A small dam is located adjacent to but above the western gully on the western end of the site (See photograph 1) and the remnant of a possible rural dam within the eastern gully in centre of the heavily timbered eastern portion of the site;

**Photograph 1 – Filled areas around the western dam and gully line**

The assessment indicates filling observed around the existing dam in the south-west corner of the Lot 42 which appears to comprise site won soils and a component of overburden soils likely to have been generated from previous coal mining activities. Based on the historical aerial photograph filling on the adjacent lot 3 in DP584658 associated with the development of the former coal mine office complex was extended over the lot boundary

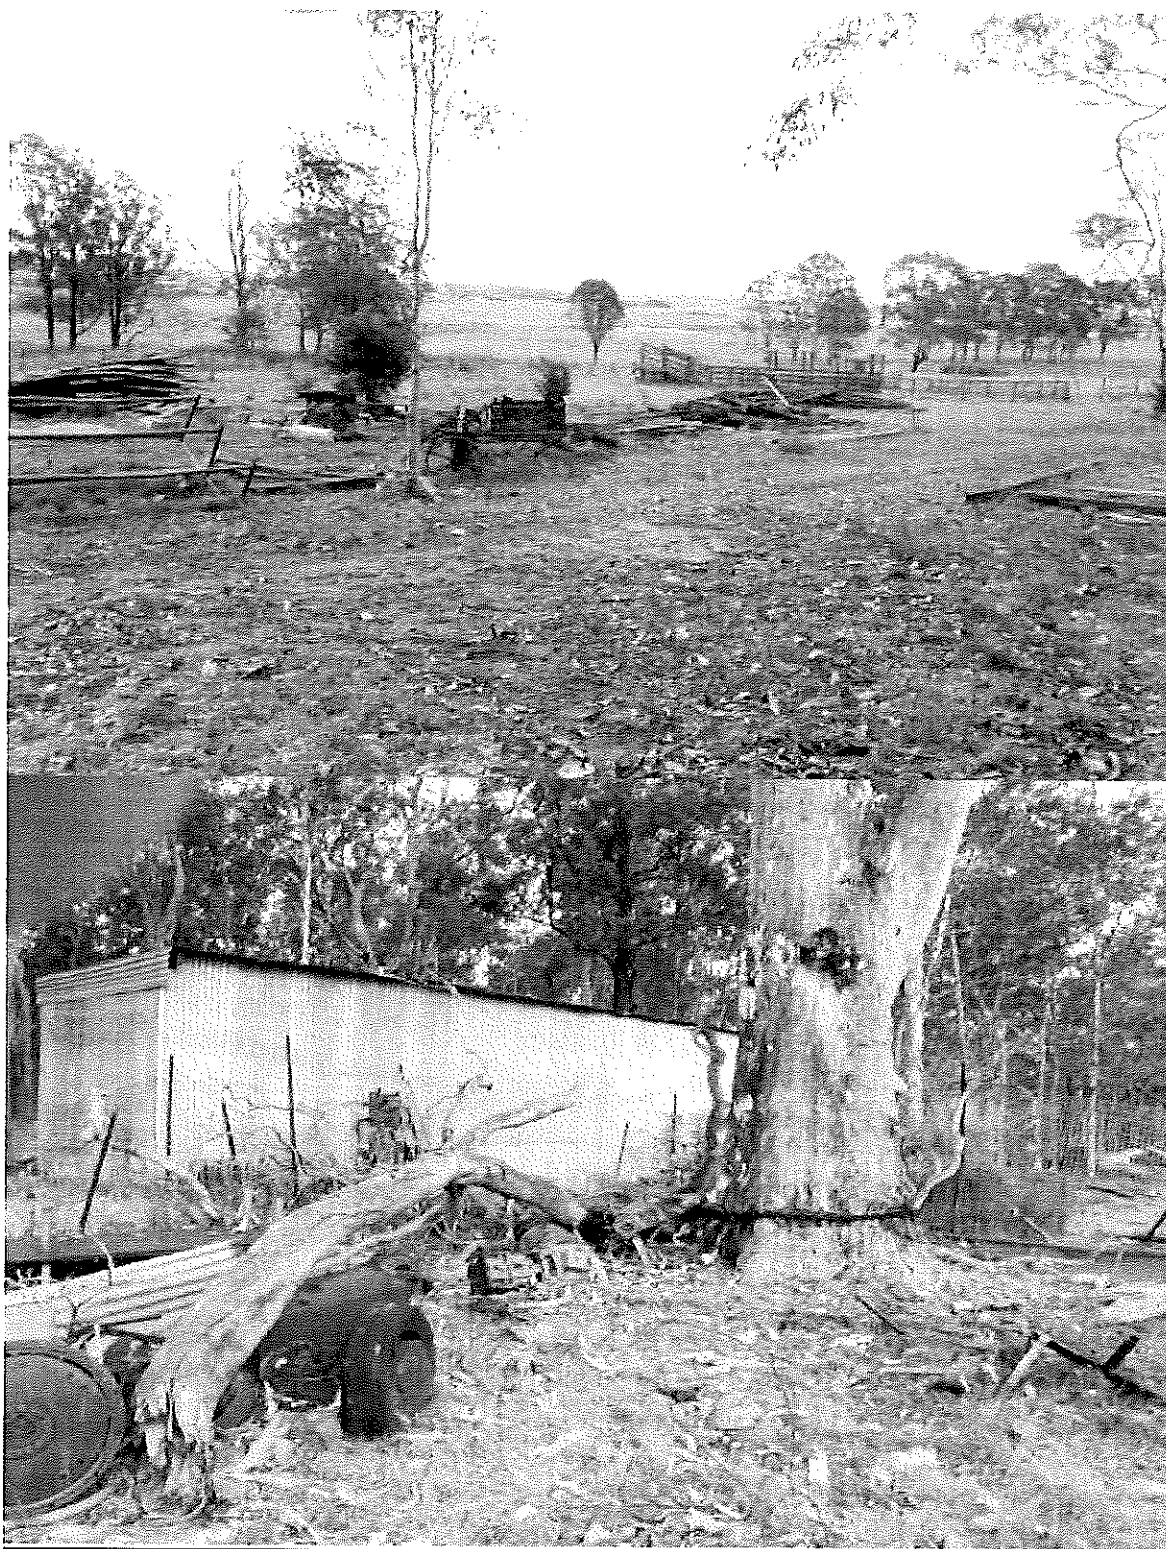
- A rural storage shed/stable and a timber stockyard is located towards the middle of the southern boundary (See Photograph 2 )
- The area around the shed also comprises a storage area for a range of farm machinery, building materials, timber, galvanised metal sheeting, irrigation pipe and other sundry item;

- Some minor hydrocarbon surface staining in proximity to the stored farming machinery and a grease drum were noted around the shed;
- One sheet of fibrous cement which was the backing of an old timber shelf was noted near the shed;
- Based on surface exposures which reveal filling, an area located at the south-western corner of the site appears to be filled with the extent based on landform confined to the western side of the gully line and around the dam;
- Several small fragments of fibrous sheeting in the observed filled profile on the southern side of the western gully; and
- A damaged telecommunication line pit on the eastern side of the Lot which was made from a fibrous cement which may contain asbestos (See photograph 3).

**Photograph 2 – Shed/Stable and stored items**

While some staining was noted at the surface around the shed, a sample of one of these areas showed only minor amounts of TPH which were below the relevant guidelines.

It is considered that the confirmed presence of asbestos material could be readily addressed during construction. The sheet on the back of the timber shelf stored near the shed which was largely intact could be removed by an appropriately licenced contractor. The observed sheet fragments within the filled area on the western gully would be removed to a licensed waste facility during construction.

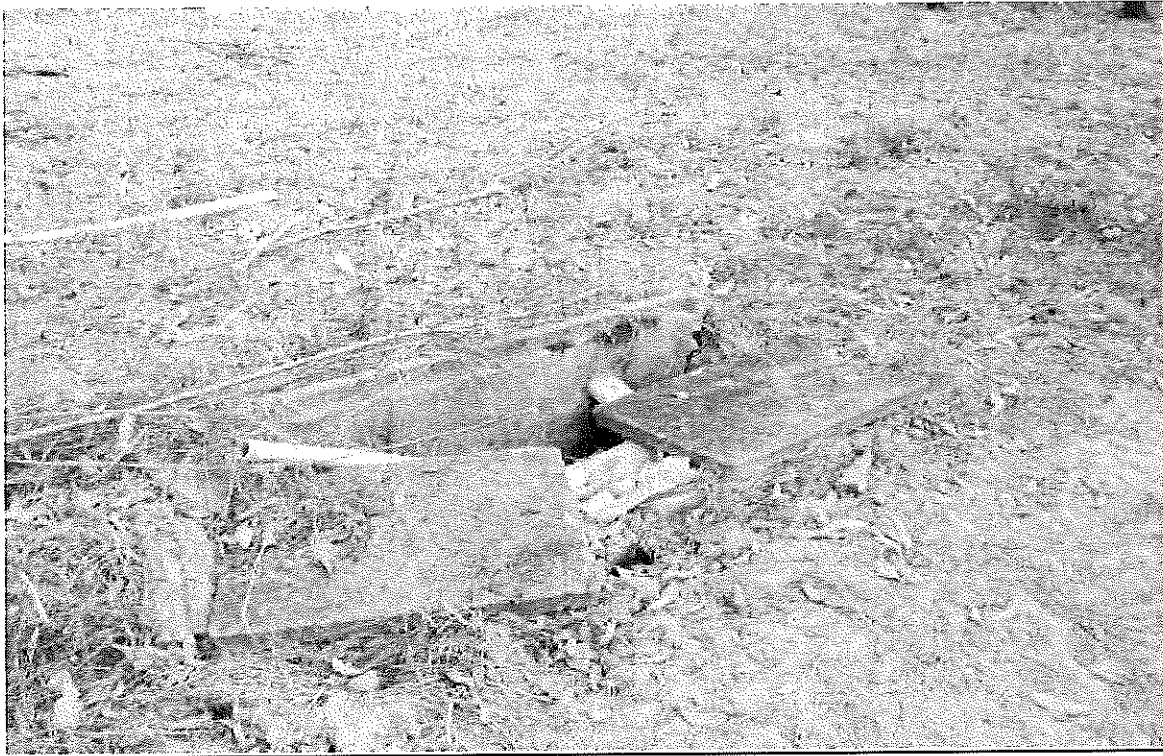
**Photograph 3** – *Telecommunication pit on eastern boundary of Lot 42*

The observed telecommunication pit which may contain asbestos should be addressed by the asset owner.

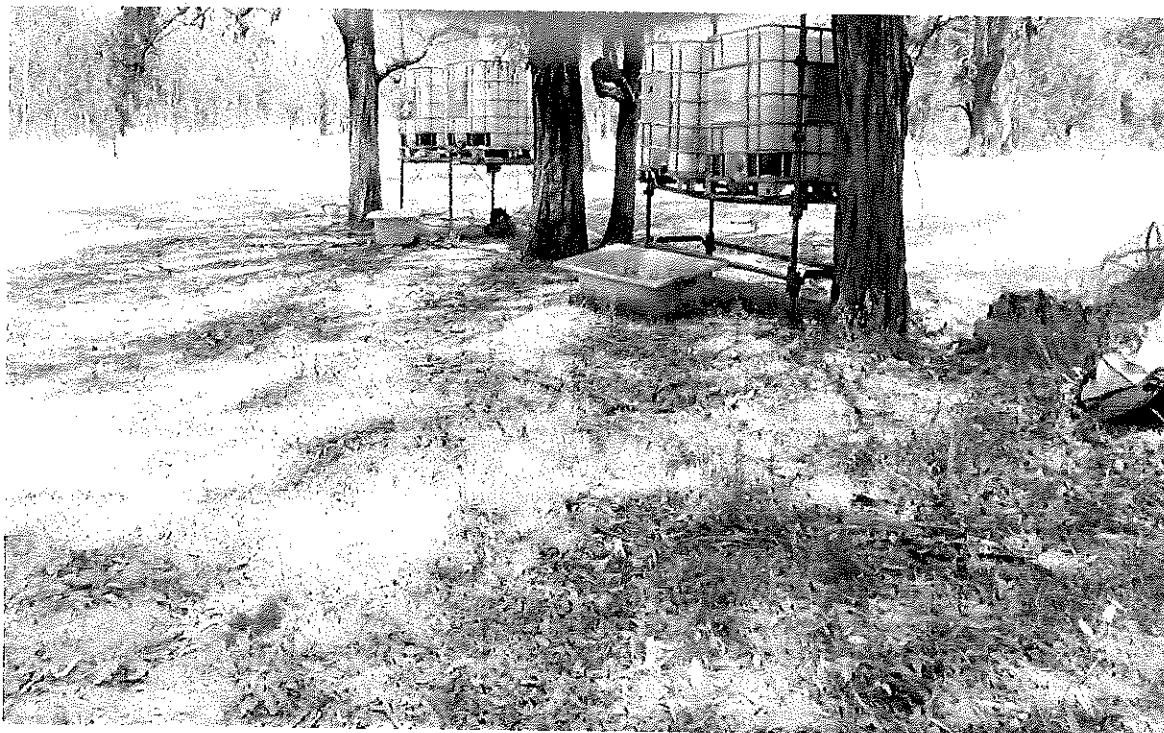
- Four 1000L plastic water tanks were noted mounted on steel scaffolding for stock watering;
- Several areas of irregular surface suggesting previous disturbance were noted in the central cleared area;
- No visual or olfactory indicators of hydrocarbon spills; and
- Several sundry items noted around the site comprising plastic lids, steel, minor household discarded items, several old tyres, fencing wire and a large stockpile of wood consisting of both milled and unmilled timber;

**Photograph 4- Stock Water Tanks**

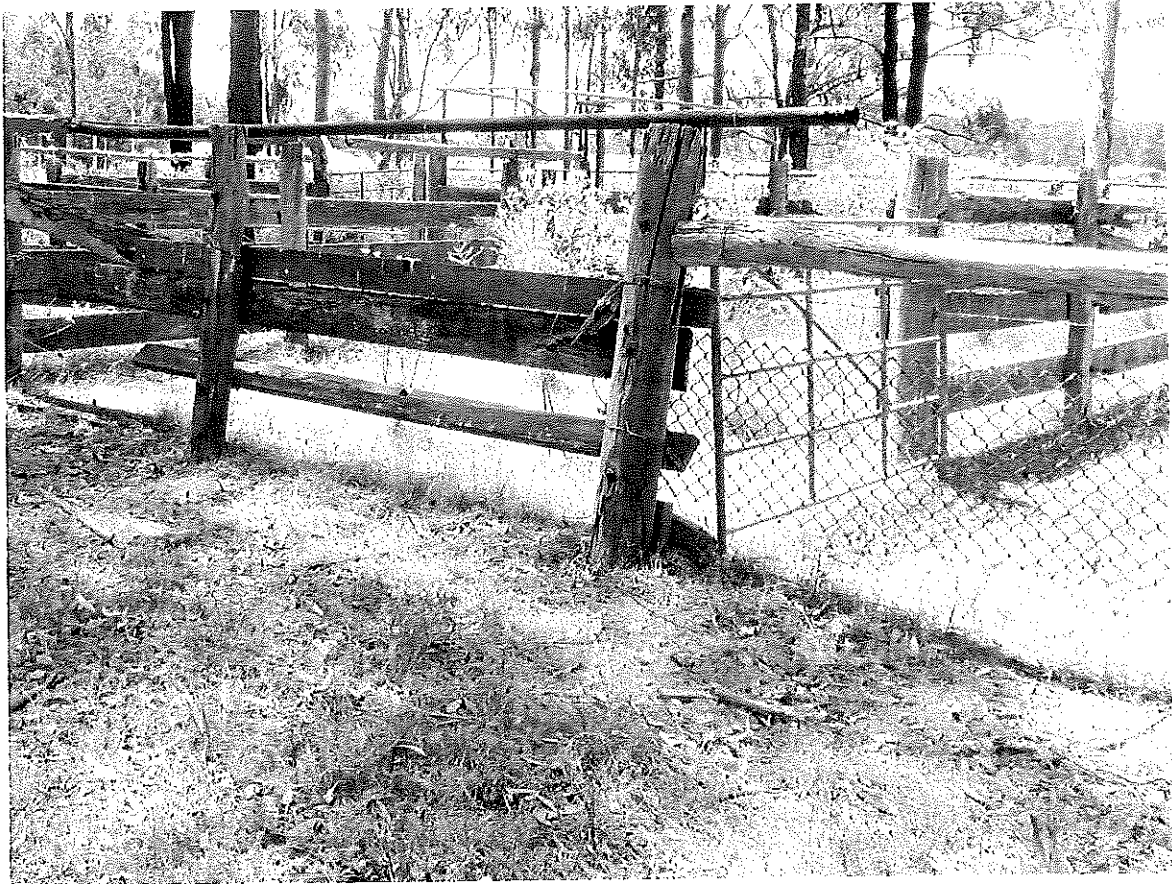
**Photograph 4 – Stockyard North western Corner**

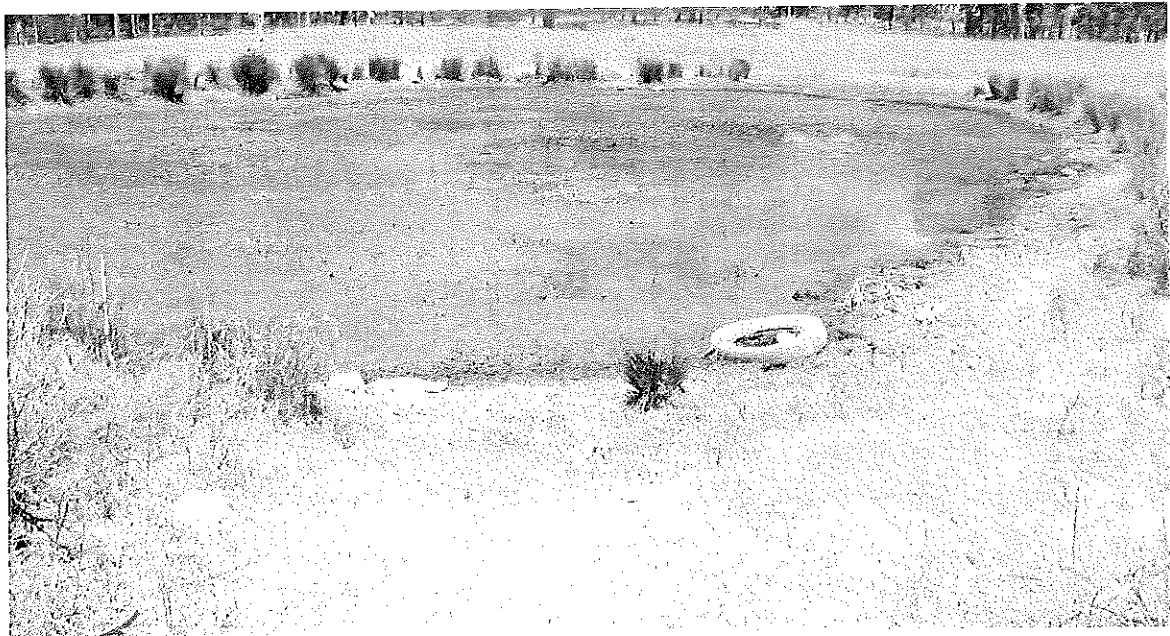
**Photograph 5 – Small dam centre of cleared area**

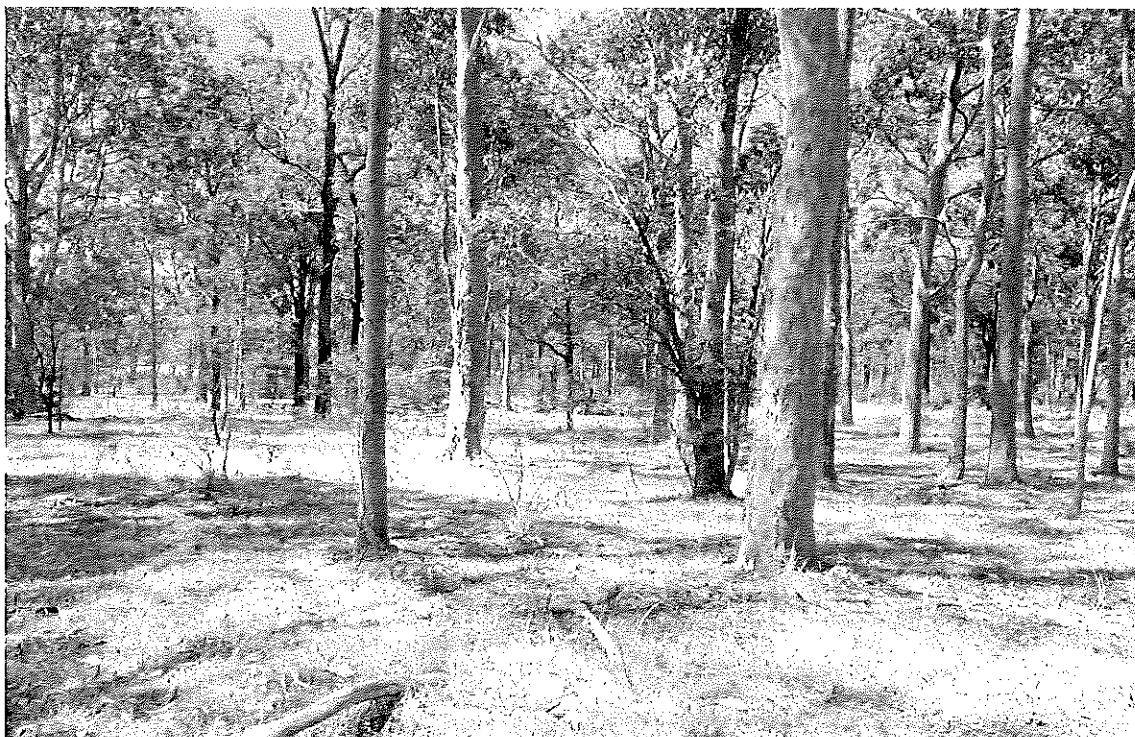
**Photograph 6 - North east Corner with timber pile in back ground**
