Report on  
Mine Subsidence Investigation

Proposed Rezoning Lot 42, DP 846326  
Corner Wilton Drive and Mount Vincent Road,  
East Maitland

Project 81674  
September 2015

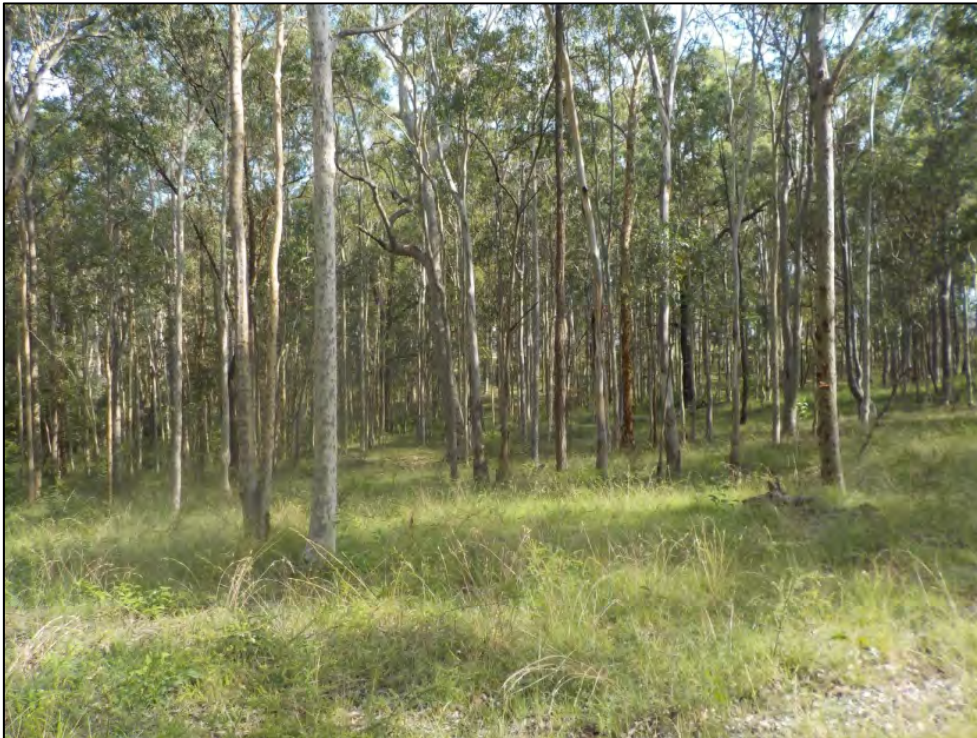
**Figure 1: Site facing north-west from south east corner of site**

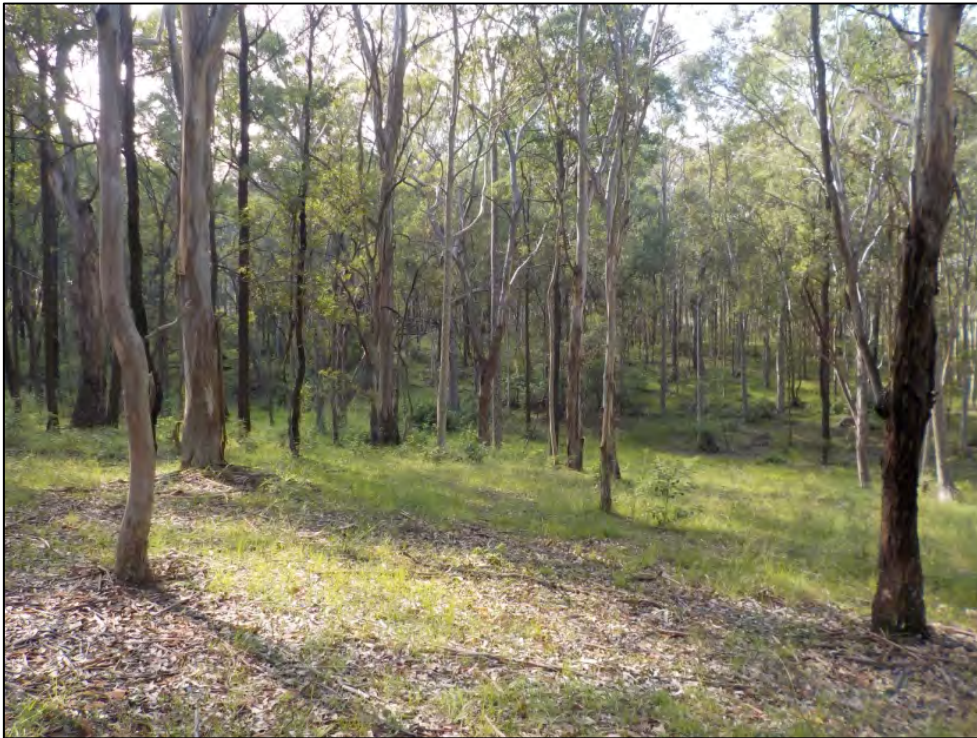
**Figure 2: Site facing east from central part of site**

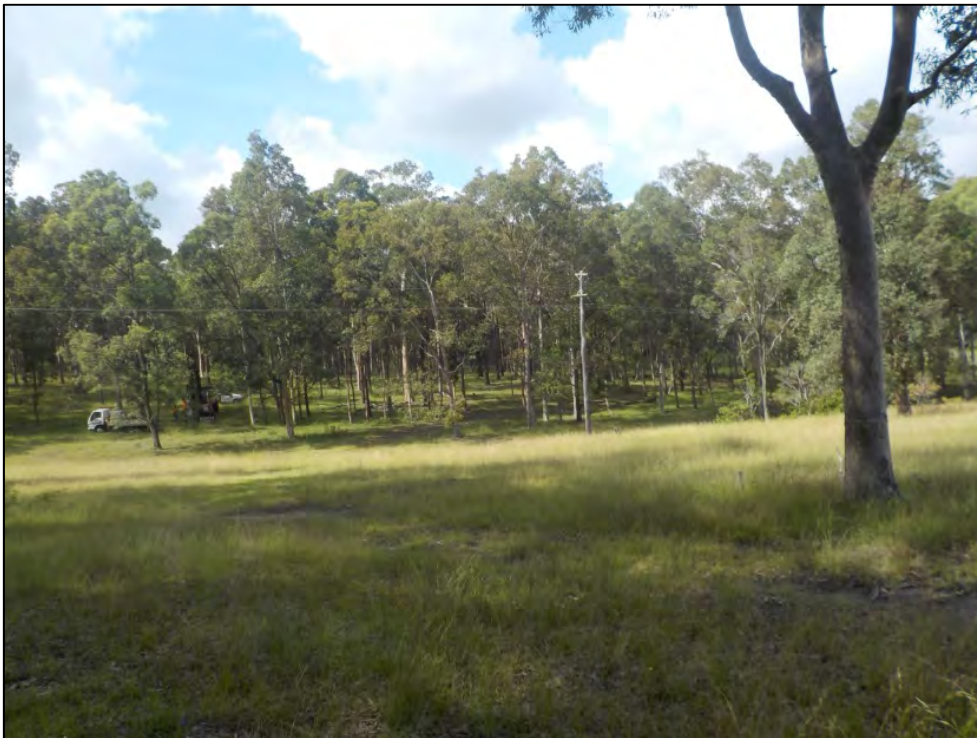
**Figure 3: Site facing south east from near adjacent Lot 8**

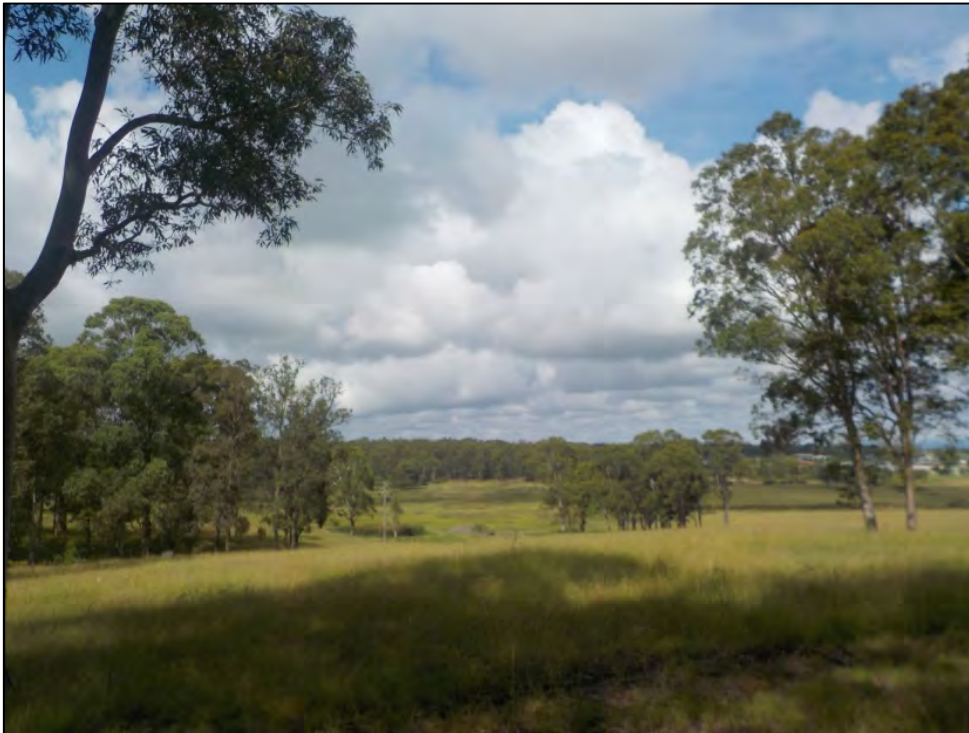
**Figure 4: Site Facing south west from near the adjacent Lot 8**

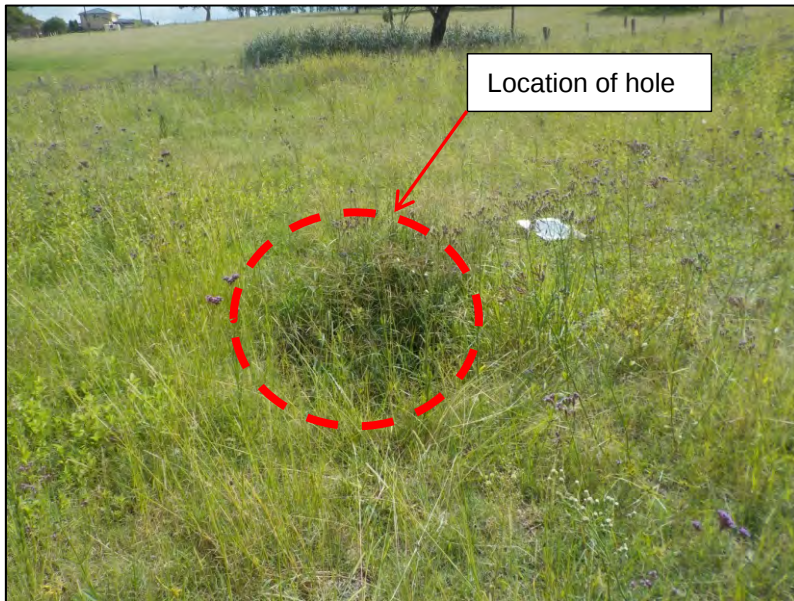
A hole was observed on the neighbouring property to the south of the site. The location of the hole is shown on the attached Test Location Plan and is shown in Figure 6 below.

**Figure 6: Hole observed at surface of neighbouring property. The hole diameter was approximately 2 m. The location of the hole coincides with the approximate location of the “Tunnel Mouth” as shown on RT603**
