**PRELIMINARY HAZARDOUS BUILDING MATERIALS  
SURVEY REPORT**

**PROPOSED INDUSTRIAL DEVELOPMENT**

**14-28 GEORGE STREET, LEICHHARDT**

**REF: E22459K.PRELIM.HM**

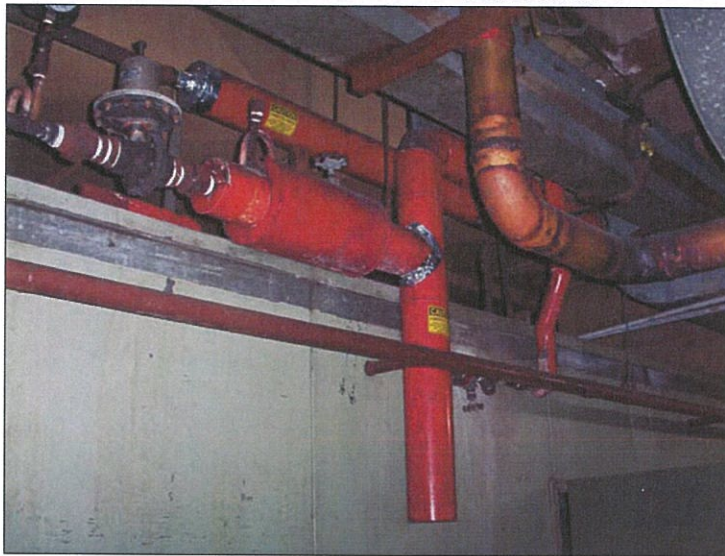
**Photograph 1**

View of pipe work within the plant room located on level 1, Building 1.

The pipe work insulation is presumed to contain asbestos.

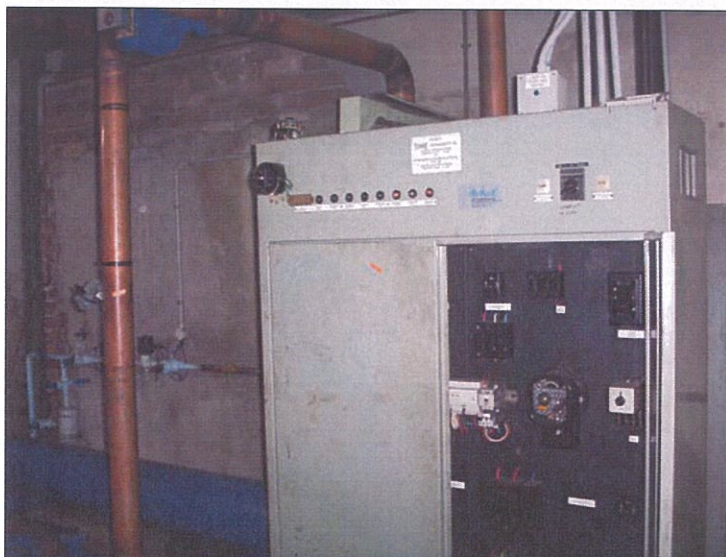
**Photograph 2**

| Material Type and Location | Material Status | Sample/Test No | Photo No | Approx. Extent | Condition | Bonded/<br>Friable | Recommendations for<br>Additional Inspections |
|---|---|---|---|---|---|---|---|
| Black backing board<br>Level 1 plant room, Air conditioning electrical distribution cabinet | Presumed to contain asbestos | - | 2 | 2m <sup>2</sup> | Generally intact, minor damage | Bonded | Requires confirmation sampling |

View of the air conditioning electrical distribution cabinet located in the plant room level 1, Building 1.

The black backing board is presumed to contain asbestos.

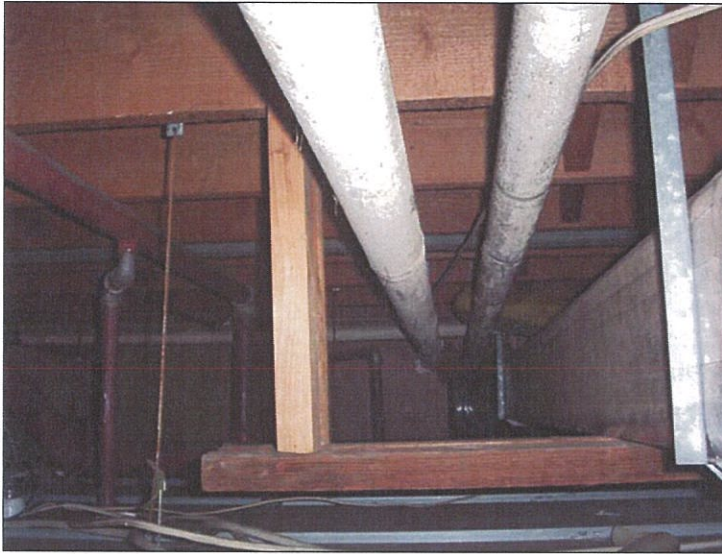
**Photograph 3**

View within the ceiling cavity of the offices, Building 1, level 1 showing a section of the reticulated pipe work.

The pipe work insulation is presumed to contain asbestos.

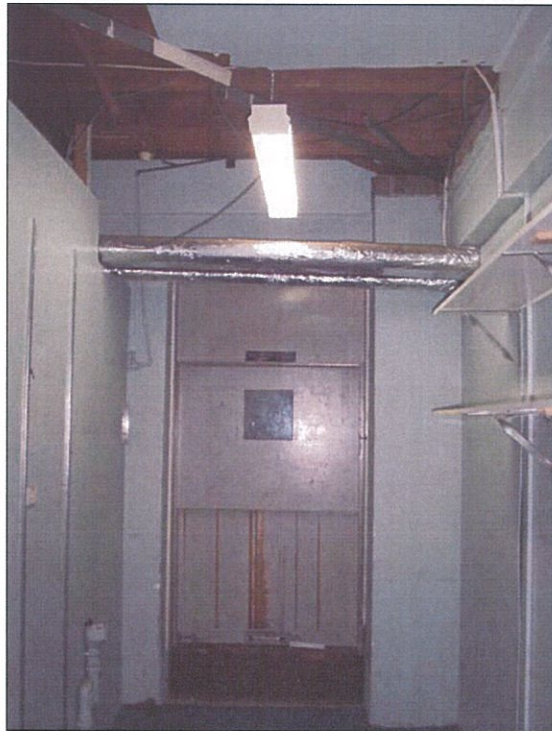
**Photograph 4**

| Material Type and Location | Material Status | Sample/Test No | Photo No | Approx. Extent | Condition | Bonded/<br>Friable | Recommendations for<br>Additional Inspections |
|---|---|---|---|---|---|---|---|
| Insulation to pipe work<br>Level 1, NW corner, foil covered section of pipe work adjacent to hoist | Contains asbestos | Sampled by New Environment (Sample 2769/pg7) | 4 | 6Lm | Generally intact, minor damage | Friable | Requires additional investigation as pipe work penetrates the north wall and continues |

View of the north-west corner of level 1, Building 1 adjacent to the hoist.

The foil covered pipes are presumed to contain asbestos.

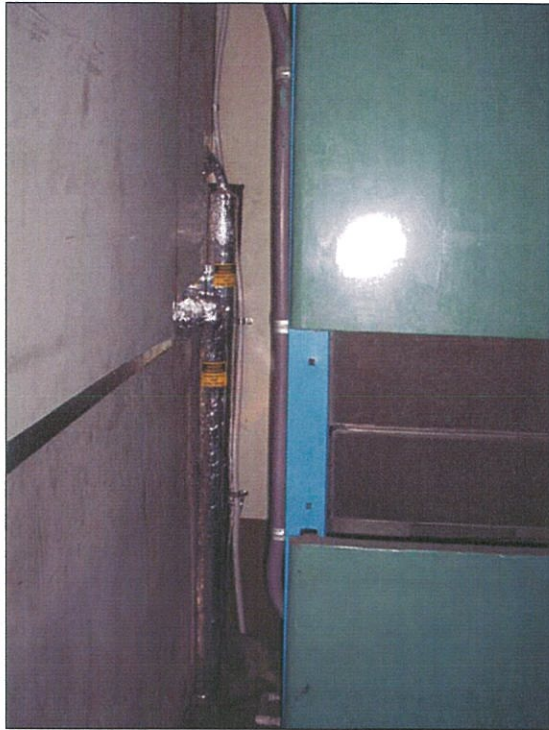
**Photograph 5**

| Material Type and Location | Material Status | Sample/Test No | Photo No | Approx. Extent | Condition | Bonded/<br>Friable | Recommendations for<br>Additional Inspections |
|---|---|---|---|---|---|---|---|
| Insulation to pipe work<br>Level 2, SE corner, foil covered pipe work behind air conditioning ducting | Presumed to contain asbestos | - | 5 | 4Lm (plus presumed 20Lm to adjacent building) | Generally intact, minor damage | Friable | Requires confirmation sampling and additional investigation as pipe work penetrates the floor and continues |

View of the south-east corner of level 2, Building 1 showing the foil covered pipe work behind an air conditioning duct.

The foil covered pipes are presumed to contain asbestos.

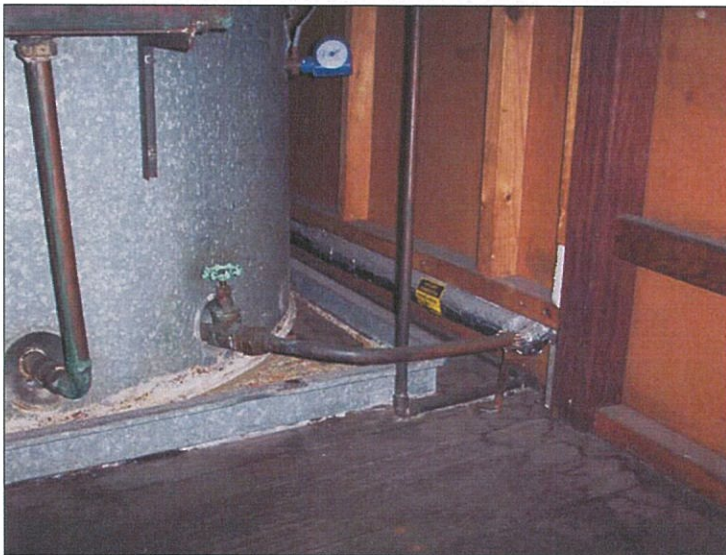
**Photograph 6**

View of the hot water system within the store room situated at the south-east corner of level 2, Building 1.

The pipe behind the water tank is insulated with asbestos lagging.

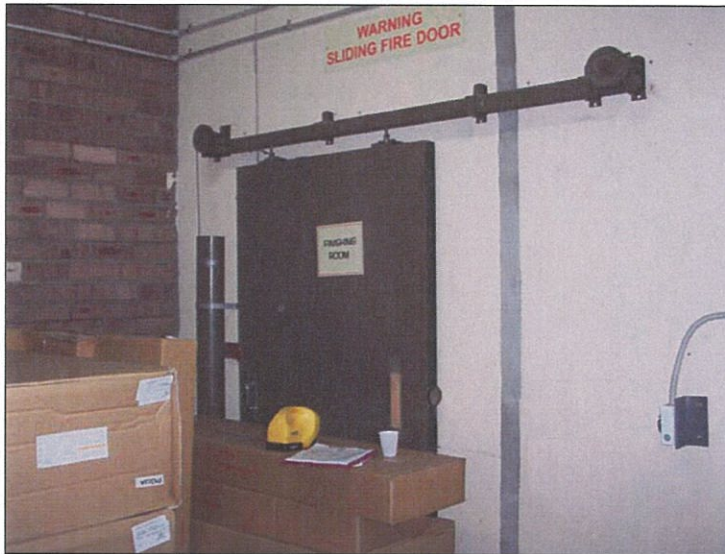
Photograph 7

View of the sliding fire door to the Finishing Room located at the west side of the Level 1, Building 2.

The fire door is presumed to have an asbestos containing insulation core.

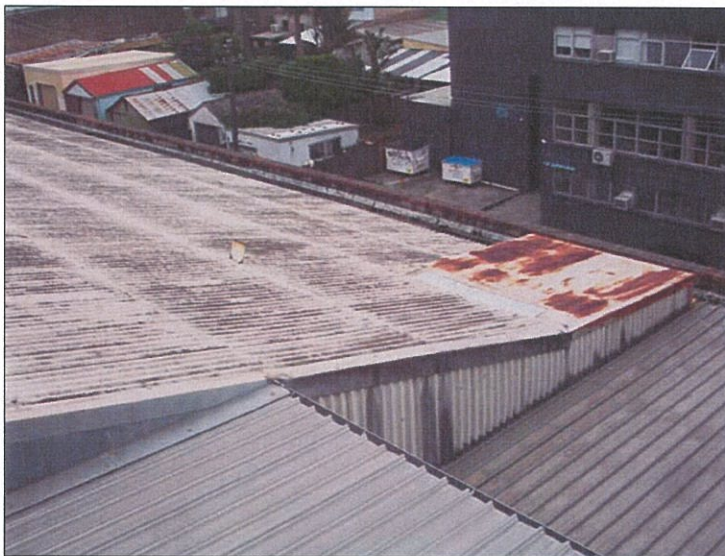
Photograph 8

| Material Type and Location | Material Status | Sample/Test No | Photo No | Approx. Extent | Condition | Bonded/Friable | Recommendations for Additional Inspections |
|---|---|---|---|---|---|---|---|
| Corrugated fibre cement sheeting (painted)<br>Roof to south section of building & NW gable infill panels | Presumed to contain asbestos | - | 8 | 1,500m <sup>2</sup> | Generally intact, minor damage | Bonded | Requires confirmation sampling |

View of the roof and north-west gable infill panels of Building 3.

The roof and gable infill panels are presumed to contain asbestos.

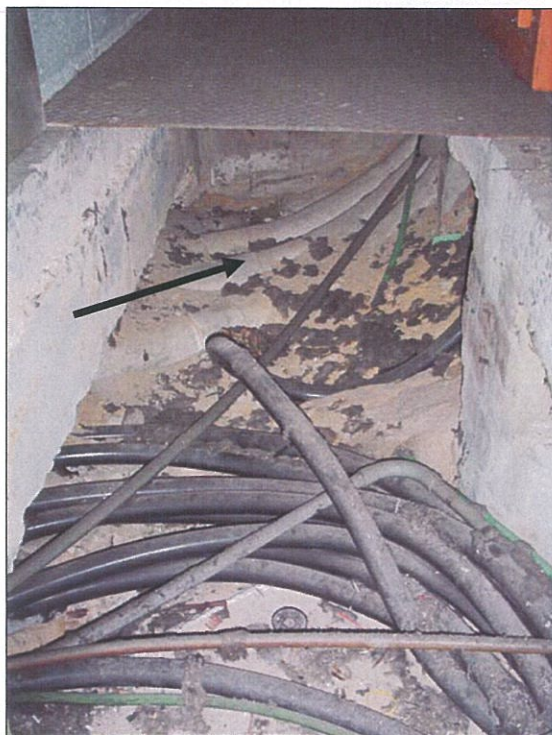
Photograph 9

View of the cable pits situated behind the bank of electrical distribution cabinets, located at the north west end of Building 1.

The arrow indicates the fibre cement pipes that house the main electrical cables. The pipes are presumed to contain asbestos.

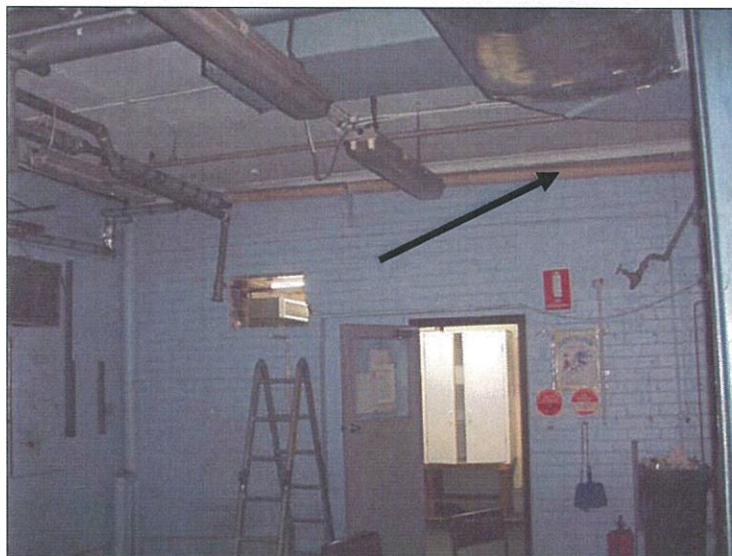
Photograph 9

| Material Type and Location | Material Status | Sample/Test No | Photo No | Approx. Extent | Condition | Bonded/<br>Friable | Recommendations for<br>Additional Inspections |
|---|---|---|---|---|---|---|---|
| Insulation to pipe work<br>Ground level, SE section of Dye House adjacent to lunchroom, calico wrapped pipe work | Presumed to contain asbestos | - | 9 | 5Lm | Generally intact, minor damage | Friable | Requires confirmation sampling |

View of the south-east section of the Dye House looking at the entry to the lunchroom.

The pipe work indicated by the arrow is presumably insulated in asbestos containing lagging.

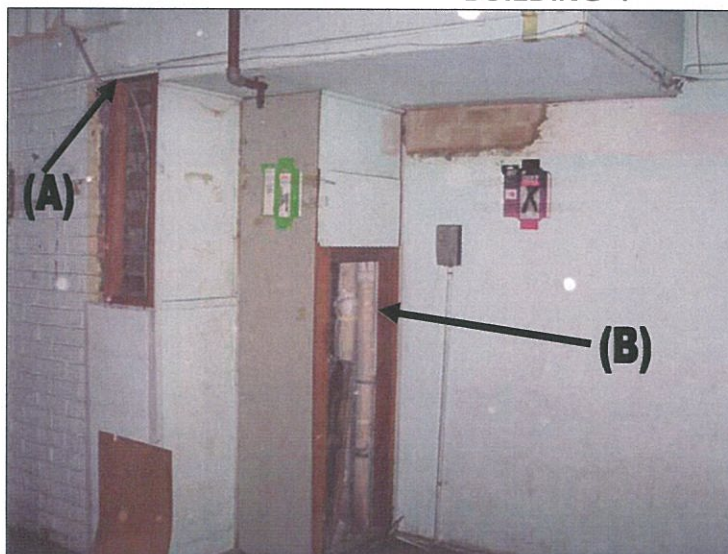
Photograph 10

View of the east wall at the north section of level 1, Building 4.

Arrow B indicates pipe work housed within the vertical boxing. The pipe work is presumed to be insulated in asbestos lagging.

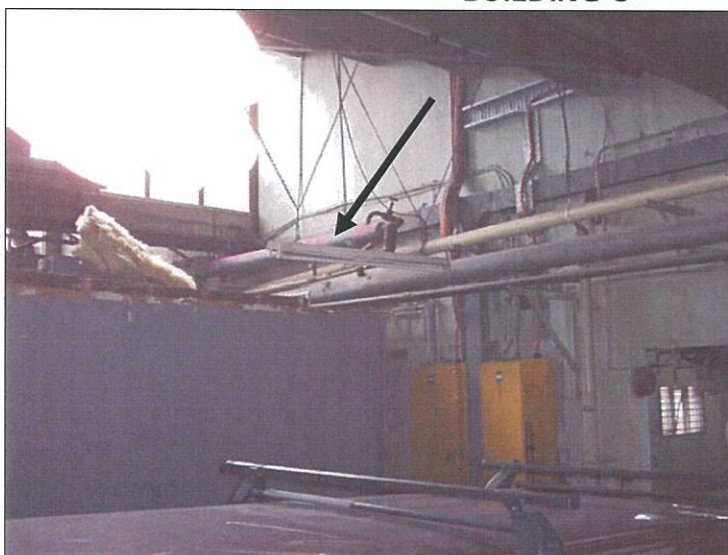
Photograph 11

View looking south and up over the internal offices of the Central Corridor.

The adjacent pipe work is insulated with SMF.

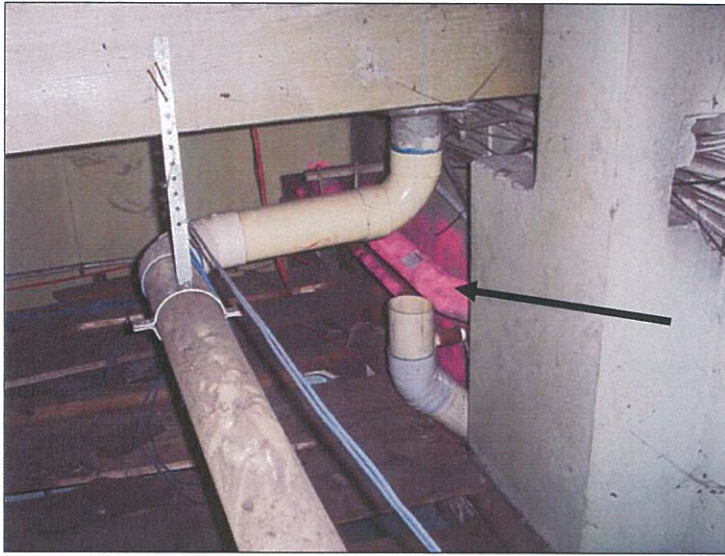
Photograph 12

View on the roof of the internal offices looking at the calico wrapped insulated pipe work presumed to contain asbestos. The pipe continues south within the ceiling cavity towards Building 4.
