Portion 54 and 61  
Mount Ousley Road, Mount Pleasant

GEOTECHNICAL INVESTIGATION FOR  
TWO PROPOSED HOUSE SITES

Report No. SC883/1-1 November 1993

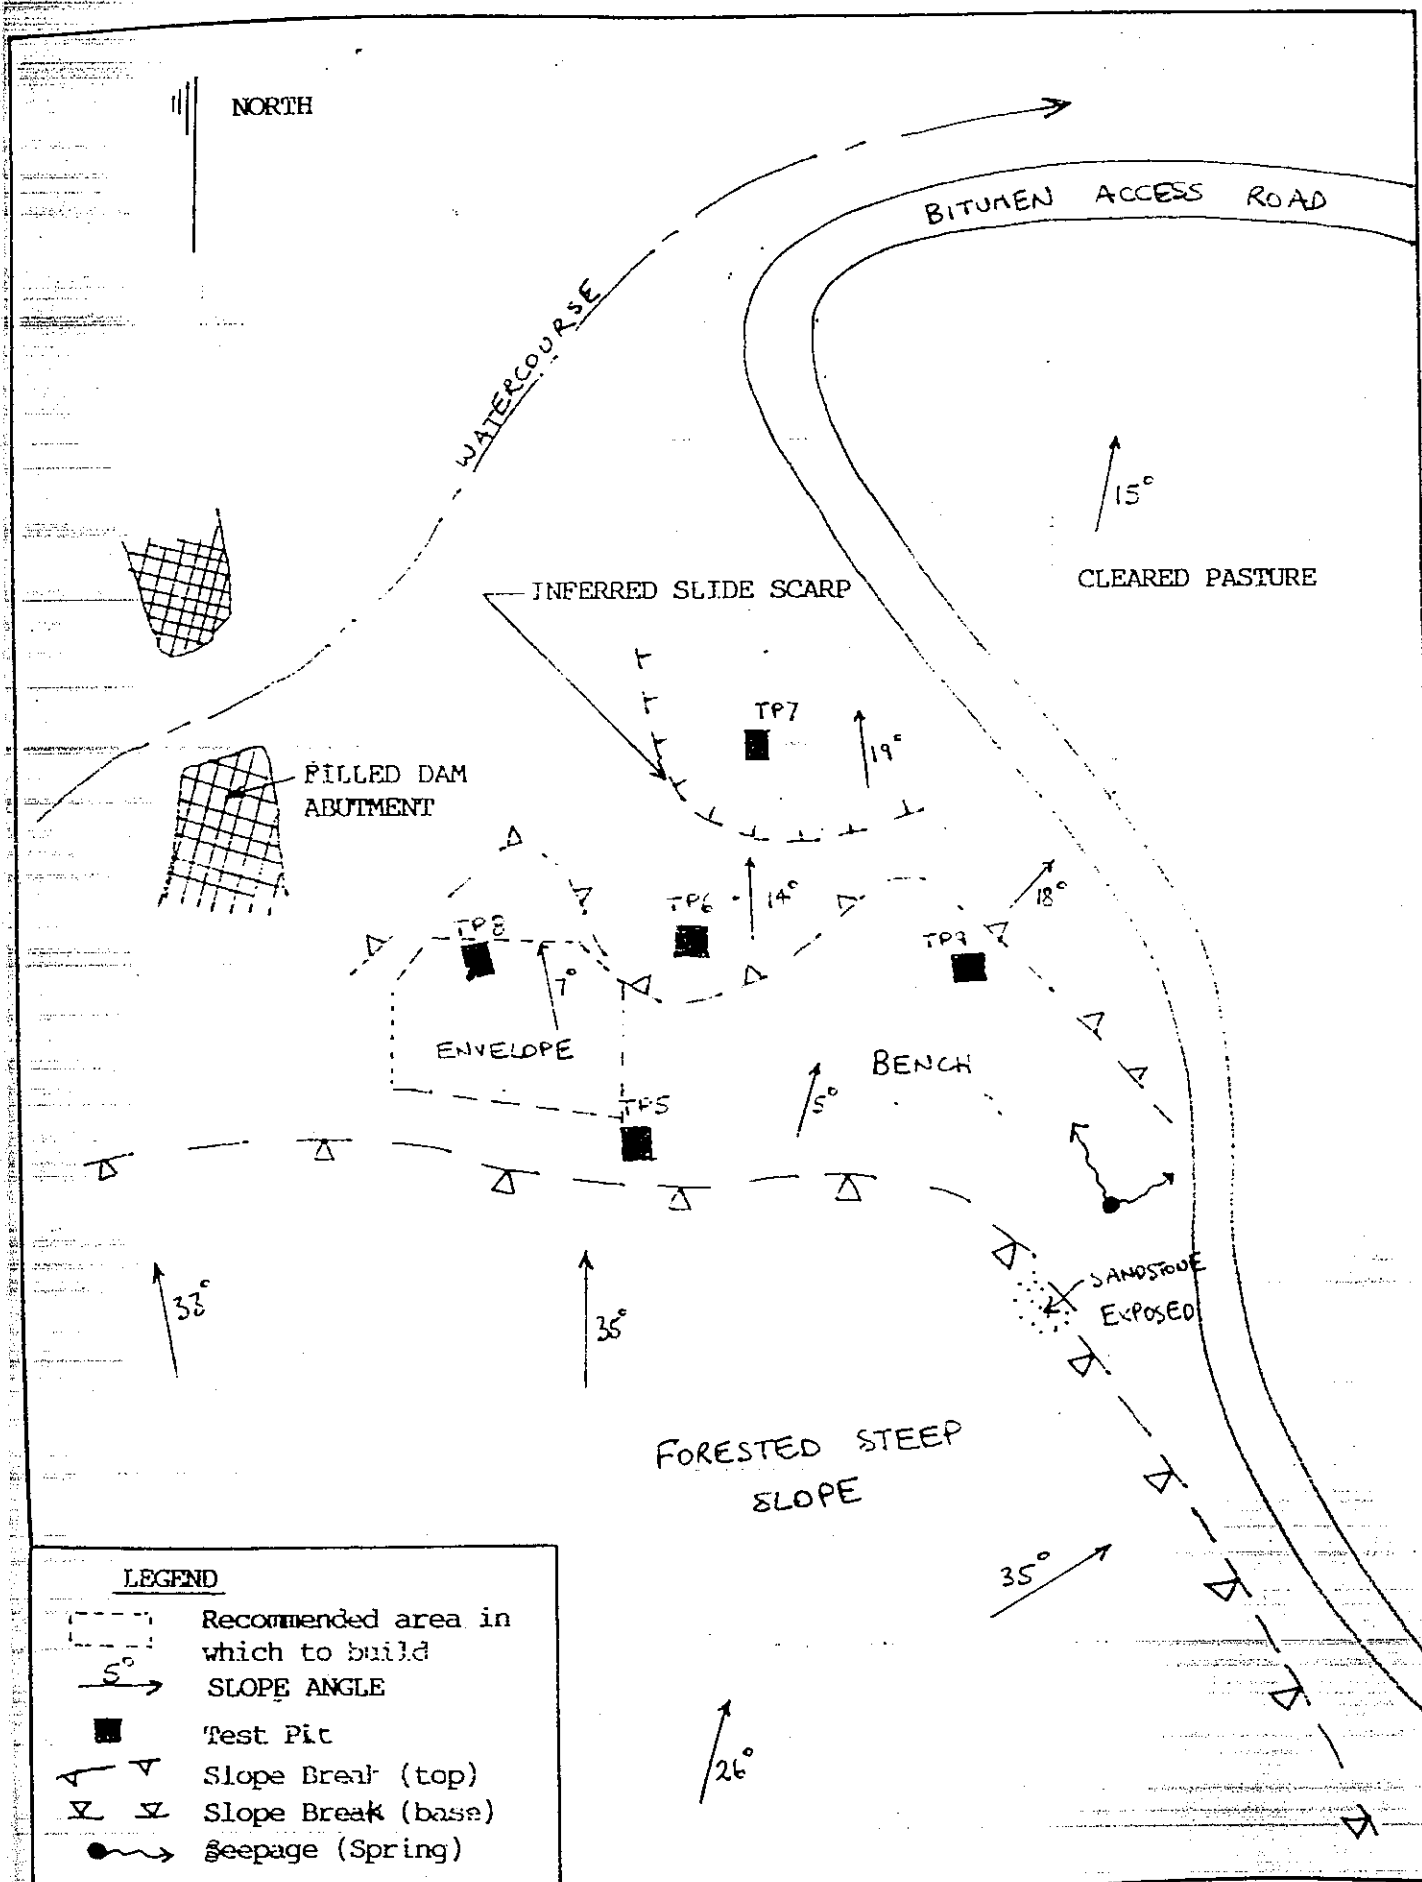
drawing no:  
SC893/1-2

The northern end of the building area bench contains a small lobe of inferred shallow slide debris. This lobe is 20m wide and may represent the toe of a shallow earthflow (1m to 2m thick) which extends about 60m upslope on a 20° slope. Seepage was observed on the bench in this area due to a leaking water supply line.

On the basis of the above listed evidence, the recommended building envelope is assessed to have a **medium risk** of slope instability in accordance with the classification system in Table 1. Residential development within the envelope is recommended to incorporate the following geotechnical constraints:

1. House foundation to be taken down at least 0.5m into intact weathered rock. Should a brick or concrete residence to be proposed for the site a rigid pier wall reinforced concrete foundation system is recommended. For flexible timber or steel framed construction isolated footings to rock would be adequate.

2. No development to occur within 10m of the crest of the 35° scarp slope below the building envelop.
3. No significant earthworks are recommended for the building site and access road. Cut and fills should be restricted to a maximum height of 0.5m.
