Report on  
Phase 1 Contamination Assessment

Proposed Rezoning of  
Lot 23 in Deposited Plan 1159704  
Berkeley Road, Fountaindale

Prepared for  
Hapido Pty Ltd

Project 75274.00  
July 2011

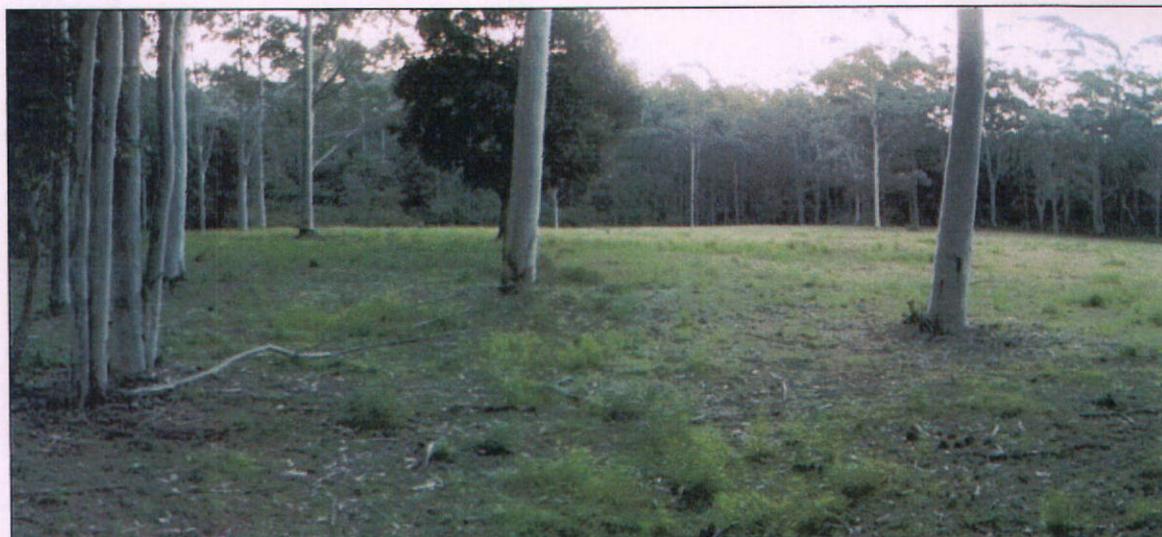
The site layout appears to have remained unchanged from the 2002 aerial photograph, although some clearing of regrowth in the south-west portion of the site had probably occurred. No evidence of existing or former buildings/structures, or an intensive agriculture (orchards/market gardens) were observed at the site. The cleared areas, within both the north-east and south-west portions of the site, were fenced and used for grazing. Portions of the site, beyond the fenced areas, appeared to comprise medium dense to dense bushland. There was no evidence of any fly tipped stockpiles.

Figure 2 – Photograph of north-east portion of the site.

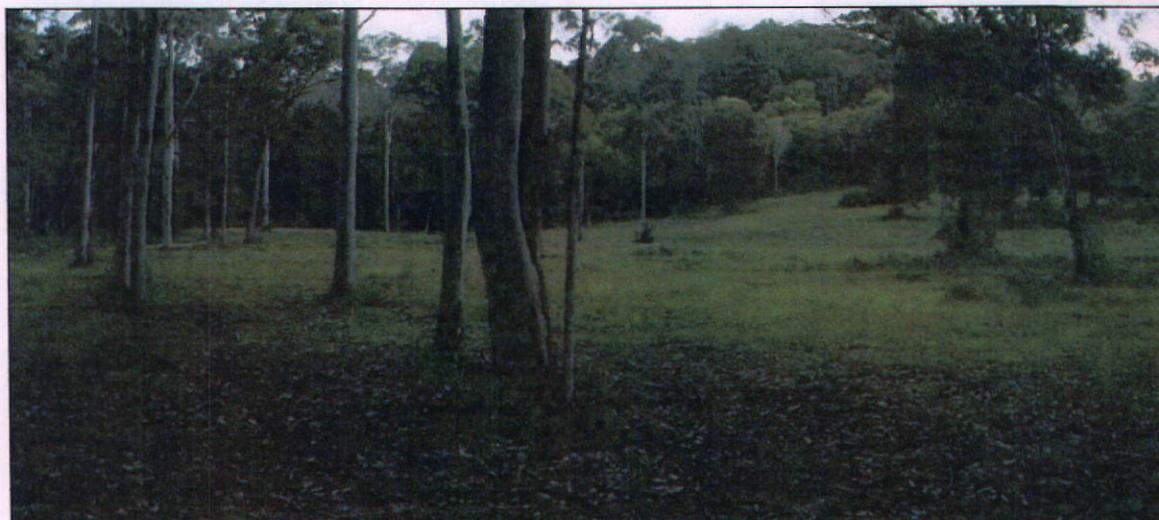
Figure 3 – Photograph of south-west portion of the site.

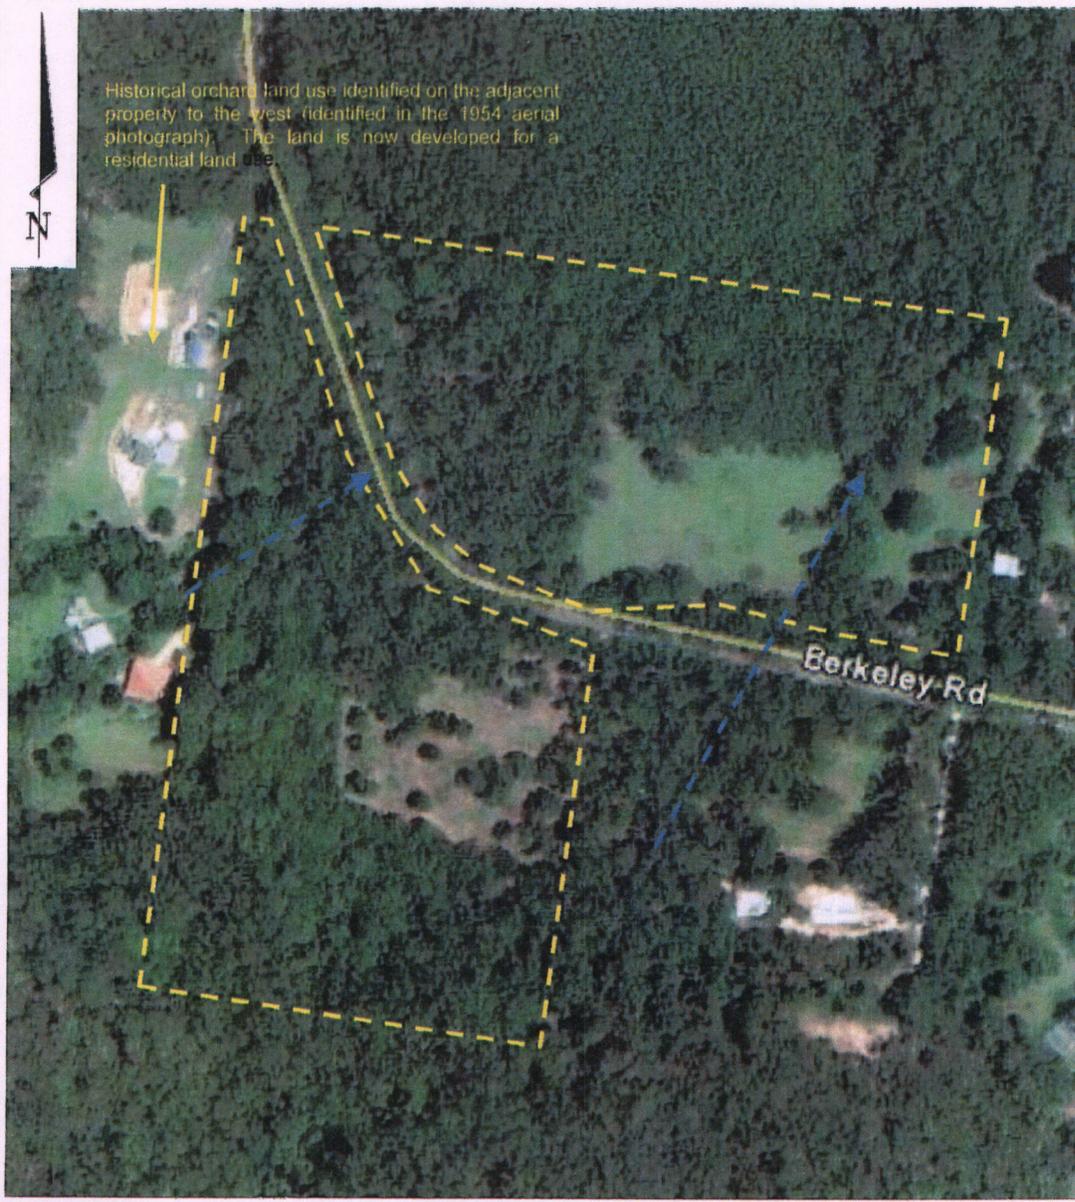
PROJECT No:	75274.00
DRAWING No:	1
REVISION:	A

Drawing 1, which is included in Appendix A, shows the existing layout of the site.

Douglas Partners conducted a Phase 1 (non-intrusive) Contamination Assessment for the site identified as Lot 23 in Deposited Plan 1159704 and located at 76 Berkeley Road, Fountaindale. It is understood that the site is proposed to be rezoned to facilitate future rural-residential development. The site is identified in Drawing 1 (Appendix A).
