# **Douglas Partners**

Report on  
Preliminary Site Investigation for Contamination

Proposed Rezoning  
165 Louisiana Road, Wadalba

Project 82936.00  
February 2016

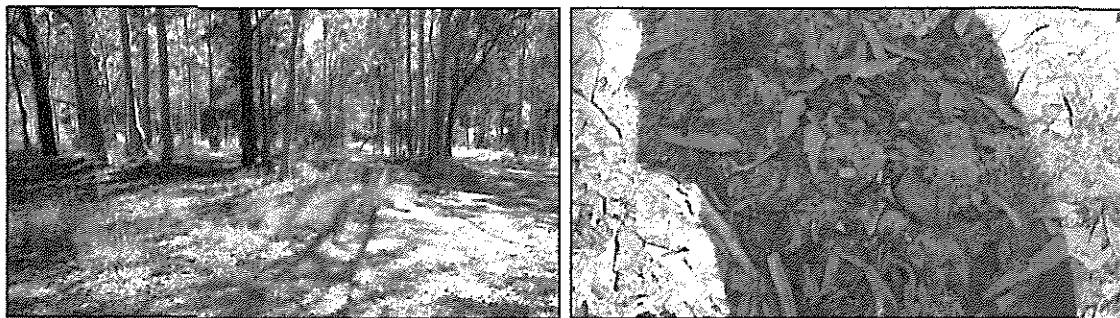
Figures 7 and 8 – Photograph from access trail that traverses the site from Louisiana Road (generally surfaced with a recycled building material aggregate). The cleared area observed in the 2001 and 2010 aerial photographs appeared to have been covered with an organic leaf mulch mix. A single fragment of a suspected asbestos-containing material (ACM) was observed at the ground surface of the access track (Figure 8). The location of the suspected ACM fragment is identified on Drawing 1, Appendix B.

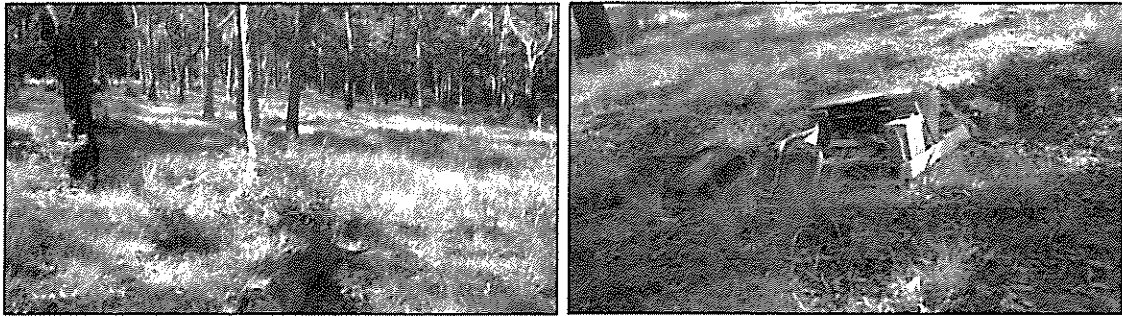
Figures 9 and 10 – Photograph of the general site conditions (scattered trees with grass/shrub surface cover). The long grass and absence of distinctive site features prevented the detailed inspection of the former shed/building footprints. Fly-tipping was observed in several isolated areas throughout the site. A variety of fly-tipped materials were identified (plastic, metal timber, concrete, asphalt, and some domestic waste).

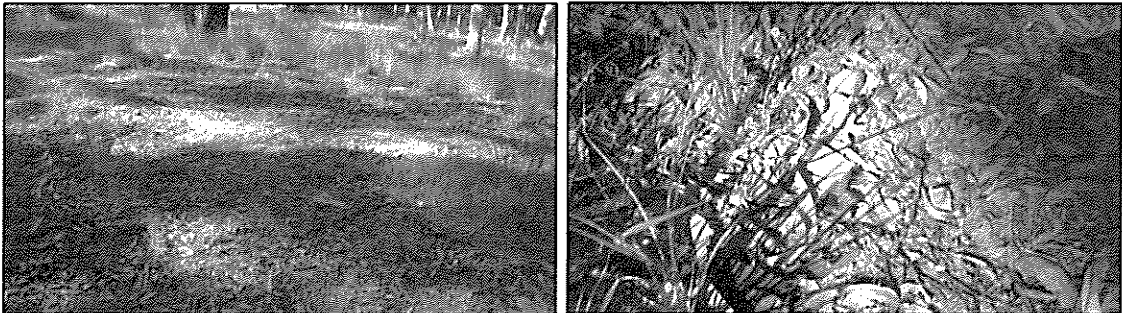
Figures 11 and 12 – Photographs of an area where a surface cover of filling was observed. Several fragments of suspected ACM were observed at the surface of the filling (refer to Figure 12). The location of the suspected ACM fragments is identified on Drawing 1, Appendix B.

Prior to completion of the further intrusive contamination investigations it is recommended that a licensed contractor is engaged to remove all fly-tipped waste materials and suspected ACM fragments observed at the ground surface (refer to Drawing 1, Appendix A).

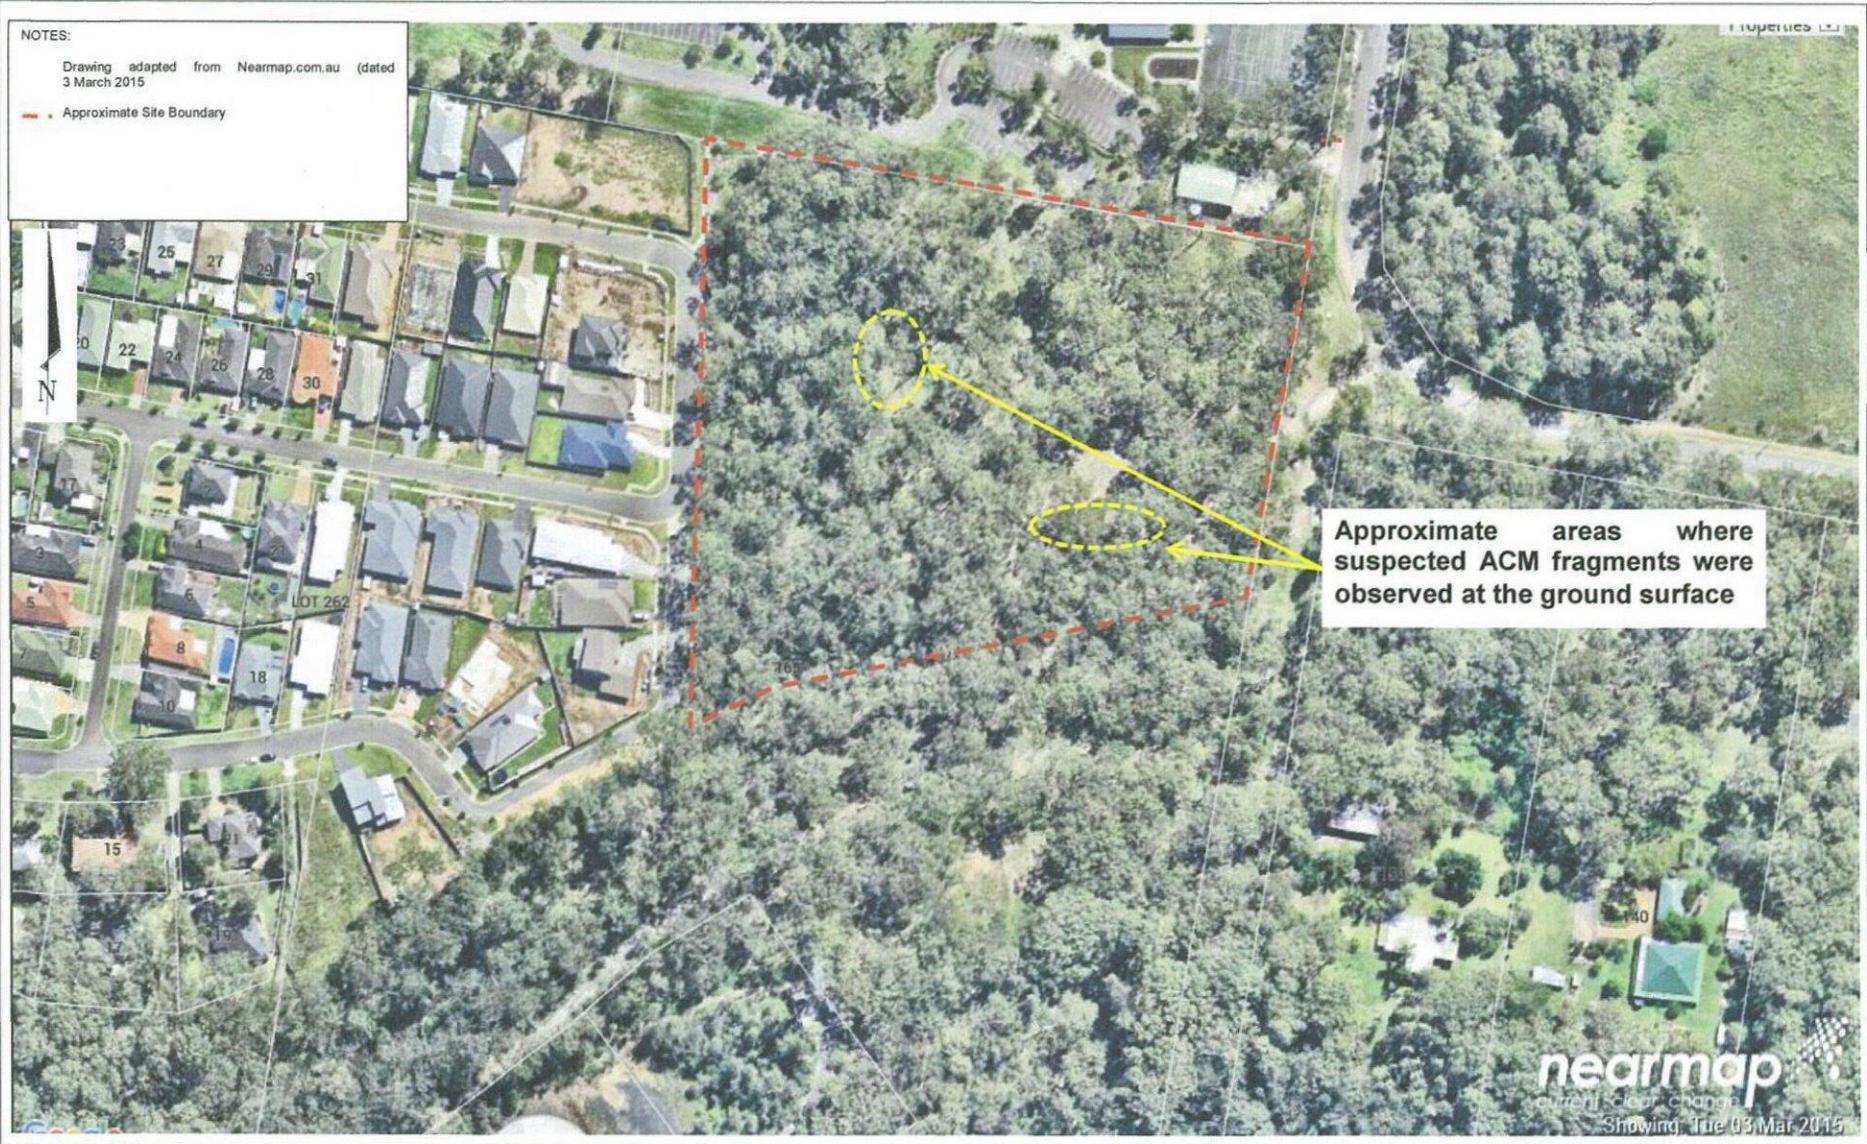
The site layout appears to have remained unchanged from the March 2015 aerial photograph (refer to Drawing 1, Appendix A). The site is currently occupied by the following features:

Prior to completion of the further intrusive contamination investigations it is recommended that a licensed contractor is engaged to remove all fly-tipped waste materials and suspected ACM fragments observed at the ground surface (refer to Drawing 1, Appendix A).
