Hazardous Building Materials Report

871-877 Pacific Highway  
Chatswood NSW

Prepared for  
Megland Group Pty Ltd  
C/-PBD Architects

Project 84772.03  
May 2017

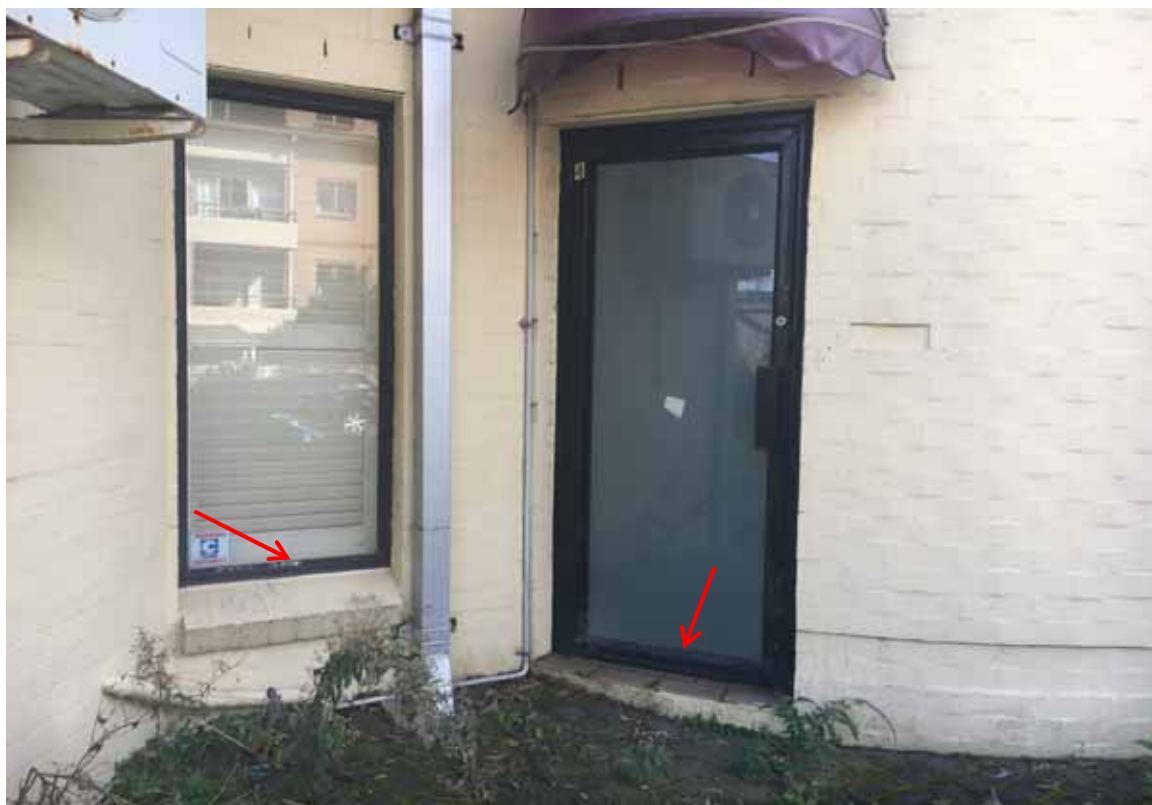
| | | | | Asbestos Risk Assessment | | | | | | | | | |
|---|---|---|---|---|---|---|---|---|---|---|---|---|---|
| External | South elevation, window putty to external metal windows and doors | A01 | Asbestos detected | 1 | 2 | 1 | 2 | 1 | 1 | 8 | Low | 1 | Reinspect condition on a regular basis. Remove material prior to any significant disturbance (e.g. renovation, demolition or maintenance work). |

Photograph 1: Building 1, external, south elevation, beige caulking to metal windows and doors (asbestos).

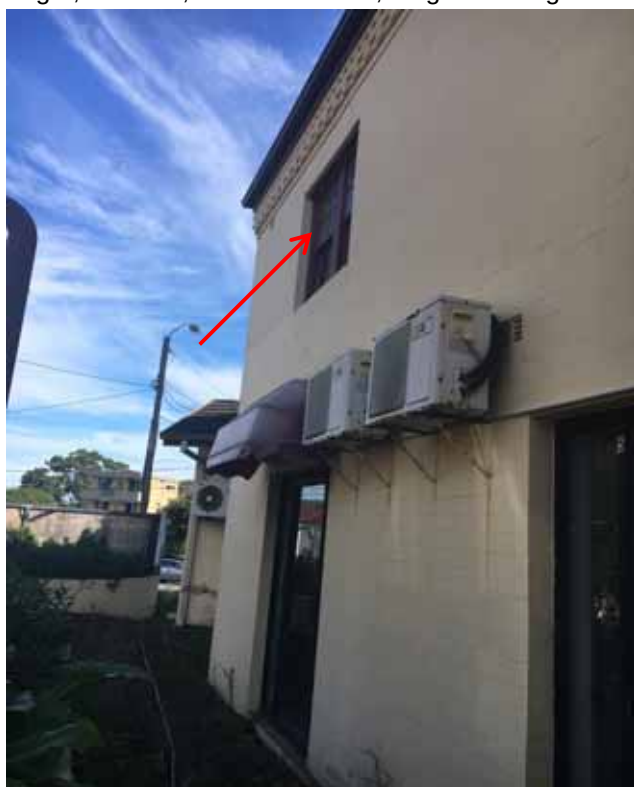
| | | | | Asbestos Risk Assessment | | | | | | | | | |
|---|---|---|---|---|---|---|---|---|---|---|---|---|---|
| External | Throughout, external, red window paint and door trims | P02 | Lead paint ( $> 1\%$ lead w/w) | N/A | N/A | N/A | N/A | N/A | N/A | N/A | N/A | 2 | Avoid disturbance and implement controls to prevent exposure and dispersal during demolition. Lead paint waste arising otherwise than from residential premises or educational or child care institutions is pre-classified as hazardous waste under the NSW EPA Waste Classification Guidelines. |

Photograph 2: Building 1, external, throughout, red paint to windows and external trims (lead paint).

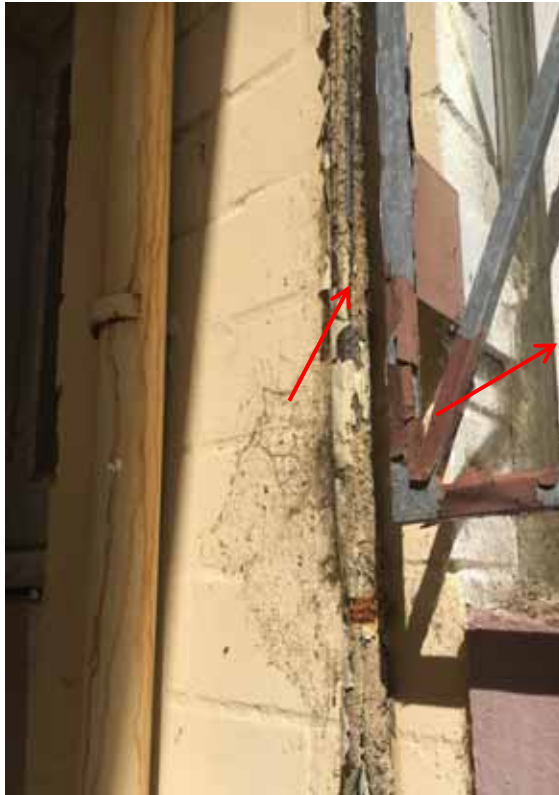
| | | | | Asbestos Risk Assessment | | | | | | | | | |
|---|---|---|---|---|---|---|---|---|---|---|---|---|---|
| External | North-facing external bathroom windows, white/brown paint system | P03 | Lead paint ( $> 1\%$ lead w/w) | N/A | N/A | N/A | N/A | N/A | N/A | N/A | N/A | 3 | Avoid disturbance and implement controls to prevent exposure and dispersal during demolition. Lead paint waste arising otherwise than from residential premises or educational or child care institutions is pre-classified as hazardous waste under the NSW EPA Waste Classification Guidelines. |

Photograph 3: Building 1, external, north facing bathroom windows, flaking white paint (lead paint).

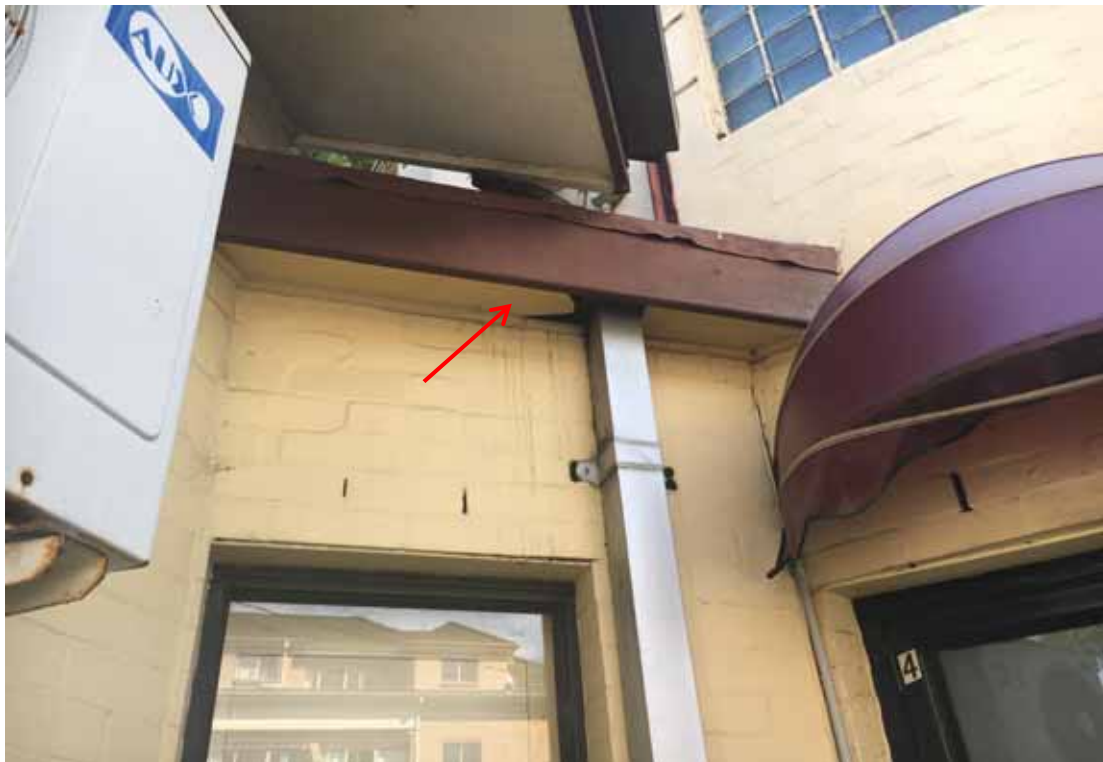
| | | | | Asbestos Risk Assessment | | | | | | | | | |
|---|---|---|---|---|---|---|---|---|---|---|---|---|---|
| External | Eaves lining around intersection with Unit 3 | Refer A19, A21 | Assumed asbestos | 1 | 2 | 1 | 2 | 1 | 1 | 8 | Low | 4 | Reinspect condition on a regular basis. Remove material prior to any significant disturbance (e.g. renovation, demolition or maintenance work). |

Photograph 4: Building 1, external, eaves linings near intersection with Unit 3 (asbestos).

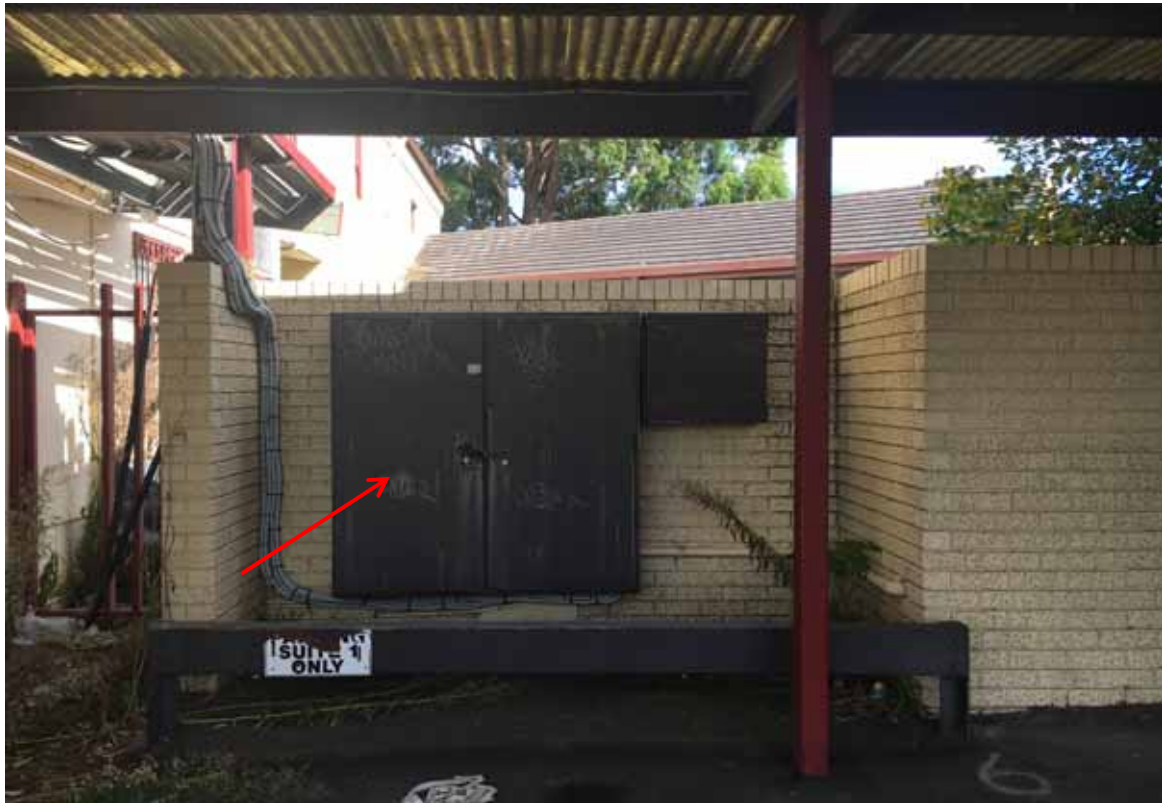
| | | | | Asbestos Risk Assessment | | | | | | | | | |
|---|---|---|---|---|---|---|---|---|---|---|---|---|---|
| External | Adjacent carport , electrical panel, electrical backing boards(x2) | N/A | Assumed asbestos | 1 | 2 | 2 | 2 | 1 | 0 | 8 | Low | 5 | Reinspect condition on a regular basis. Remove material prior to any significant disturbance (e.g. renovation, demolition or maintenance work). |

Photograph 5: Building 1, external, carport, electrical backing board x2 (assumed asbestos).

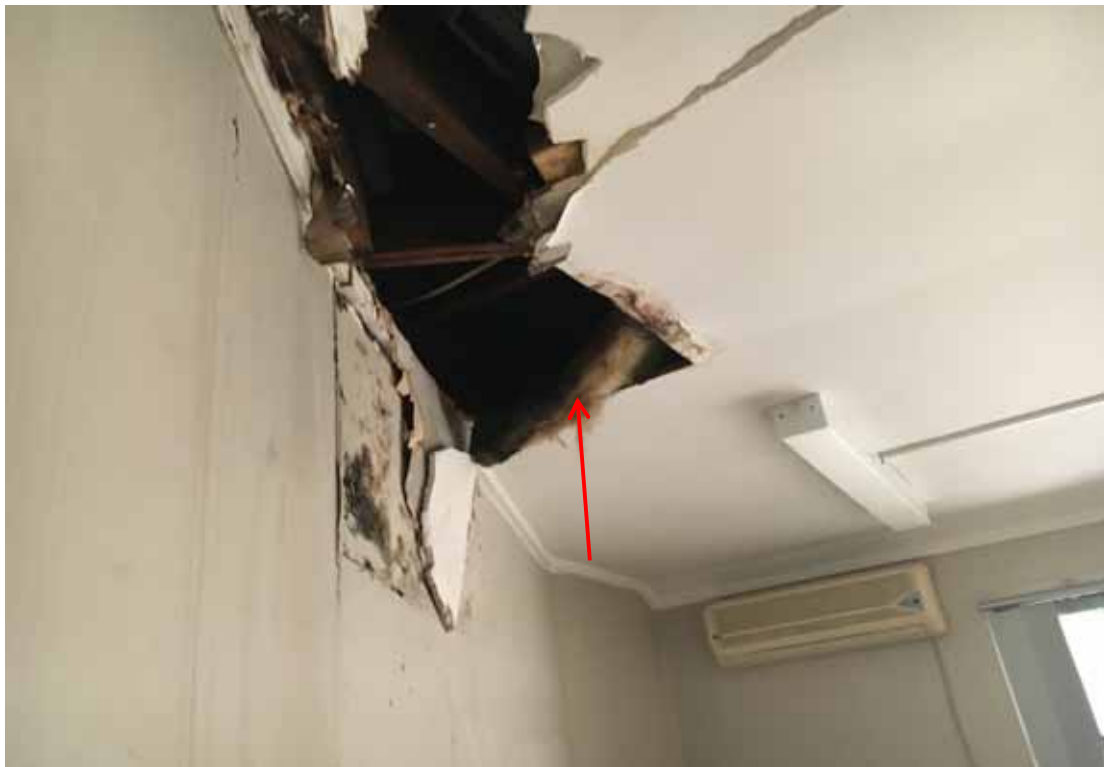
Photograph 6: Building 1, internal, ceiling space throughout, ceiling insulation (SMF).

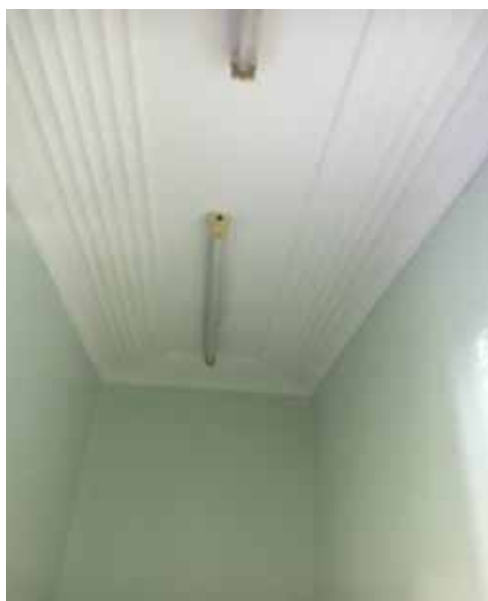
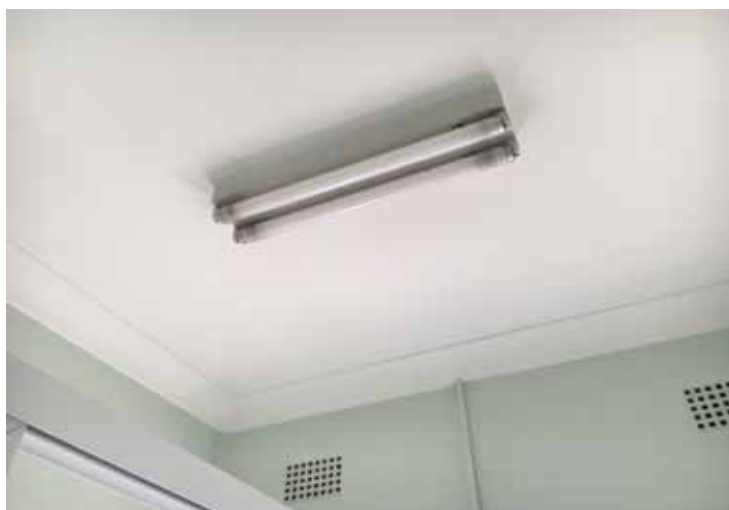
Photograph 7: Building 1, throughout, capacitors in fluorescent light fittings (assumed PCB).

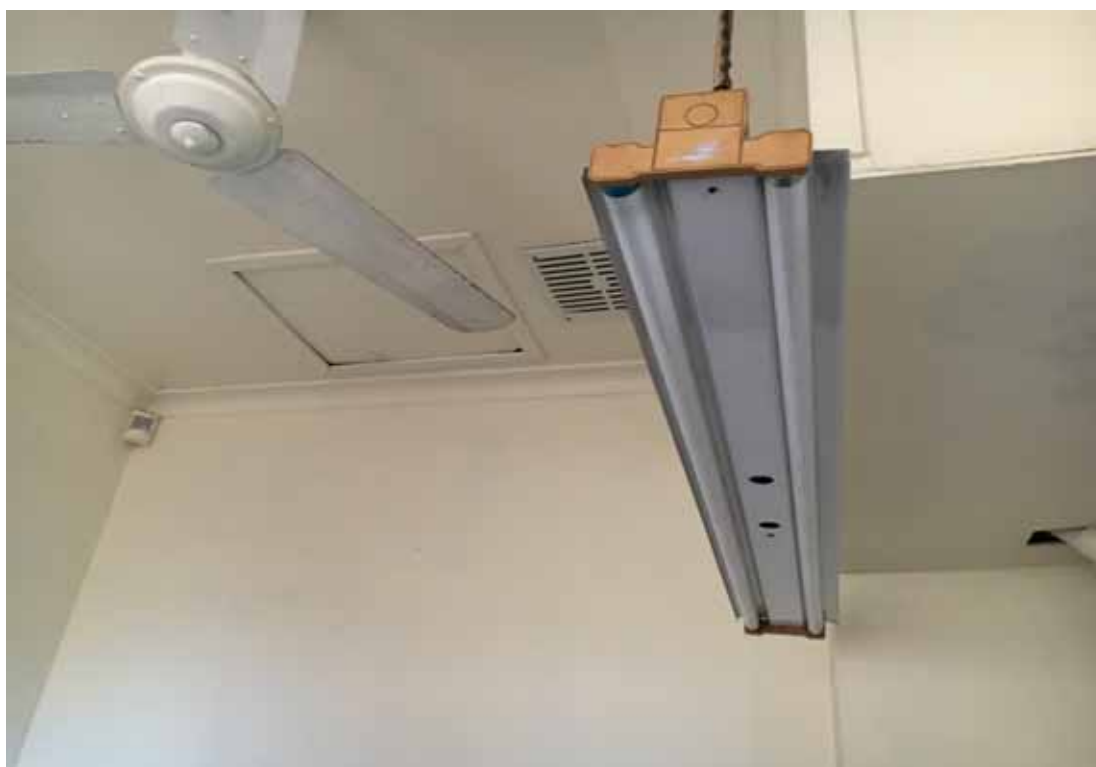
Photograph 8: Building 2, internal, capacitors in fluorescent light fittings (PCB).

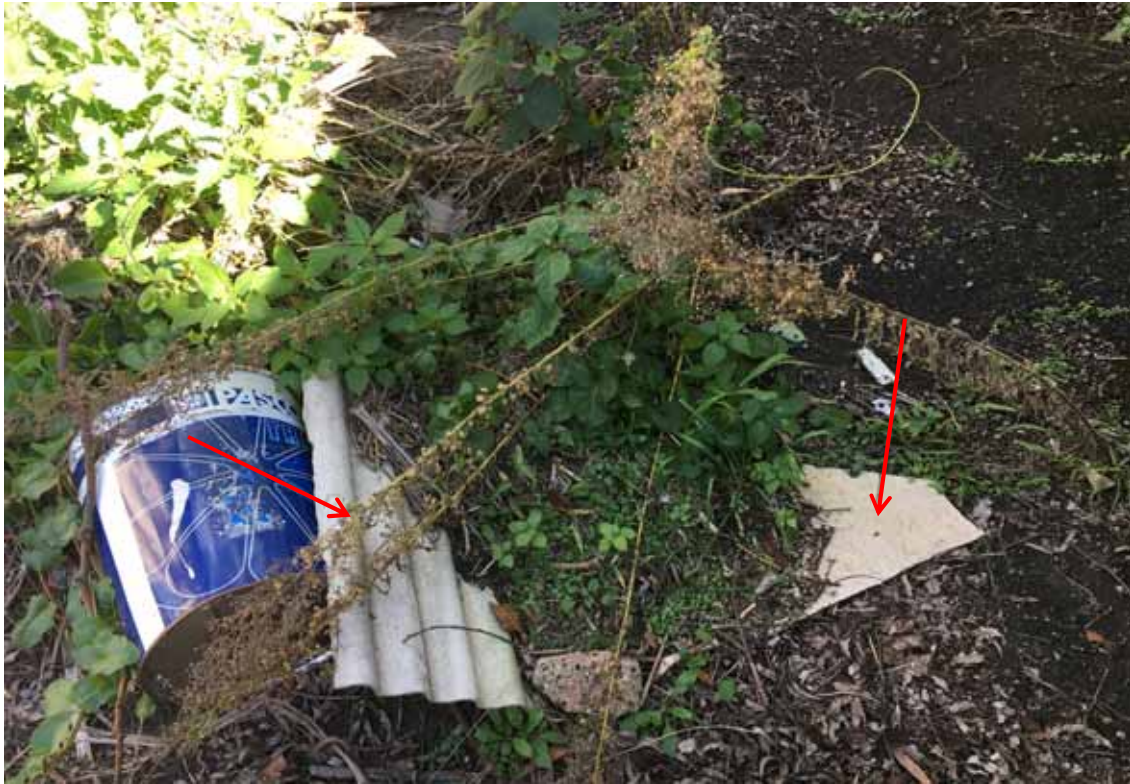
Photograph 9: Building 2, external, north-east corner of site, loose asbestos debris on ground (asbestos).

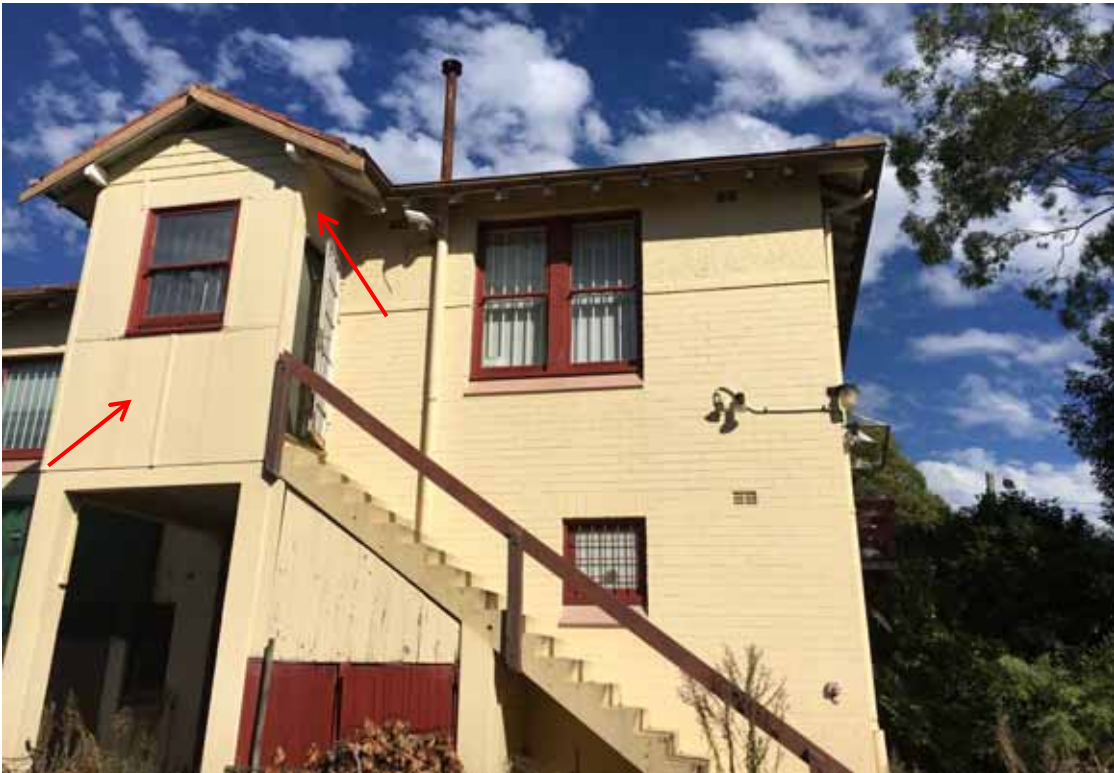
Photograph 10: Building 2, external, walls to sunroom and porch above door infill panel (asbestos).

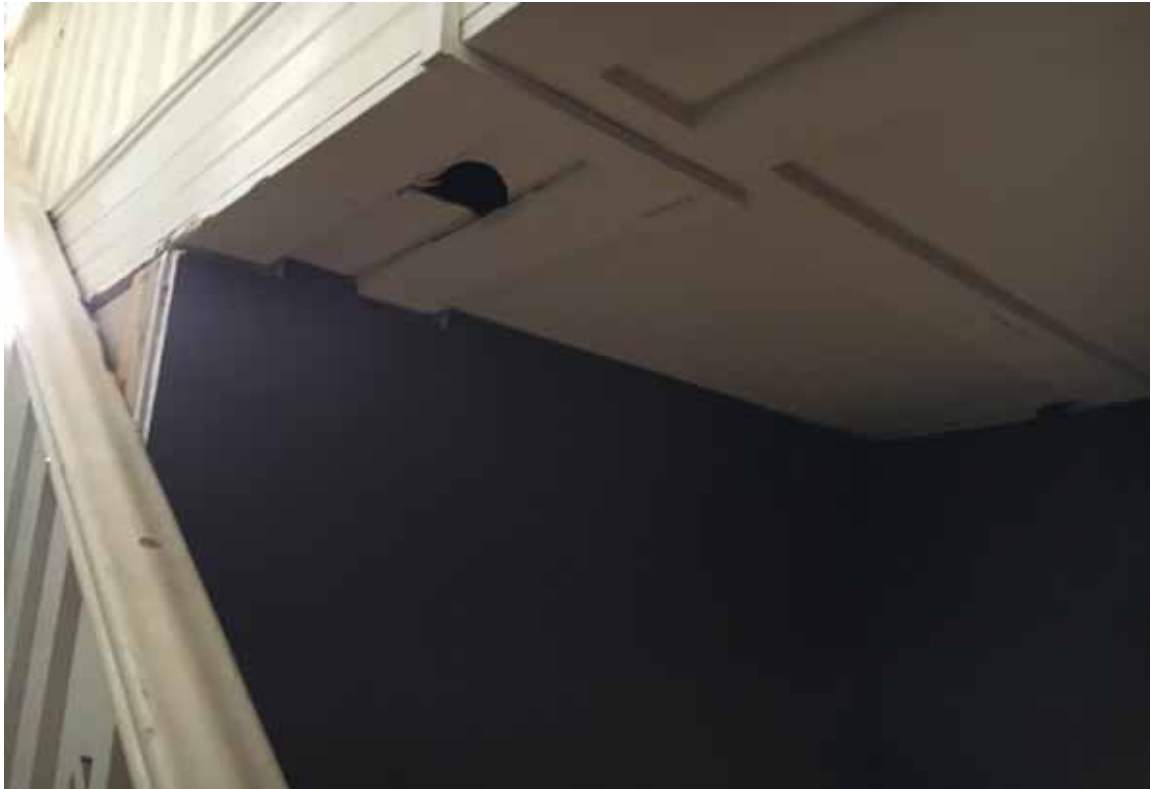
Photograph 11: Building 2, fibre cement ceiling lining below stairs (asbestos).

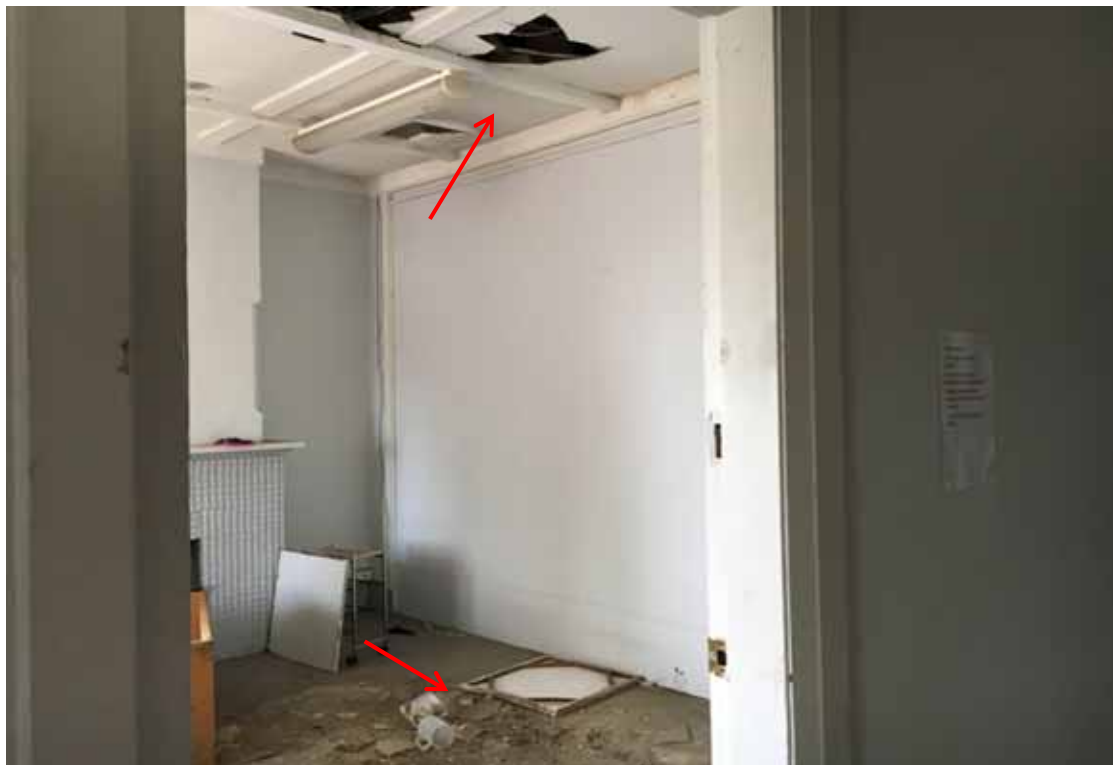
Photograph 12: Building 2, ceiling lining and associated debris, north west portion of first floor (asbestos).

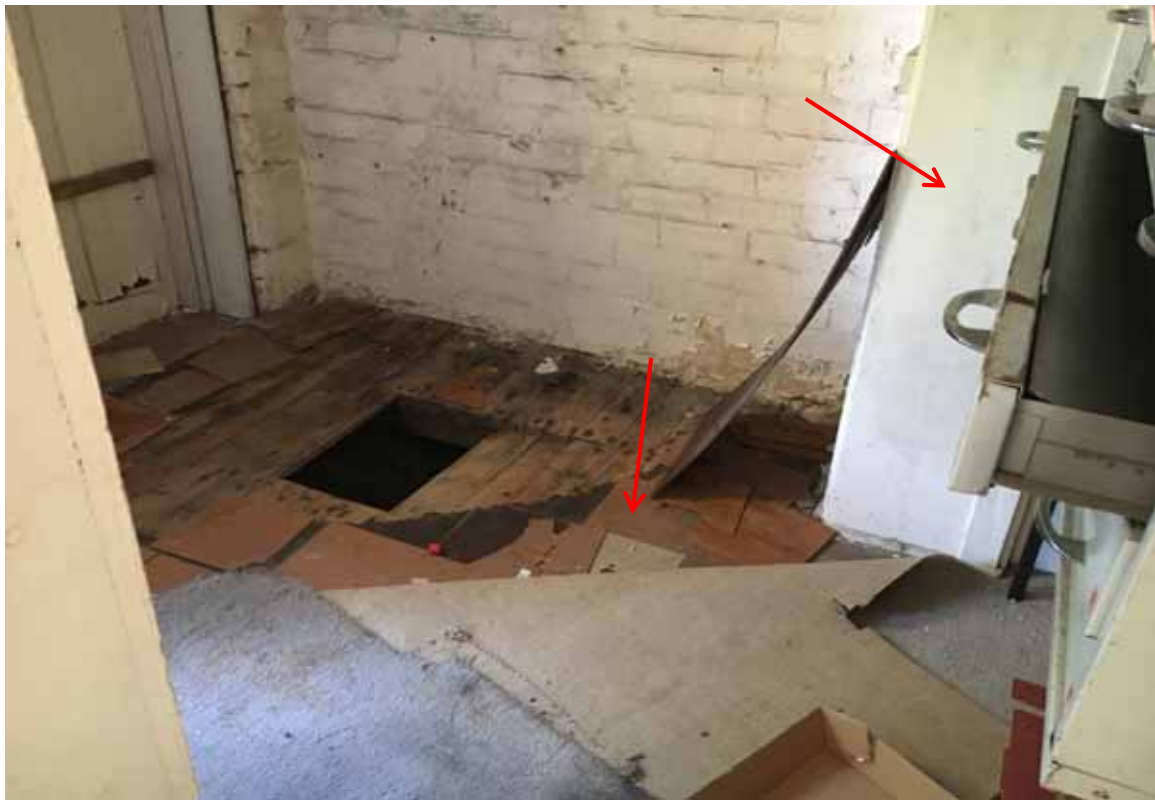
Photograph 13: Building 2, internal, rear exit room, brittle brown vinyl tiles (asbestos) and fibre cement service riser (asbestos).

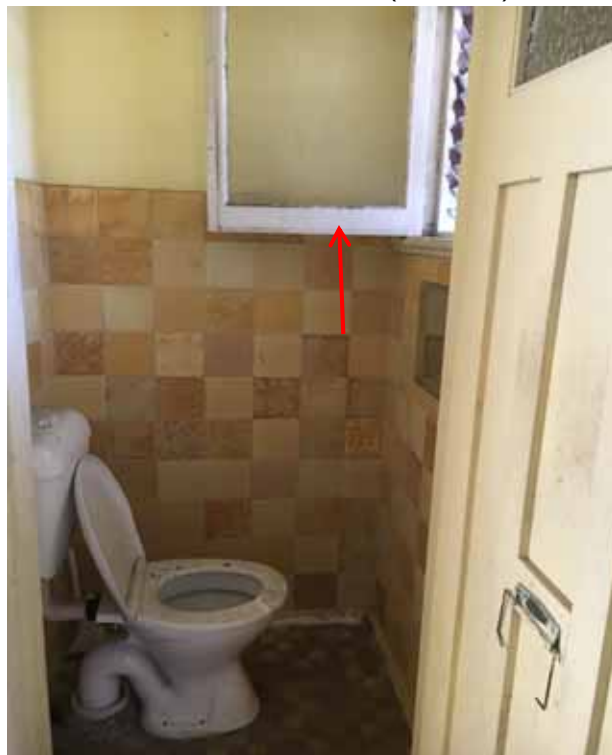
Photograph 14: Building 2, internal, white paint to window sills throughout (lead).

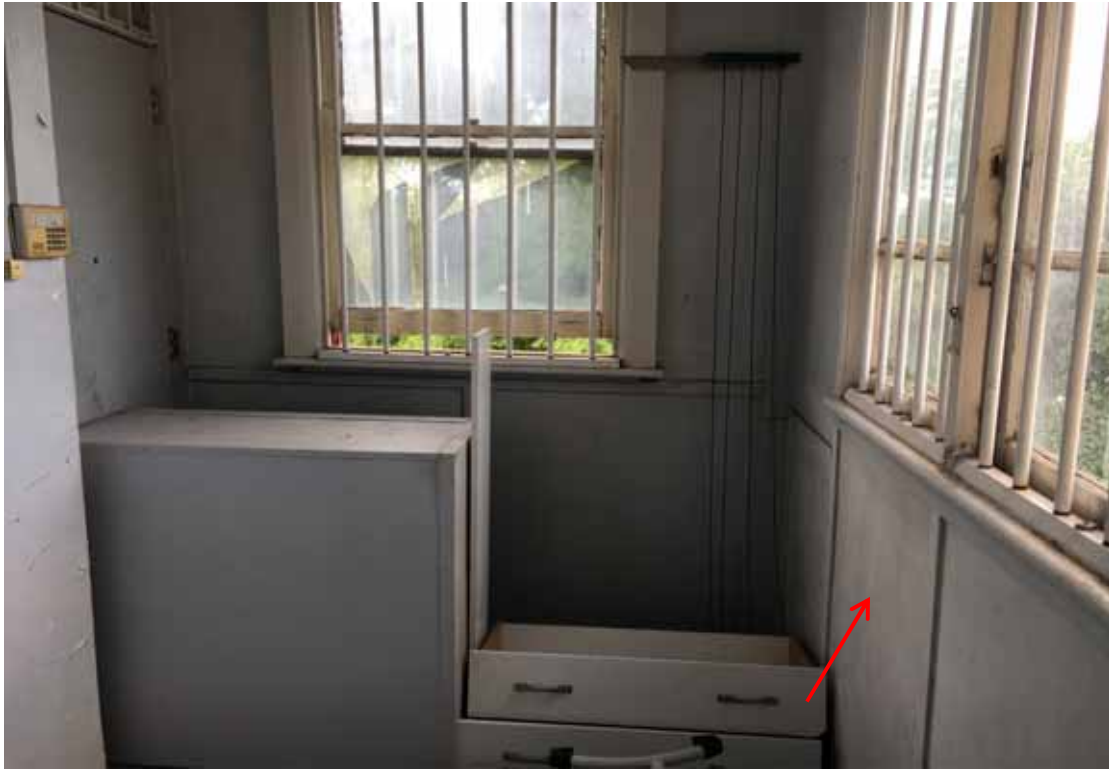
Photograph 15: Building 2, internal, sunroom wall lining, fibre cement sheet (asbestos)

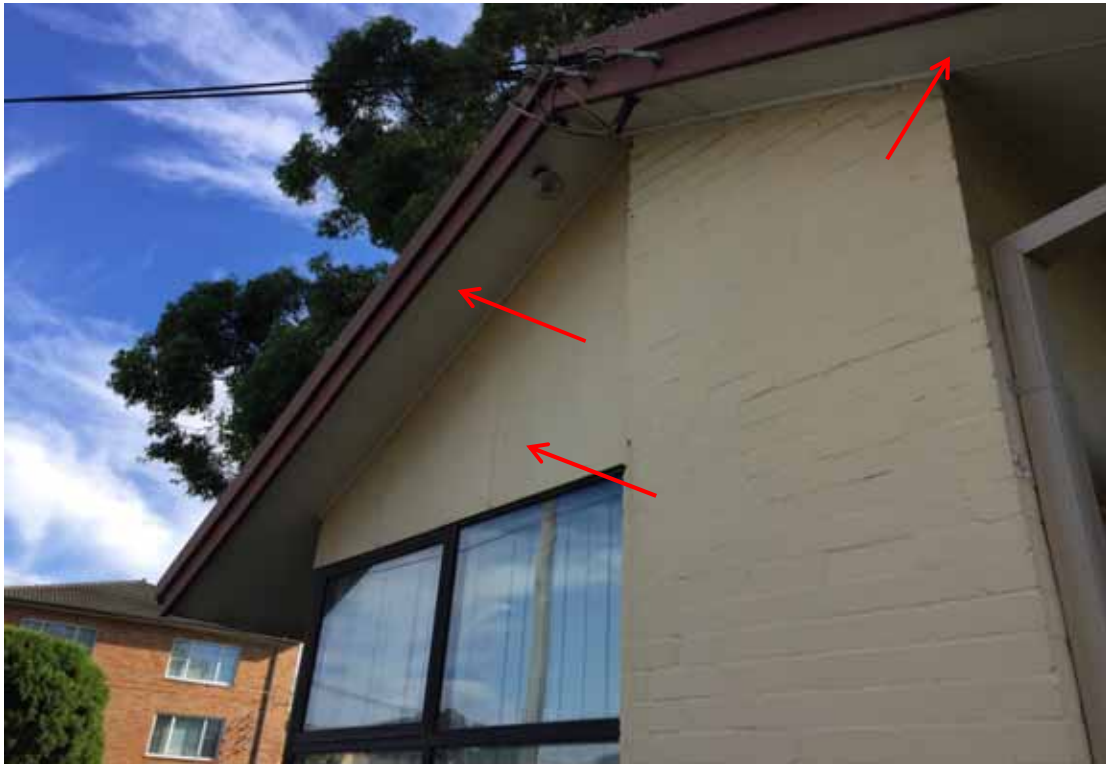
Photograph 16: Unit 3, eaves and gable lining, fibre cement sheeting (asbestos).

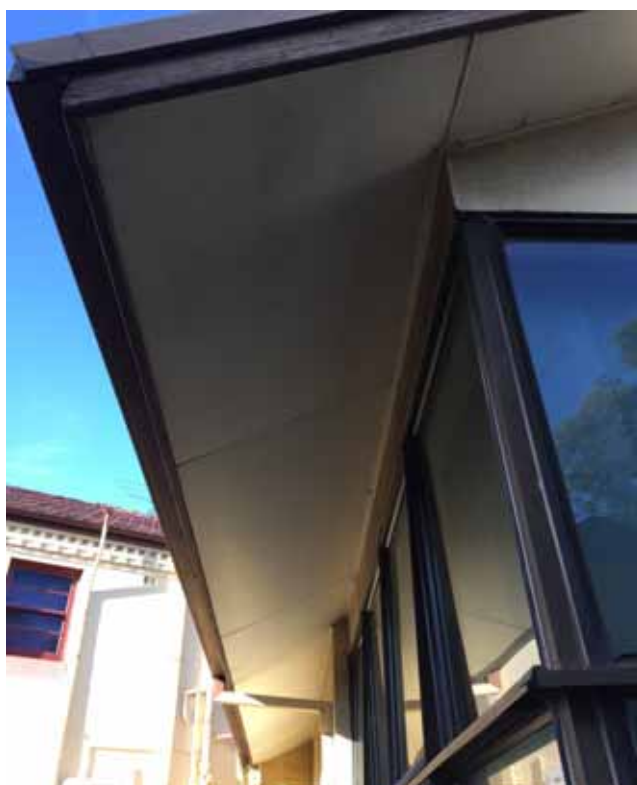
Photograph 17: Unit 3, eaves, fibre cement sheeting (asbestos).

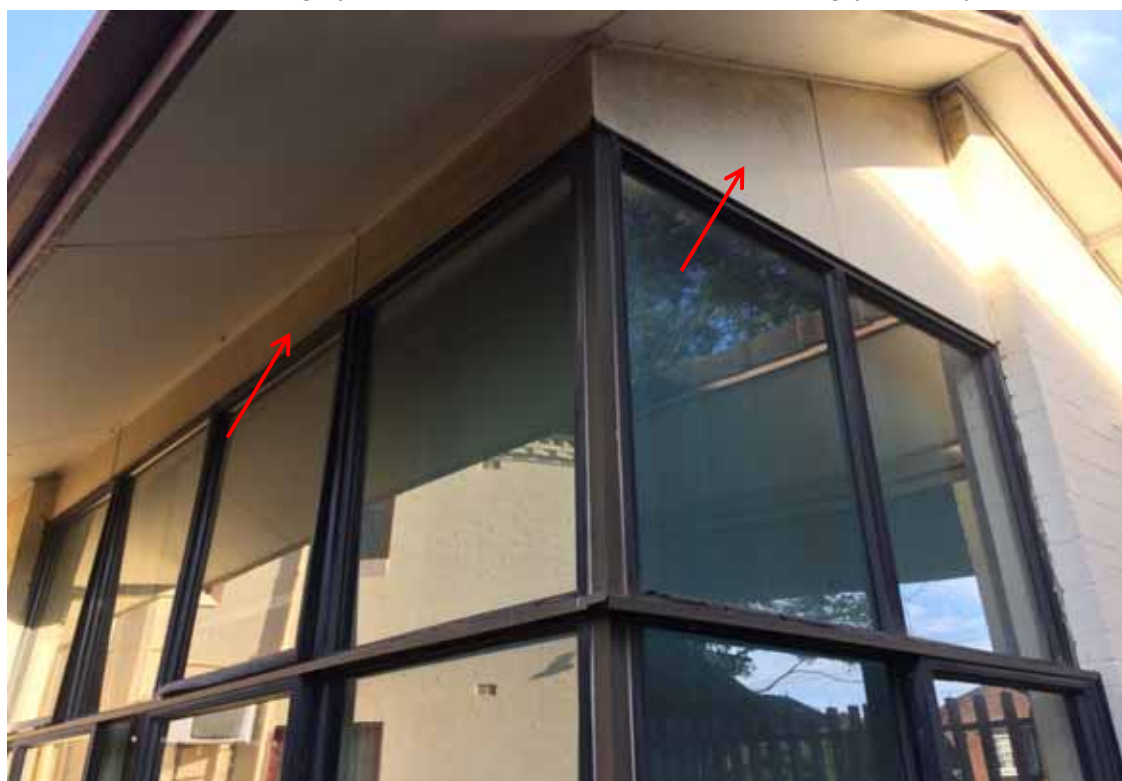
Photograph 18: Unit 3, Gable and head linings throughout (asbestos).

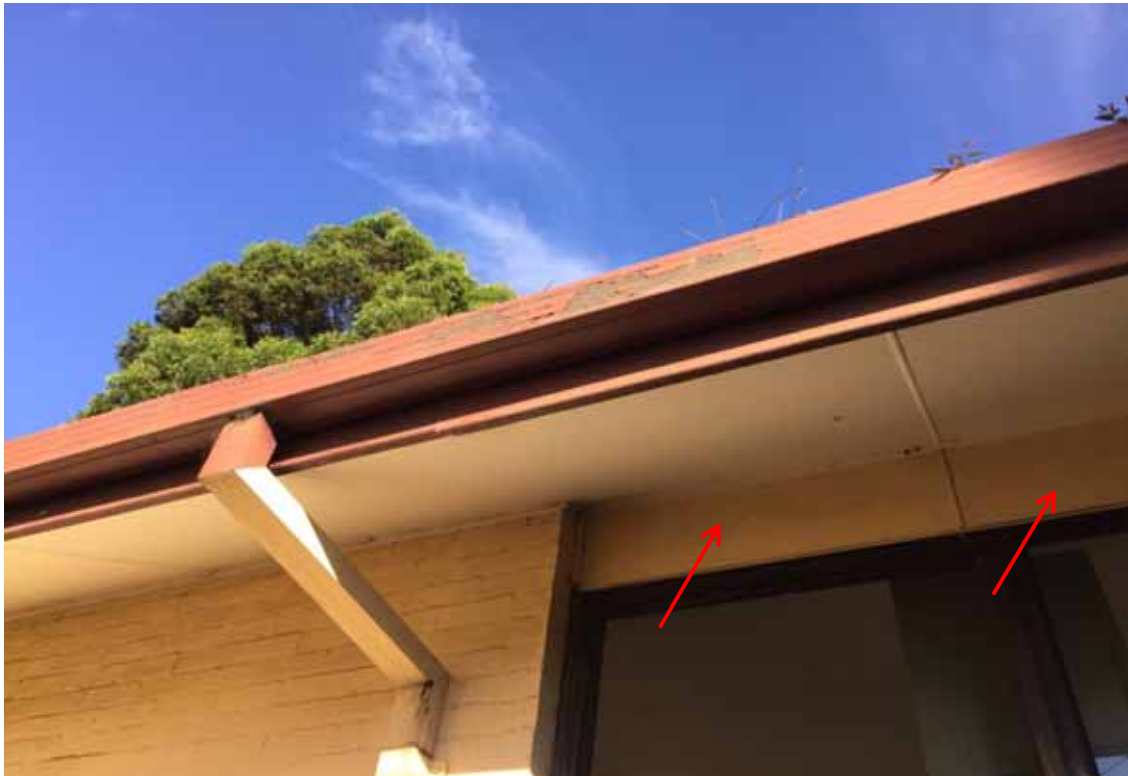
Photograph 19: Unit 3, Gable and head linings throughout (asbestos).

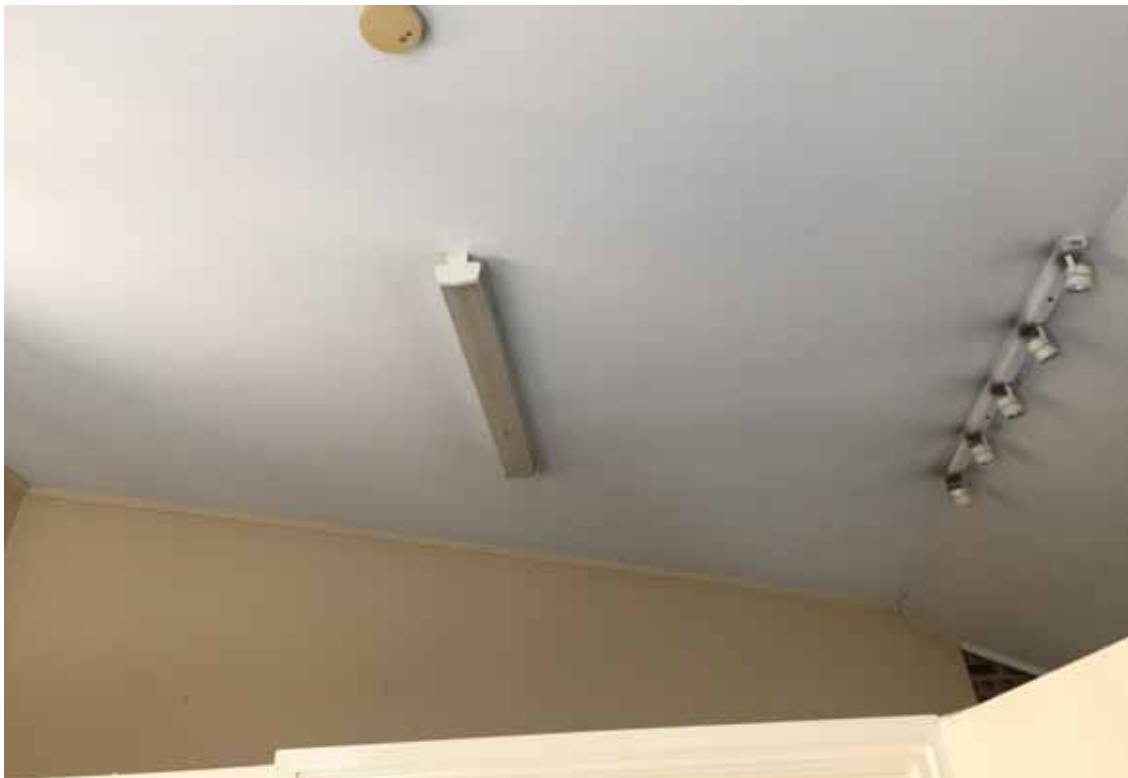
Photograph 20: Unit 3, interior, fluorescent light, capacitor (assumed PCB).

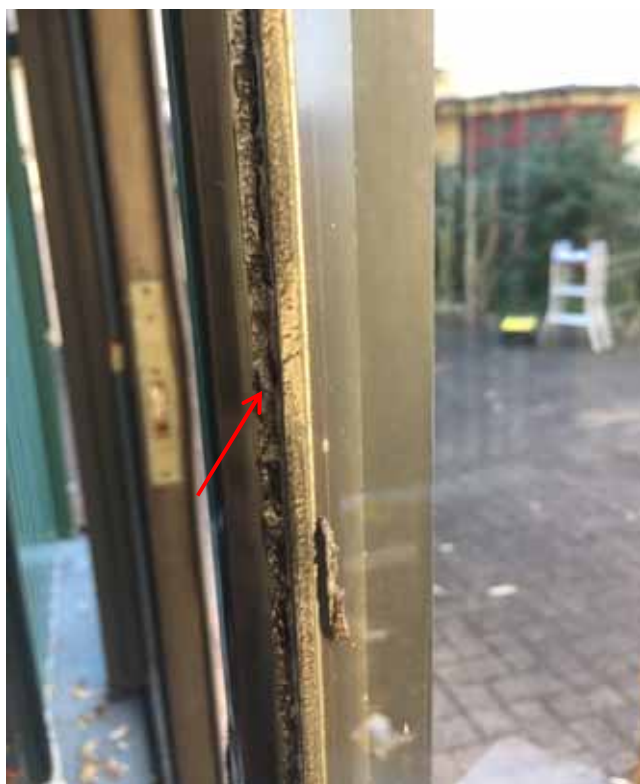
Photograph 21: Unit 3, window frames, glazing putty (asbestos).

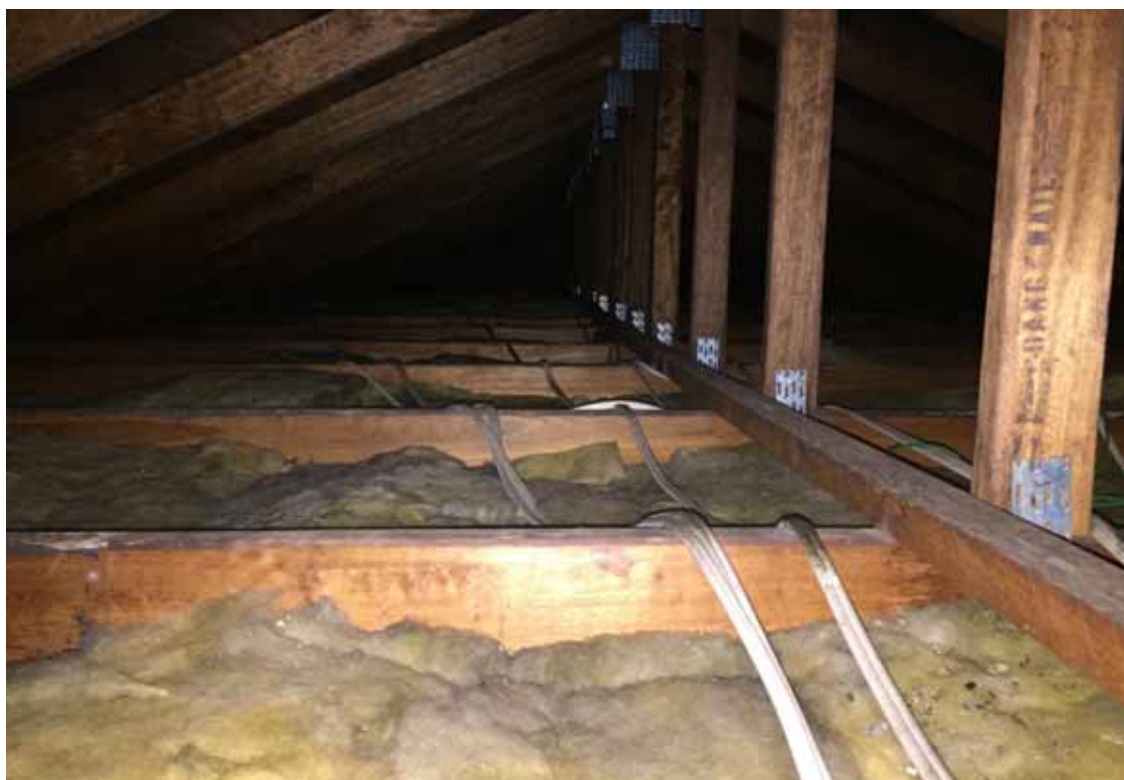
Photograph 22: Unit 3, ceiling cavity, settled dust (lead) and insulation batts (SMF).

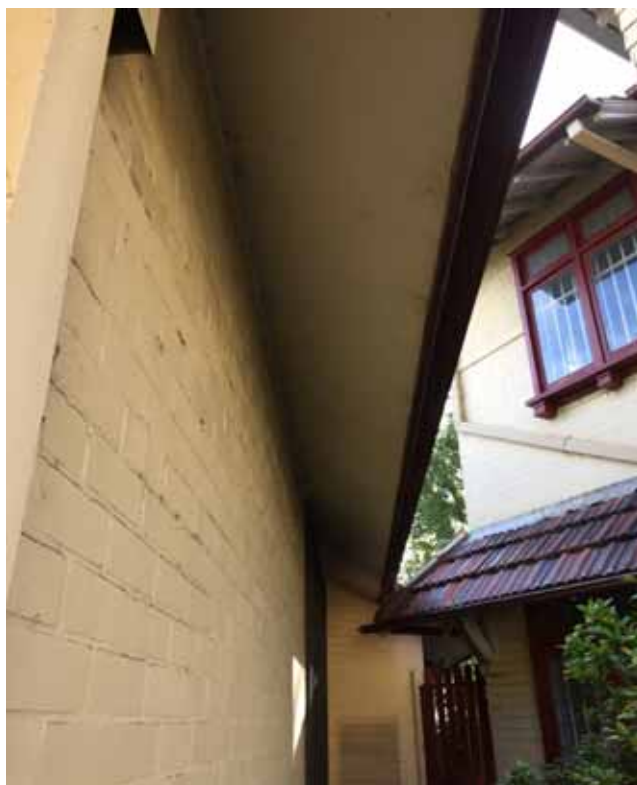
Photograph 23: Unit 2, eaves, fibre cement sheeting (asbestos).

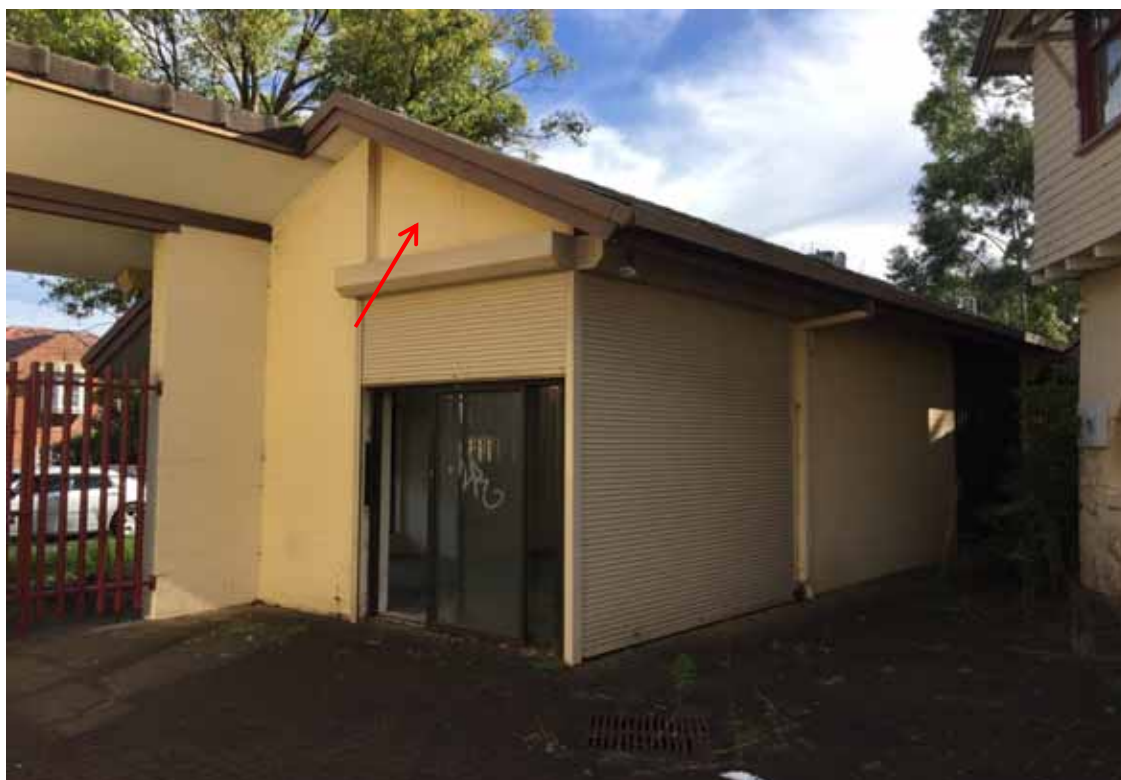
Photograph 24: Unit 2, gable and head linings (assumed asbestos).

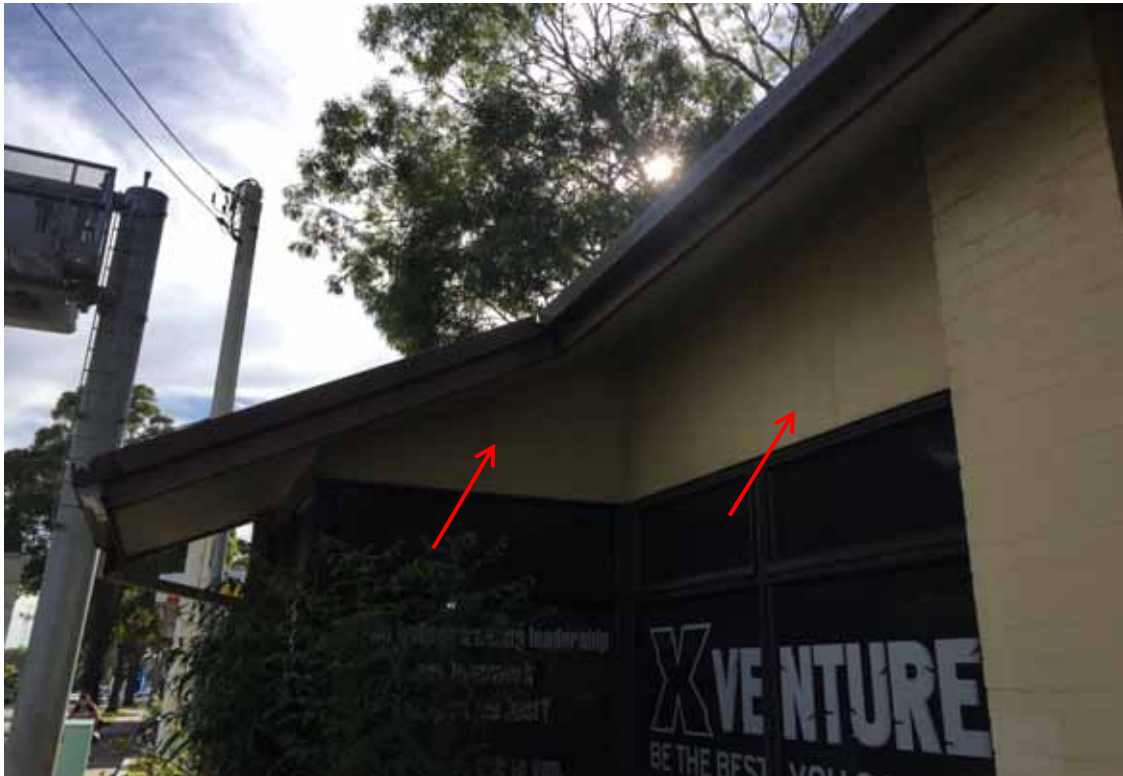
Photograph 25: Unit 2, gable and head linings (assumed asbestos).

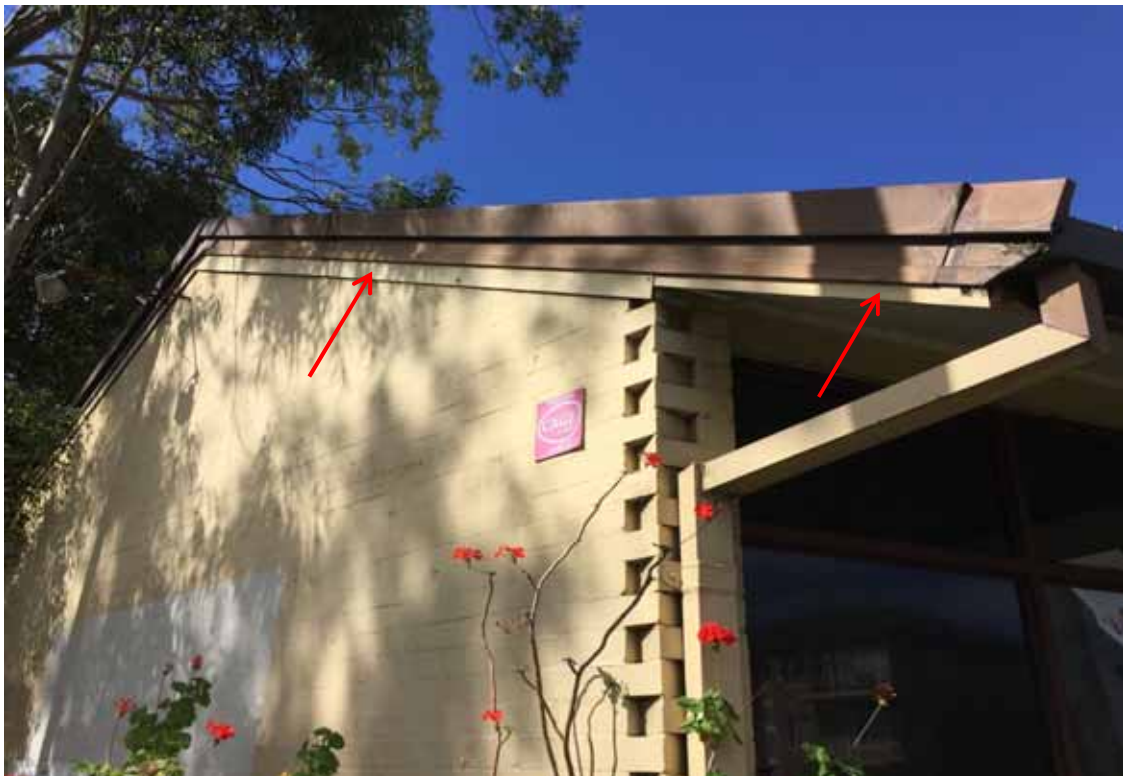
Photograph 26: Unit 2, gable ends, linings at base of metal bargeboard (assumed asbestos).

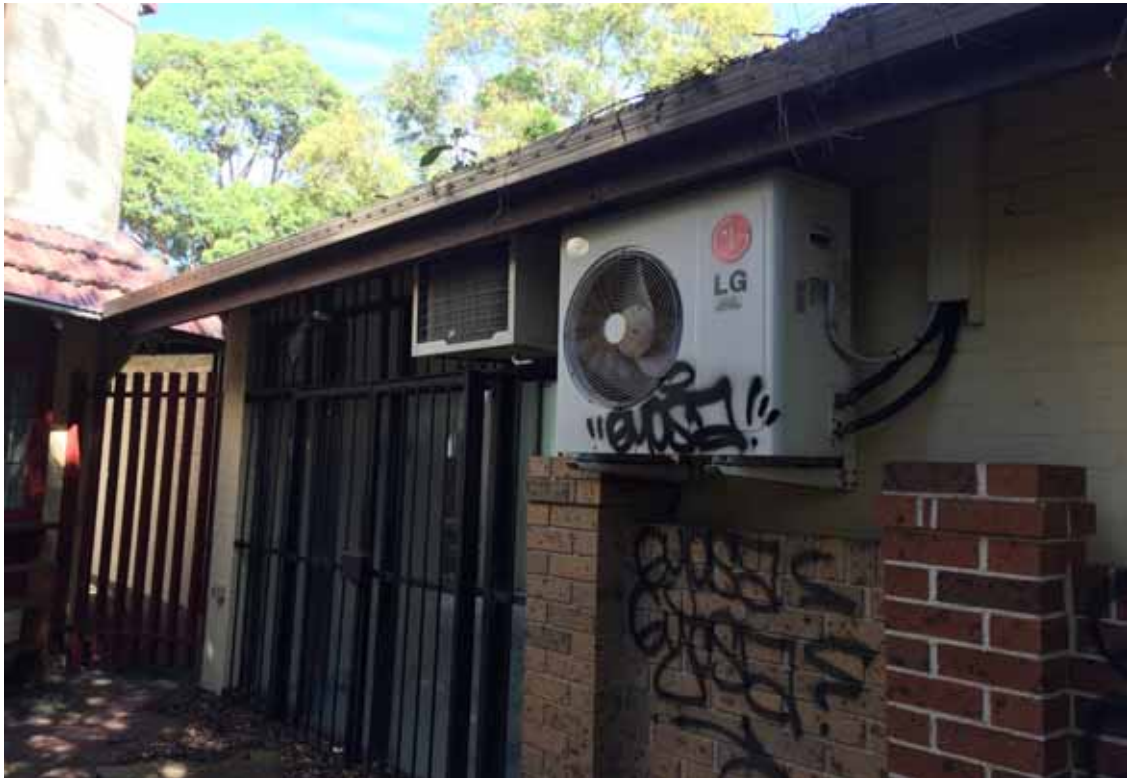
Photograph 27: Unit 2, air-conditioning units, internal insulation (assumed SMF).
