# ROAD SAFETY AUDIT

## EXISTING ROAD

Wilsons Creek Road / Alidenes Road Intersection  
at Wilsons Creek

August 2018

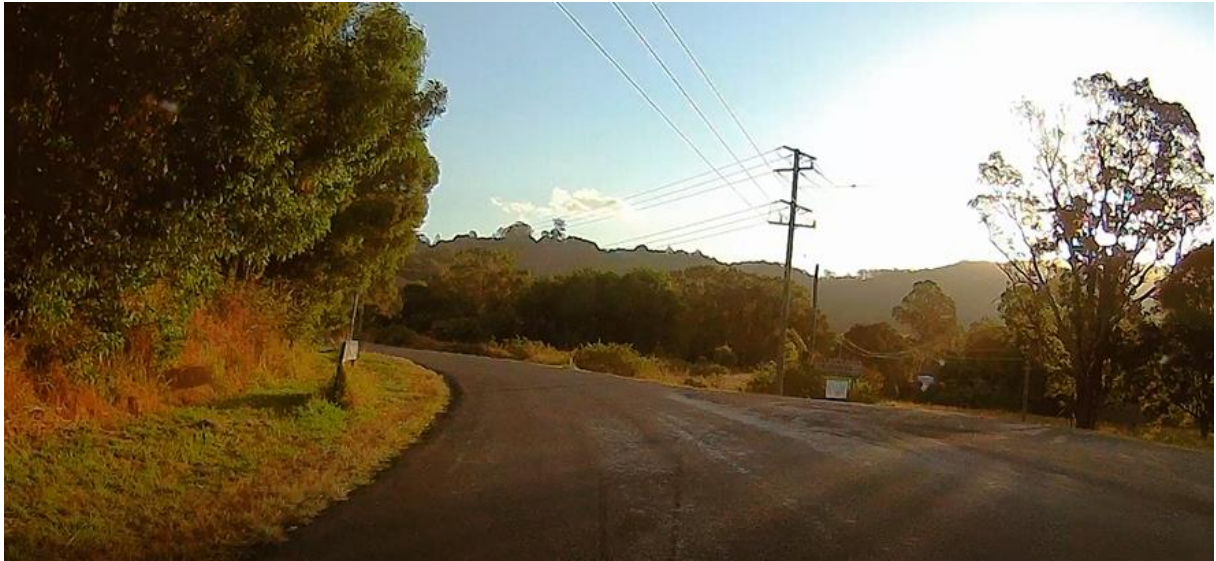
Severity:	Serious
		Risk:	High
03	<p><b>No line marking or guide posts in intersection</b></p> <p>There is no centre or edge line marking and no guide posts in the intersection.</p> <p>The lack of line marking and guide posts leads to poor delineation through the intersection.</p> <p>There is a risk that vehicles could stray to the incorrect side of the road whilst negotiating the bend or slowing to turn, and collide with oncoming or turning traffic.</p> <p>Refer to Photo No. 1.</p>	Frequency:	Occasional
		Severity:	Serious
		Risk:	High

**Photo No. 1: Lack of line marking and signage**

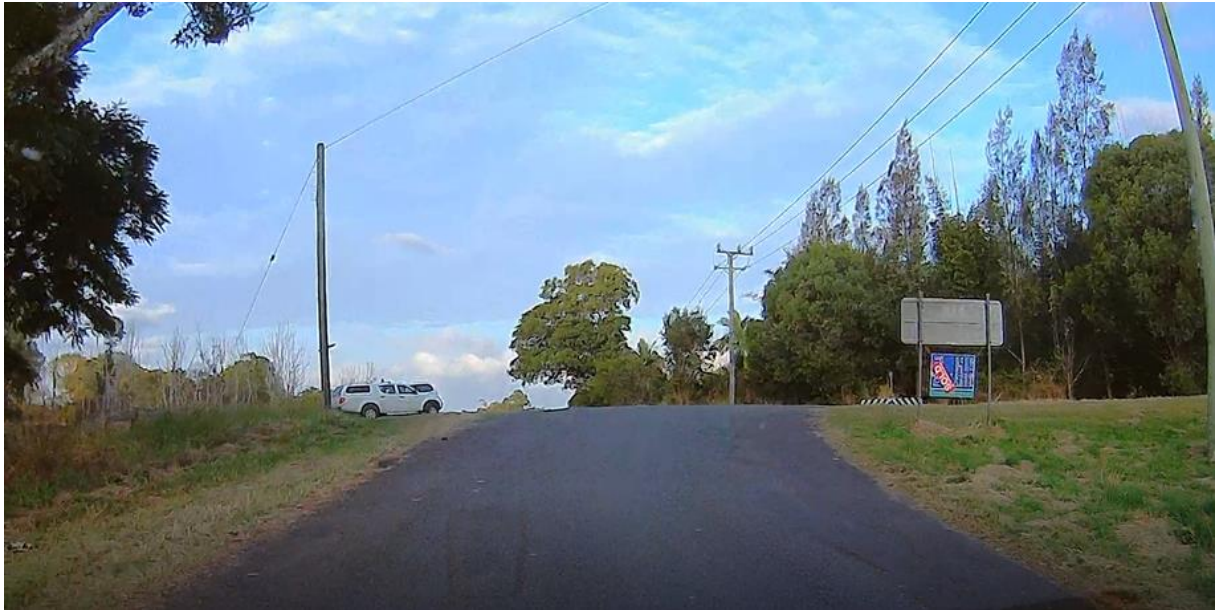
**Photo No. 3: Lack of 'Give Way' and/or 'Stop' signs and markings;  
poorly located hazard marker sign**

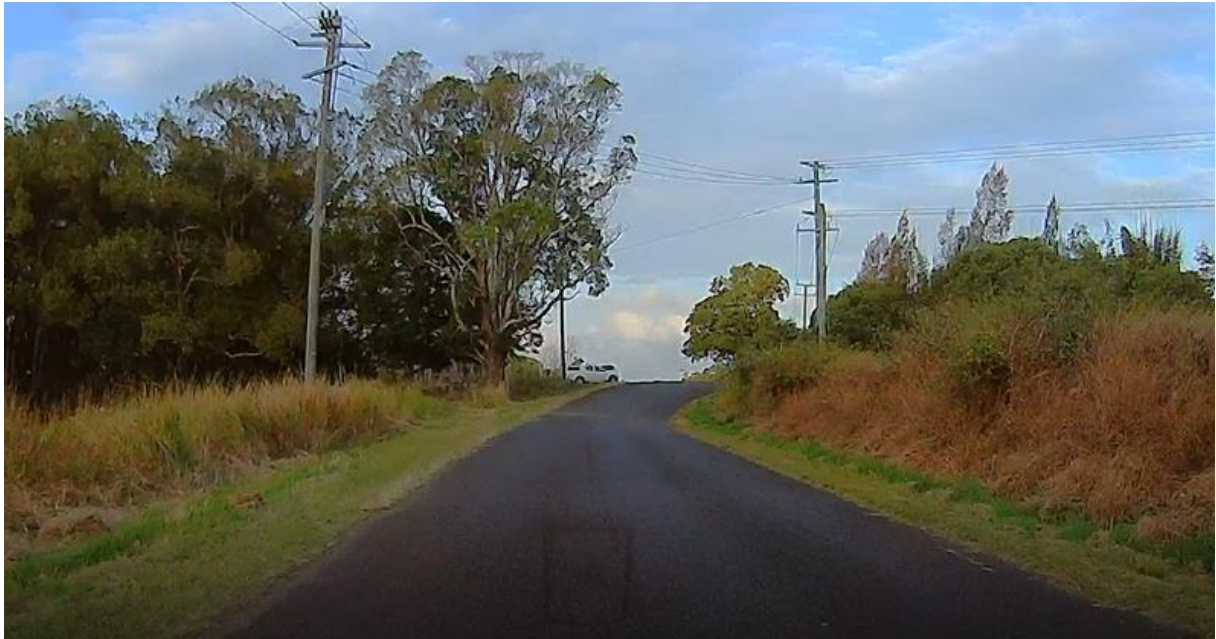
06	<p><b>Location of end of road hazard marker</b></p> <p>The bi-directional hazard marker opposite the intersection is poorly situated.</p> <p>Due to the angle of approach, the hazard marker appears to be offset to the right. At the time of the inspection, the sign was also obscured by signage on the northern side of the road. An approaching driver will not be clearly informed as to the intersection layout.</p> <p>There is a risk that vehicles could brake suddenly and lose control and collide with another vehicle.</p> <p>Refer to Photo No. 3.</p>	<p>Frequency: Improbable</p> <p>Severity: Serious</p> <p>Risk: <b>Medium</b></p>
07	<p><b>Alidenes Road – intersection alignment</b></p> <p>Alidenes Road intersects with Wilsons Creek Road at an acute angle. The first 30-40m is a steep grade on a curve.</p> <p>This makes it difficult for drivers to look west and check the line of sight. Drivers wishing to turn left into Alidenes Road would find it very difficult due to the alignment (particularly heavy vehicles). Drivers turning into or out of Alidenes Road tend to "cut the corner", thereby increasing the risk of an accident. Drivers approaching along Alidenes Road could be confused as to the road alignment.</p> <p>There is a risk that turning vehicles could cross into the wrong lane or lose control, and collide with another vehicle and/or a roadside hazard.</p> <p>Refer to Photo Nos. 4, 5 and 11(night).</p>	<p>Frequency: Occasional</p> <p>Severity: Serious</p> <p>Risk: <b>High</b></p>

**Photo No. 5: Poor intersection alignment – approach from Alidenes Road.  
Intersection is offset to the right of the photo behind the power poles**

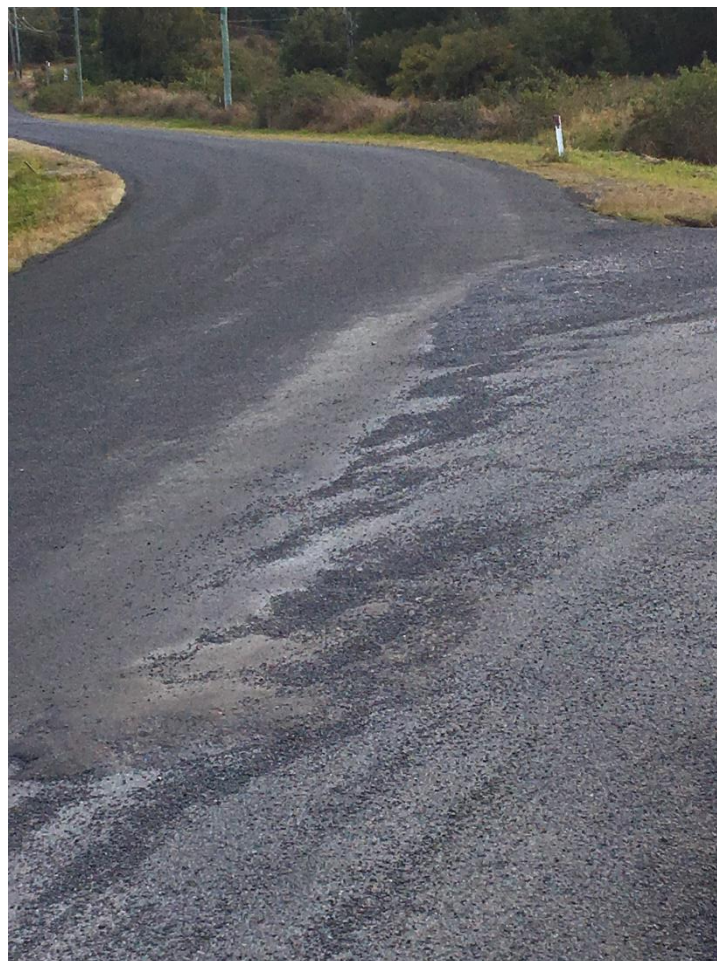
08	<p><b>Gravel on road</b></p> <p>There is a large gravel area on the north-east corner of the intersection.</p> <p>Drivers turning into or out of Alidenes Road tend to “cut the corner” (across the gravel area). As a result, there is loose gravel in the through lanes, and on the outside of the bend.</p> <p>There is a risk that vehicles could lose control in the loose gravel, and collide with another vehicle and/or a roadside hazard.</p> <p>Refer to Photo Nos. 6 and 7.</p>	<p>Frequency: Occasional</p> <p>Severity: Serious</p> <p>Risk: <b>High</b></p>
09	<p><b>Sight distance from the east on Wilsons Creek Road</b></p> <p>Approach sight distance from the east is sub-standard.</p> <p>Approaching drivers cannot see approaching traffic from the west until they are in the intersection. The Alidenes Road intersection (and Alidenes Road itself) is also not clearly visible in the approach.</p> <p>There is a risk that vehicles could collide with vehicles turning into or out of the intersection, or enter the intersection too fast and lose control, colliding with oncoming traffic and/or a roadside hazard.</p> <p>Refer to Photo No. 4 and 12 (night).</p>	<p>Frequency: Occasional</p> <p>Severity: Serious</p> <p>Risk: <b>High</b></p>

**Photo No. 6: Loose gravel on road**

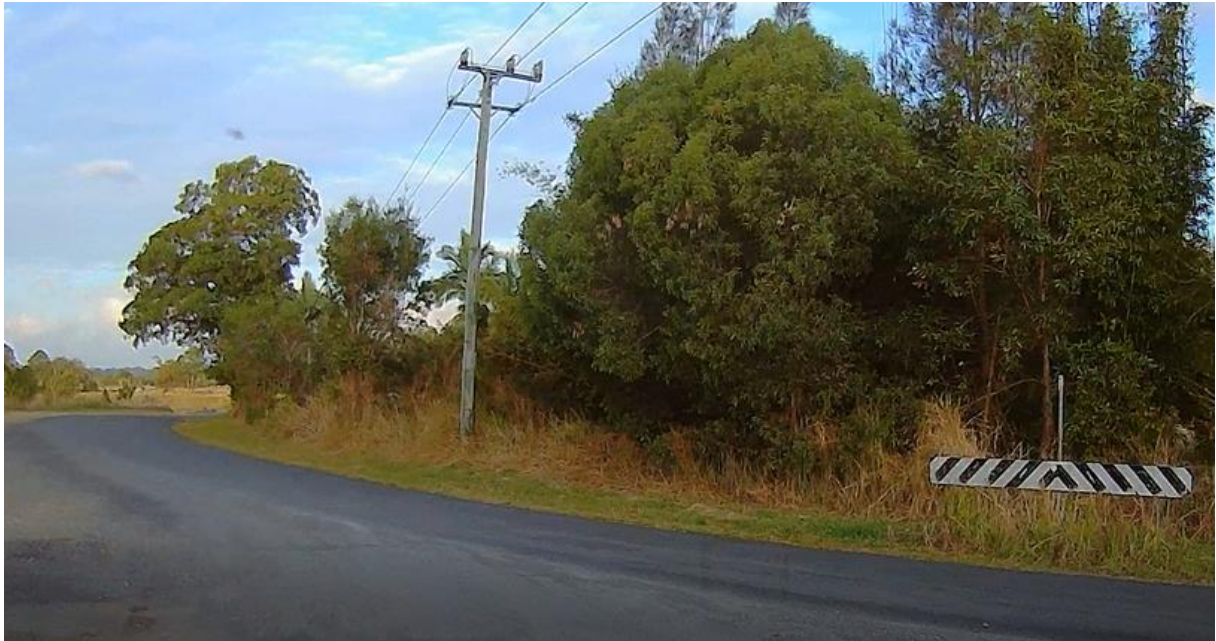
**Photo No. 7: Sub-standard sight distance to the east.  
Note the large gravel area to the left of the photo**

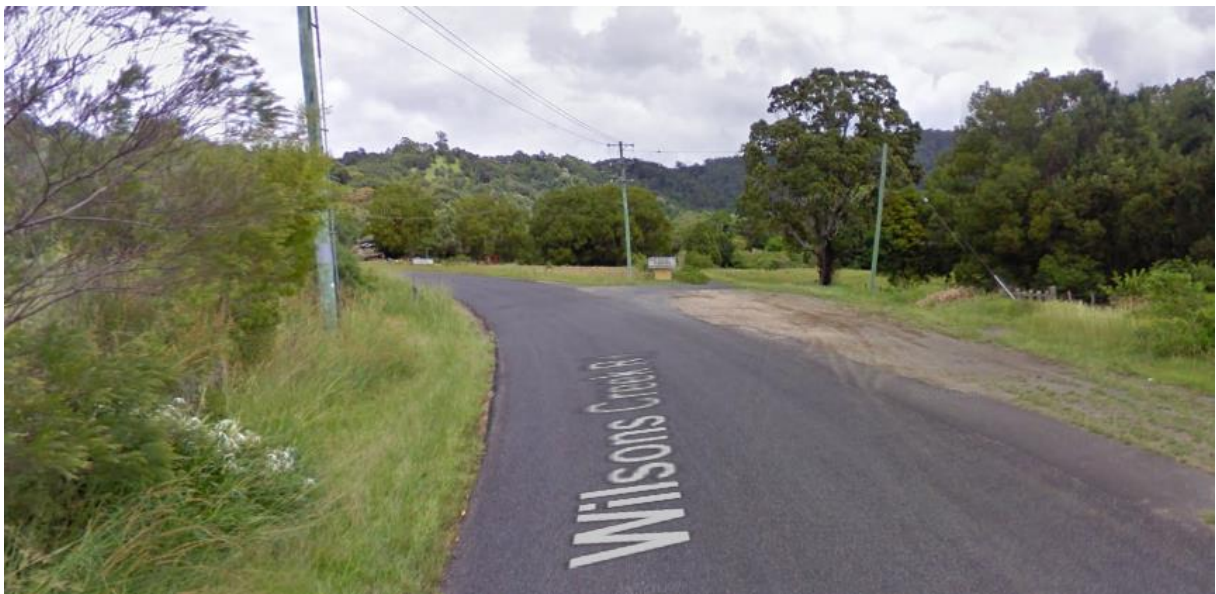
**Photo No. 8: Power pole near intersection (middle of photo)**  
(Photo from Google Street View)

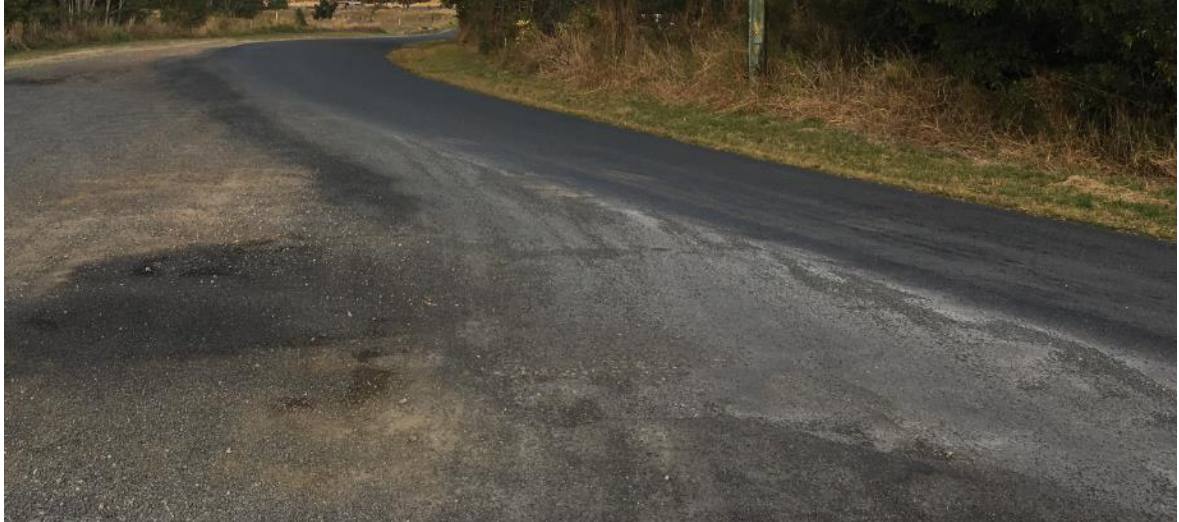
12	<p><b>Condition of road surface</b></p> <p>The existing bitumen surface on Alidenes Road at the intersection is in poor condition, with some potholes, patches and broken edges.</p> <p>There is a risk that vehicles could lose control due to the road surface condition, and collide with another vehicle and/or a roadside hazard.</p> <p>Refer to Photo No. 9.</p>	<p>Frequency: Improbable</p> <p>Severity: Minor</p> <p>Risk: <b>Low</b></p>
13	<p><b>Bus drop-off location</b></p> <p>During the site audit, a school bus was observed dropping off passengers in the gravel area on the north-east corner of the intersection. The bus approached from the east, crossed Wilsons Creek Road, and stopped. Passengers alighted from the left of the bus towards Wilsons Creek Road. The bus then continued west.</p> <p>The bus manoeuvres and the passengers alighting towards the roadway are both considered unsafe.</p> <p>There is a risk that the bus could collide with through or turning traffic, or an alighting passenger could be impacted by a vehicle.</p> <p>Refer to Photo No. 7.</p>	<p>Frequency: Improbable</p> <p>Severity: Serious</p> <p>Risk: <b>Medium</b></p>

**Photo No. 9: Condition of road surface**

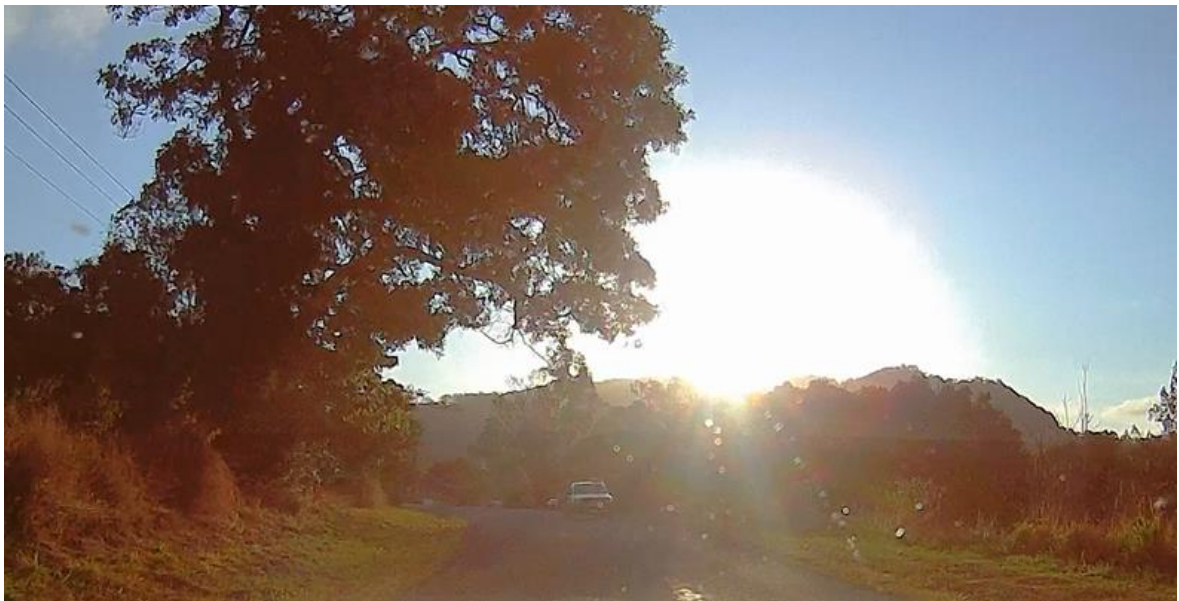
14	<p><b>Setting sun</b></p> <p>The setting sun reduces visibility of the intersection in the afternoon.</p> <p>An approaching driver may be blinded by the sun and not see the intersection or turning vehicles.</p> <p>There is a risk that vehicles could stray into the wrong lane and collide with an oncoming or turning vehicle.</p> <p>Refer to Photo No. 10</p>	<p>Frequency: Improbable</p> <p>Severity: Serious</p> <p>Risk: <b>Medium</b></p>

**Photo No. 10: Setting sun**

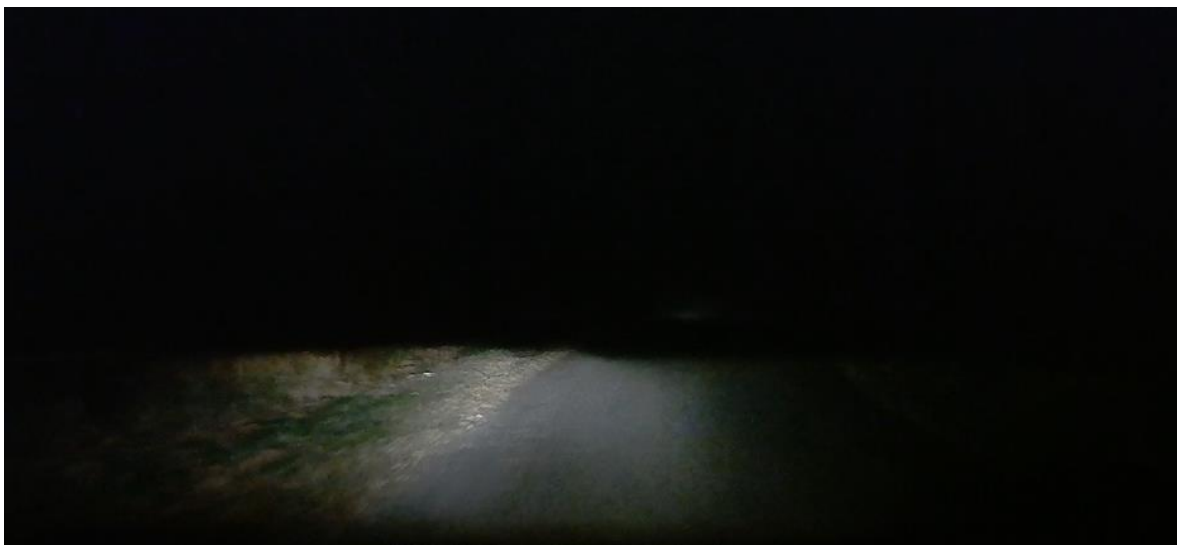
**Photo 11: Alidene Road at intersection – night approach – low beam**

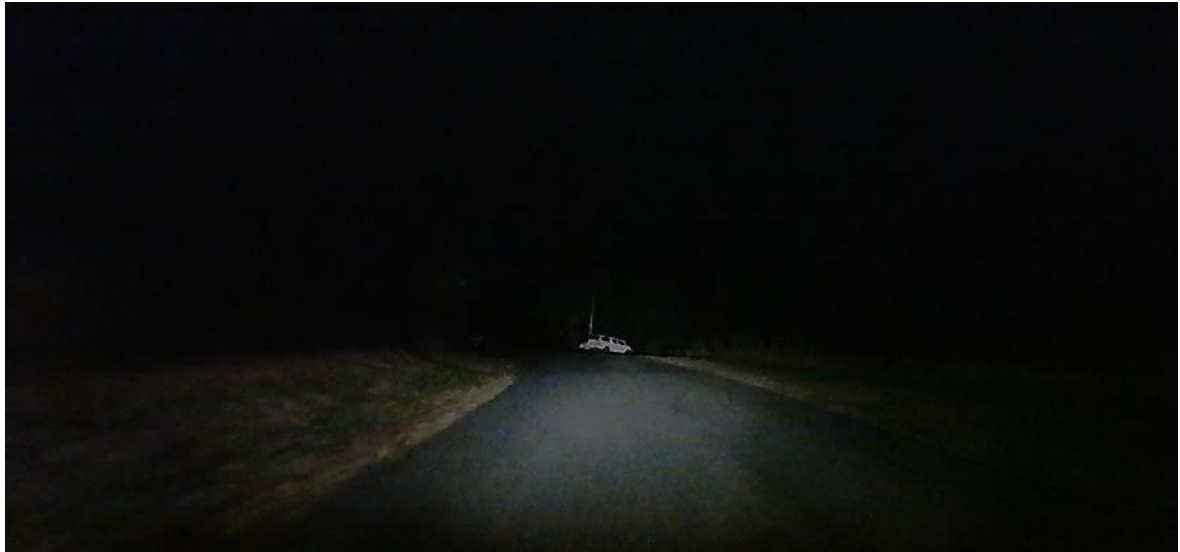
**Photo 12: Eastern approach to intersection – night time – high beam.  
Note lack of definition of intersection  
(intersection just beyond parked cars)**
