ARBORICULTURAL IMPACT ASSESSMENT REPORT

**58 – 76 Stanmore Road
Stanmore**

The Cypress Club

1st December 2021

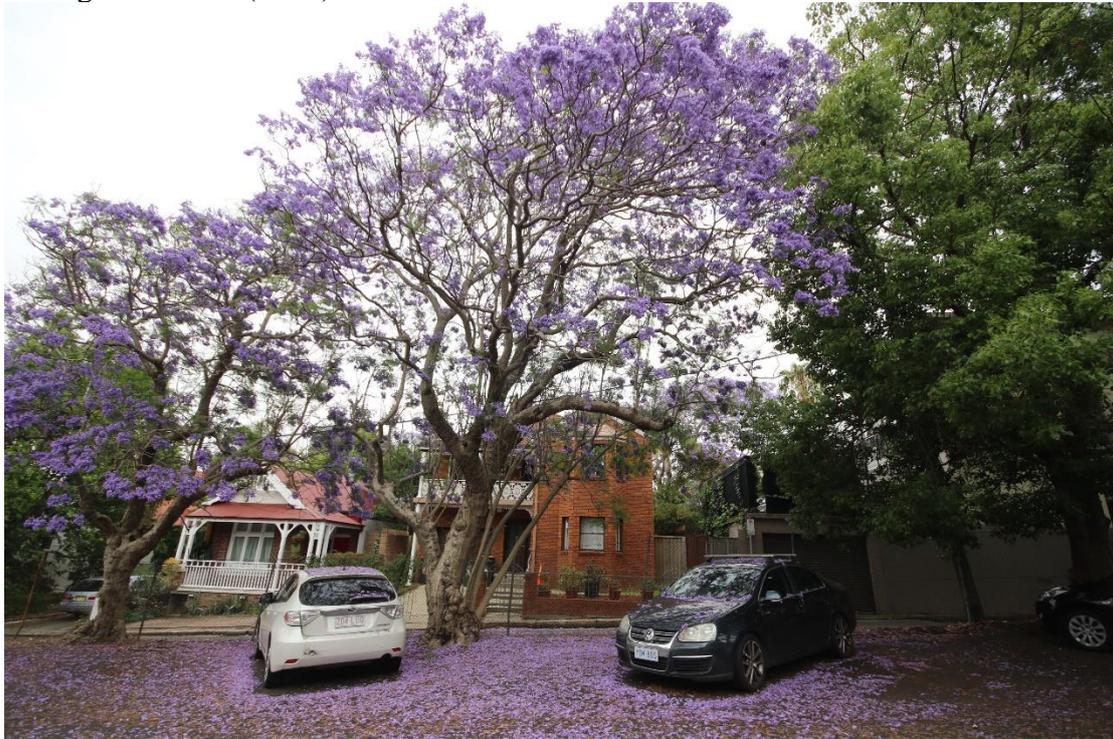
1. The following trees are located on Site along Alma Avenue: Tree 1 & 2 *Jacaranda mimosifolia* (fair to good condition but with upper canopy being pruned to provide clearance for the overhead power lines in Alma Avenue [refer plate 3], resulting in their canopies being skewered to the east including old pruning wounds and their root plates are covered in asphalt on all sides), tree 4 & 5 *Ulmus parvifolia* (good condition but with upper canopy being pruned to provide clearance for the overhead power lines in Alma Avenue [refer plate 3], resulting in their canopies being skewered to the east, plus their root plates are covered in asphalt on all sides) – refer plate 1 & 2.

The construction and associated excavations will have a detrimental impact on all these trees resulting in a loss of root mass and with the need to prune their branches to provide clearance for the new building – resulting in poor form.

Plus, the Jacaranda is an undesirable species in a public open space where falls can occur on petals that rain down in spring – refer plate 1.

Plate 1: Trees 1 & 2.

Removal of these trees is recommended. Note these trees for removal in the Tree Management Plan (TMP).

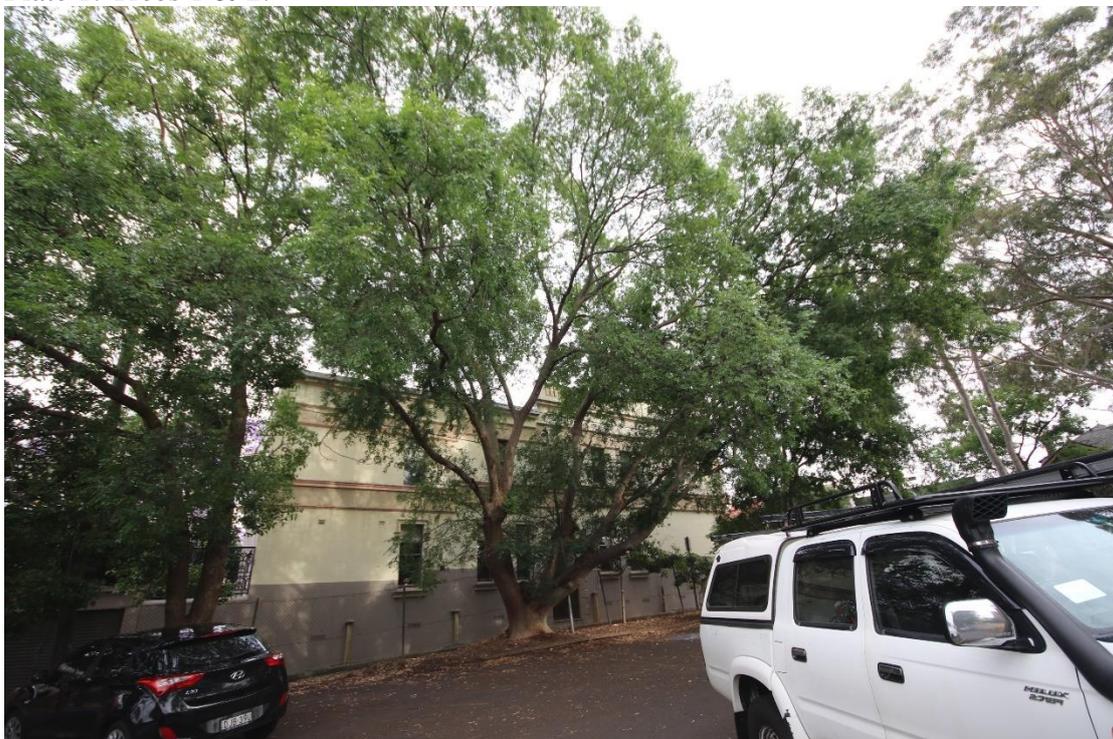
Plate 2: Trees 4 & 5.

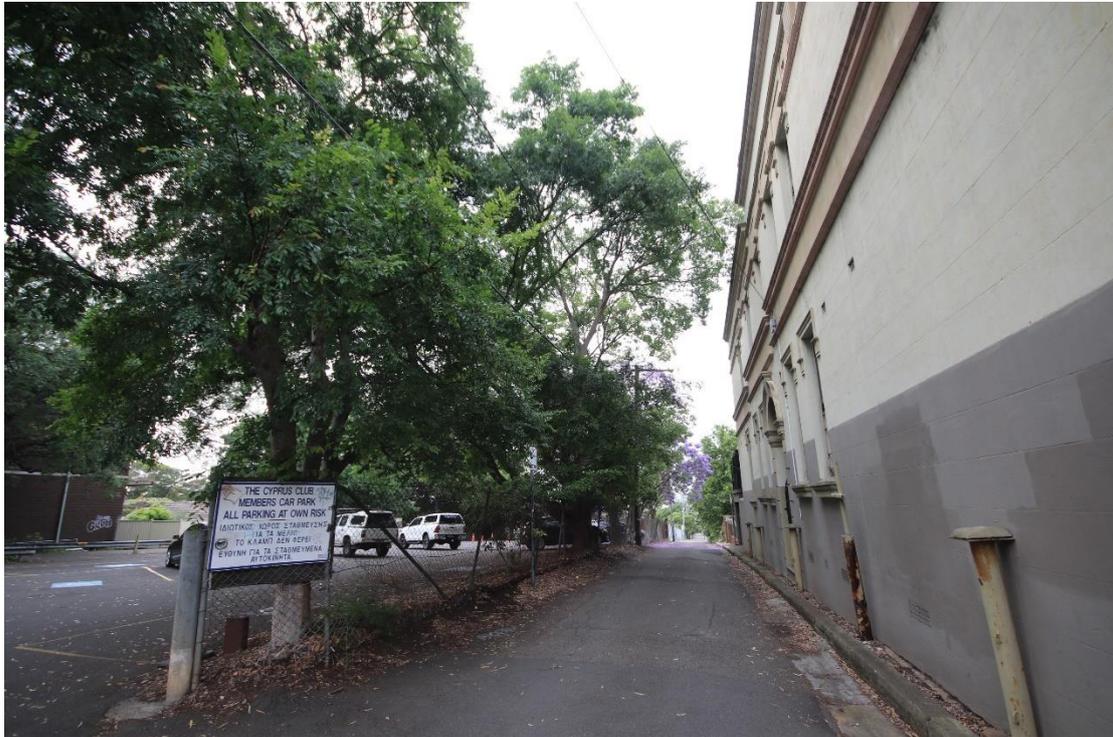
Plate 3: Trees 1 – 5 pruned to provide power line clearance in Alma Avenue.

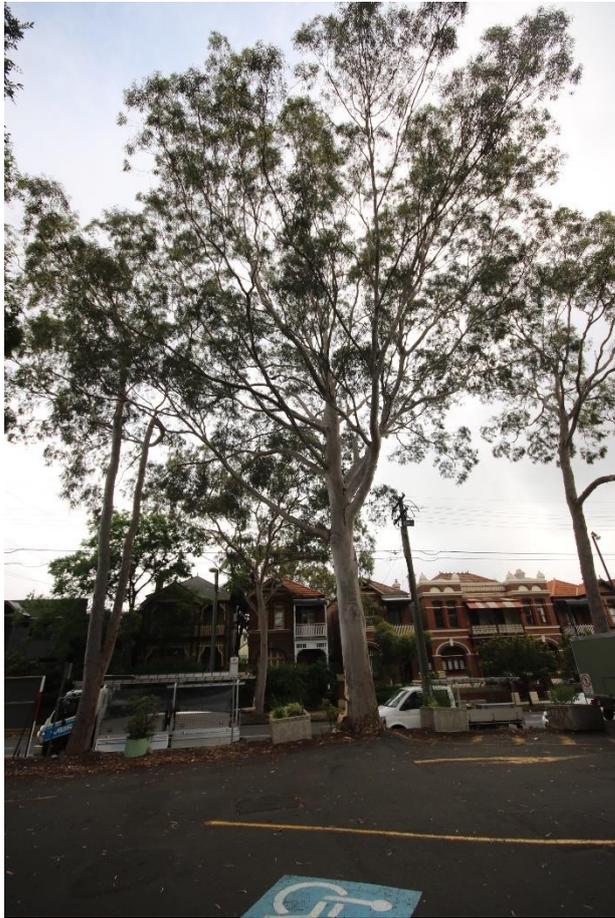
4. Trees 7, 9 & 11 *Corymbia citriodora* are showing good condition and are a prominent feature along the front of the site in Stanmore Road – refer plate 4.

The development works have been designed to have less than 10% encroachment within these trees TPZ to ensure their retention – refer Annexure C.

The removal of the surrounding asphalt will improve the environment conditions for these trees which will improve their vitality.

Plate 4: Trees 7, 9 & 11.

These trees will require trunk and protective fencing to be installed at the commencement of the development works.

Note these trees for retention in the TMP.

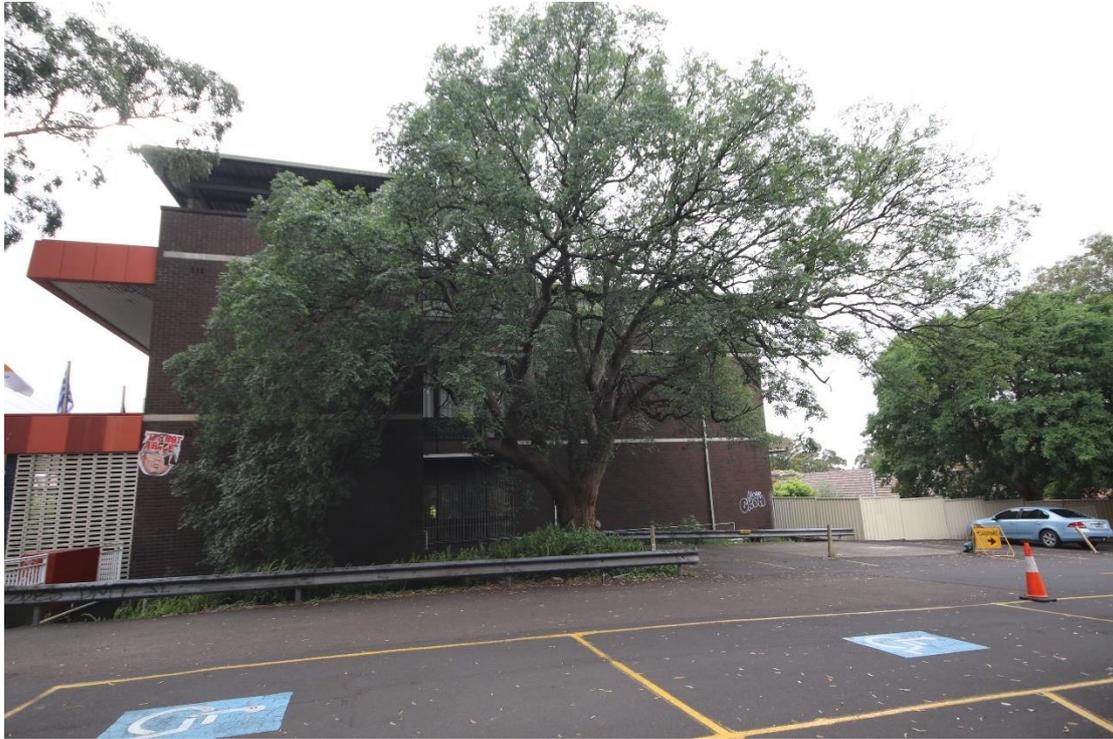
Plate 5: Tree 15

5. Tree 15 *Ulmus parvifolia* is showing good condition and is the highest retention value tree on site – refer plate 5.

The design of the development works has purposefully ensured minimal disturbance, level changes and soft landscaping around this tree.

It is acknowledged there is a new retain building to the east of this tree. However, these works are over the former Cypress Club footprint and thus will not have a detrimental impact on this tree's stability and longevity.

The removal of the surrounding asphalt will improve the environment conditions for this tree which will improve its vitality.

Note this tree for retention and protection in the TMP.

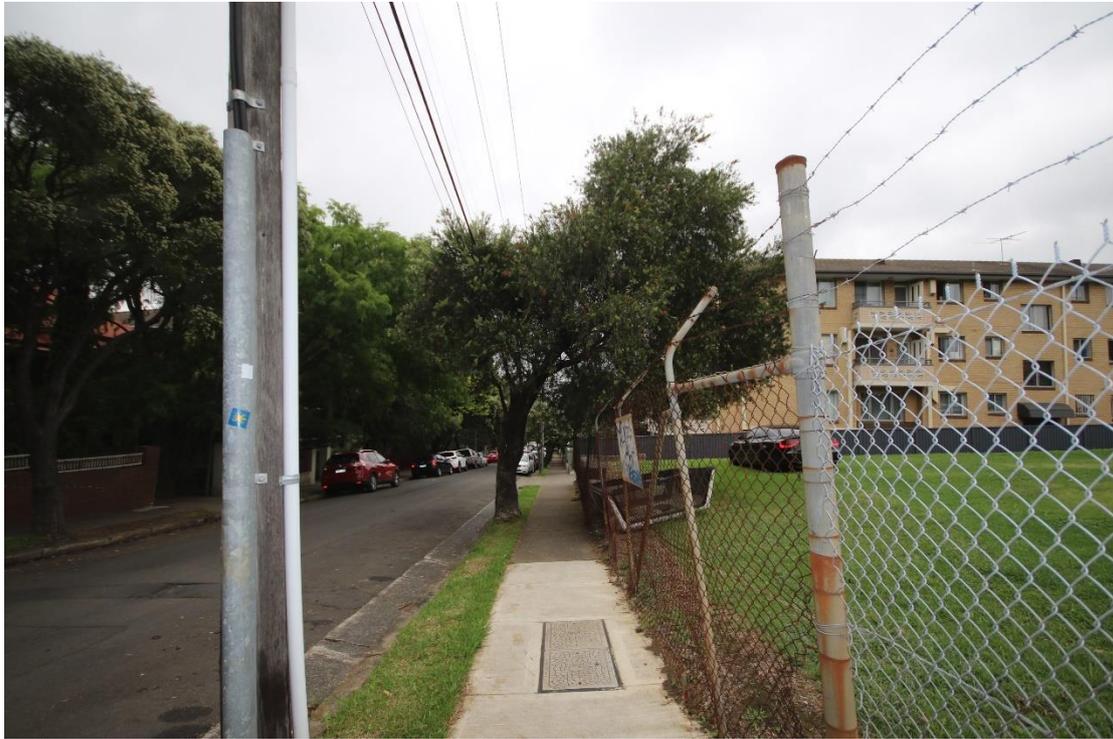
Plate 6: Tree 23.

7. The following trees are Street trees along Tupper Street: Tree 23, 25, 28, 32 *Callistemon viminalis* and tree 37 *Elaeocarpus reticulatus* are showing fair condition except for tree 37 that appears to be a recent street tree planting.

All of these trees have been topped to provide overhead clearance for the powerlines in Tupper Street (refer plate 6 – tree 23 as an example) except tree 37.

It is proposed to retain these tired street trees. N.B. It is an opportunity to place the power lines underground or use Aerial Bundling for the power lines.

Note these street trees for retention in the TMP.

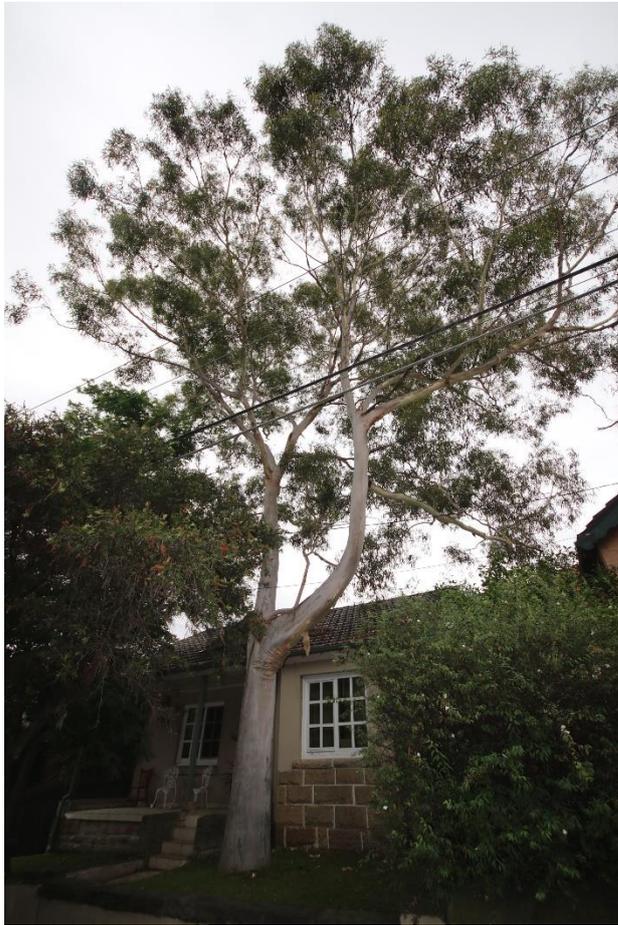
Plate 7: Tree 29

8. Tree 29 *Corymbia citriodora* shows good vitality with a strong secondary leader – refer plate 7.

It is proposed to retain this tree as the new buildings will be located over the existing building footprints, thus having little or no impact on this tree.

Minor lower branch pruning maybe required to provide clearance for the new dwellings. All pruning to be undertaken in compliance with AS 4373 – 2007 Pruning of amenity trees. N.B. The pruning is less than 10% of the live canopy ratio.

Note this tree for retention in the TMP.
