Report on
Geotechnical Investigation

Pondicherry Residential Rezoning
Pondicherry, Oran Park, NSW

Prepared for
Department of Planning and Environment
And Camden Council

Project 76778.28
August 2017

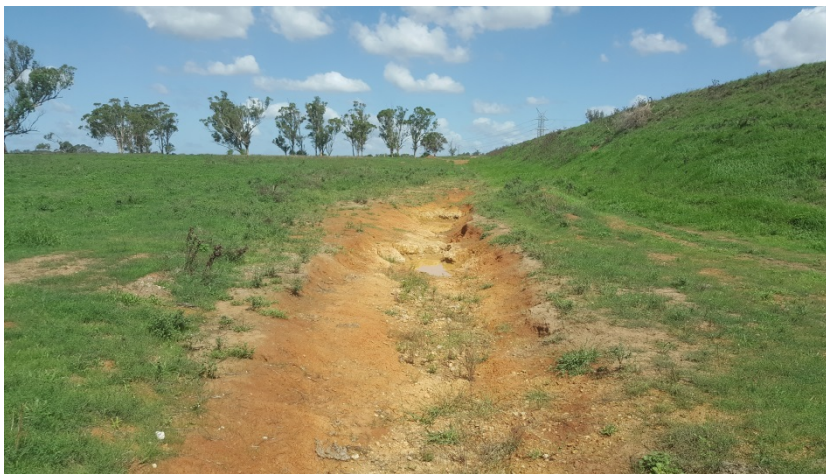
Figure 4 – Incised gully at MRP 49

- The landform is predominantly gently sloping undulating terrain of gradual topographical relief. Crests and gullies are mostly broad, although incised gullies to depths of 1 m were noted along some drainage lines (Mapping Reference Point (MRP) 49 shown in Figures 4 and MRP 72, 76);

- In general the site is considered to be stable with slopes typically less than 10 degrees;
- No areas of hillslope instability were observed during the site walkover (as was expected of such gentle relief);
- Steepened creek banks have the potential for minor instability and localised bank collapse.

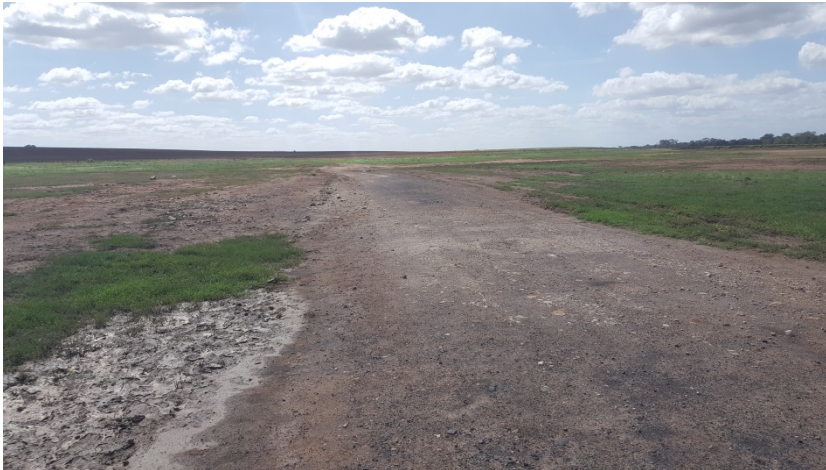
Figure 5 – Sheet erosion at MRP 41

- Sheet erosion is also locally developed where there has been disruption of the vegetation by previous development (e.g. gullies, or recent clearing) and likely large scale flows following inclement weather. An example of this type of erosion (at MRP 41, 45, 47, 49 and 76), which exposes the underlying clays, is shown in Figure 5 and is located on the southern edges of the northern large dam.

It is considered that the erosion hazard within the site would be within usually accepted bounds which may be managed by good engineering and land management practices (refer Sections 8.4 and 8.5).

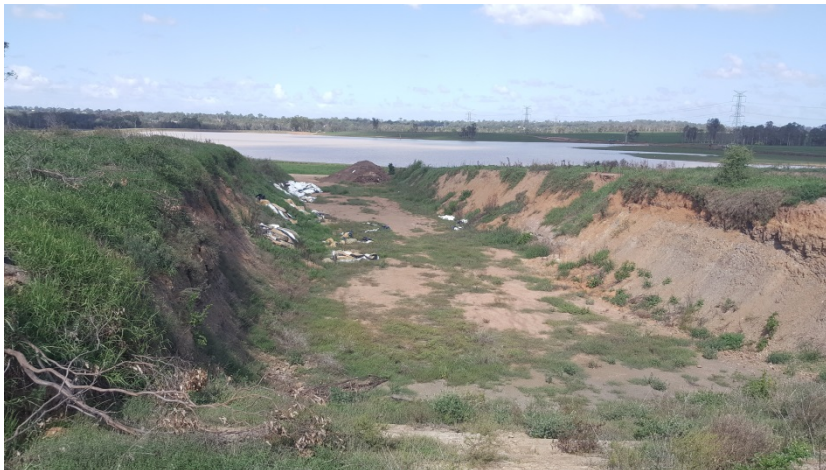
Figure 3 – Shale outcropping at MRP 56

- Soil exposures in the incised drainage lines, MRP 49, 72 and 76, (Blacktown and South Creek soil group) indicated a relatively deep topsoil profile of between 0.2 m to 0.3 m).
- Where observed topsoil was significantly organic and root affected only in the top 150 mm. Below the topsoil, the profile remained quite silty but was not significantly organic.
- Rock profiles observed in the quarry/silage area indicated a typically fine grained shale (MRP 56), refer Figure 3);
