Residential Subdivision of No. 105 Cooby Road,  
Tullimbar NSW

Report on Preliminary Geotechnical Assessment

Our Ref: TERRA18320.Rep1.Rev1

15 August 2019

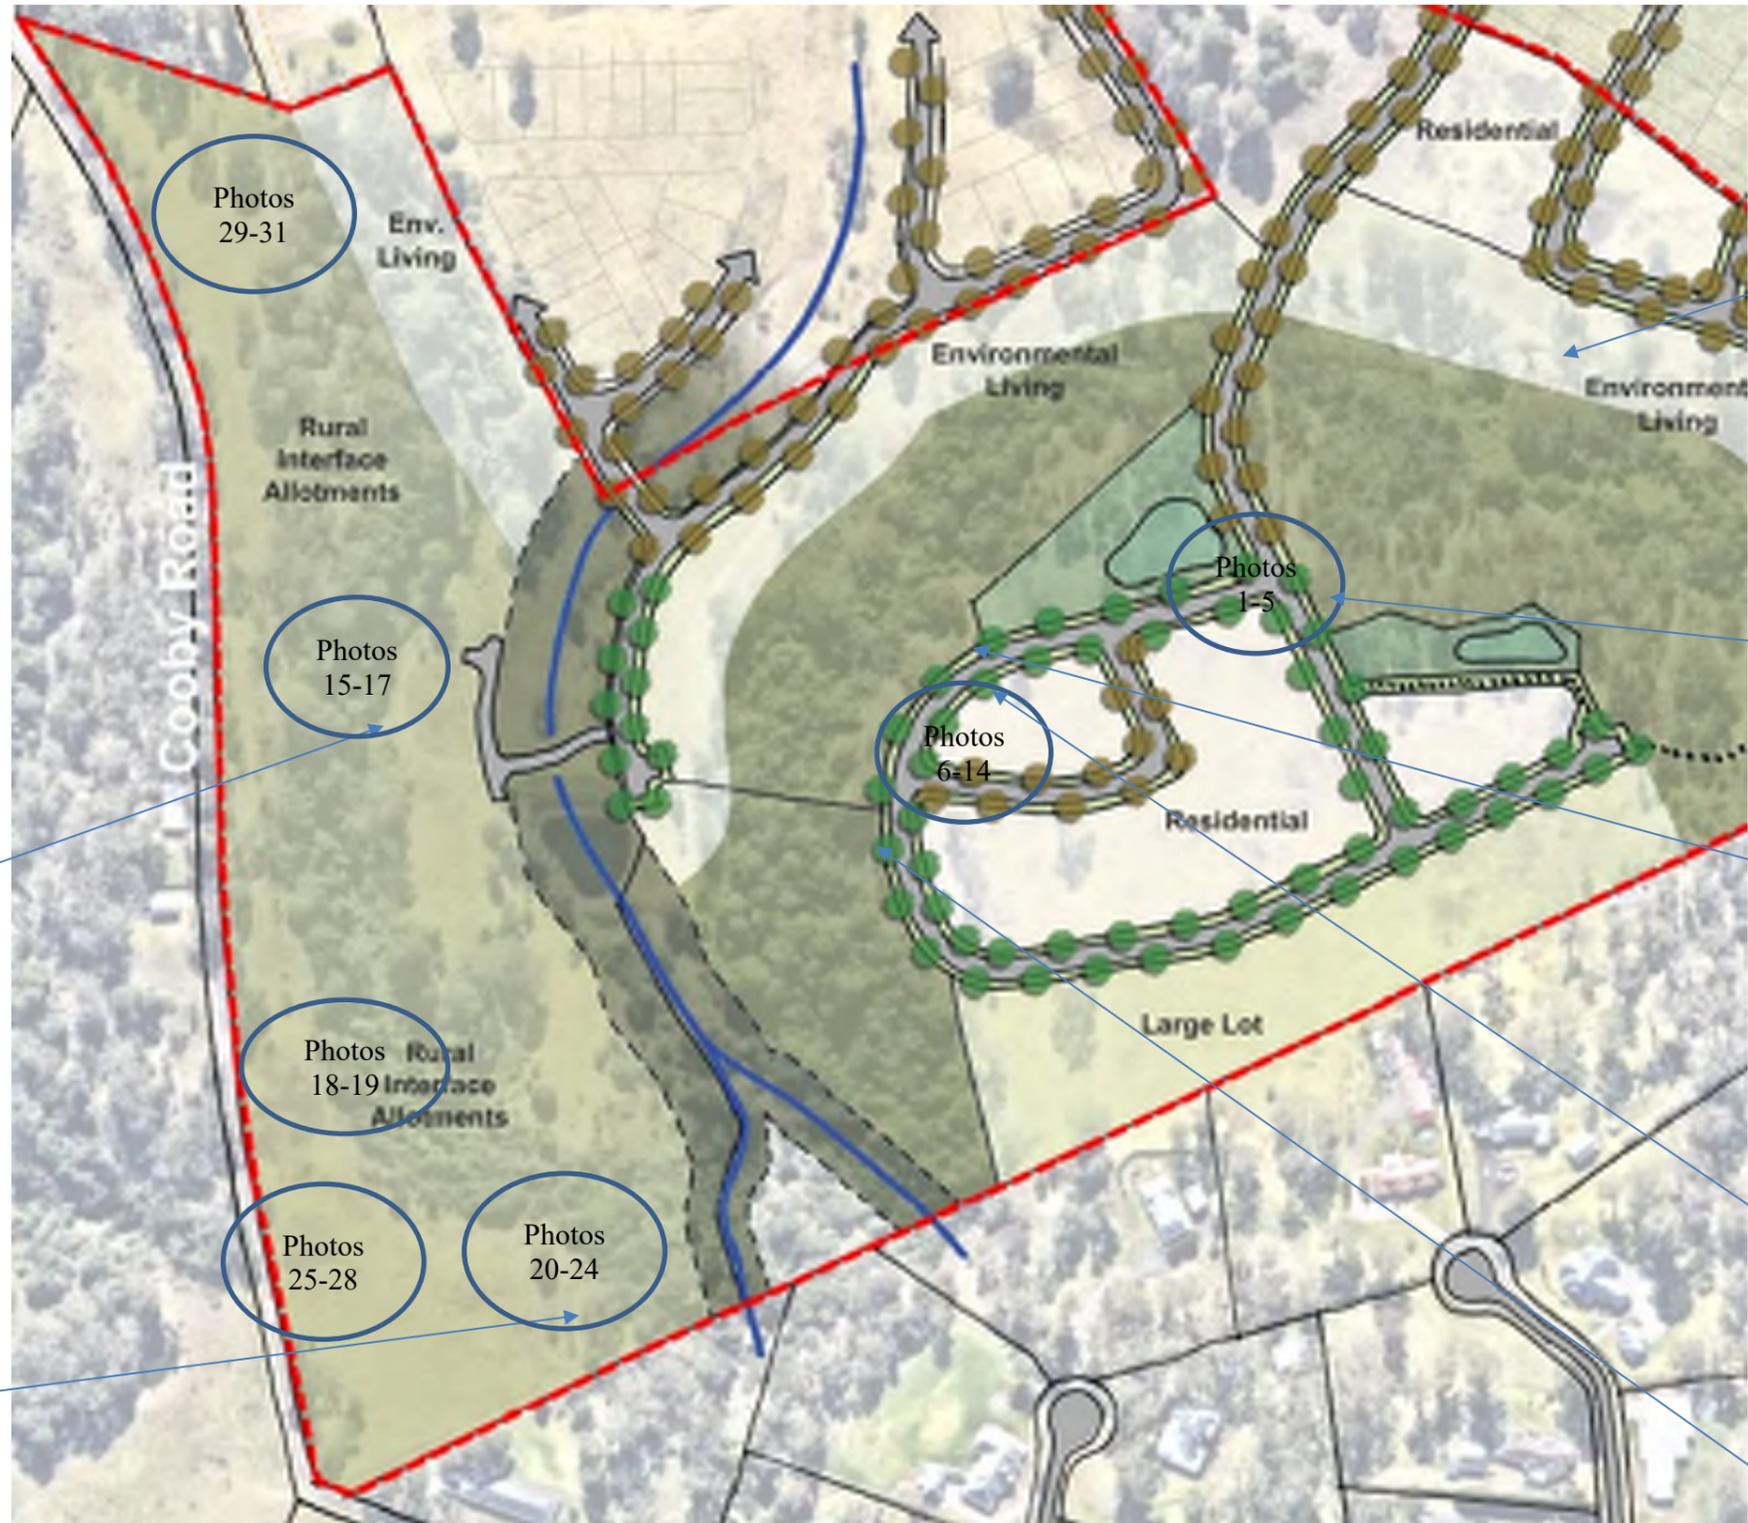
Rock outcropping (photograph 14 and 15). Steep drop off of rock along crest of slope (photograph 16)

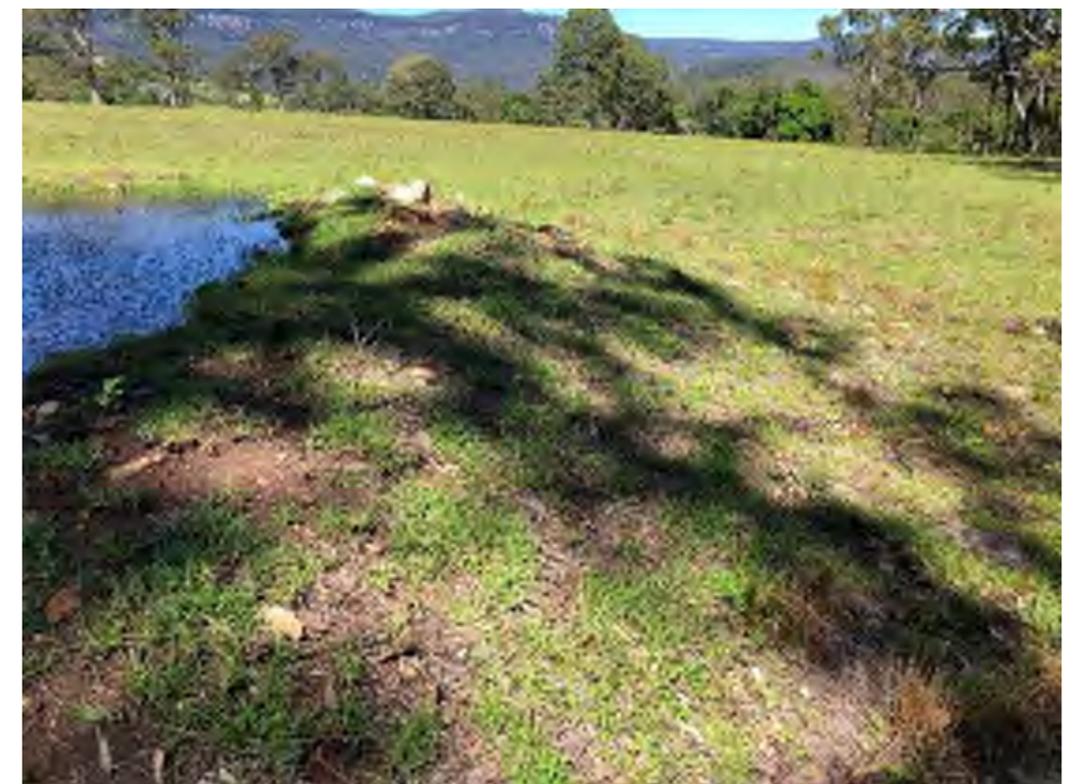
Photograph 4: looking south west at the northern wall of Dam South

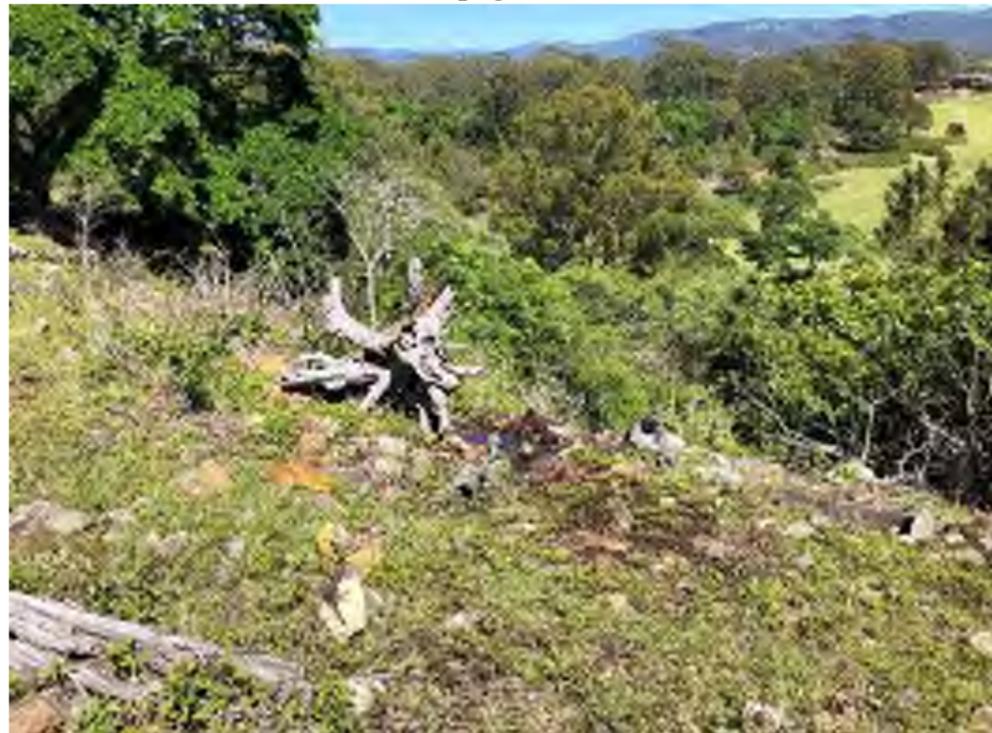
Photograph 7: looking west on the western edge of Terrace 1A, showing water and latite rock on Area 2s escarpment edge

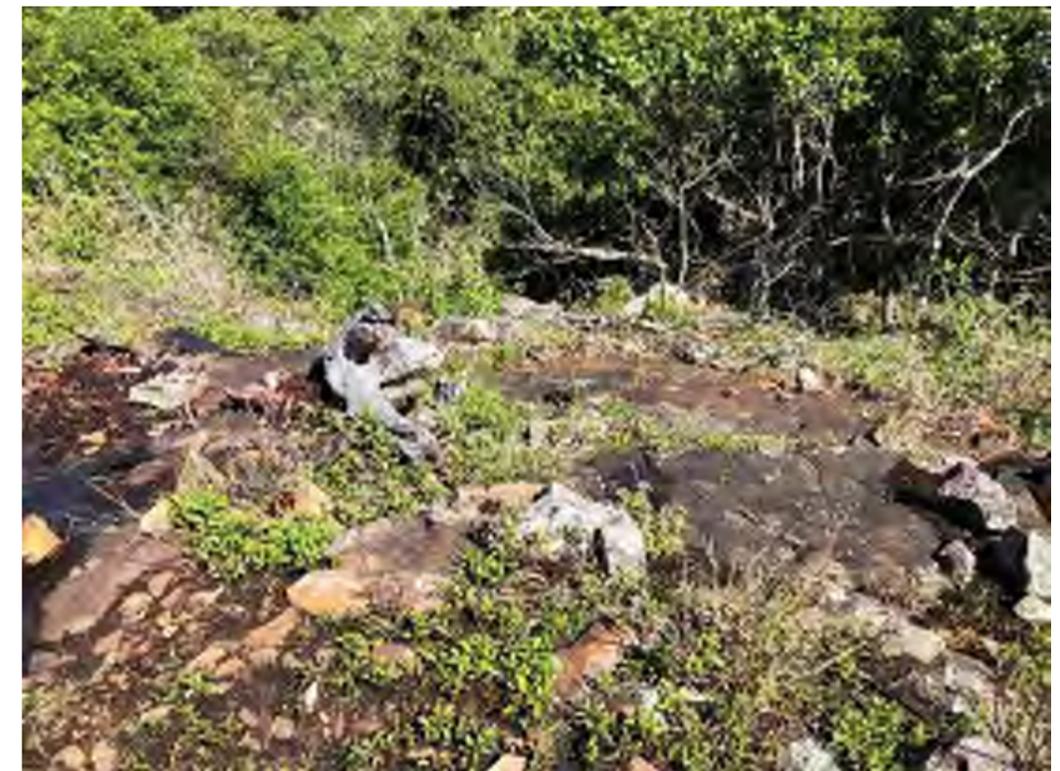
Photograph 8: Close up of photo 45 with water to the left and in-situ latite

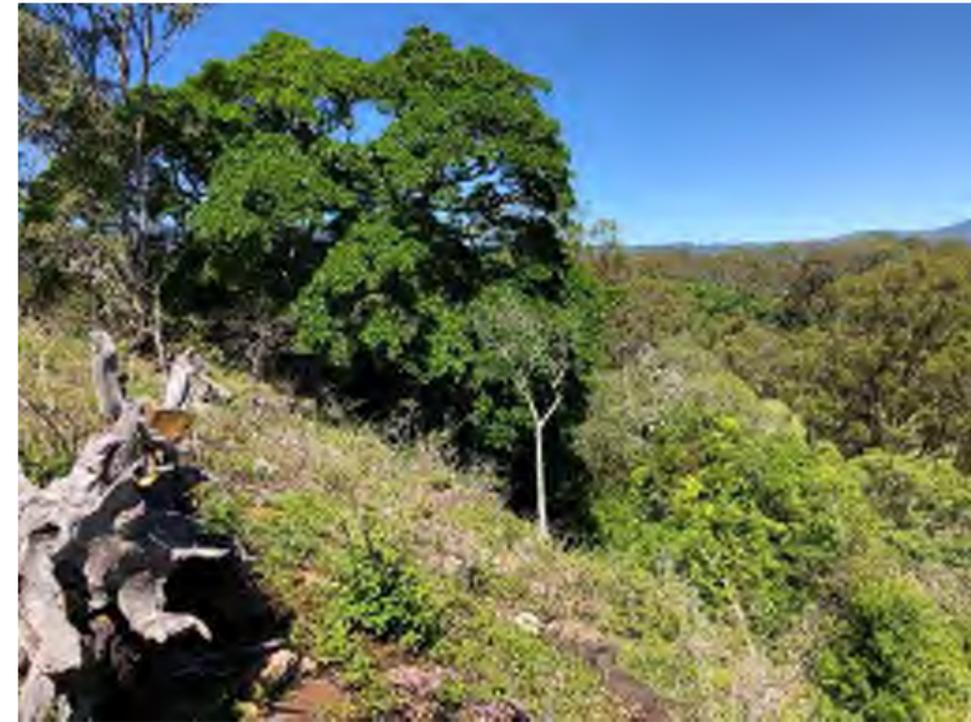
Photograph 10: View looking west from Terrace 1A showing the steep nature of Area 2

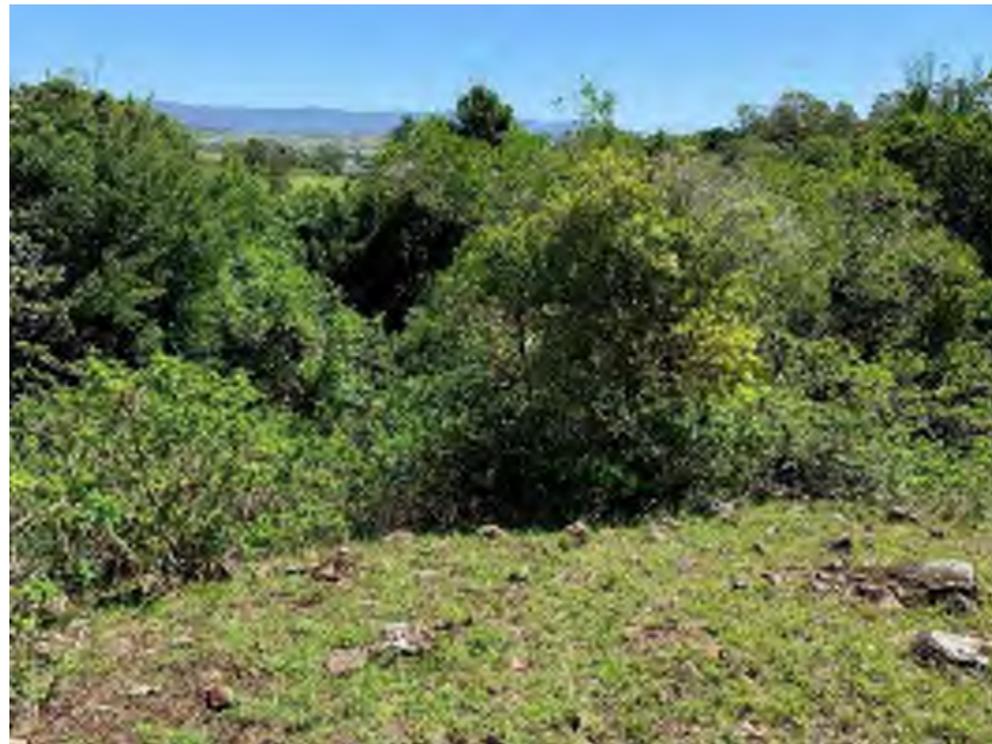
Photograph 23: View from the southern section of Terrace 1B looking north. Showing the steep drop and thick vegetation of Area 2

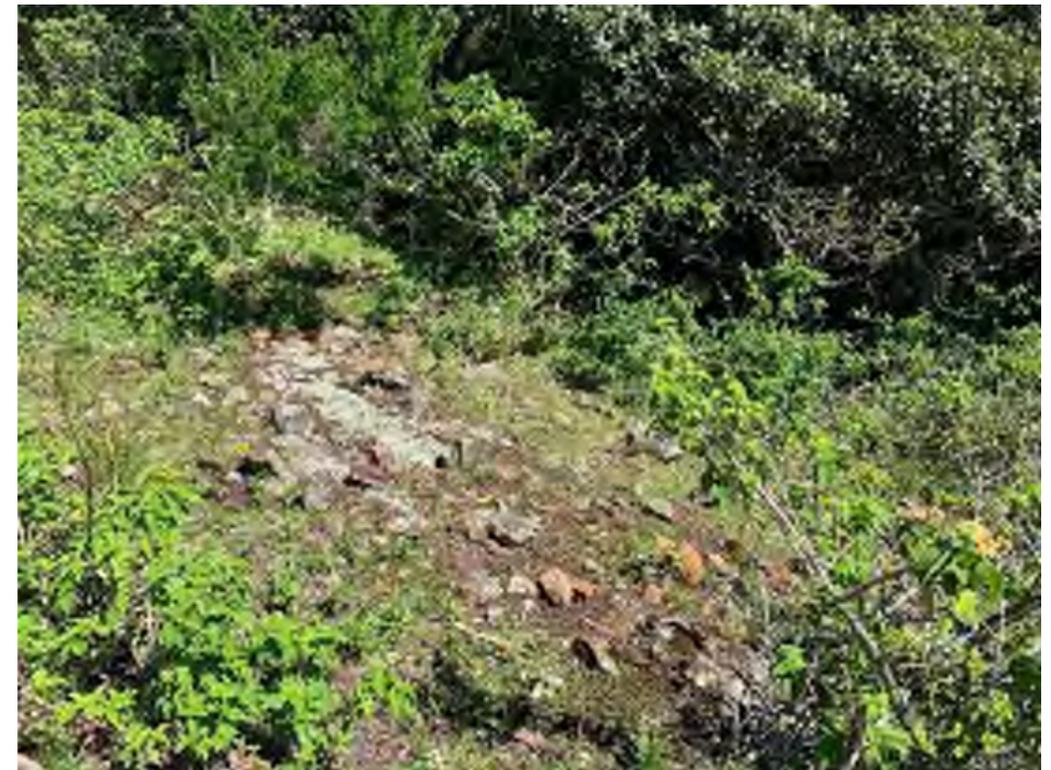
Photograph 24: Rock outcropping on the boundary of Terrace 1B and Area 2

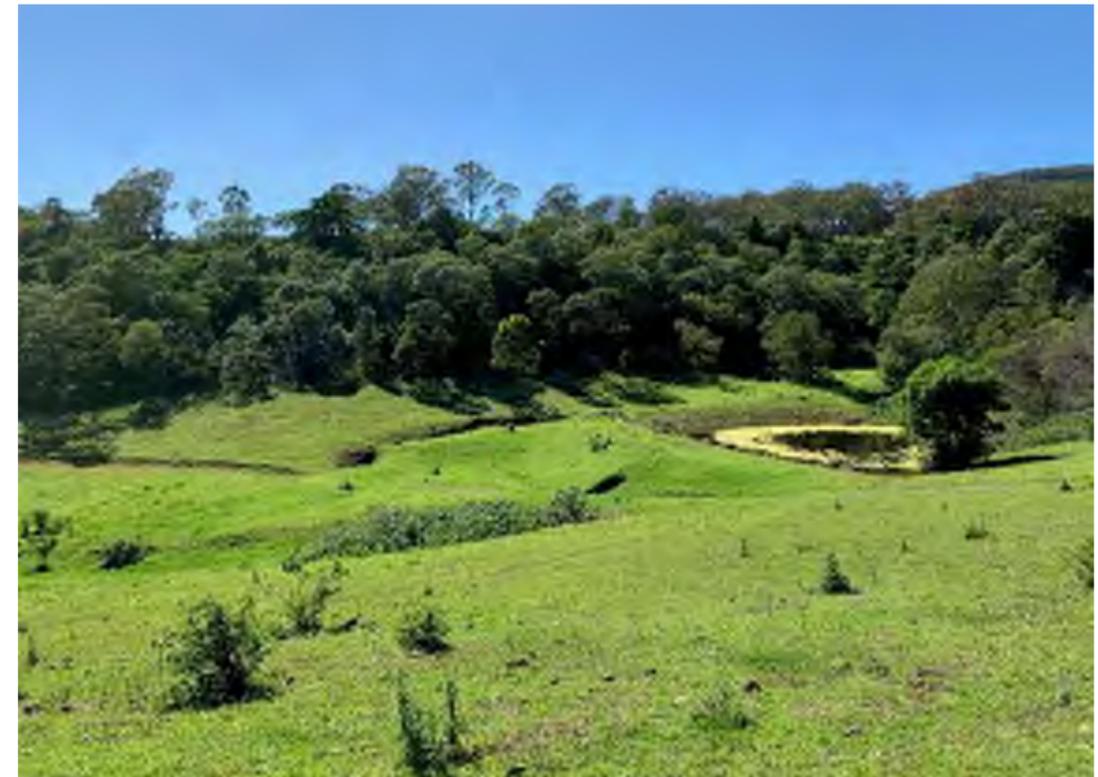
Photograph 32: View of Dam West in Area 3 looking south east. Shows the steep nature of Area 2 as it steps up to Terrace 1A

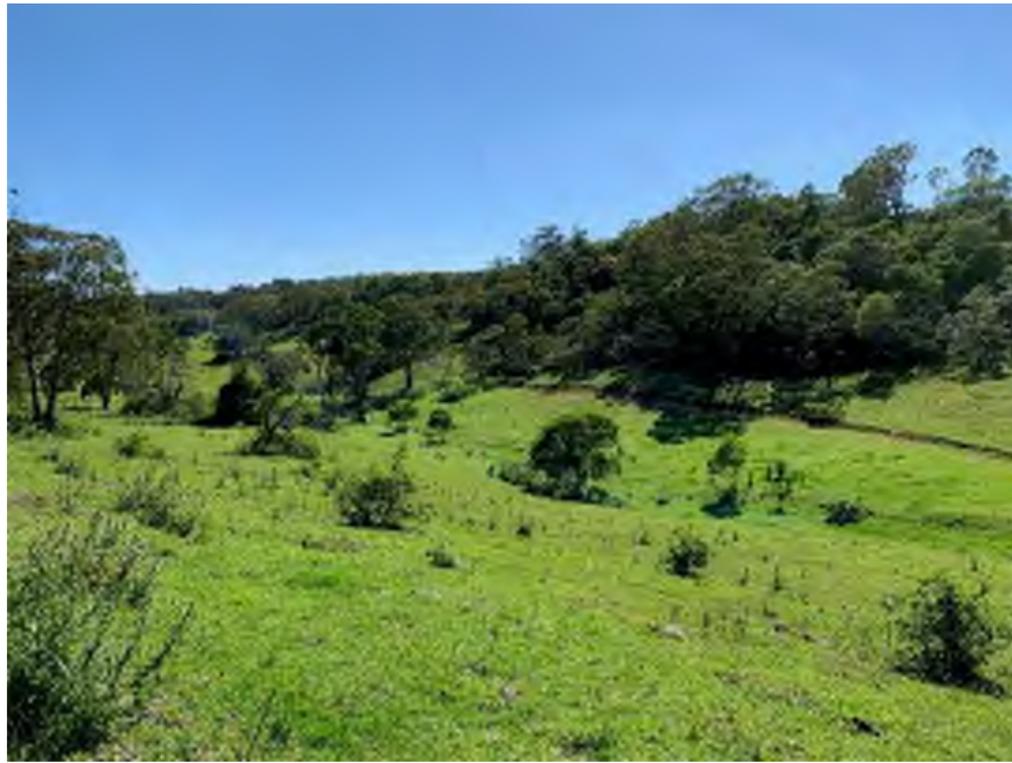
Photograph 33: View of area 3 looking north from farm road at the base of Area 2. Shows the steep hill face of Area 2 up to Terrace 1A

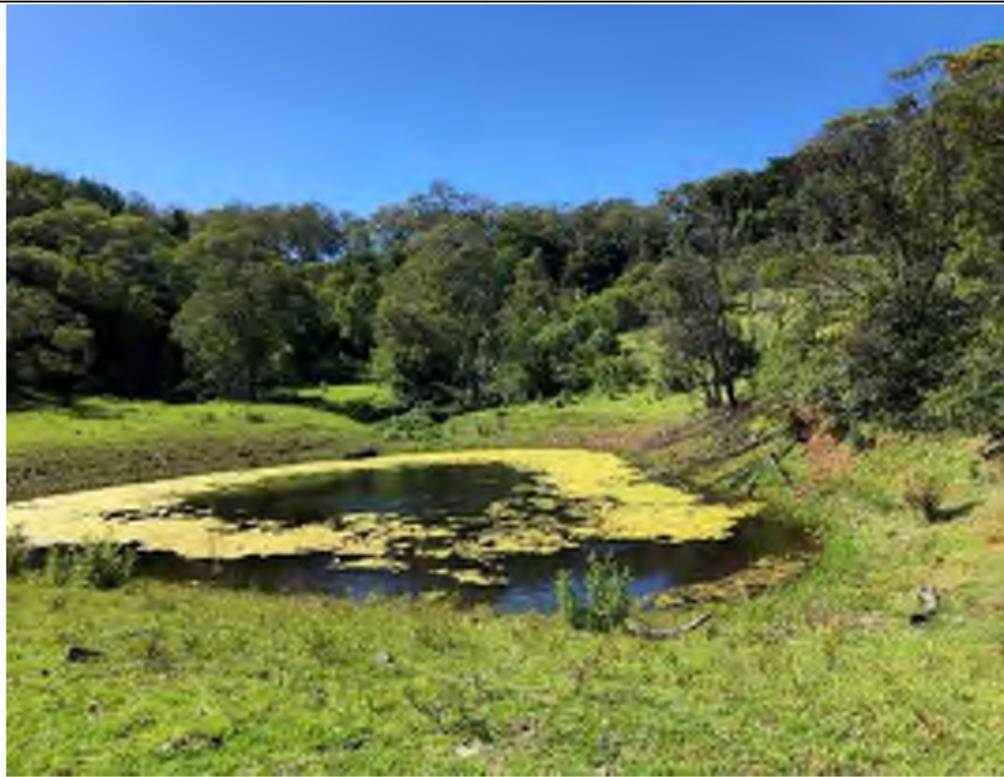
Photograph 37: Looking south at Dam West in Area 3. Depicts the steep nature of Area 2 surrounding the gully

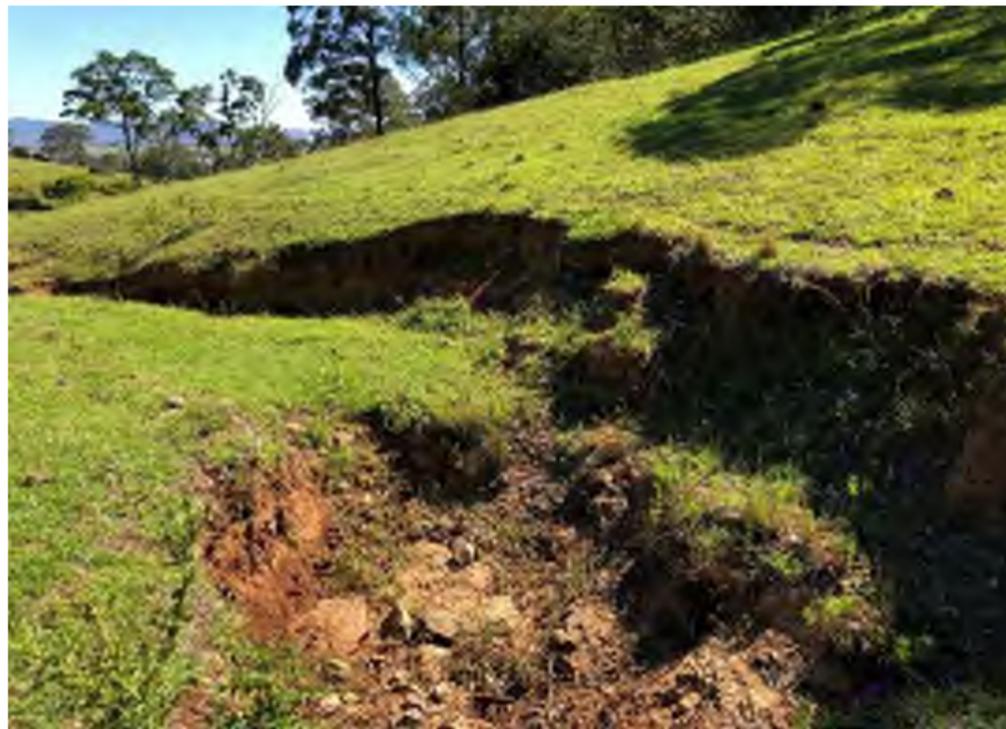
Photograph 39: View of heavy erosion of spill way on Dam West

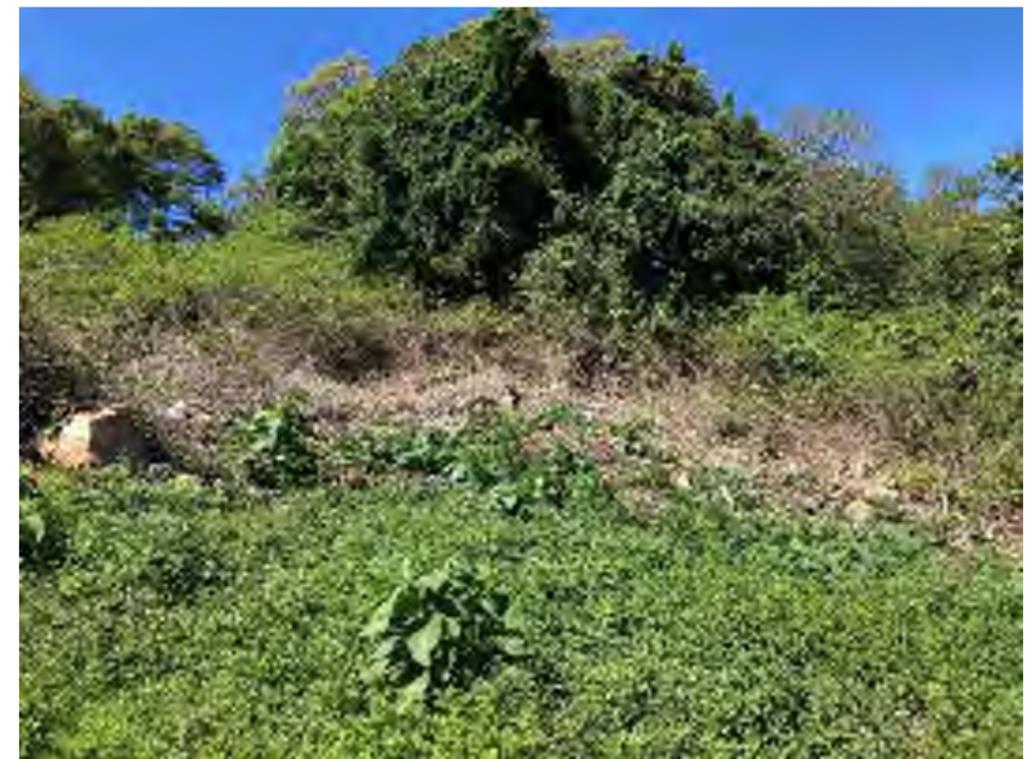
Photograph 56: North eastern Area 2, vegetated with boulders

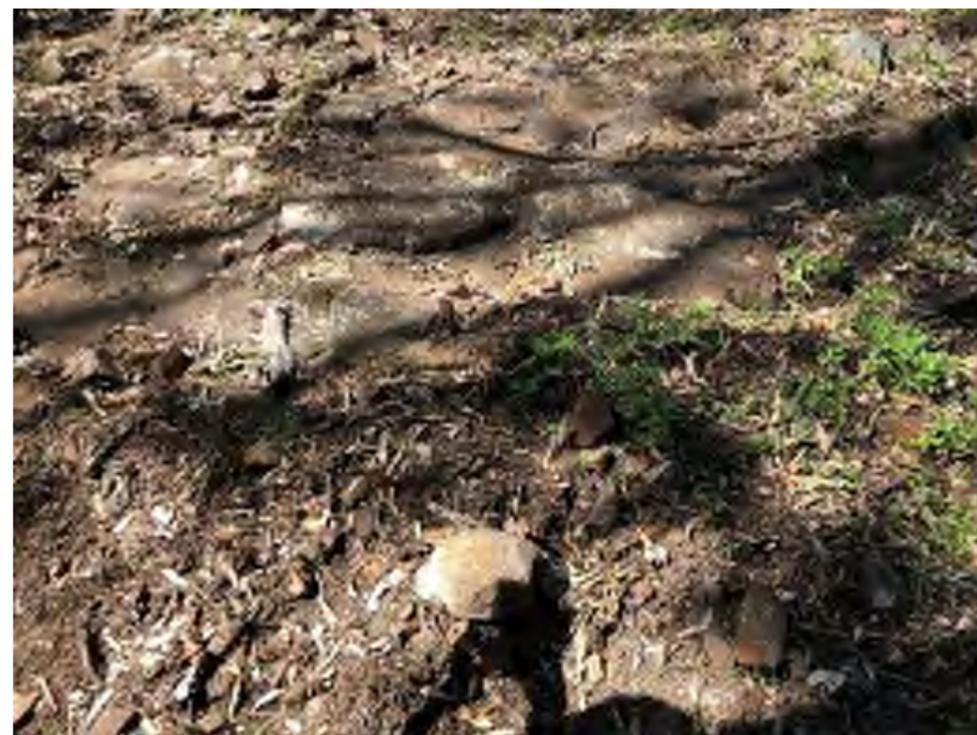
Photograph 59: Latite rock outcropping on access road in Area 2

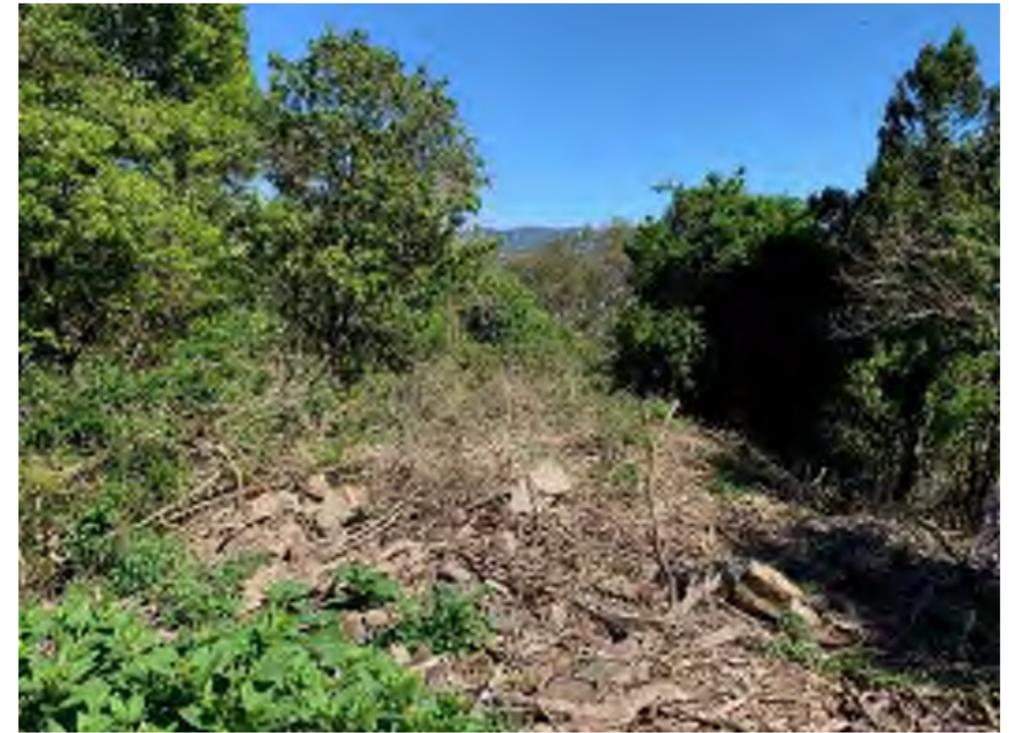
Photograph 62: View looking north from the top of Zone 4. Showing the thick vegetation and latite cobbles and boulders
