Traffic Engineering – Road Safety Audit

Existing Road Stage

At 150 Lismore Road, Bangalow NSW

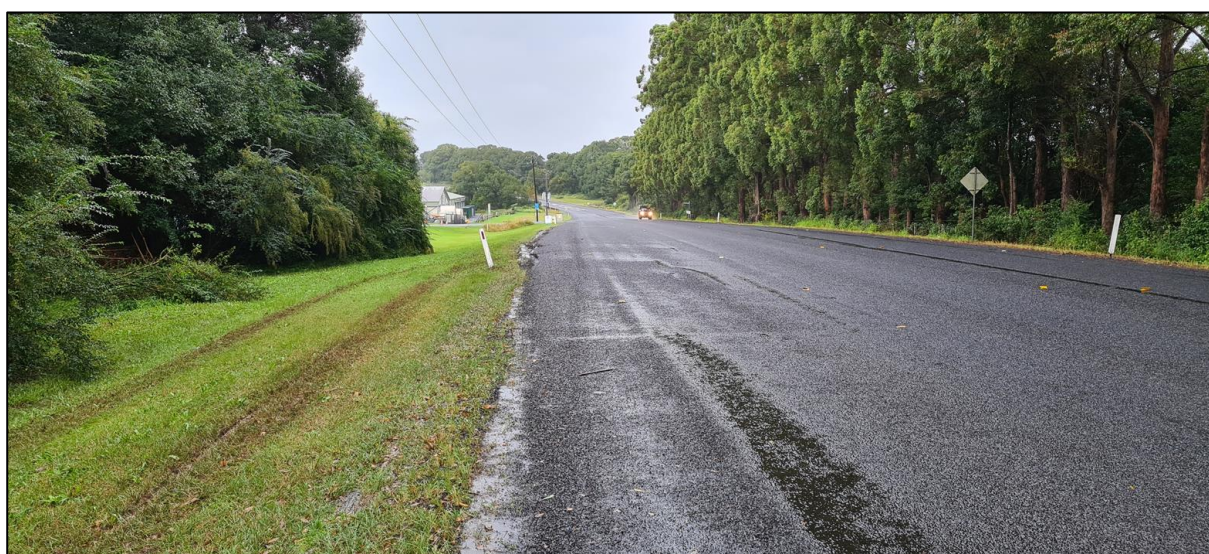
Figure 2-2: Lismore Road / Dudgeons Lane resurfacing works

It was noted during the site inspection that the intersection of Lismore Road / Dudgeons Lane has recently been resurfaced, with line marking still to be carried out.

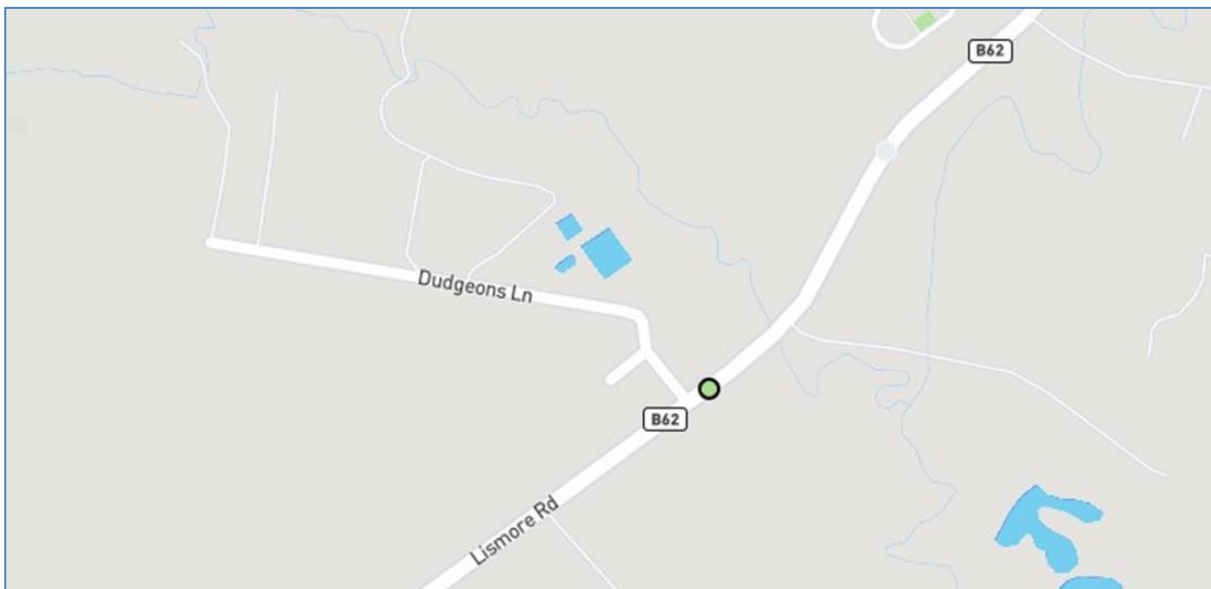
Figure 2-3: Crash Locations (TfNSW data Jan 2015 – Dec 2019)

There was one (non-casualty) crash at the Lismore road / Dudgeons Lanes intersection (2015 – therefore six years ago), where a driver turning right side swiped another vehicle. No crashes were recorded for the Dudgeons Lane / Site Access location.

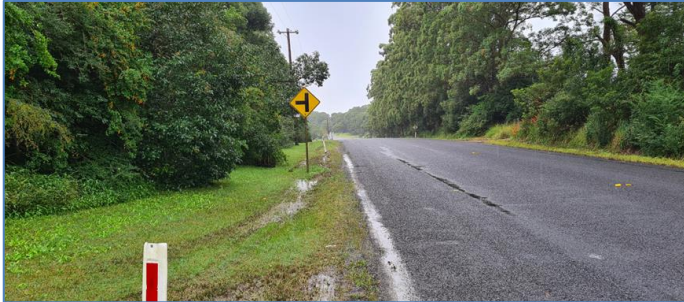
Item	Audit Findings/Recommendations	Rankings	Client		
			Accept Yes/No	Response	Status
1	<p>The sight distance to the south from Dudgeons Lane along Lismore Road is slightly obscured by a small crest about 180m south of the intersection. The SISD for a 90km/h design speed is 214m, the available distance viewed on site was 185m. The SISD for the 80km/h speed is 181m, which is achieved.</p> <p>There is an increased risk of a side swipe or t-bone crash at this location when vehicles traveling from the south are exceeding the posted 80kmh speed limit, possibly resulting in a serious injury or a fatality.</p>

<p>View from the crest towards the intersection with Dudgeons Lane. (above)</p>	Medium	Yes	There is nothing to address for the purpose of the Planning Proposal. Additional signage can be assessed and installed if required as part of a future development application for the subdivision of the land.

<p>View from Dudgeons Lane southbound towards the crest (above)</p> <p><i>It is recommended that additional warning signs are provided on the approach to the crest warning drivers of this crest and a further warning sign of the side road (with distance marked e.g. 200m).</i></p>				
--	----------------------------------------------------------------------------------------------------------------------------------------------------------------------------------------------------------------------------------------------------------------------------------------------------------------------------------------------------------------------------	--	--	--	--

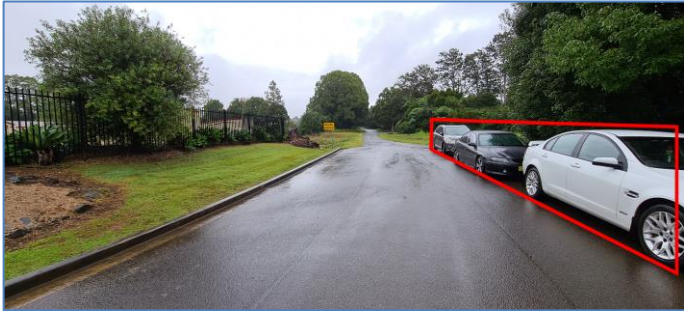
Item	Audit Findings/Recommendations	Rankings	Client		
			Accept Yes/No	Response	Status
2	<p>Unrestricted parking opposite the proposed intersection, may lead to sideswipes on parked vehicles and could also reduce sight lines for vehicles exiting the proposed development.</p>

<p><i>It is recommended that yellow lines or no parking signs are provided to control parking at this location.</i></p>		Yes	Can be addressed at subdivision stage.	
Item	Audit Findings/Recommendations	Rankings	Client
