No 3 (Lot 3 DP 1018217) Dido Street, Kiama, 2533  
Combined Preliminary (Contamination) Site Investigation and  
Geotechnical Site Investigation

Our Ref: TERRA18228 Rep 1 Rev 0

22 October 2018

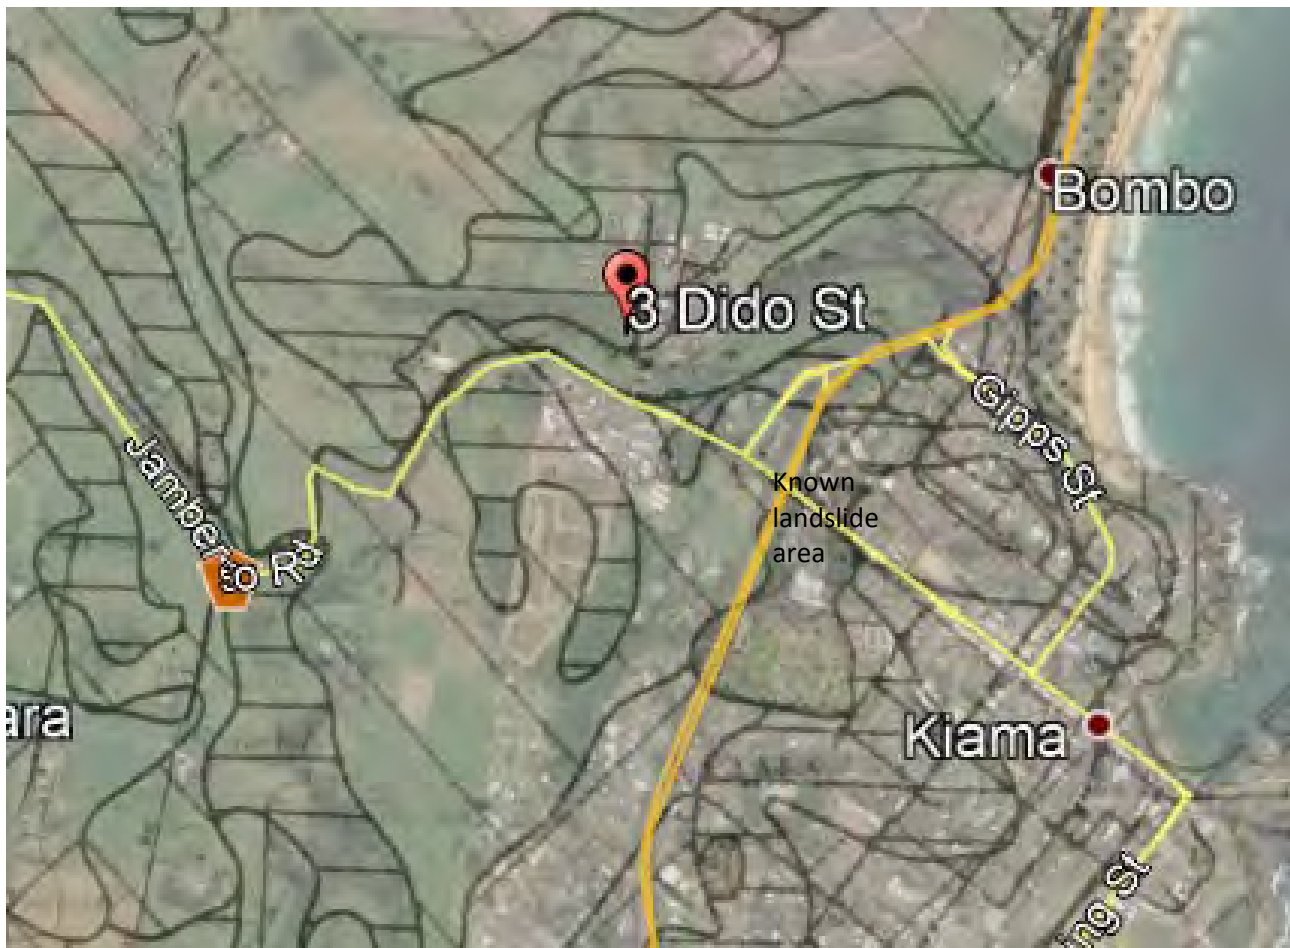
Image 1: Historical Land Stability Mapping

Reference to Neville's Geological Hazards indicates the site is located within an area mapped as potentially unstable land. This terrain is described as comprised of 'land with steep slopes of 15 to 20 degrees and includes areas of lesser slope on talus covered benches. Excavation or fill placement in this region or seepage could cause instability. Urban development is not recommended. Detailed geotechnical investigations should precede any site development'.

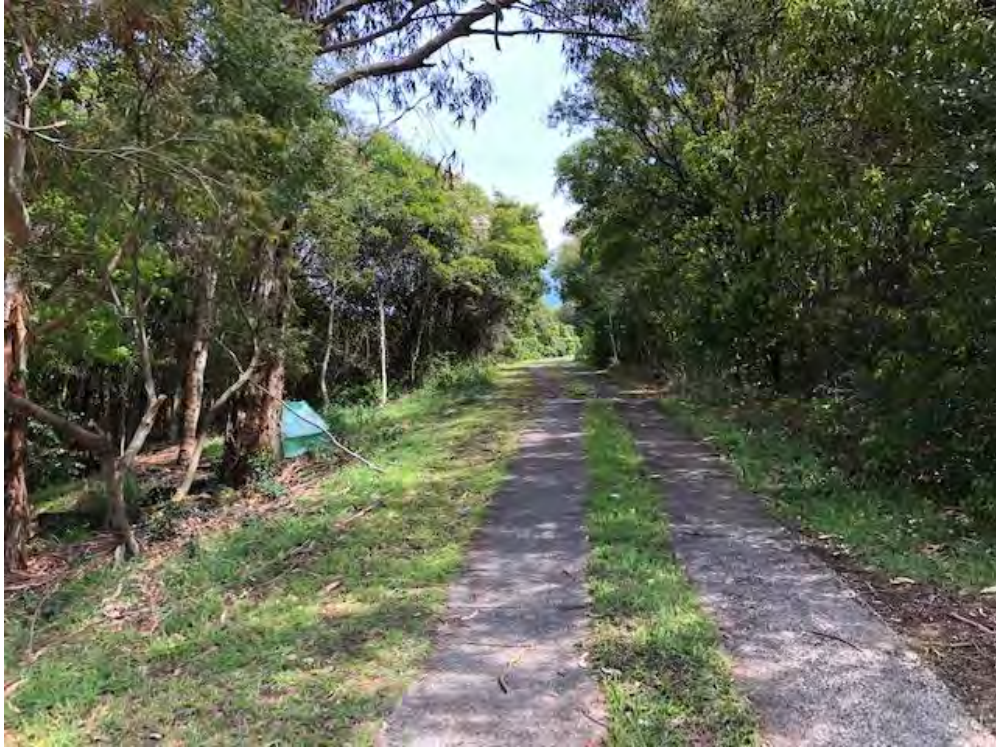
- **Waste material 3- Near surface fill materials associated with the access road:** The near soils are expected to comprise some localised fill material and road building materials. Testing of these materials is recommended to allow waste classification for off site disposal. It is expected these materials can be disposed of off-site as general solid waste. They cannot be reused off site as ENM/VENM.

Photograph 4: View of existing access driveway, looking west from proposed Lot 10 towards proposed lots 3 (left hand side of image) and 9 (right hand side of image).

- Testing of the material which has been used to construct the existing driveway shall be undertaken to facilitate removal and disposal of these road building materials;
- Waste classification of the near surface topsoils, to facilitate disposal if required; and
- To managed unexpected finds during construction, it is recommended that a construction environmental plan is developed for the site as detailed in the following section.

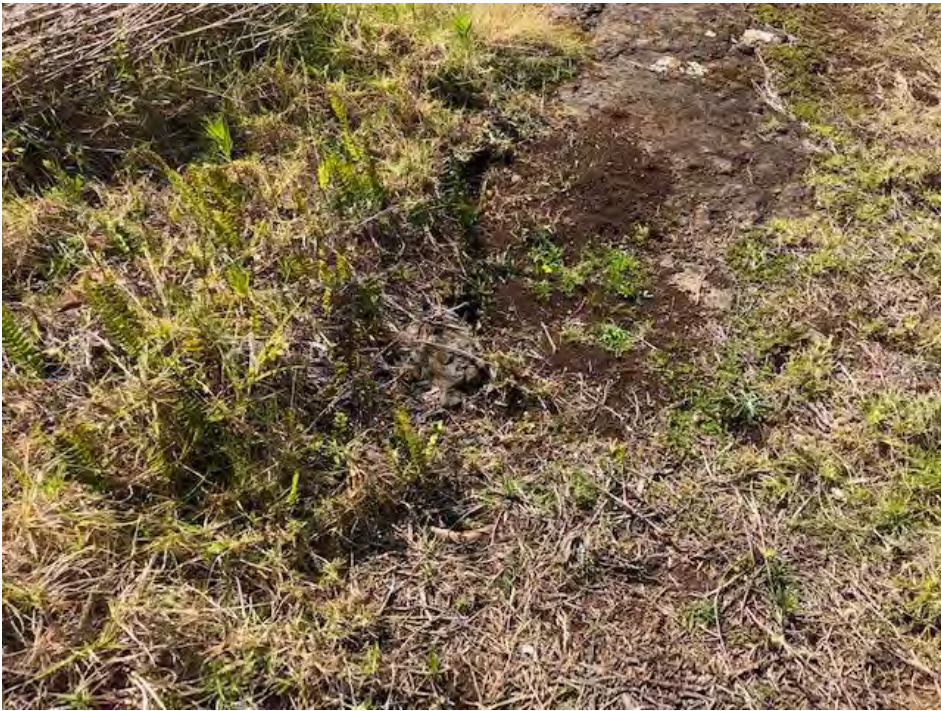
- No groundwater seepages were observed.
- Rock was visible as outcrops and embedded boulders on the site.
- There was no notable signs of large scale or localised slope instability. Erosion of the near surface soils due to overland surface water flows was visible, however no large rills or gullies were observed.

Photograph 8: View of bedrock outcropping on site near boundaries between Lots 2 to 5.

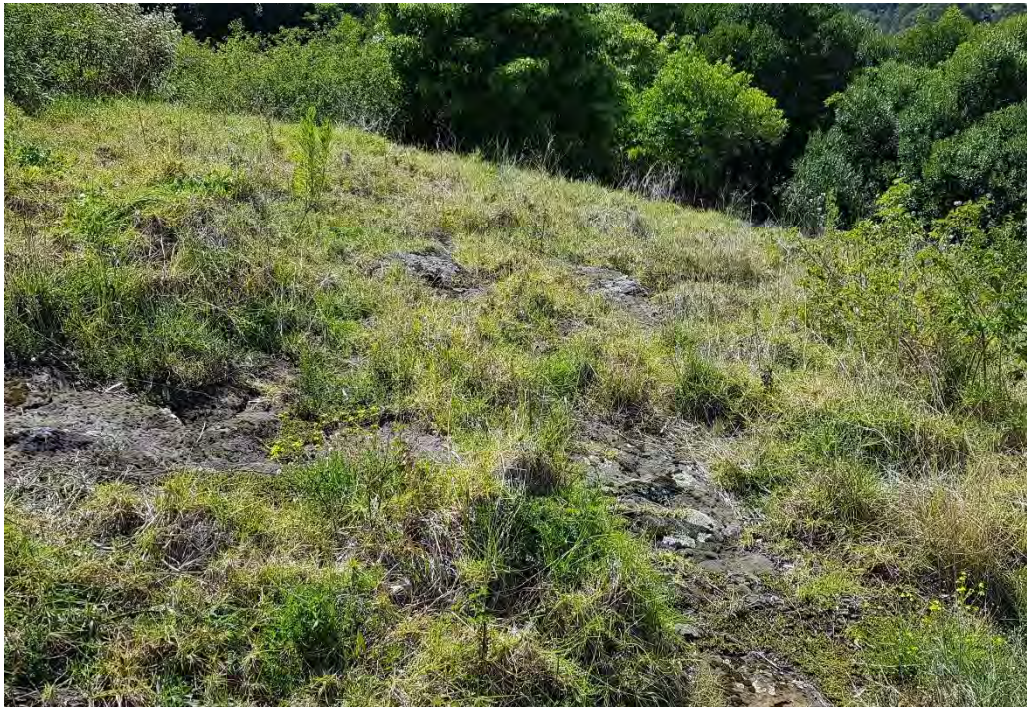
Photograph 9: View of latite boulders exposed on the ground surface on proposed lot 5.

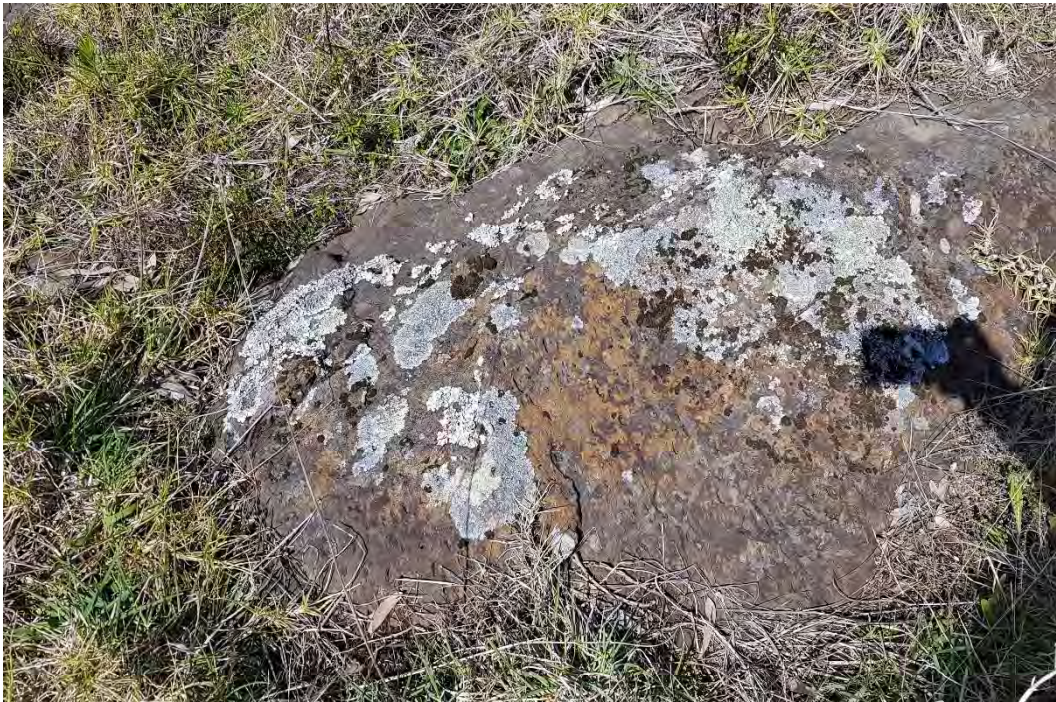
Photograph 10: View of latite boulders exposed on the ground surface on proposed lot 5

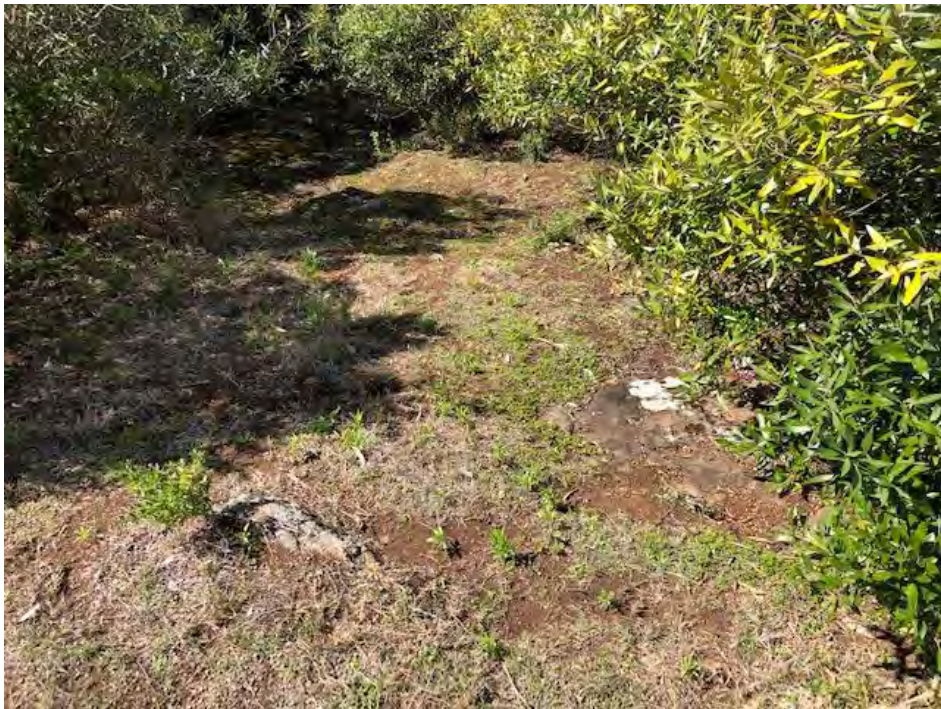
Photograph 14: View of Lot 6 looking south. View of boulders in near surface soils.

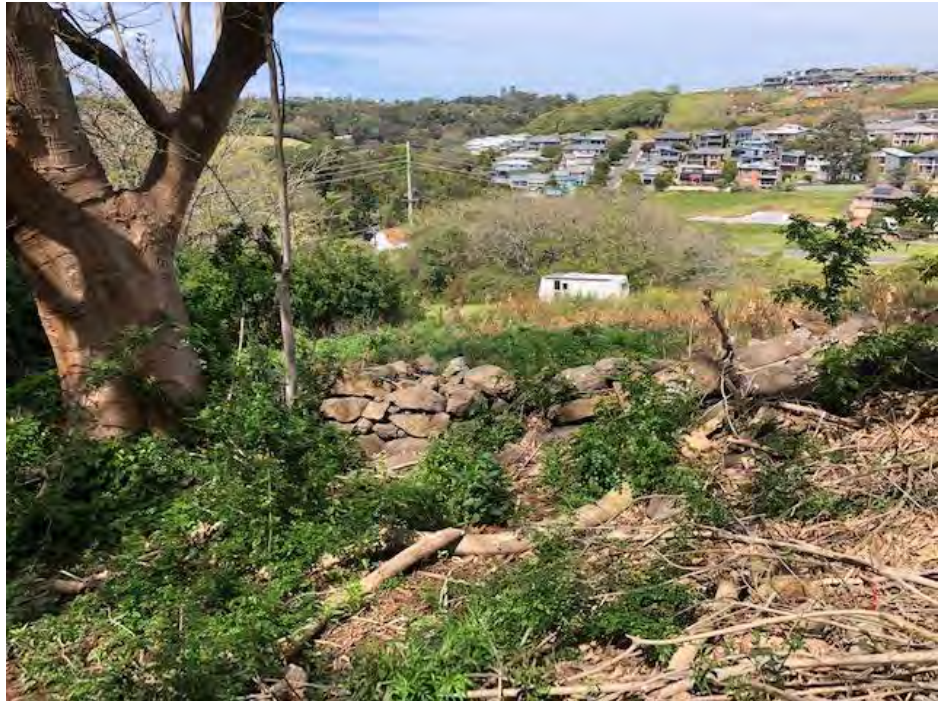
Photograph 17: View of rock wall located on southern boundary Lot 8
