Report on
Summary of Investigations

Proposed Residential Development
Off Link Road, Wallsend

Prepared for
Eden Estates (Newcastle) Pty Ltd

Project 91610.05
December 2020

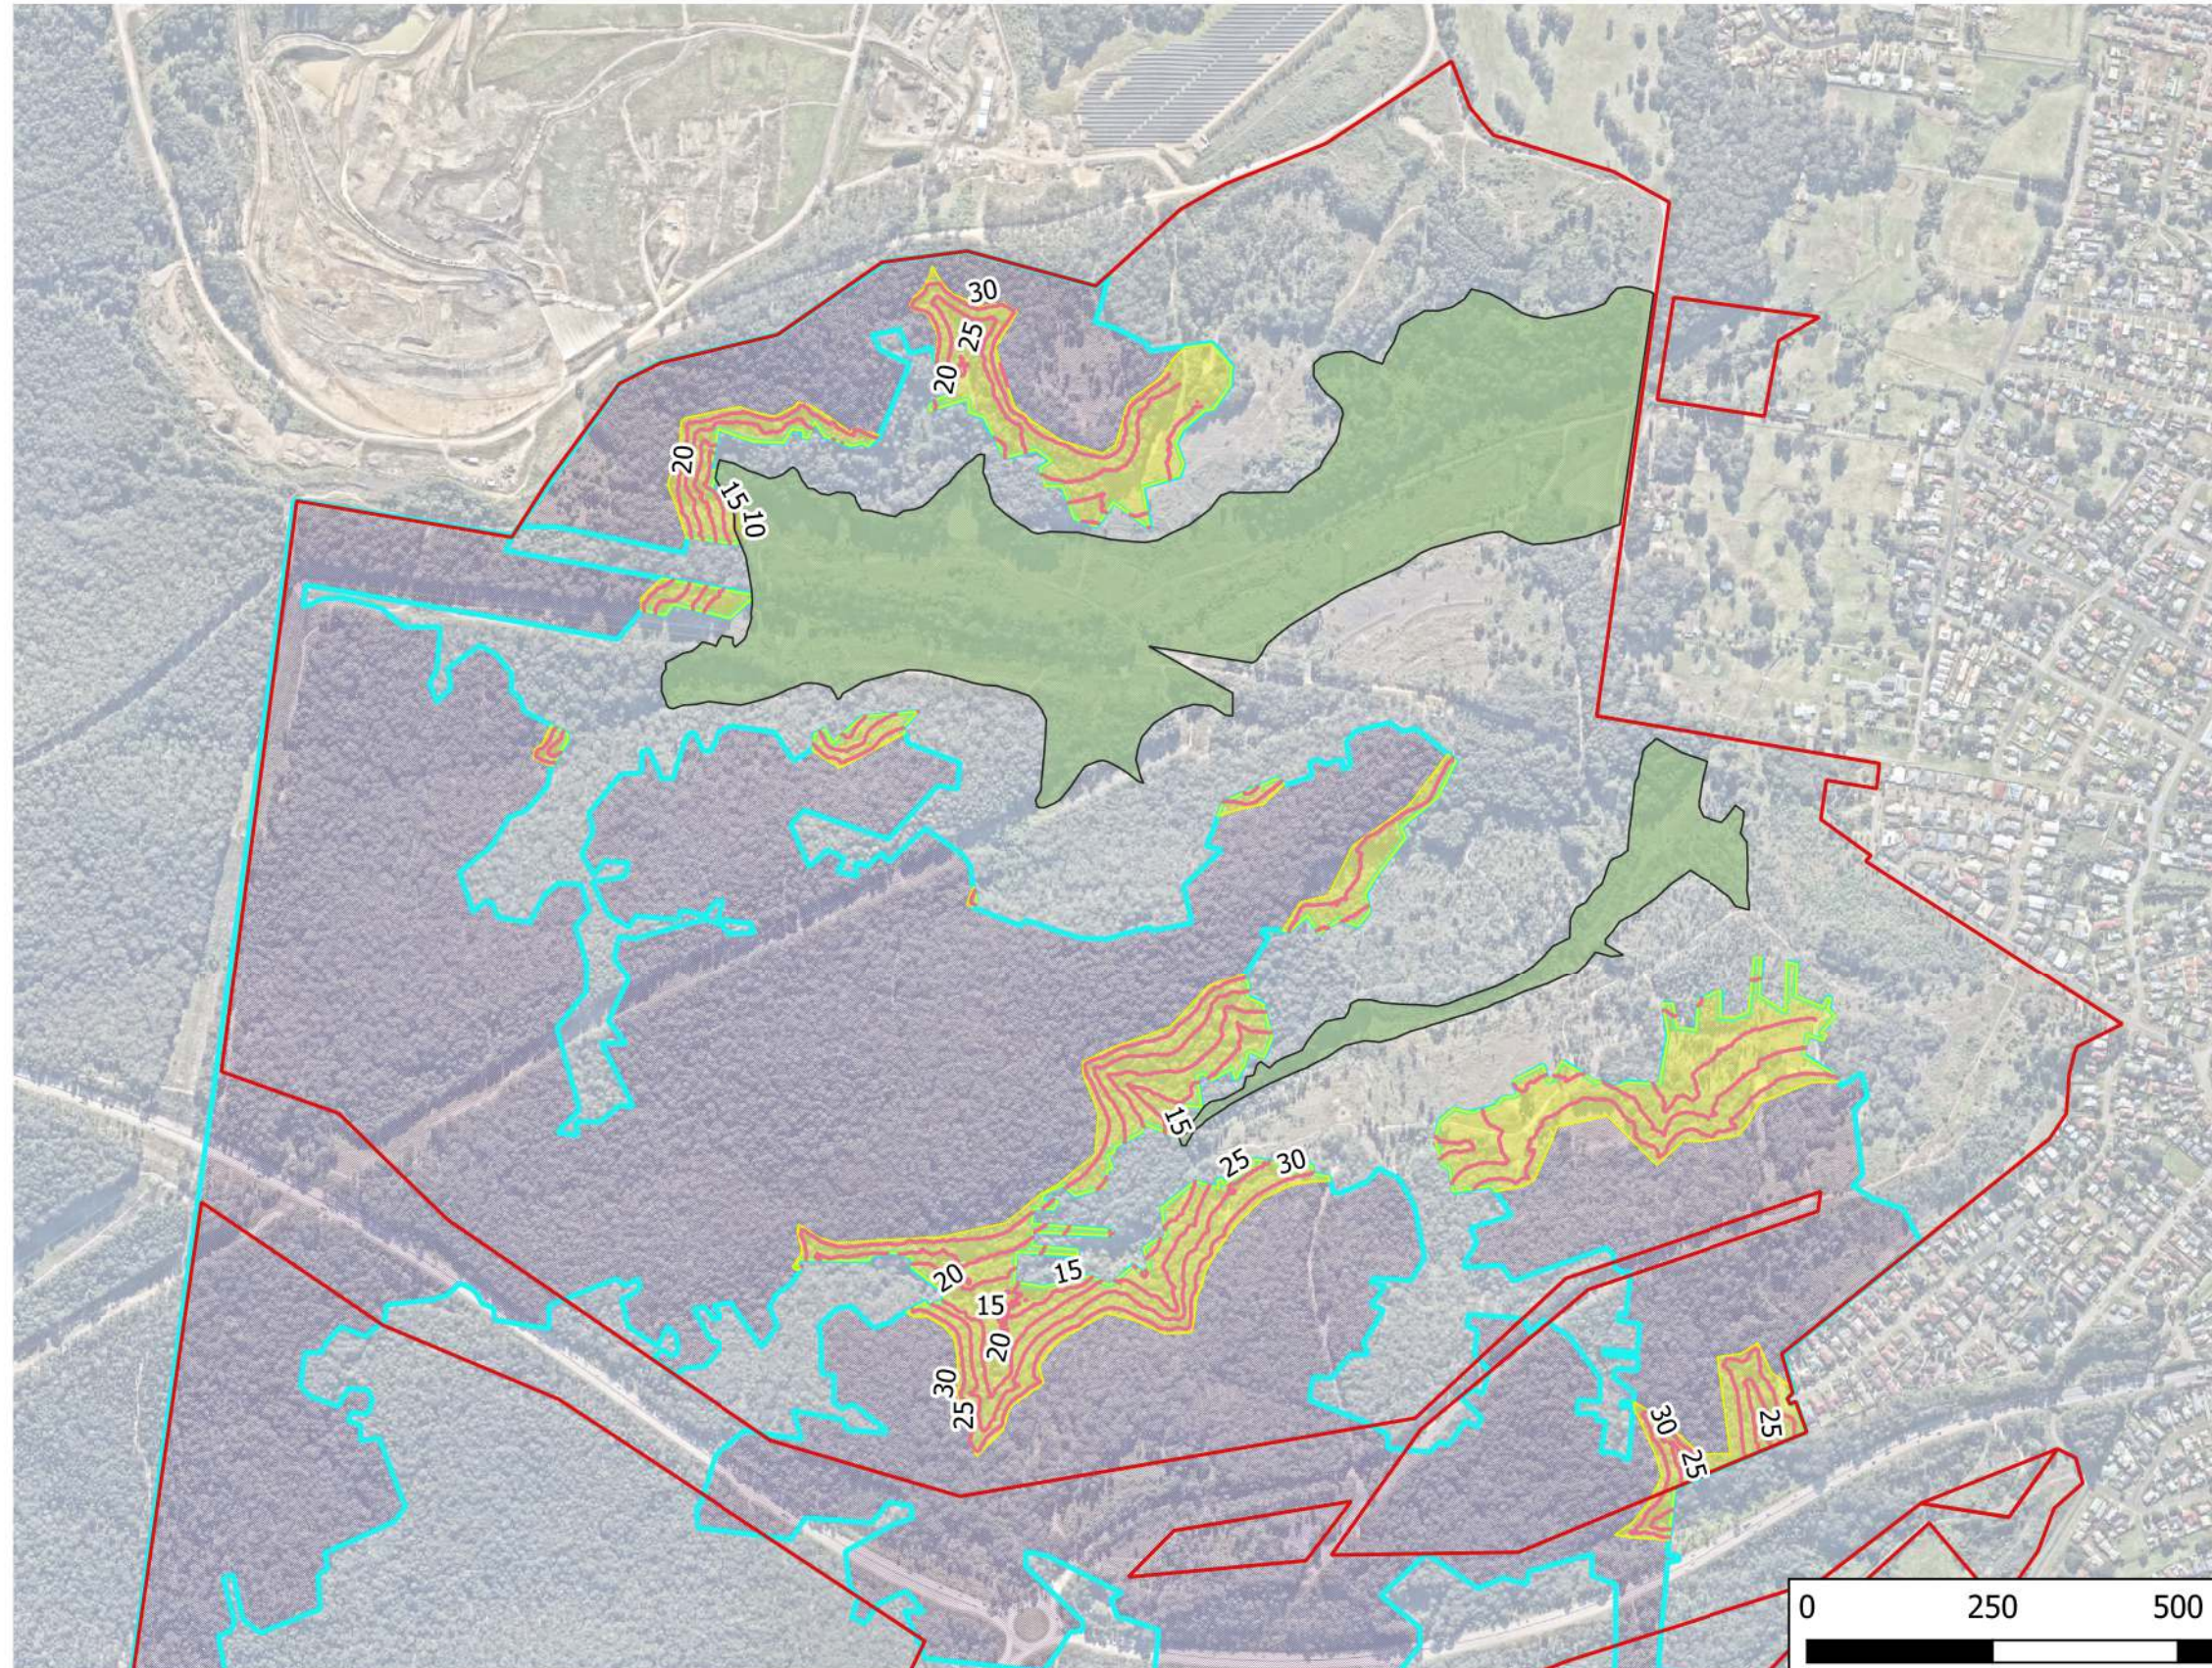
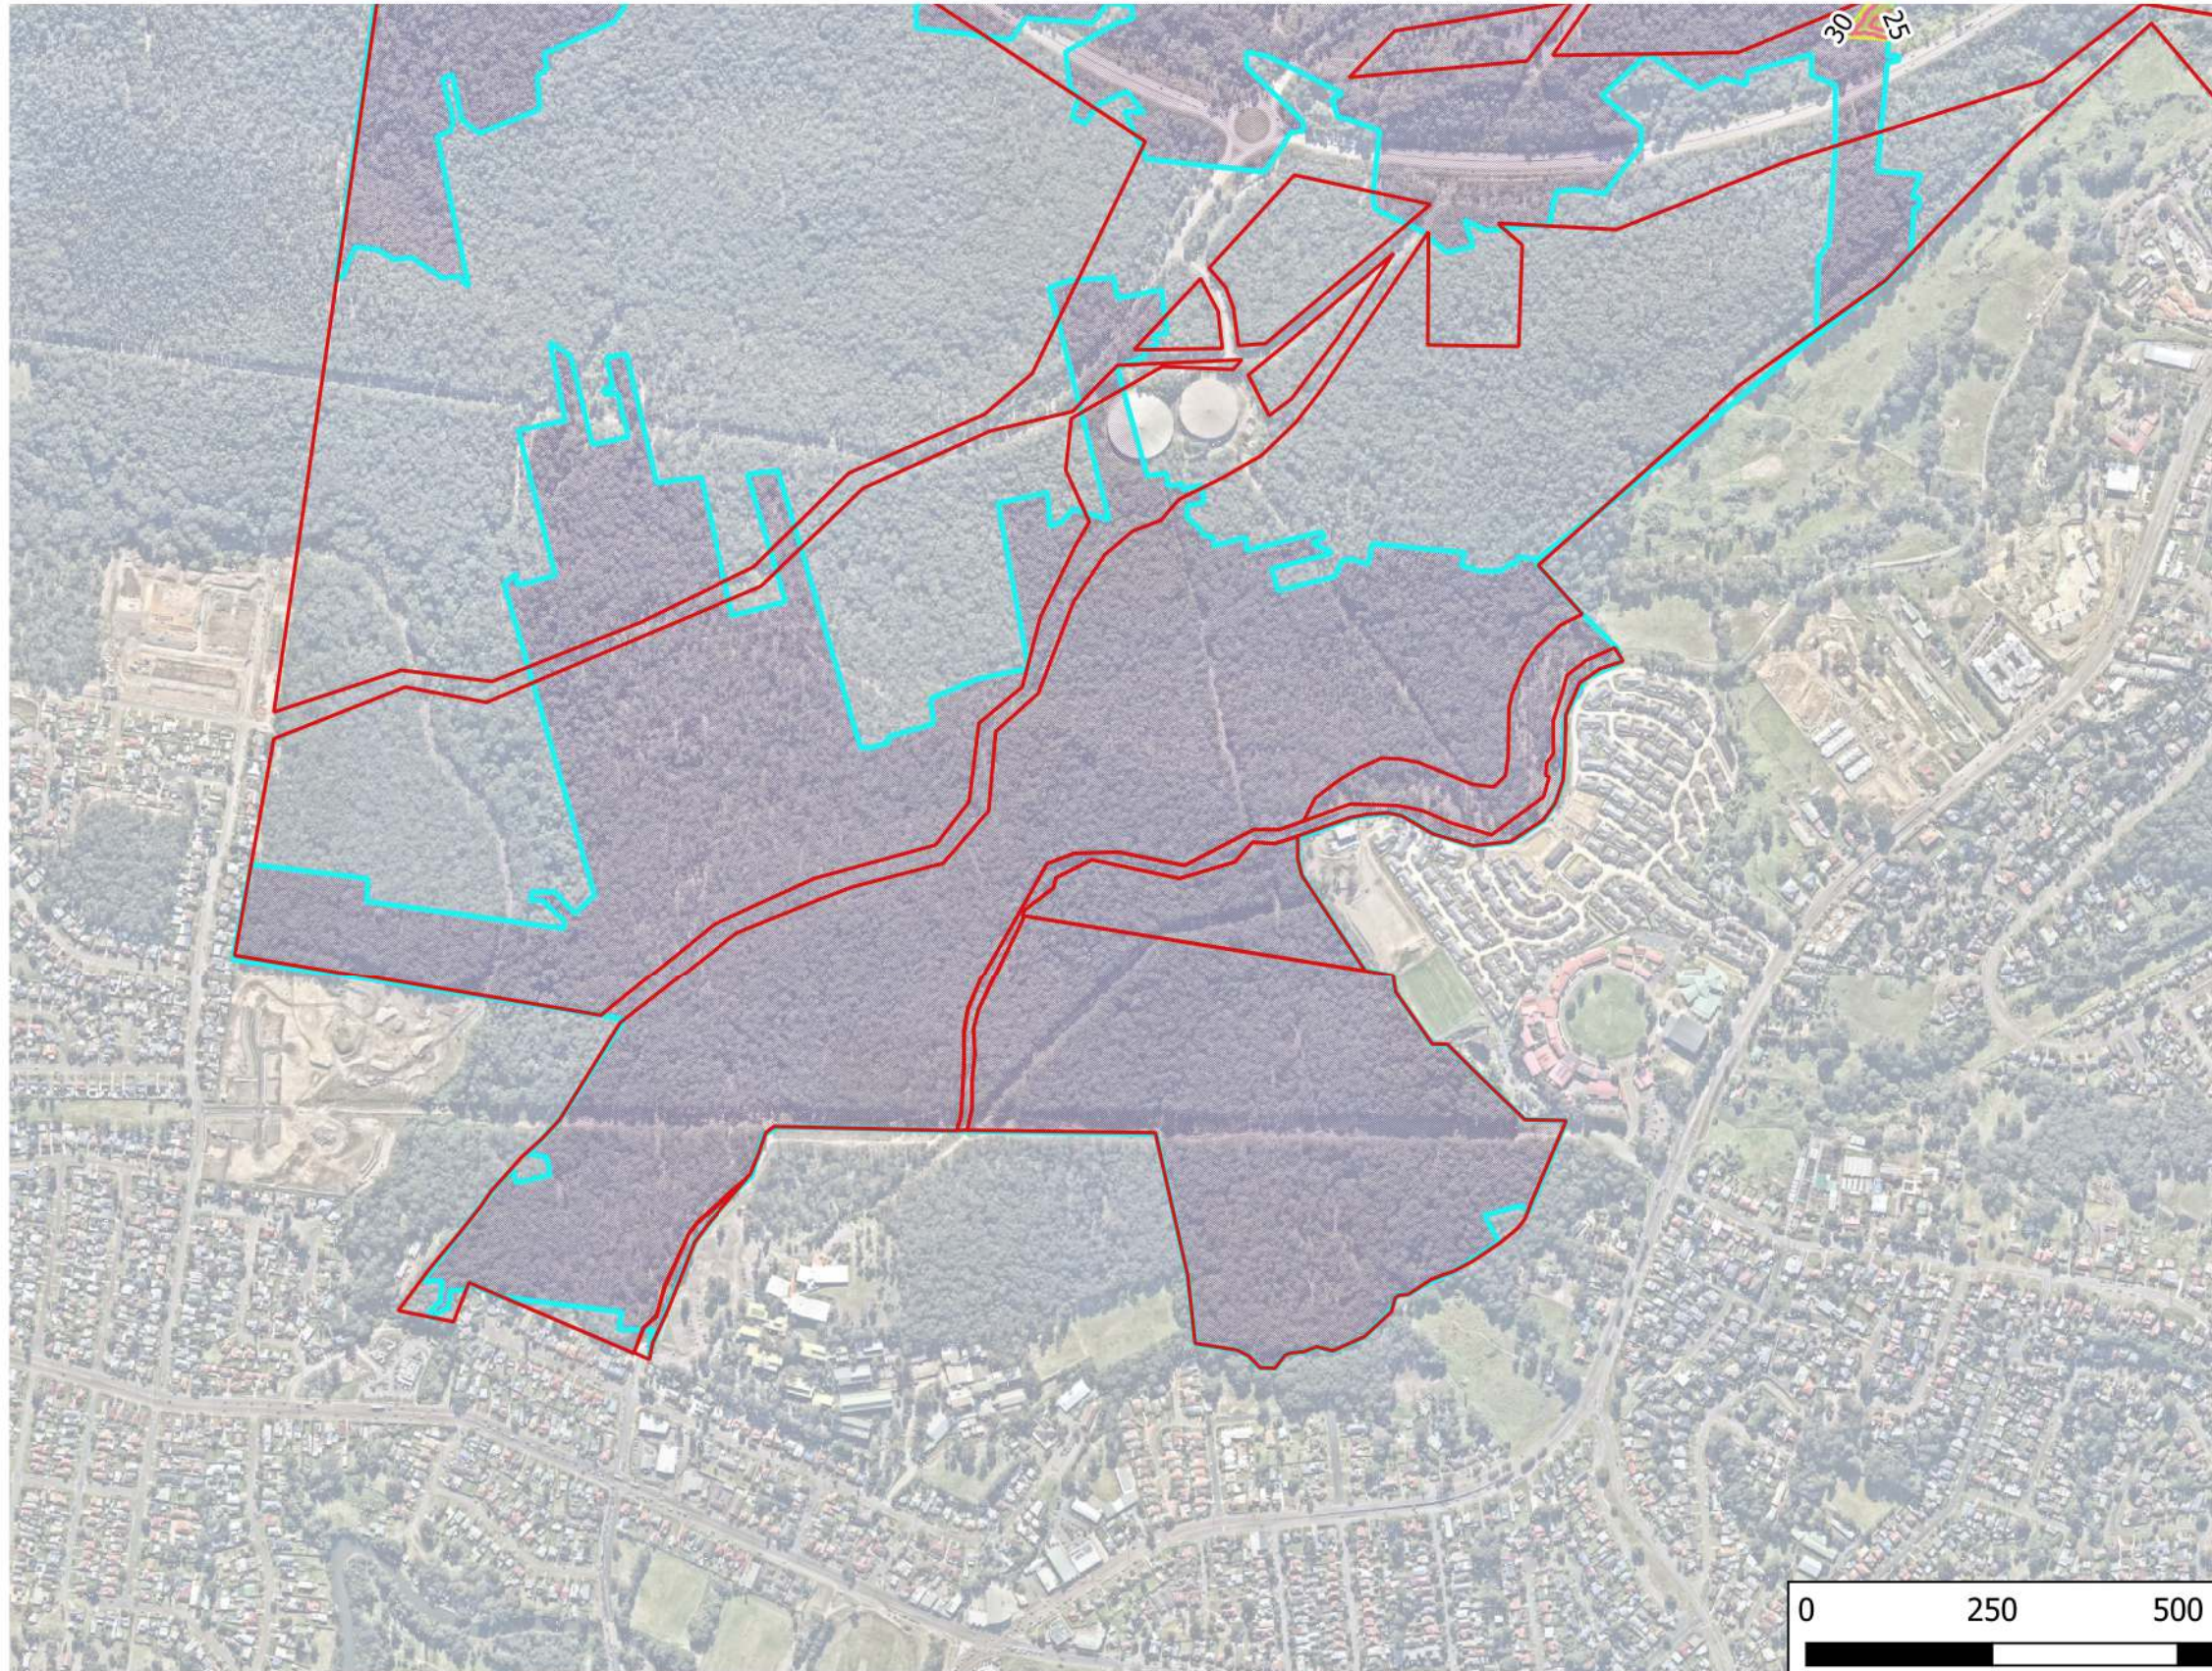
Numerical analysis suggests that should collapse of the standing pillars occur, areas above the Dudley/Young Wallsend and Borehole Seam workings where the depth of cover ranges between 25 m and 65 m are considered unlikely to develop tilts of more than 7 mm/m, curvatures $> 0.2 \text{ km}^{-1}$ or strains $> 3 \text{ mm/m}$ because the pillars are likely to remain stable in the long-term. There are, however, several potential high subsidence impact hazard zones for the site where tilts of greater than 7 mm/m could development above the old first workings pillars and partial pillar extraction workings panels in the Dudley / Young Wallsend or Borehole Seams. It is considered likely that all the proposed buildings in the study area are likely to require articulation and subsidence impact amelioration details to be included in the design of the superstructure of the proposed buildings. Some of the high subsidence impact areas of the site may experience subsidence parameters, should failure occur which may not be readily catered for in the design of residential structures without remedial grouting. Further discussions with the SA NSW regarding appropriate building design constraints are recommended.

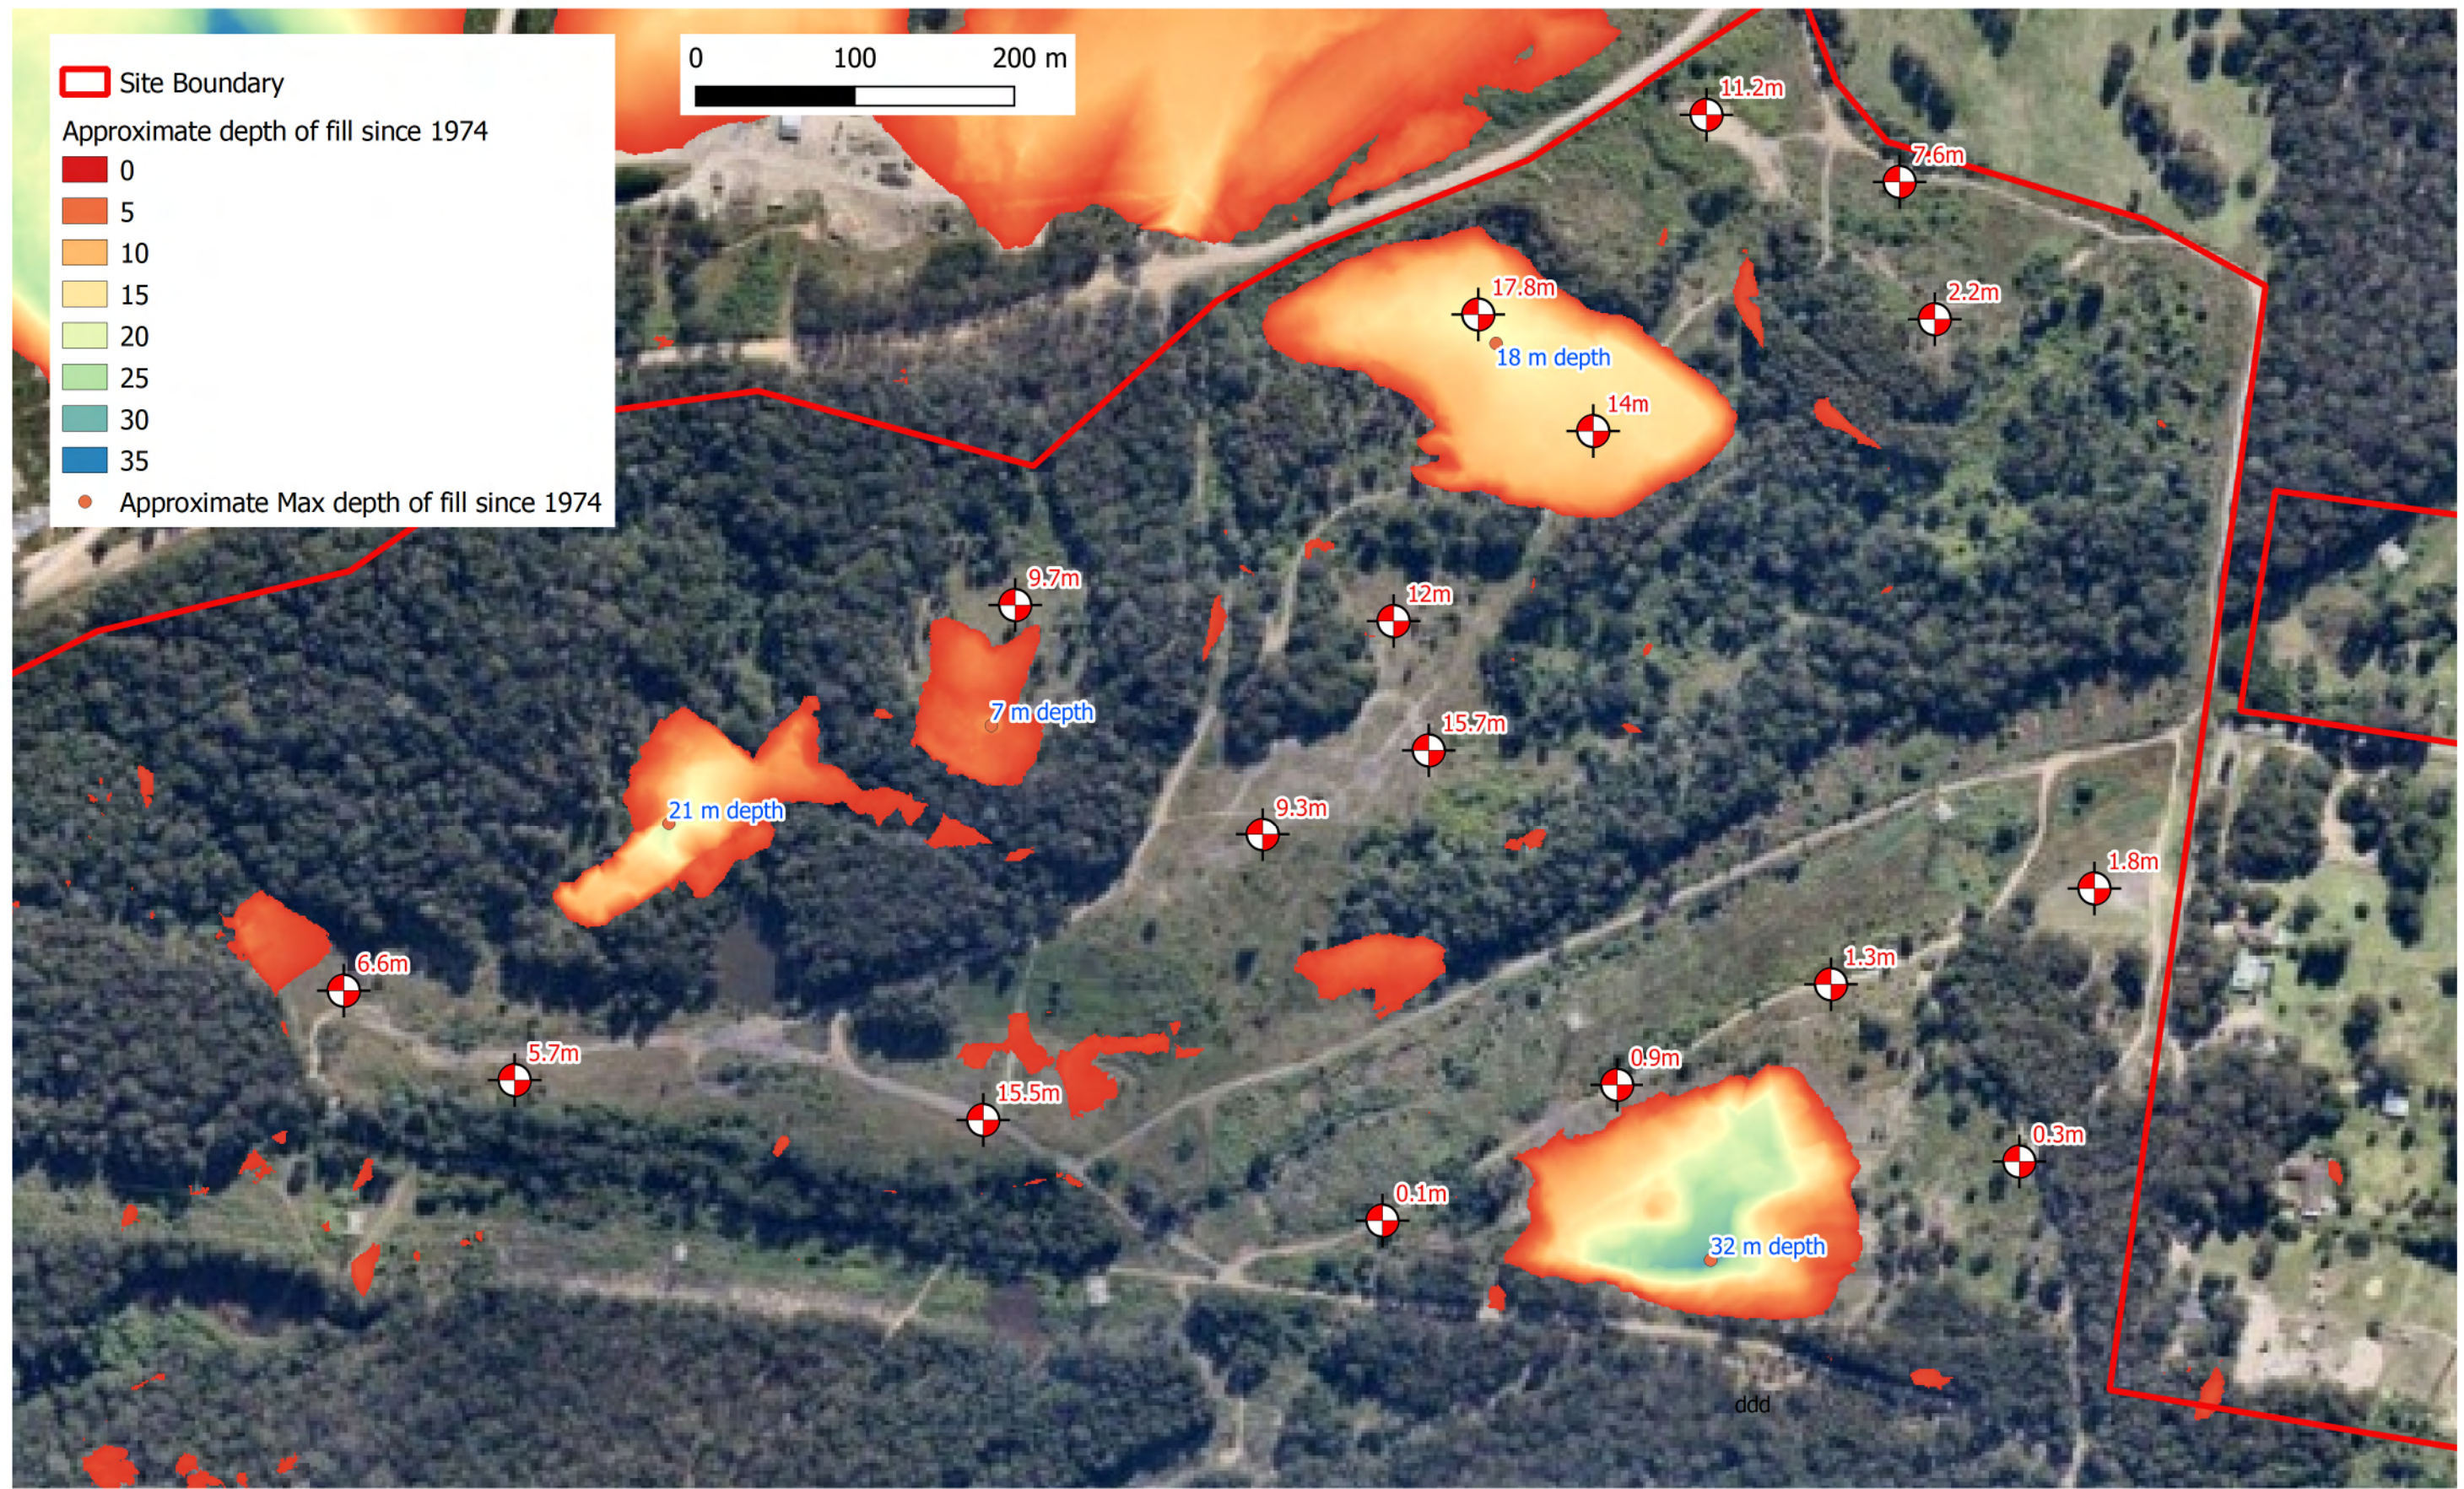
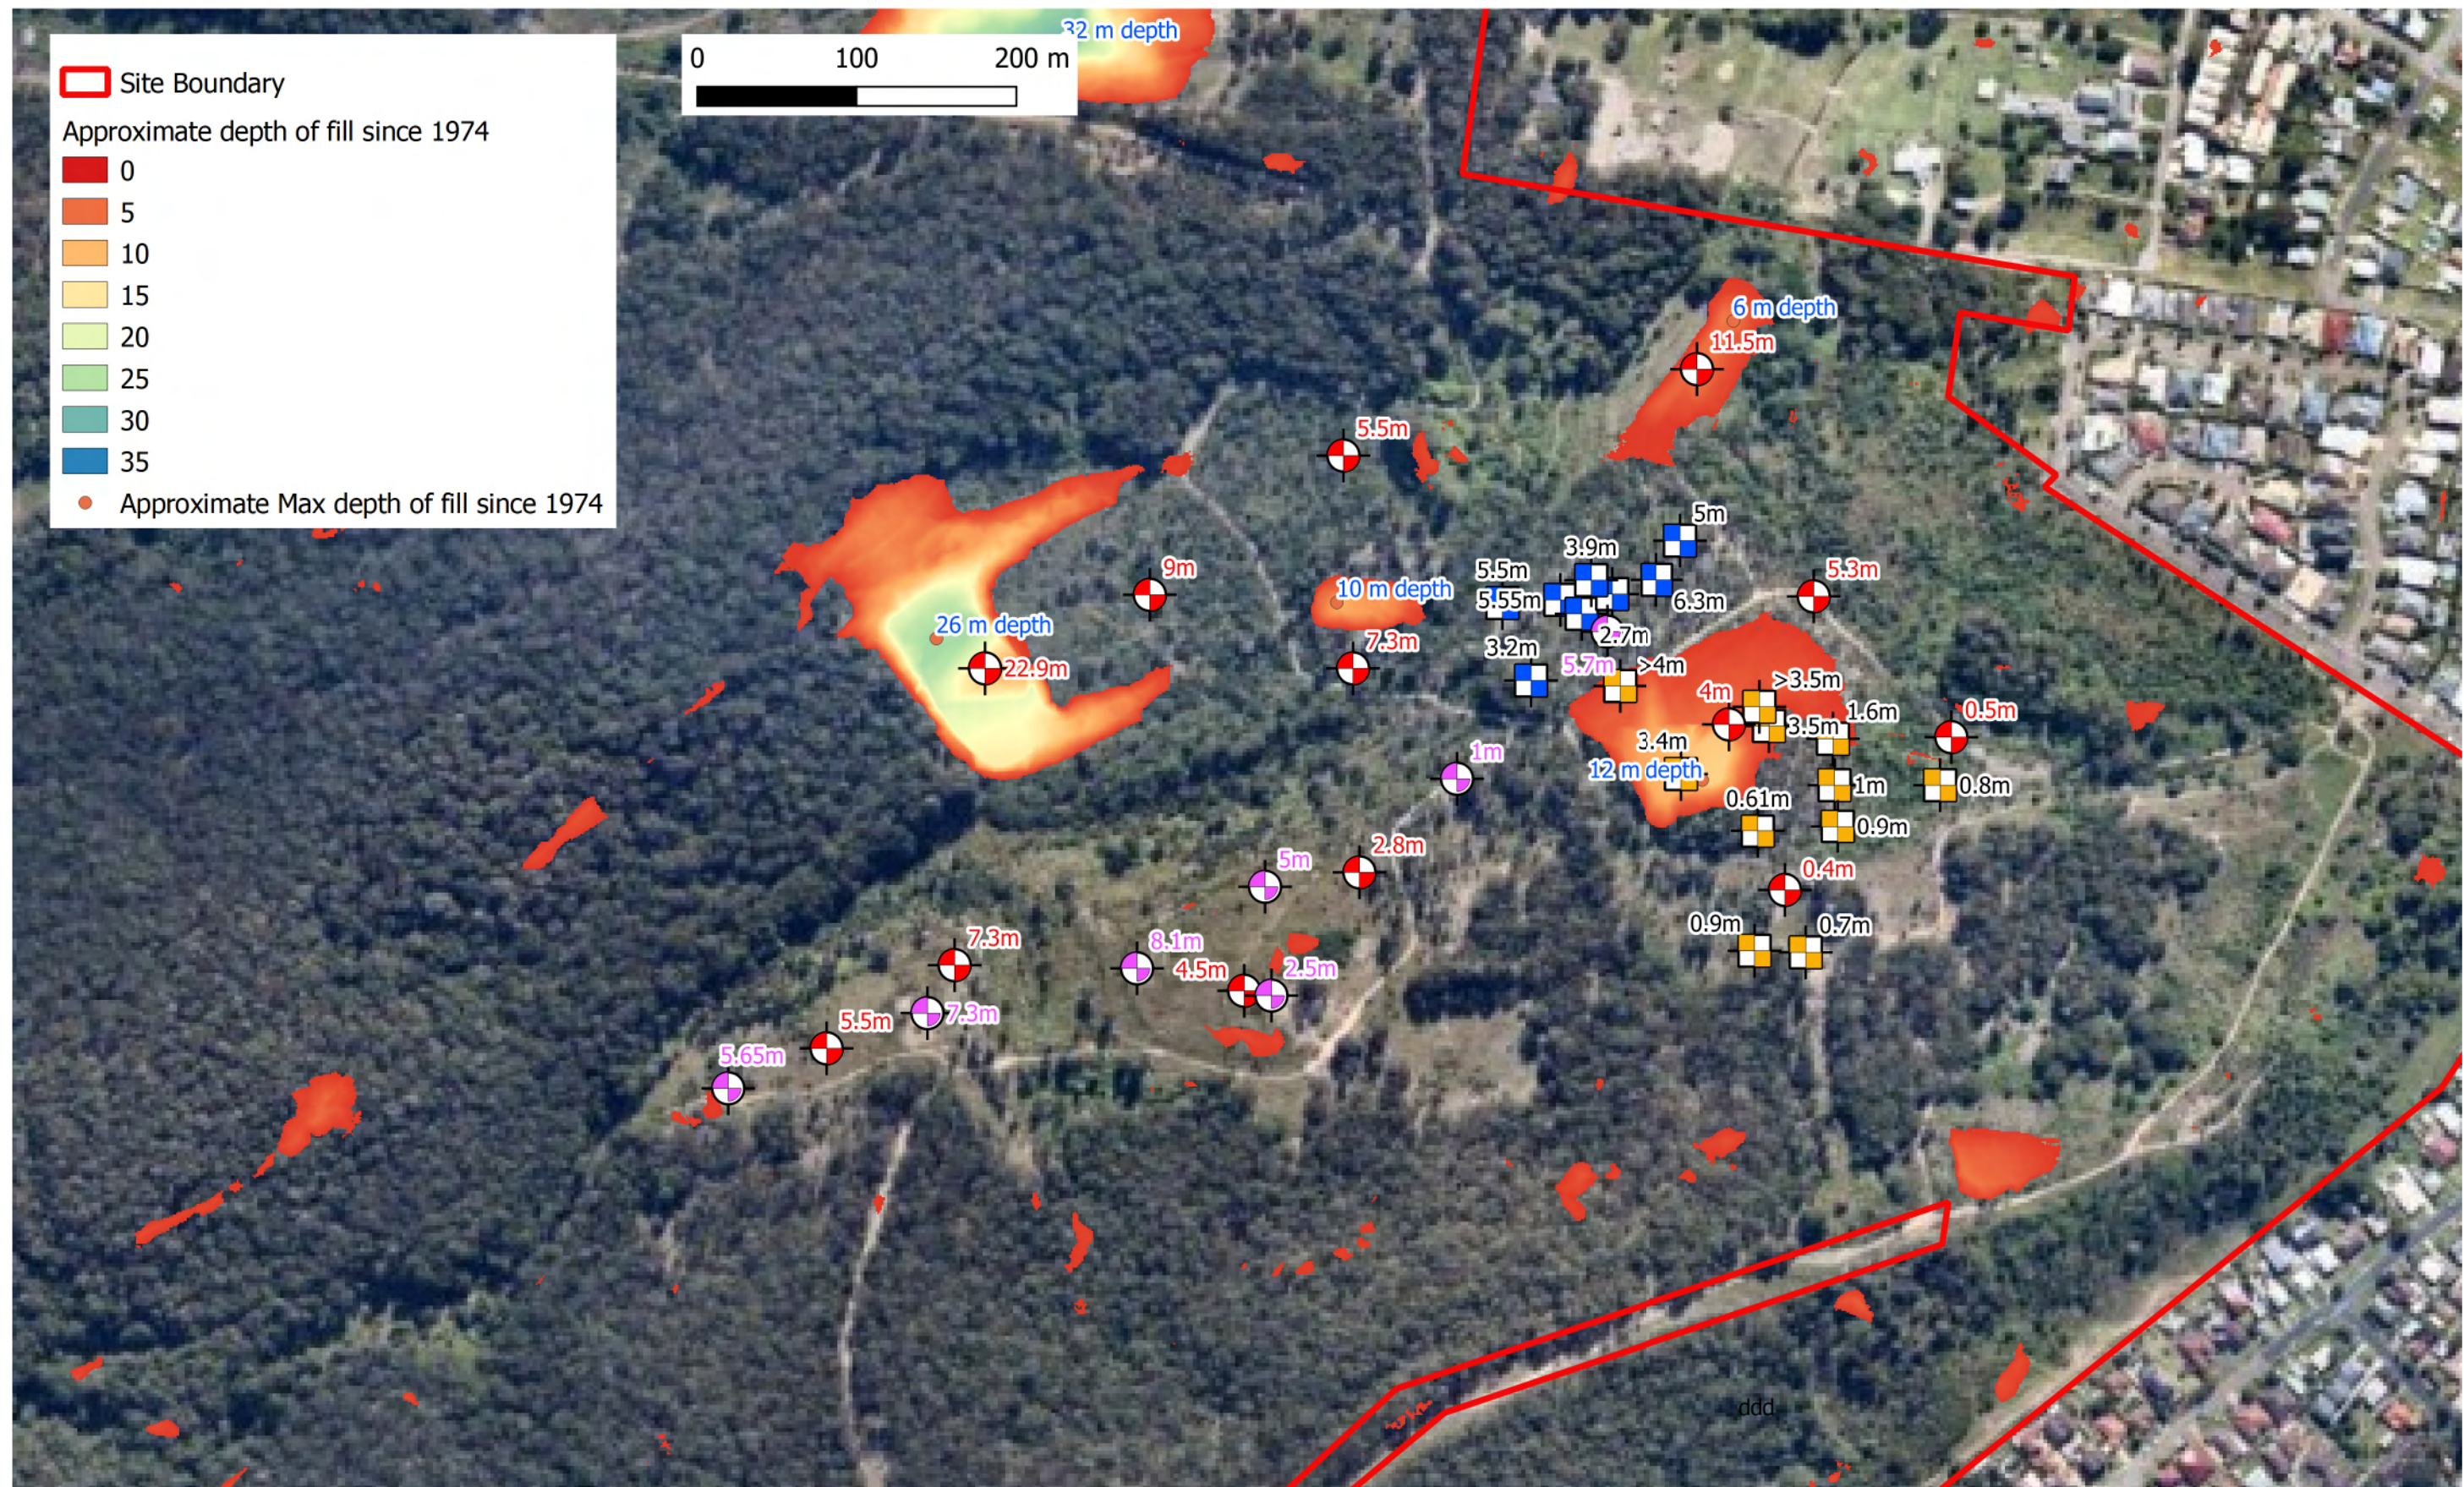
PROJECT: 91610.05
 DRAWING No: 4-2
 REVISION: 2

Drawing 4-1 and 4-2 in Appendix B provide both an indication on the depth of fill placed across the site since 1974 (shading), the approximate area of fill which appears to have been on the site prior to 1974 (green polygons) and the depth of fill encountered in test pits and bores undertaken by DP and others at the site. The ability of the existing fill to support future development is dependent on a number of factors, primarily relating to the degree of control used during placement of the fill, particularly in relation to the compaction achieved during placement. The results of the in-situ testing undertaken during DP (2020c), primarily comprising standard penetration testing (SPT), were utilised to provide guidance on the level of compaction (and relative density) of the fill material.

The results of the assessment indicate that the majority of the fill is in a poorly compacted condition and in areas contains shallow groundwater and is not suitable in its current condition to support future structures or surface development, and site improvement measures would be required to allow development within these areas of the site.

Based on the results of DP (2020c), coal rejects and coal fines have been placed within the site, to depths ranging from about 1 m to 28 m (refer Drawings 4-1 and 4-2 in Appendix B). The rejects area has a low risk of spontaneous combustion. There is, however, a potential for combustion from external sources (such as bushfires). The risk profile for combustion is dependent on the possible external ignition source and mechanisms. It is considered that the risk of combustion could be managed by a combination of blending the existing fill with non-carbonaceous material, recompaction of the existing fill and/or blended material, and / or provision of a suitable cap of non-combustible material over filled areas.

These improvement measures would also be tailored to mitigate additional identified risks, such as potential for combustion of carbonaceous material and generation of acid, and is likely to include removal of the existing fill and recompaction after blending with non-carbonaceous material.

It may be possible to undertake a less onerous earthworks procedure, such as partial removal and recompaction of the upper portion of the existing fill together with the provision of a suitable capping layer, followed by support of future structures via piled foundations through the existing fill profile to be founded within the underlying rock profile. This alternative site preparation option as the approach to earthworks will depend on the type and scale of development; relatively rigid multi-storey buildings, for example, would probably require piles but flexible warehouse-type buildings may be suitable to be supported on re-compacted fill with some structural allowances to accommodate settlement.
