Report on
Summary of Investigations

Proposed Residential Development
Off Link Road, Wallsend

Prepared for
Eden Estates (Newcastle) Pty Ltd

Project 91610.05
December 2020

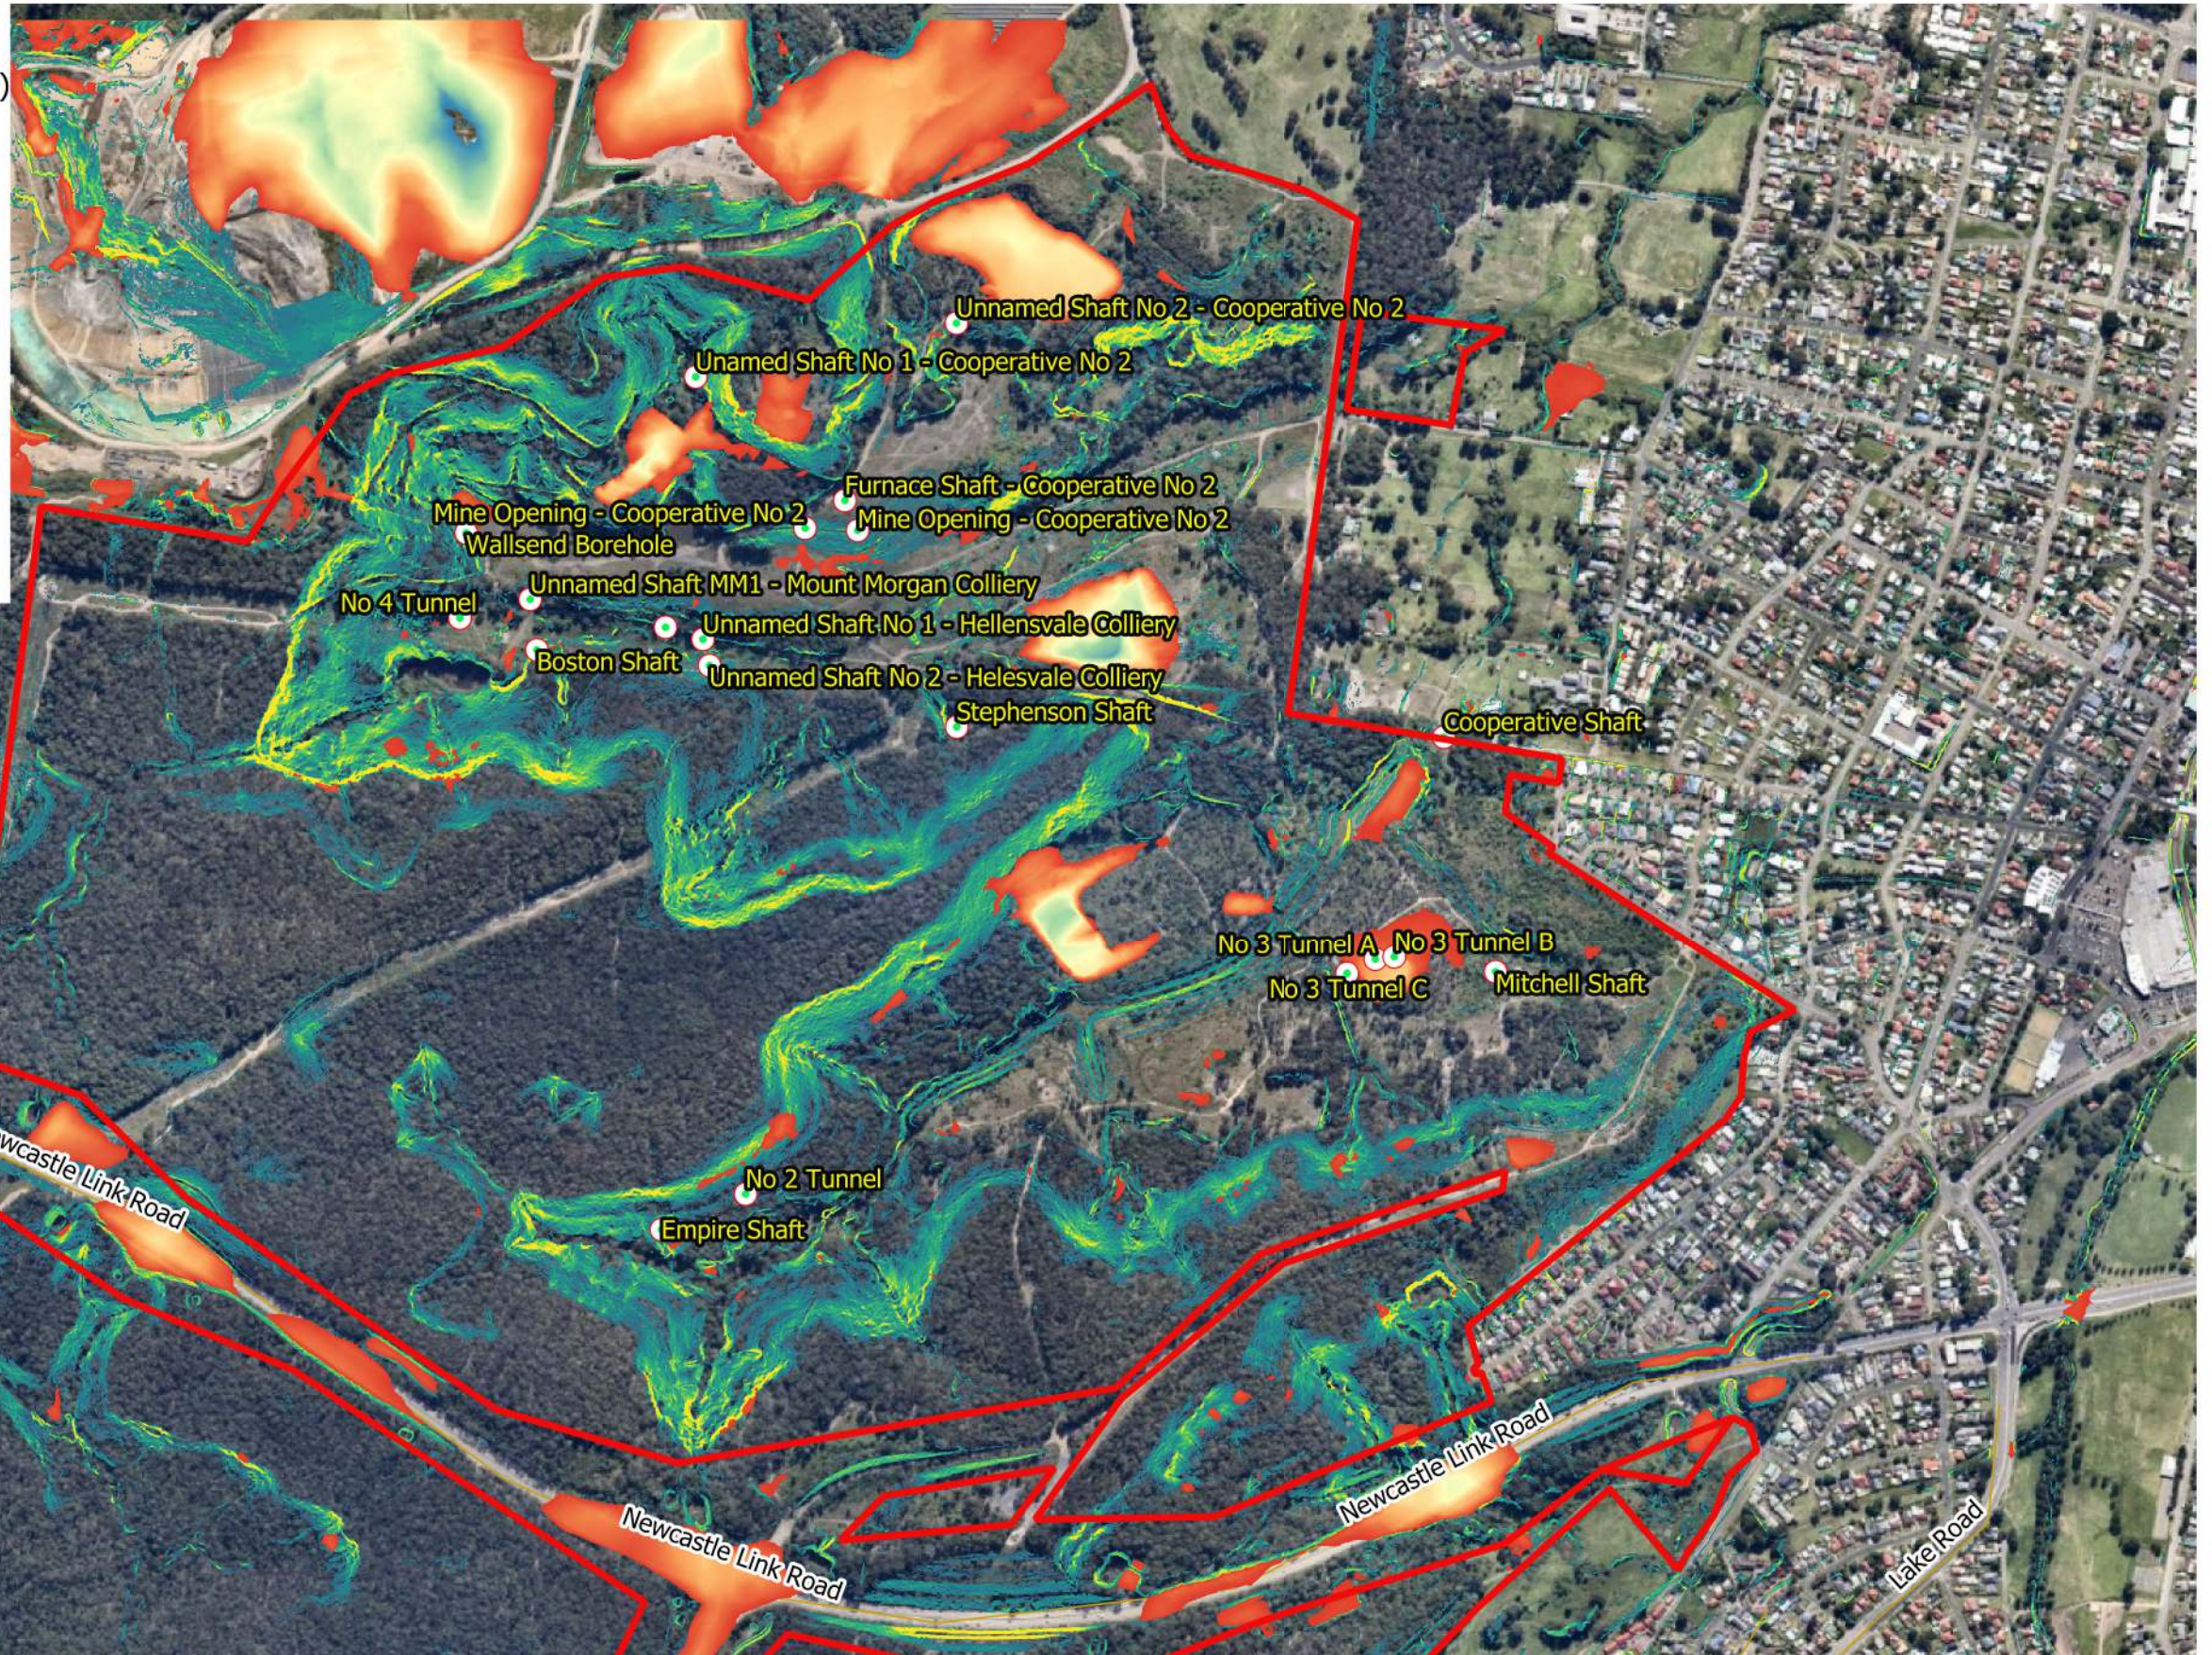
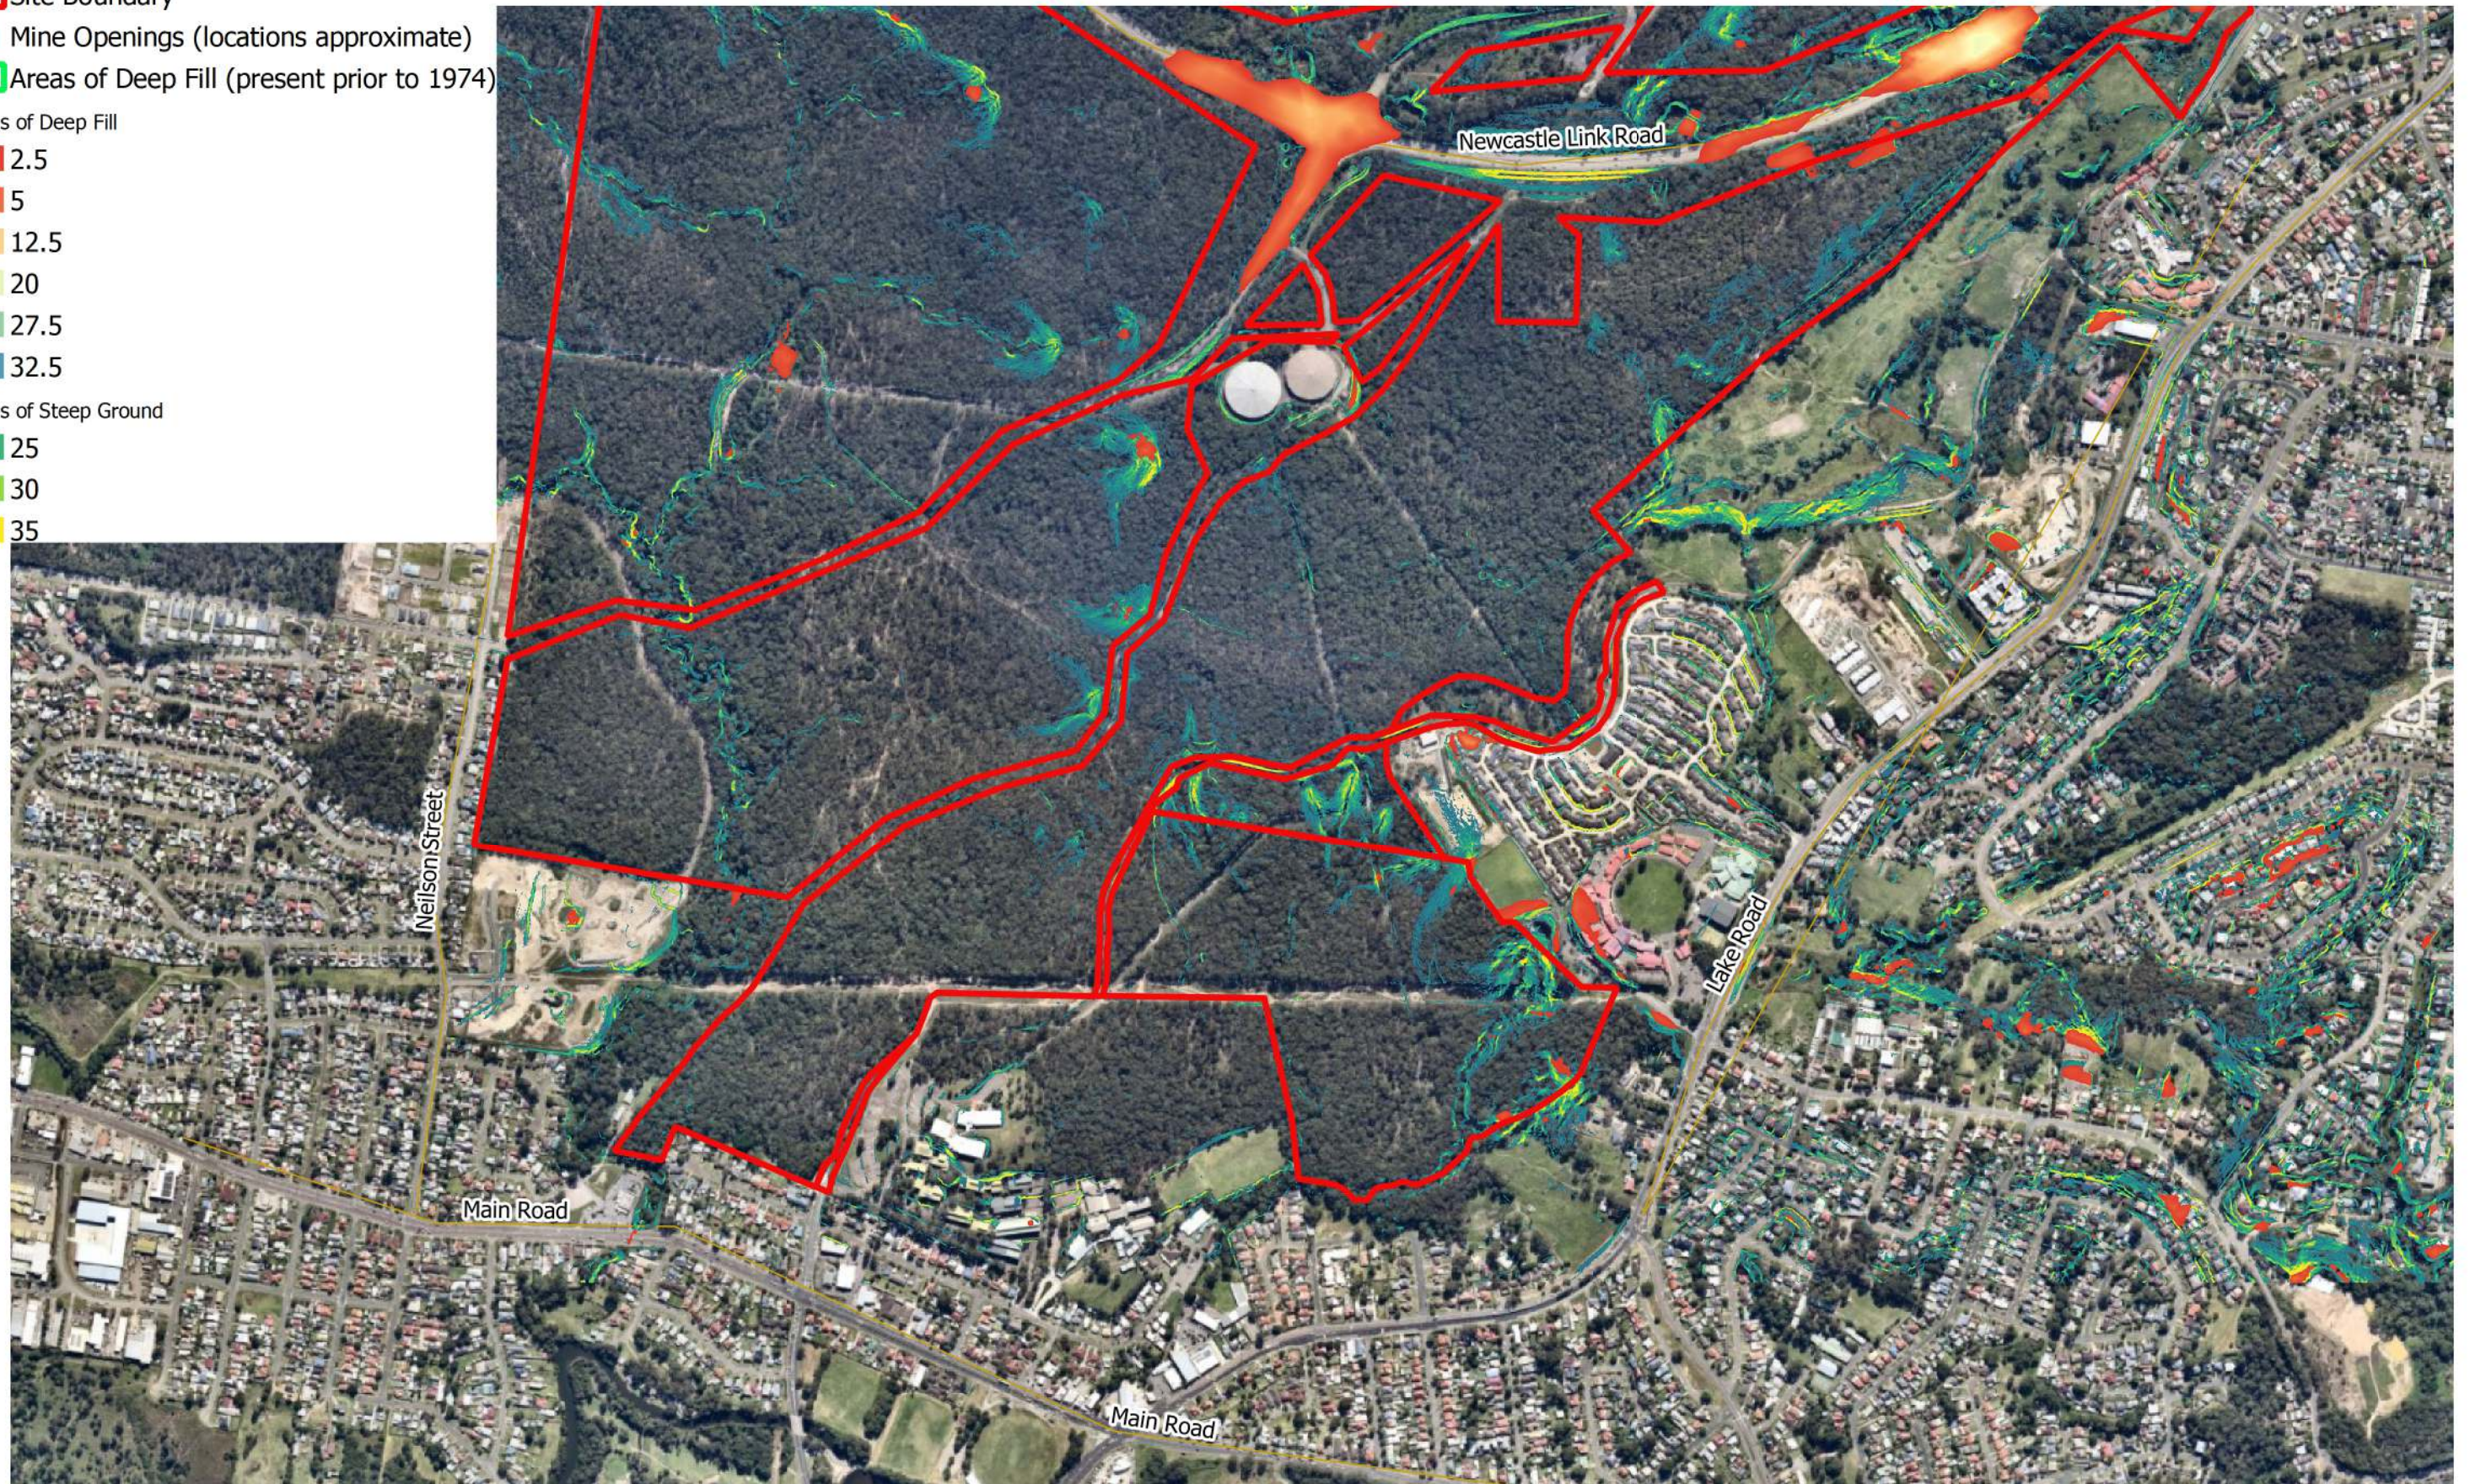
The trial box cut experienced a high wall failure and exposed an ancient landslide of up to 12 m in height overlying the Nobby's Tuff. Some tension cracking was observed in the steep ground upslope of the former trial box cut during the 2020 inspection by DP.

The approximate location of these shaft and mine openings are shown on Drawing 8-1 and 8-2 of (DP, 2020a). Further investigation will be required, including subsurface investigation to locate key shafts within these record traces to allow more accurate georeferencing and positioning of mine openings.

Note that additional mine openings and shafts may be present on the site - additional work may be required to identify location and condition of openings

Confirmation of the sealing of these mine openings would be required together with their exact location where not known.
