A Geomorphic Assessment of 'Keyhole Site', Horsley Park, NSW

Flow and Loam Environmental

Report prepared for:
écologique

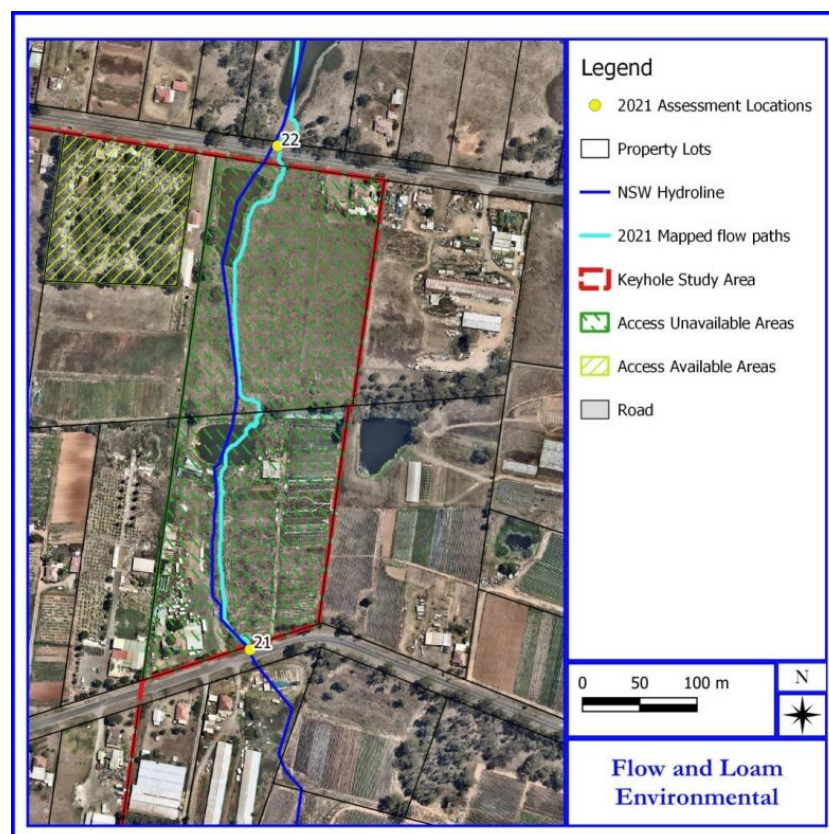
Figure 2. Study Area 1

Desktop interpretation of contemporary aerial photography and DEM indicates that the reach between Chandos Road and Redmayne Road consists mainly of two agricultural dams, their associated spillways and connecting drainage pathways.

Within Area 1 the low gradient and fine grained substrate would normally define a reach of moderate to high sinuosity but the sinuosity here is very low at 1.03 for the Hydroline and 1.13 for the contemporary mapped flow paths.

An existing flow path can be identified from the aerial photographs but it is masked by dense growth of vegetation and its character cannot be determined by aerial photograph interpretation alone. With a very low sinuosity these channels are probably artificial and are essentially agricultural drains.

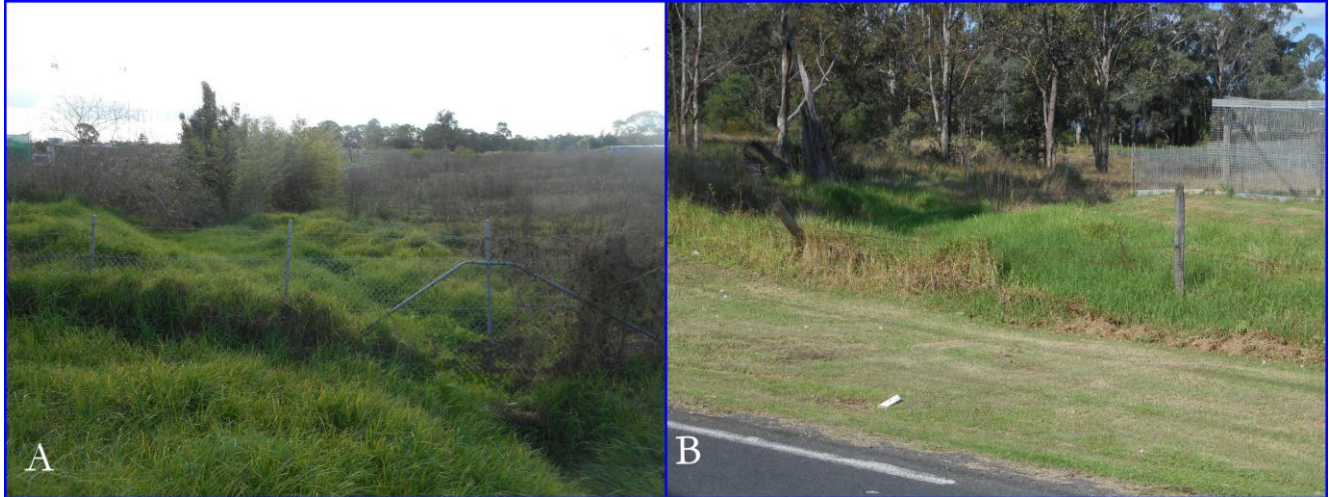
Figure 3. Site 21. 'A' Looking down slope and 'B' Looking upslope

At site 21 there is a very low sinuosity drainage line extending downslope from the road. Upslope, the channel passes around what appears to be an infilled agricultural dam. At road side the channel has a very narrow base with low angle stable banks. The channel cross section is trapezoidal which indicates anthropogenic modification (Figure 3).

Down slope there is a macro channel with width increasing to greater than 12 m. The inset base flow channel is masked by vegetation.

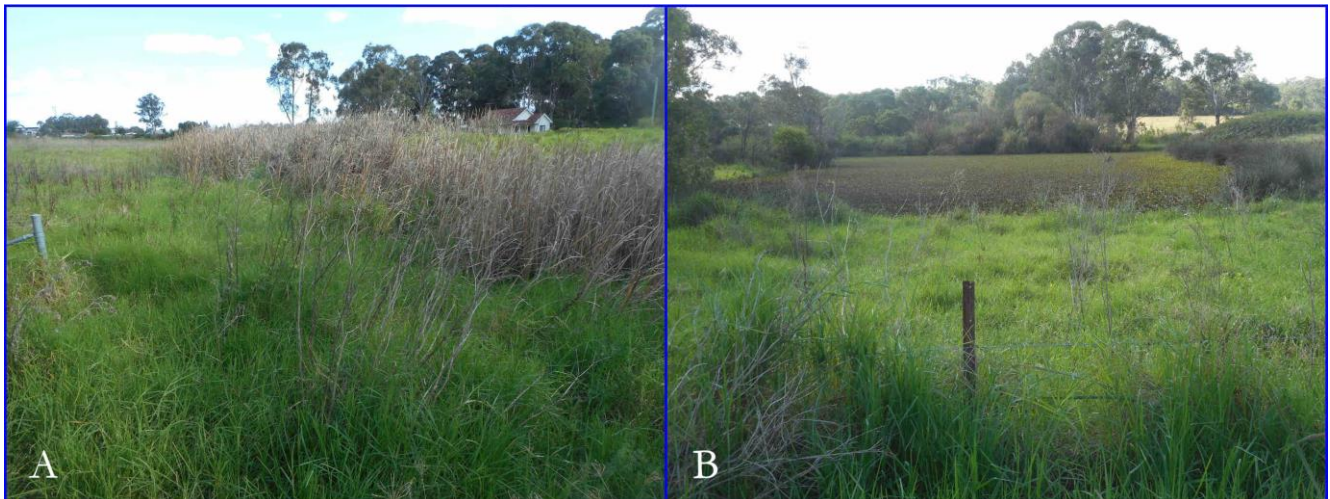
Figure 4. Site 22. 'A' Looking upslope and 'B' looking downslope

At site 22, downslope from the road, there is a minor flow path is less than 2 m wide and is completely obscured by weed infestation. The character of the channel cannot be determined. The flow path leads to weed choked dam down slope (Figure 4).

There is a similar morphology on upslope side of road where the drainage channel from an agricultural dam spillway is choked with rushes.

The upslope channel appears to be narrow, very low sinuosity, and anthropogenically modified.

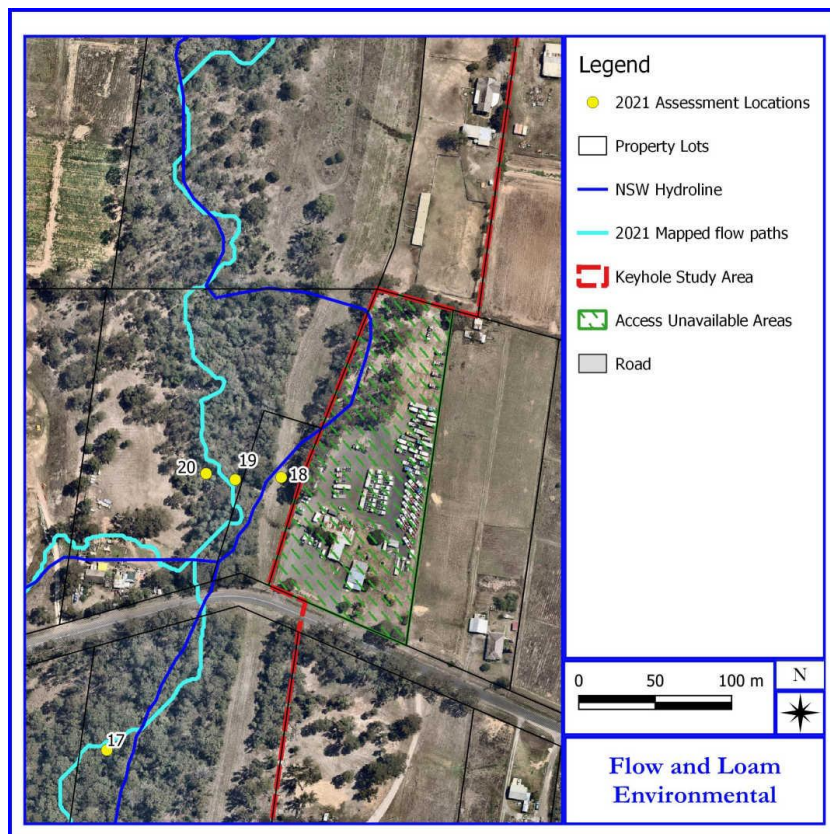
Figure 5. Study Area 2

During desktop assessment there was no evidence found of a channel as at this location extending into Lot 59B. Mapping of the contemporary channel line indicates Eastern Creek as a well defined channel to the west.

An assessment of channel sinuosity for Eastern Creek between Chandos Road and Redmayne Road was completed. The sinuosity of the Hydroline is 1.46 and the sinuosity of the 2021 mapped line is 1.37. The sinuosity for the Hydroline is artificially increased by the meander bend that has been mapped as extending into Lot 59B. This degree of sinuosity indicates a low level of anthropogenic channel modification. Ignoring channel incision processes as a function of changes in catchment hydraulics.

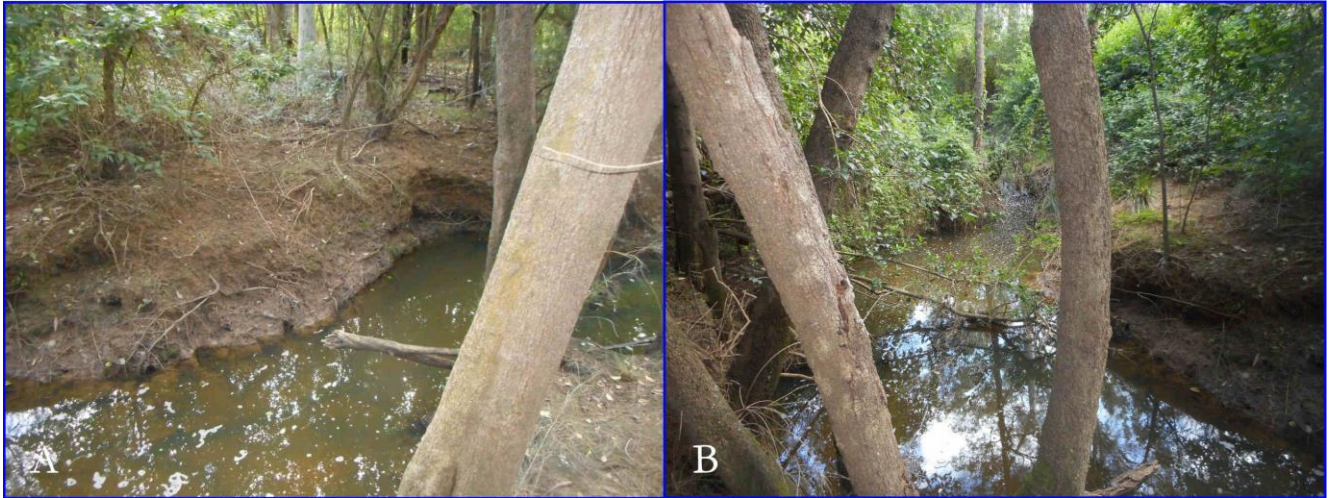
At site 17 Eastern Creek exists as an elongate pool – glide – riffle sequence (Figure 6). Elongated pools and glides are separated by steps in the longitudinal profile varying between 0.40 and 0.80 m. There are three profile steps within 40m of site 17 location. The water surface over the riffles is not broken.

There is a short length of, what may be, remnant floodplain inset within the low flow channel that has a scour feature around tree fall indicating an erosional environment.

Water depth is greater than 1.05 m in places and less than 0.10 m over riffles. The width of channel at water surface is variable from 0.40 m to a maximum of 3 m. The bank height is also variable to a maximum of 3.5 m. Channel width, bank top to bank top is 8 – 10 m.

Figure 6 Site 17 'A' Looking downstream and 'B' looking upstream

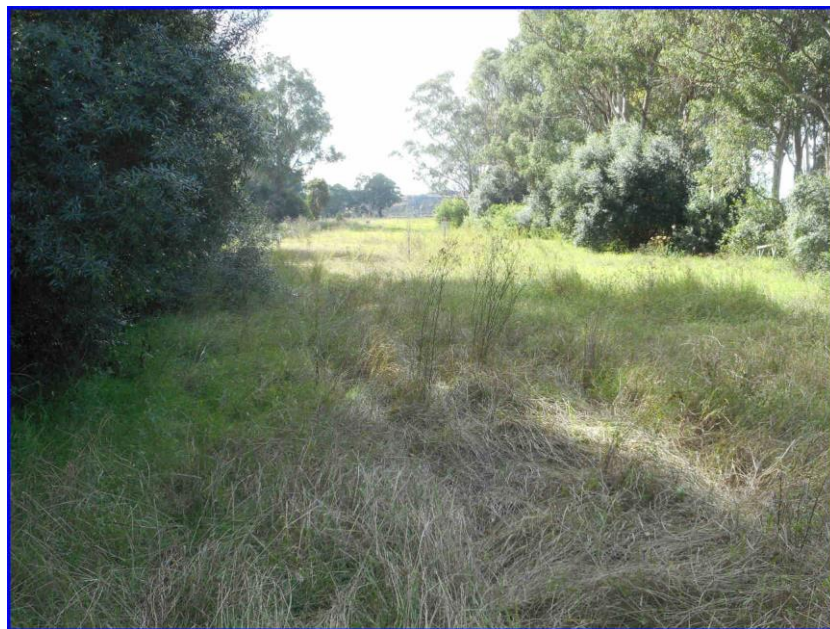
Often, where channels are realigned for some reason, the old pre-existing channel is filled in. However, over time, there is often faint surface morphology reflecting the position of the old channel as the fill settles.

An assessment of historical aerial photography may reveal a pre-existing channel here but there is no indication or evidence of any pre-existing channel.

Figure 7 Site 18 looking down slope to the location of the Hydroline meander bend.

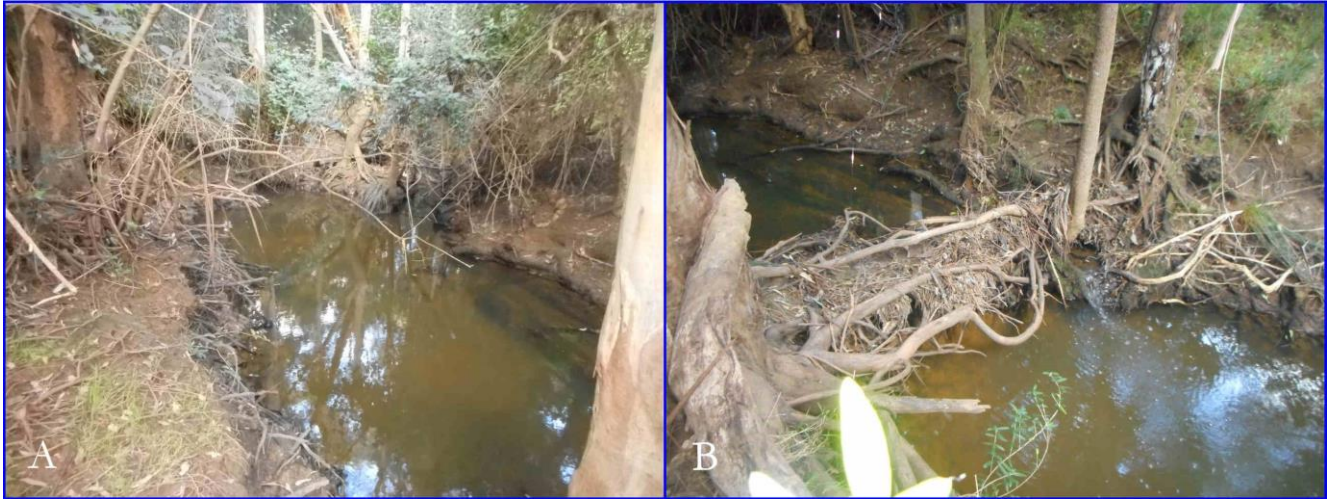
Multi phase, sub-vertical banks extend to 3.5 m; the channel width at water level varies between 4 and 5 m and the channel width from bank top to bank top is variable between 7 and 9 m. The banks are erosional.

At proximal bank top, right bank, there are scour zones and litter dams in and around vegetation indicating recent overbank flows and that the channel is still coupled with the floodplain..

Figure 8. Site 19. 'A' looking upstream over a pool and 'B' showing a step in the longitudinal profile that has formed at roots crossing the channel

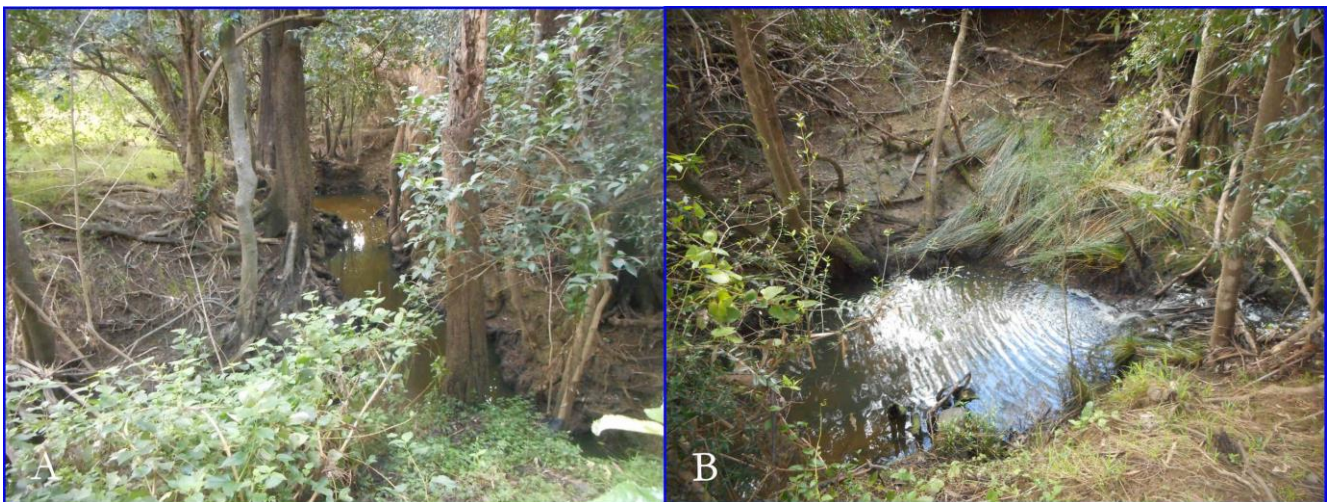
There are scour zones proximal to right bank top indicating recent overbank flows.

There is opportunistic deposition of sediment in backwater of small tributary at left margin.

Figure 9. Site 20. 'A' Looking upstream over an elongate pool and 'B' Riffles over root dam in base of channel

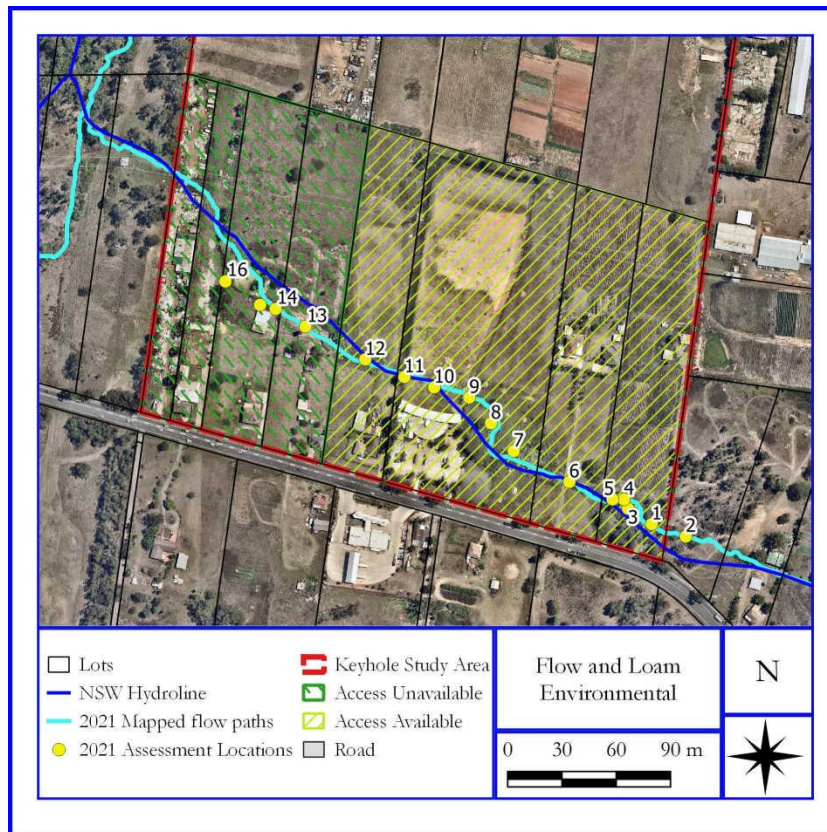
Figure 10. Study Area 3

The NSW Hydroline extends through the study area and upslope for another 360 m. The contemporary 2021 mapped channel also extends upslope of the study area for another 170 m.

Desktop review and analysis of the aerial photography reveal a channel with remarkable little variation of character and morphology. Channel sinuosity was measured from the confluence with Eastern Creek to the maximum upstream extent of the mapped channels. The sinuosity of the Hydroline is 1.04 over a channel length of 1125.3 m. The sinuosity of the 2021 mapped channel 1.11 over a channel length of 962.3 m. Both sinuosities are very low and are indicative of a highly modified channel.

Aerial photograph interpretation reveals what appears to be partially artificial channel and partly intact channel, especially in the upper reaches.

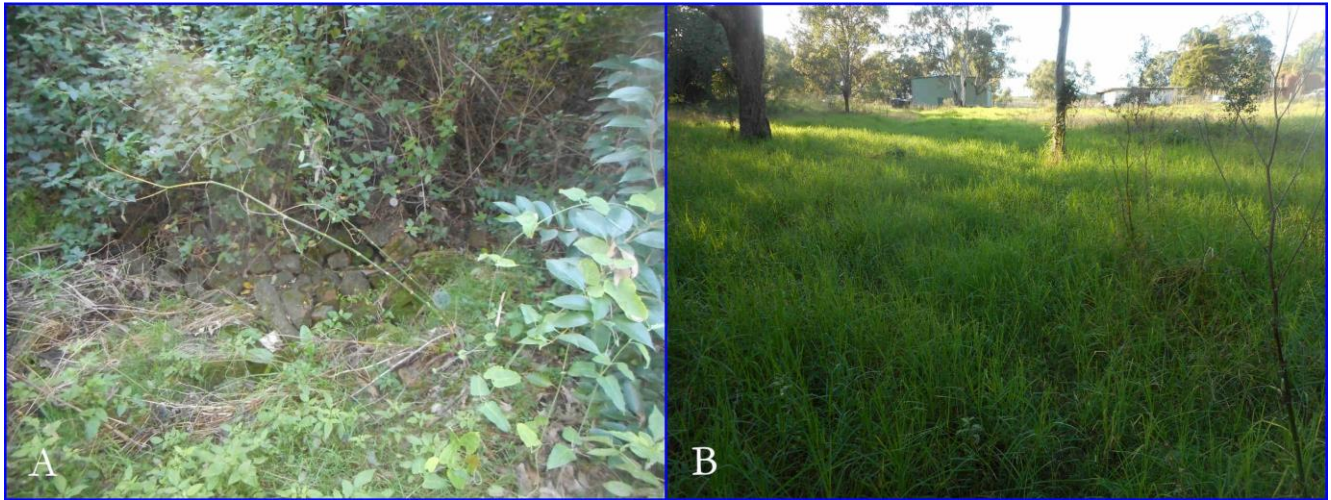
There is a short length of channel between site 5 and the upper boundary of the study area that has remnant chain of ponds morphology with a continuous channel. The channel ends at the boundary between Lots 73B and 81B which is also the boundary of the study area. At this location the defined channel and has been stabilised by rock fill (Figure 11A). Site 2 is located outside of the study area upslope on an area where there is no defined channel (Figure 11B).

The low flow channel through this reach is well defined with low angled and well vegetated banks. At some locations the banks appear to be two stage which may indicate the passage of a knickpoint through this reach.

Figure 11. 'A' shows knickpoint stabilised by rock fill. Defined channel ends here. 'B' is looking up slope from Site 2; no defined channel

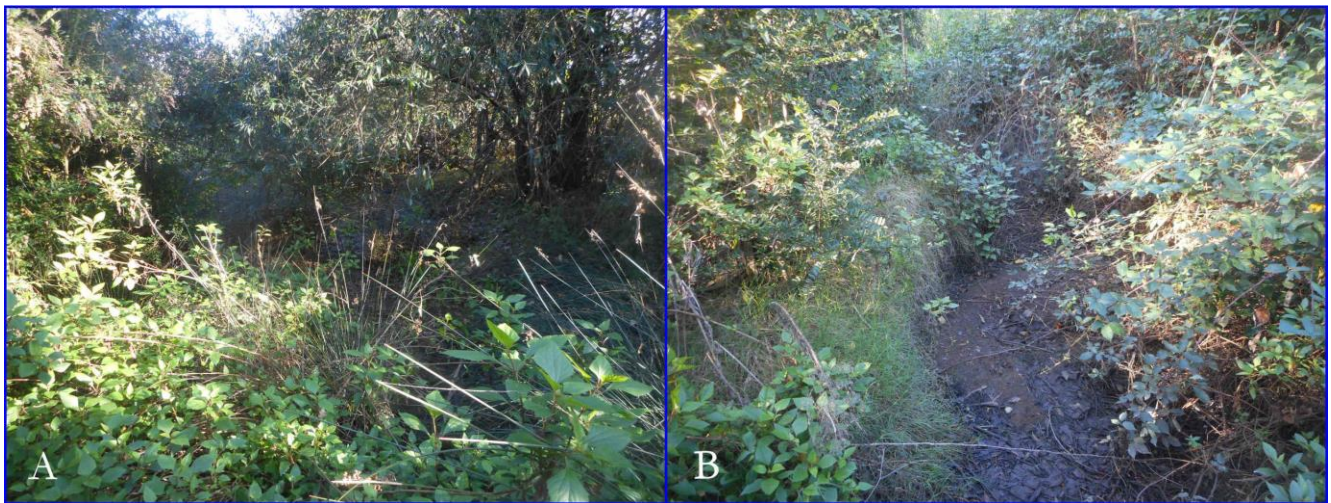
There is also some remnant pond morphology at site 3 where the channel widens out from 2 metres in width to more than 8 metres. The stagnant water that was evident at site 1 is not in evidence here. The channel and pond base has been dry for an extended period.

Sediment spear testing at sites 3 and 4 penetrates easily, with very little resistance to 1.05 m. There is a narrow, sub-horizontal, floodplain pocket at bank top left bank that has sediment over saprolite to 0.40 m as indicated by sediment spear testing.

Figure 12. 'A' looking upstream along the tributary towards site 4 and 'B' the tributary joining from left margin with recent deposition in the base of the channel

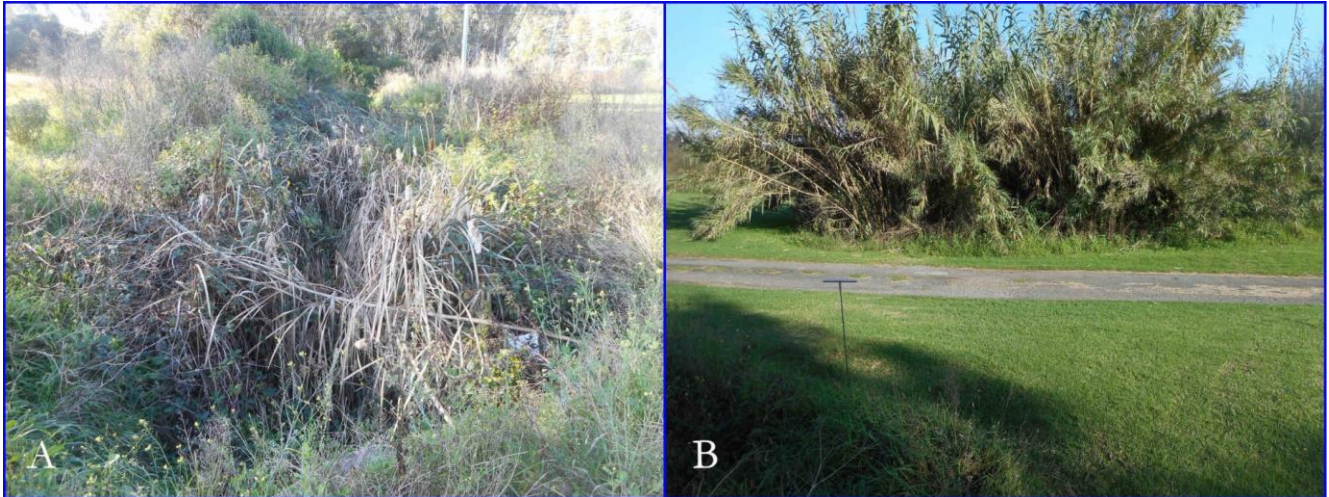
There is a suspiciously straight channel extending upslope of crossing. A straight channel in this environment indicates anthropogenically modified channel or an artificial channel. Sub-vertical banks to 3 m high are vegetated and stable. The channel width, bank top to bank top, is between 5 and 6 m.

Figure 13 'A' looking upstream from site 6. 'B' looking downstream from site 6. In both instances the channel is straight and choked with weed infestation.

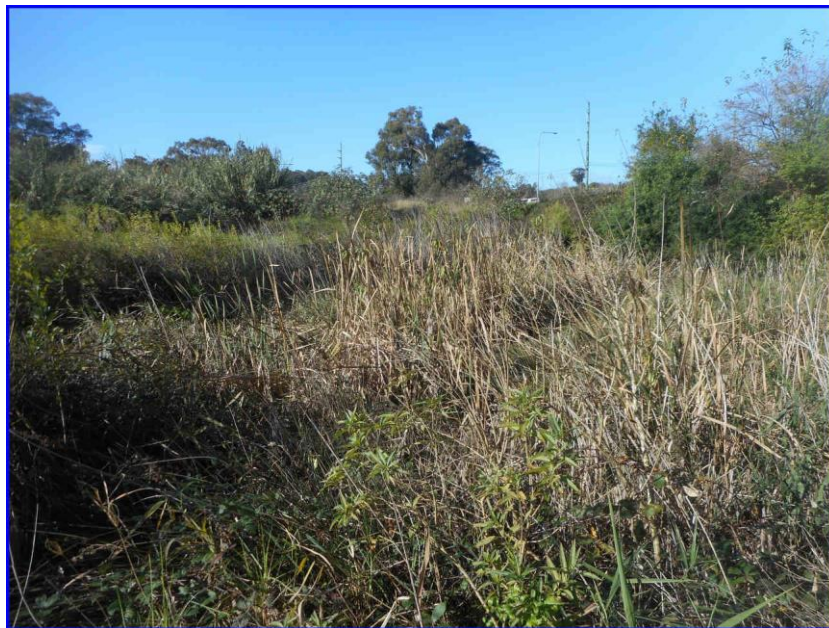
Access to the channel zone downstream of site 6 is extremely difficult and limited by abundant and dense weed growth, notably blackberry. Site 8 is located on an old dam wall and is looking upstream.

Figure 14 Site 8 looking upstream across the impoundment of the old agricultural dam that is now choked with weeds.

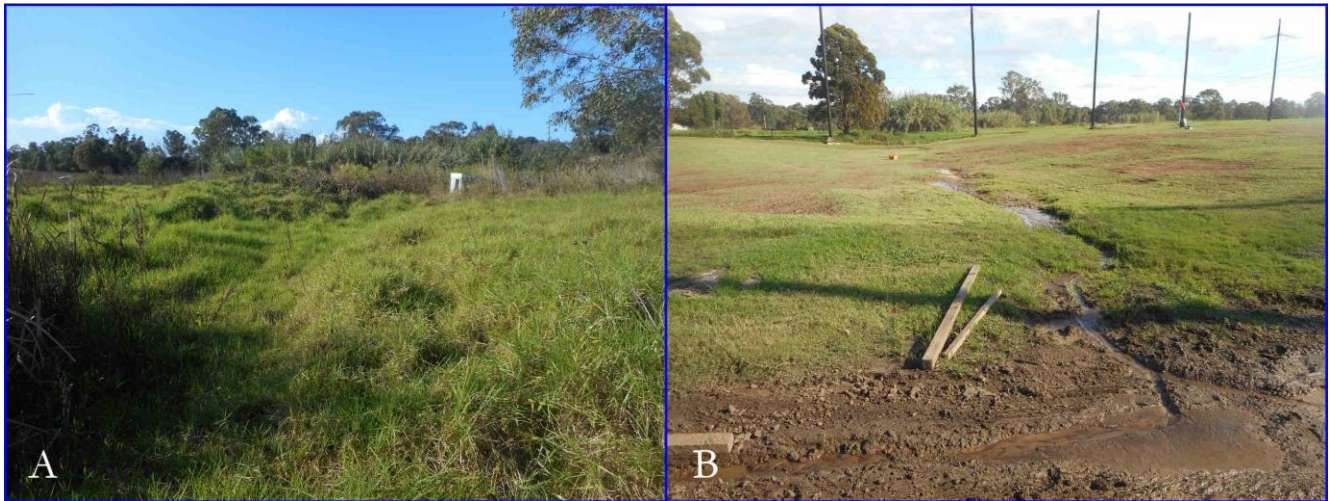
The upstream intake of the pipe is located between site 8 and site 9 but this area is completely overgrown and the exact location was unable to be determined. Most flows are diverted underneath the driving range through a subterranean pipe. There is a surface inlet grid at site 10 and at site 11. The end of the piped section is between sites 11 and 12 but is obscured by vegetation.

There is a surface low flow channel that has a low to moderate sinuosity with remnant ponds morphology. The low flow channel has a low capacity and discontinuous banks to 0.30 m. Flows that are unable to be contained within the pipe flow across the surface of the golf range. Interrogation of the historic aerial photography for 1978 (Appendix 3) show an agricultural dam at this location.

Figure 15. Location is site 9 at golf range boundary. 'A' is looking upstream to site 8 and 'B' is looking downstream to site 10.

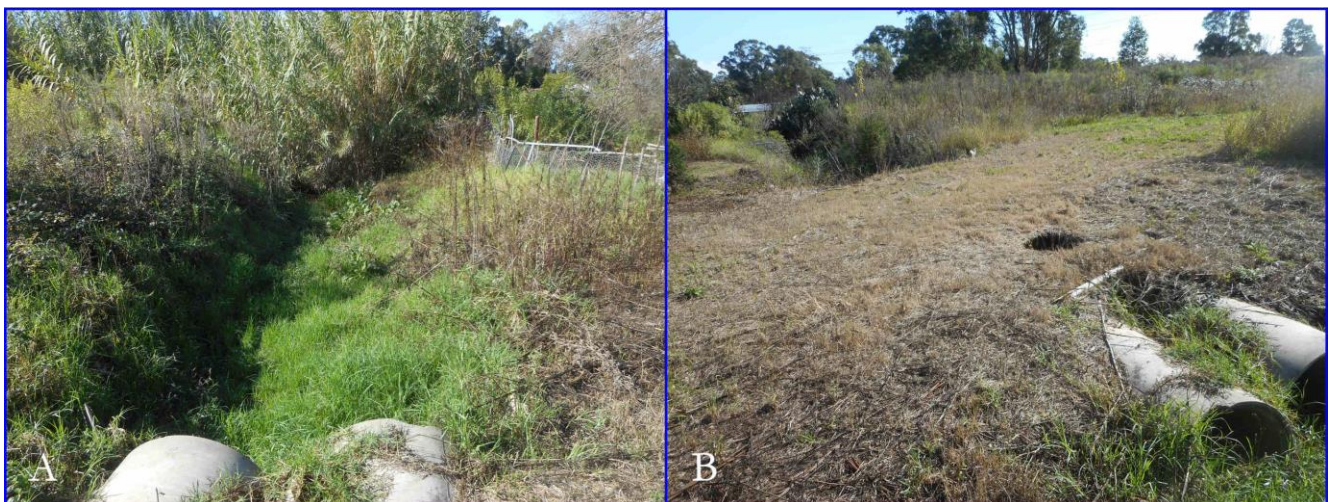
There is a very low sinuosity channel that shows evidence of anthropogenic realignment. Most of this reach was unable to be viewed and was largely inaccessible due to the abundant growth of blackberry, and other weed, obscuring the channel.

Figure 16. Site 13. Artificially straightened channel extending upstream 'A' and downstream 'B'

Further channel straightening and piping has occurred at sites 13 and 6. The channel has a very low sinuosity and is generally in a very poor condition.

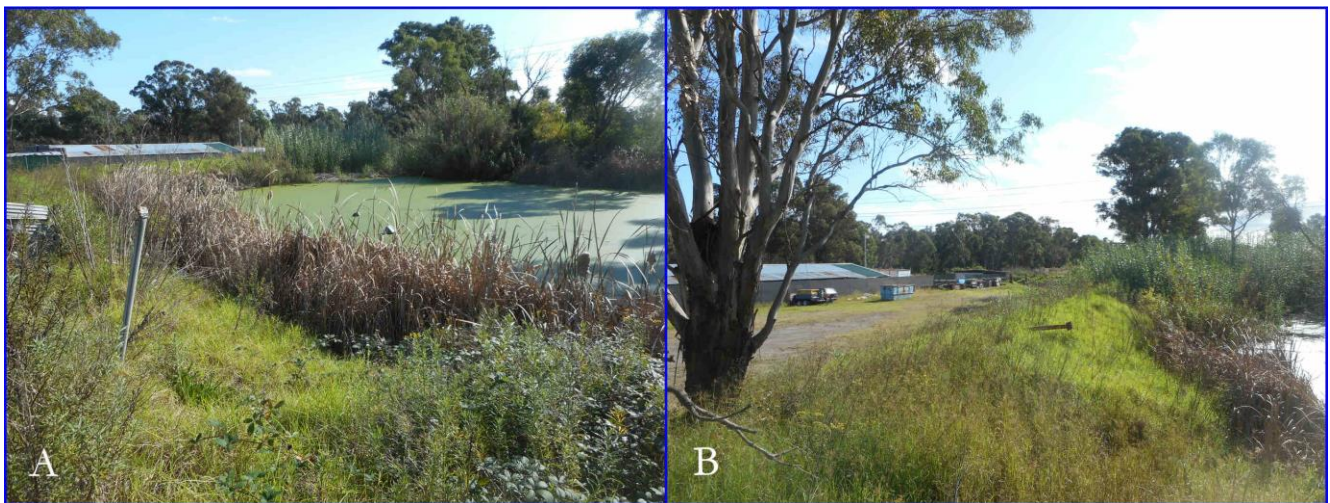
Agricultural dam (Figure 17). The channel ends where it flows into the dam at site 15. Site 16 is at the dam wall at property boundary.

Figure 17. 'A' Looking downstream from site 15 across the dam and 'B' is looking across the dam wall to a highly modified zone of degraded channel
