HERITAGE ASSESSMENT, WILLOW RUN, 105-119 BONG BONG ROAD, MITTAGONG

ATTACHMENT 1. CURRENT PHOTOGRAPHS. All photographs: Paul Wallace.

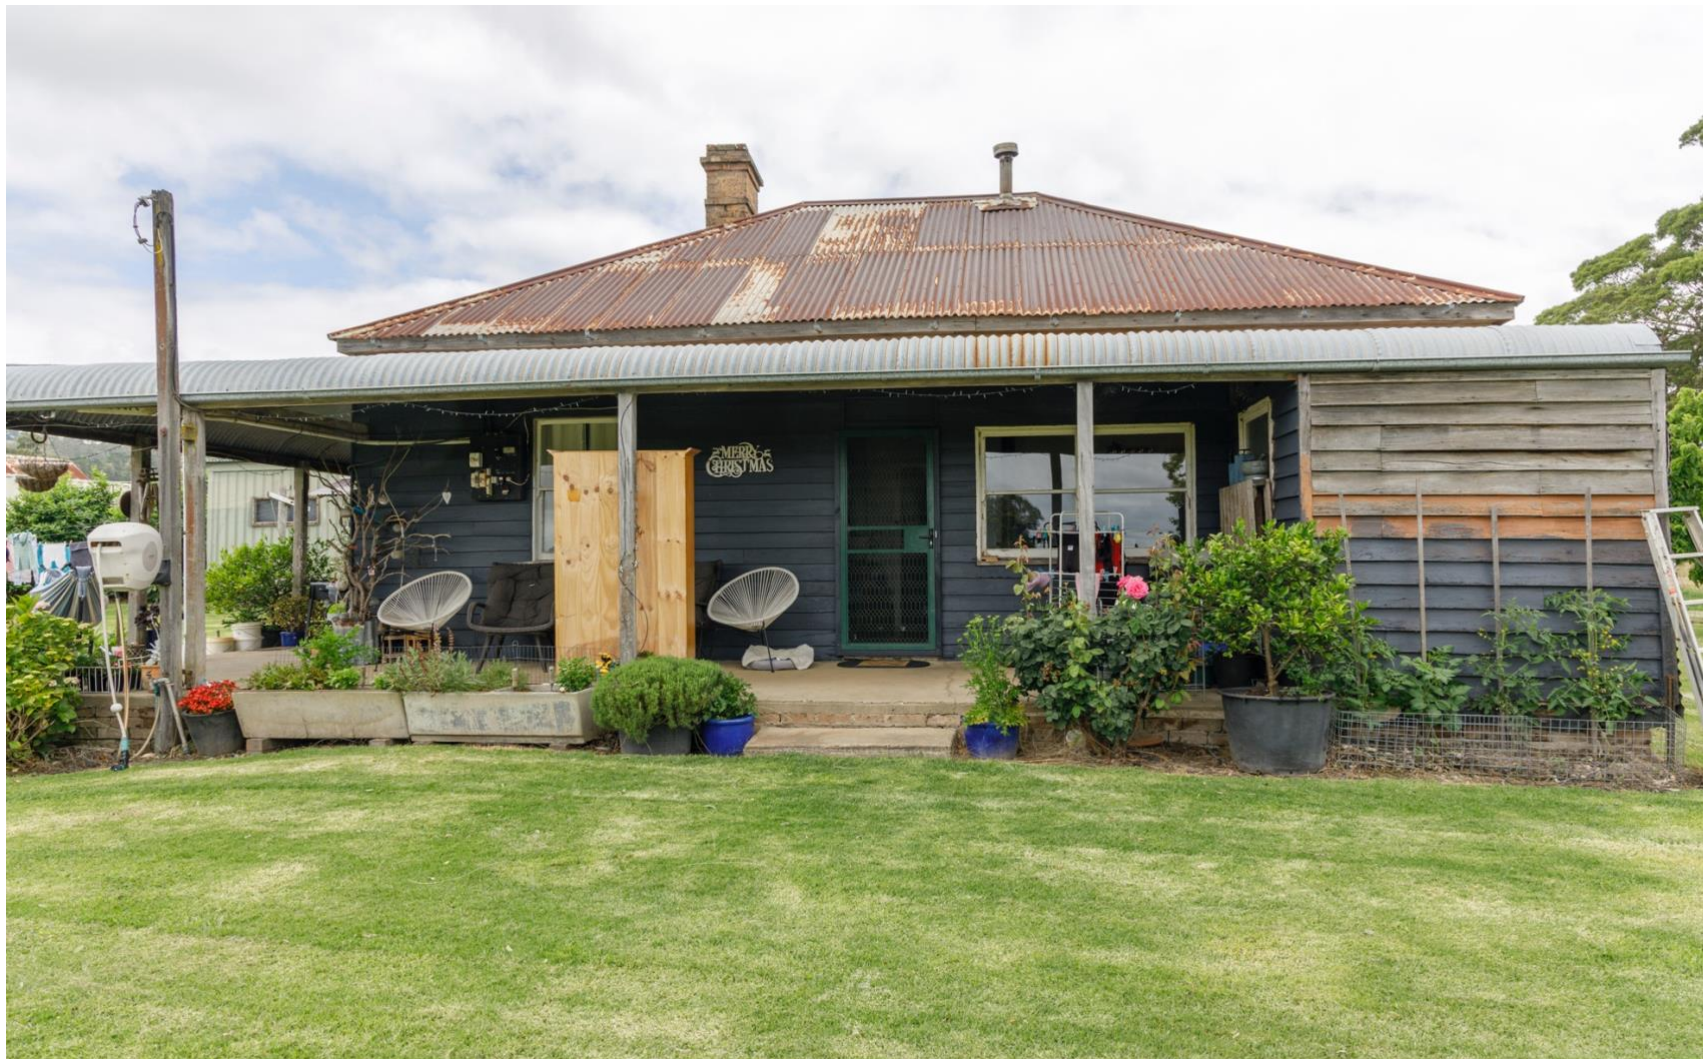
Figure 1. Homestead building, Willow Run, front (north eastern) view (no. 7)

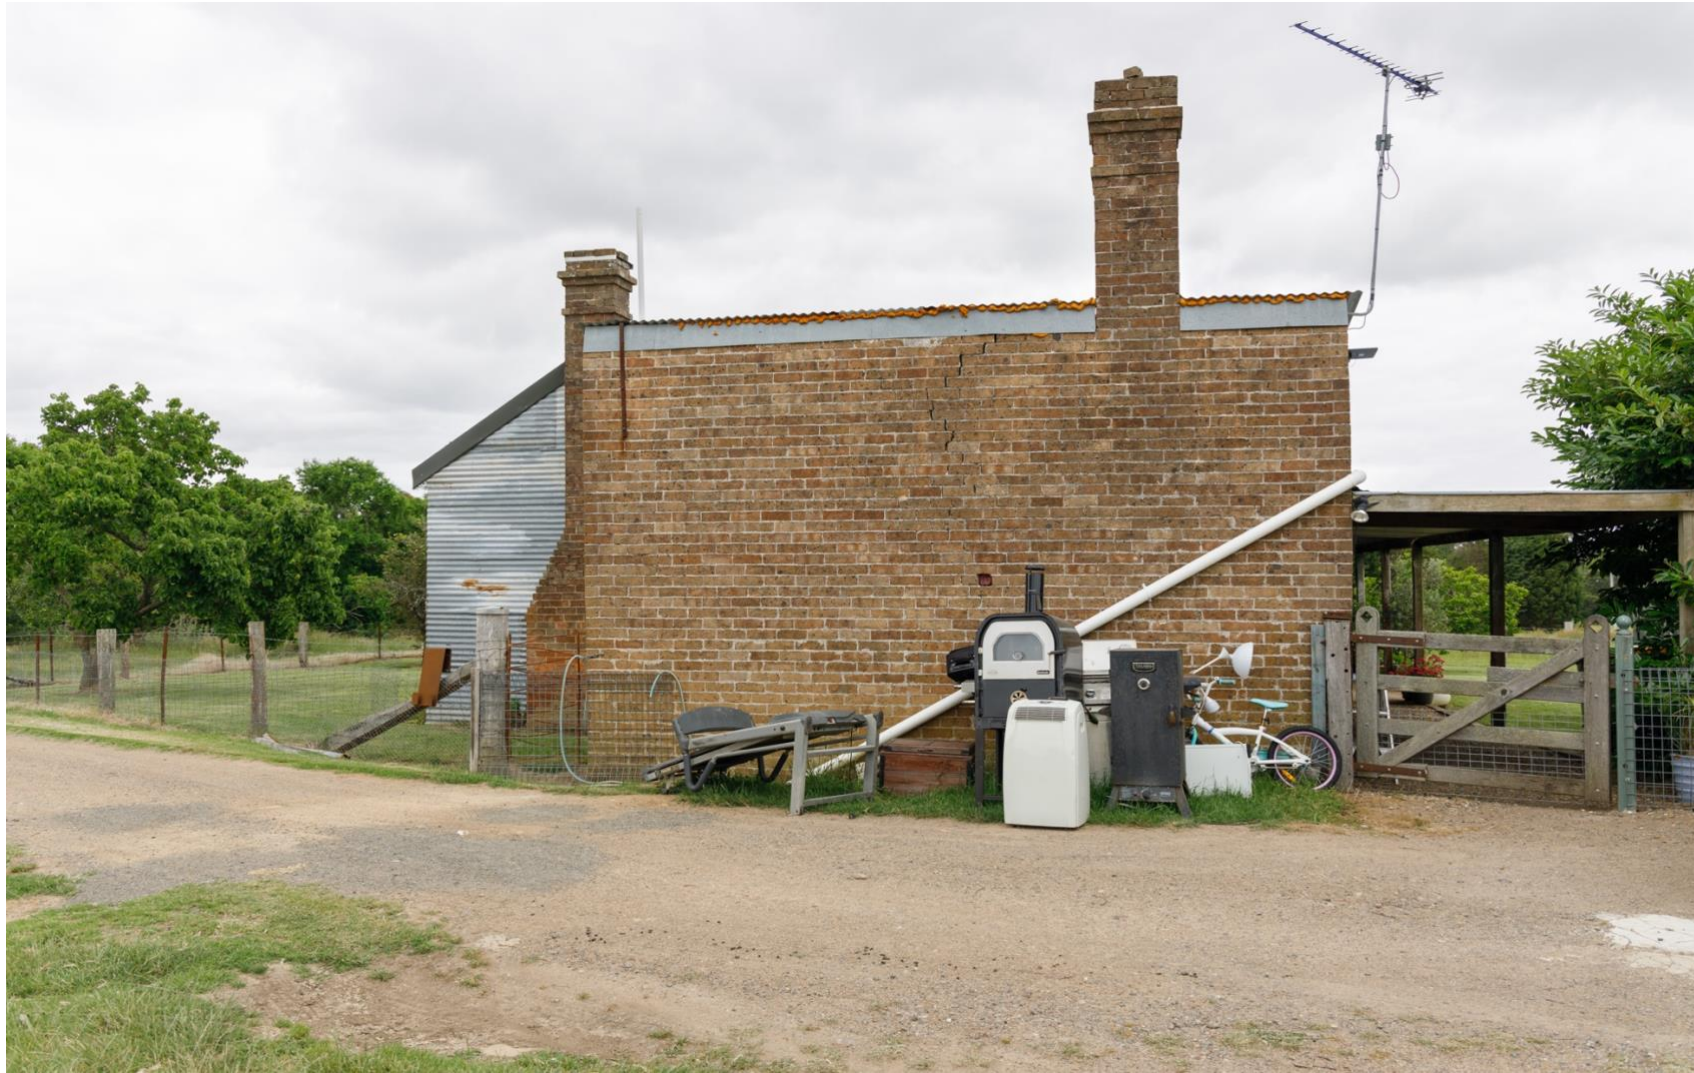
Figure 2. Homestead building, Willow Run, rear (south western) view – sole driveway access (Osage Orange trees at left of photo) (no. 9)

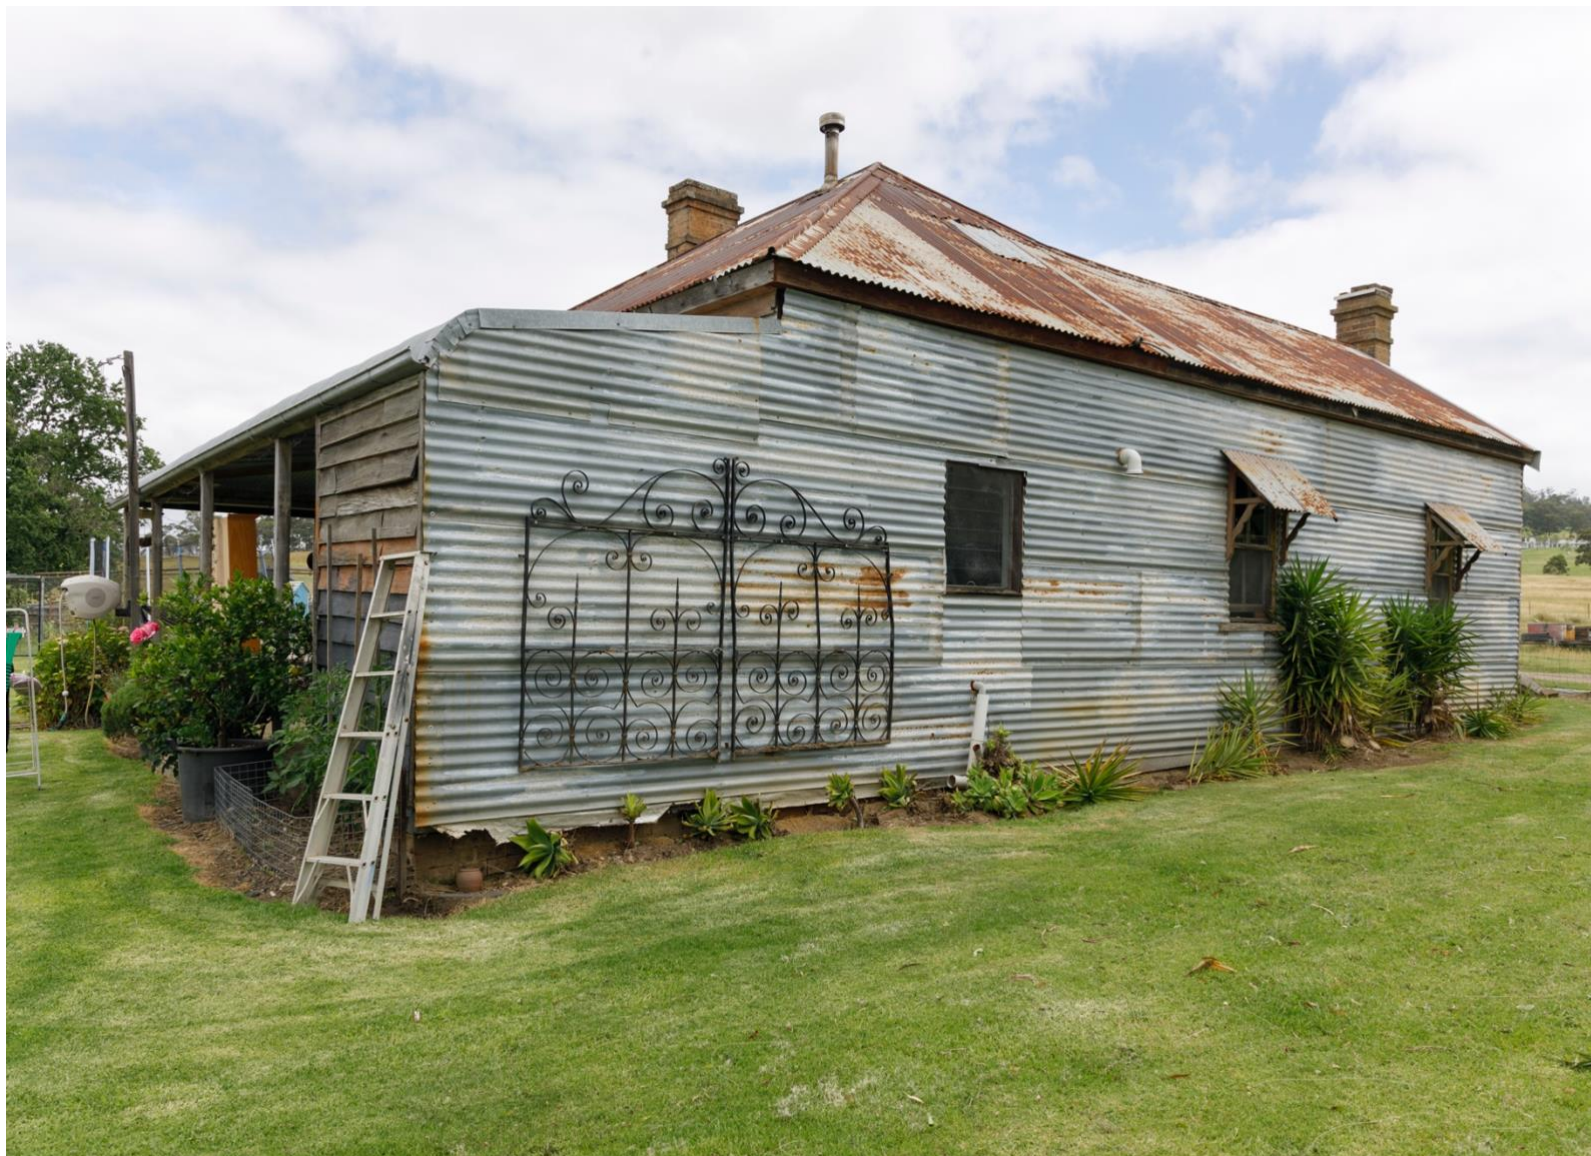
Figure 3. Homestead building, Willow Run, north western side (no. 4)

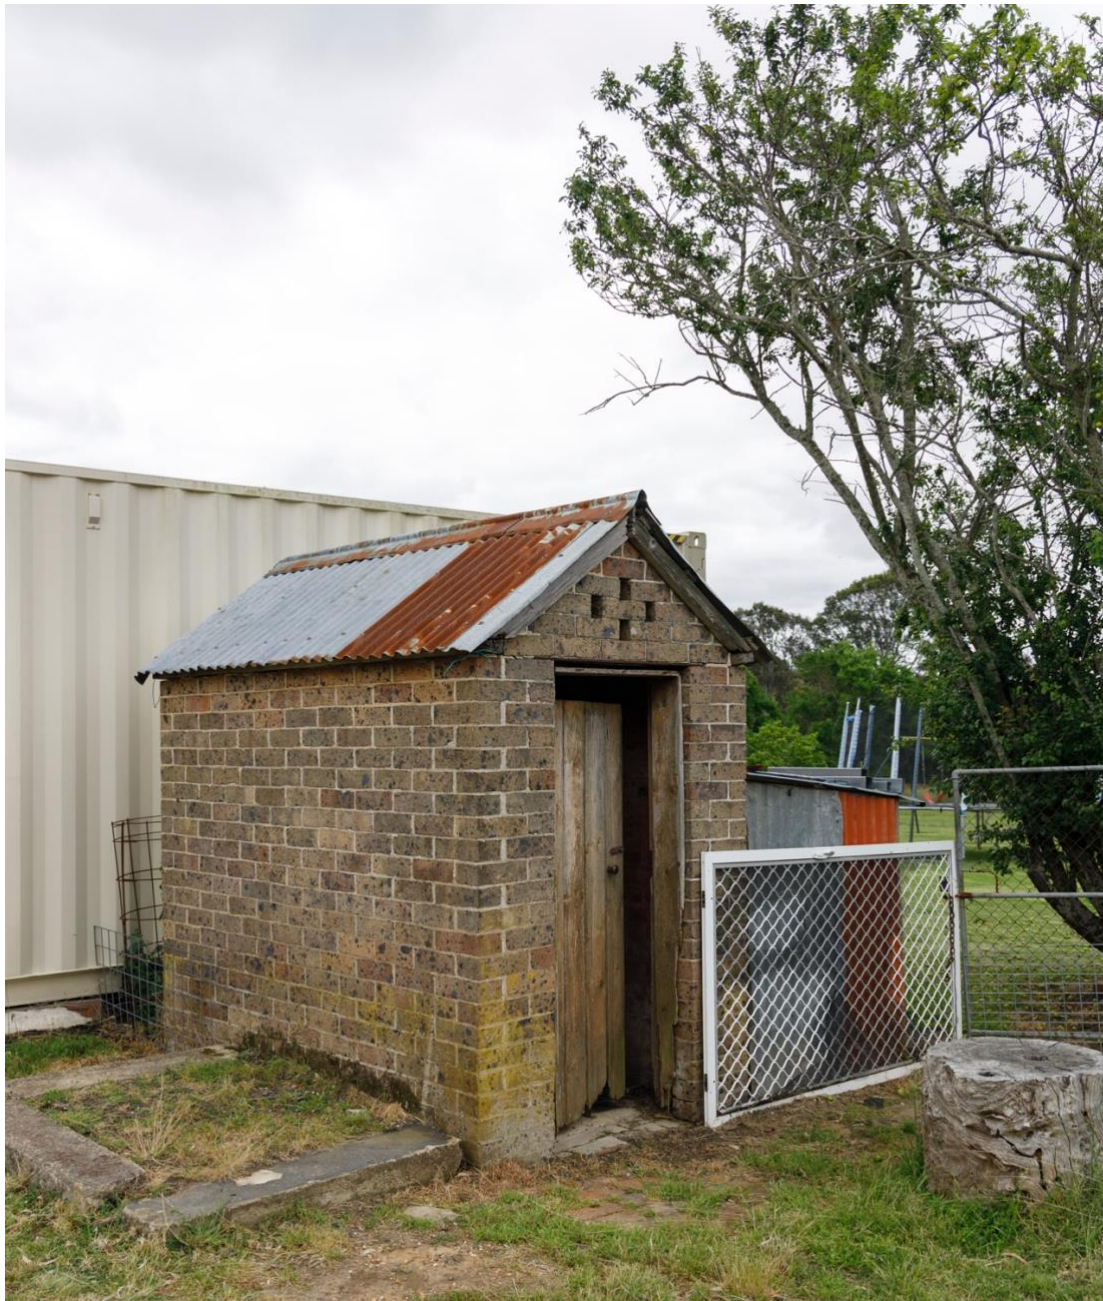
Figure 4. Toilet building near homestead (eastern side), Willow Run (no. 17)

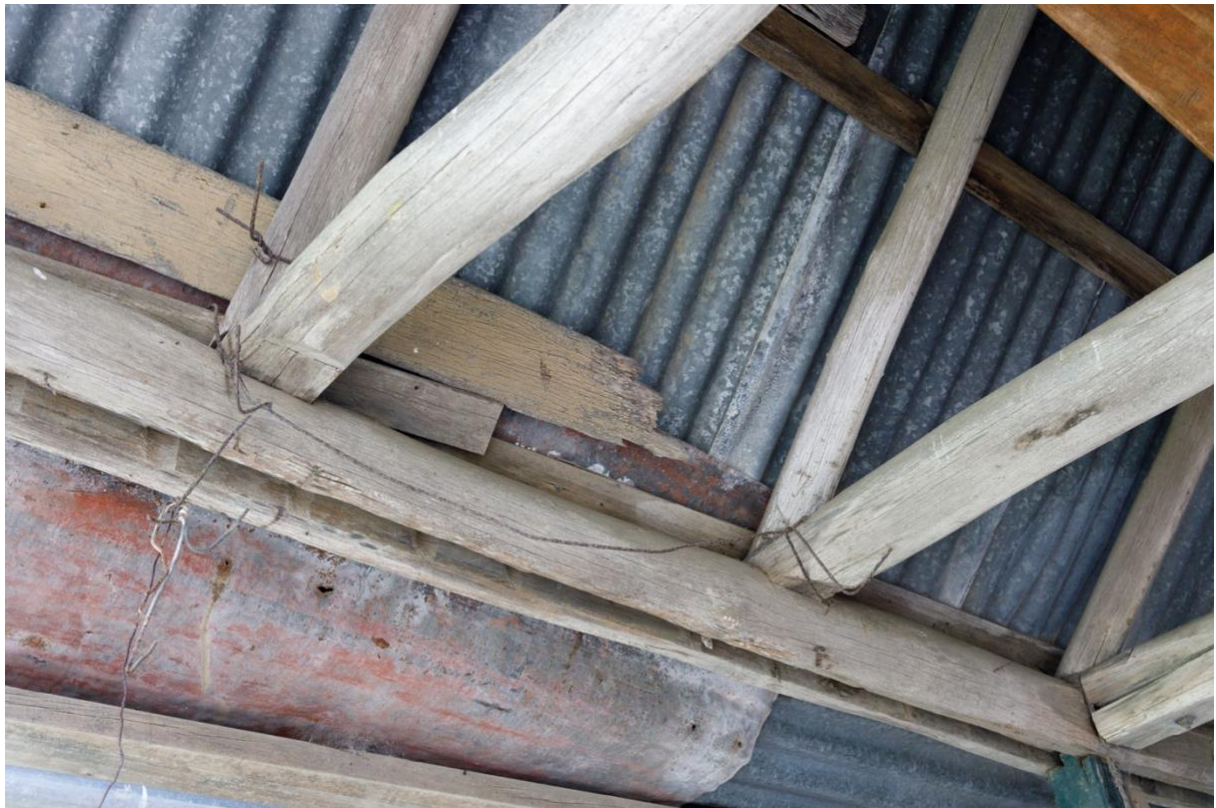
Figure 5. Shed building, showing recessed rafters in roof, near homestead (south eastern side), Willow Run (no. 13)

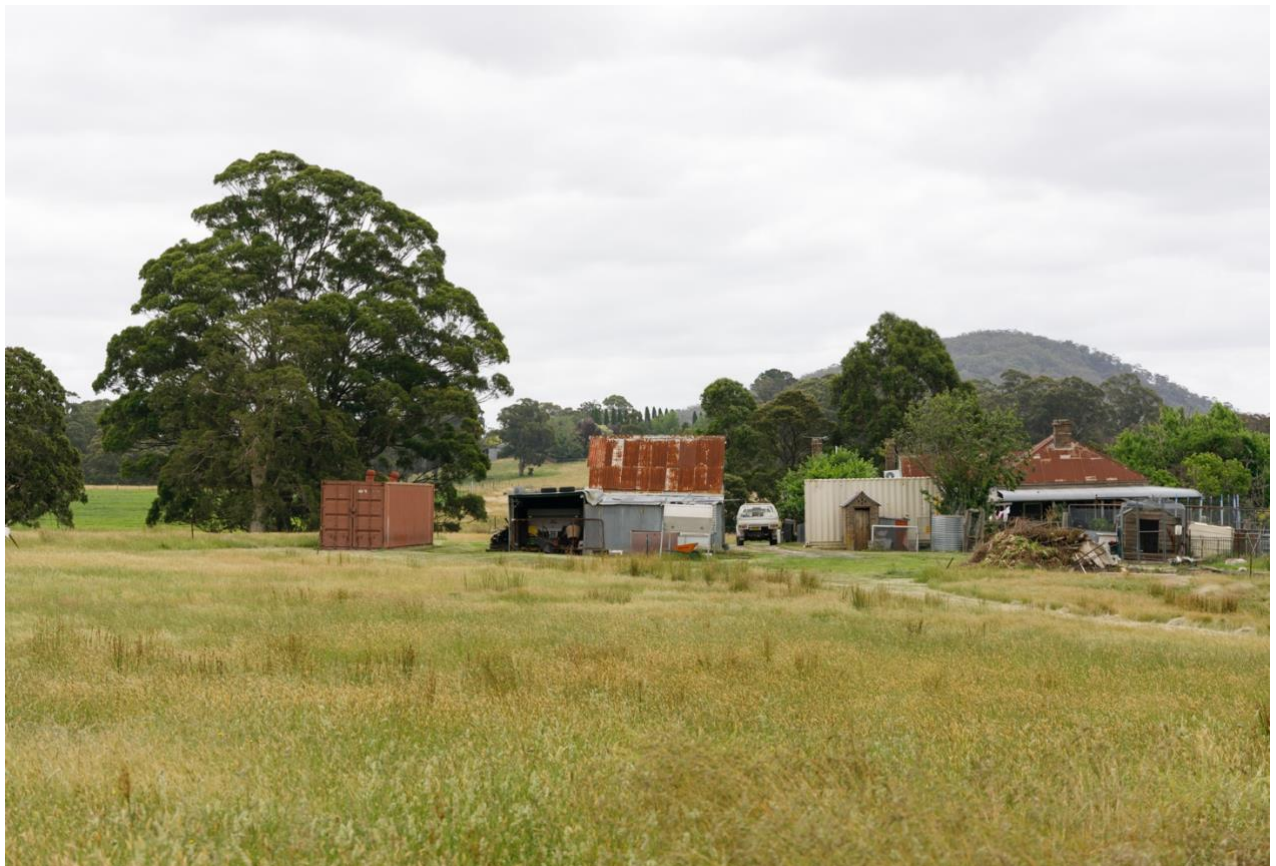
Figure 6. View to shed and eastern side of homestead, Willow Run (no. 23)

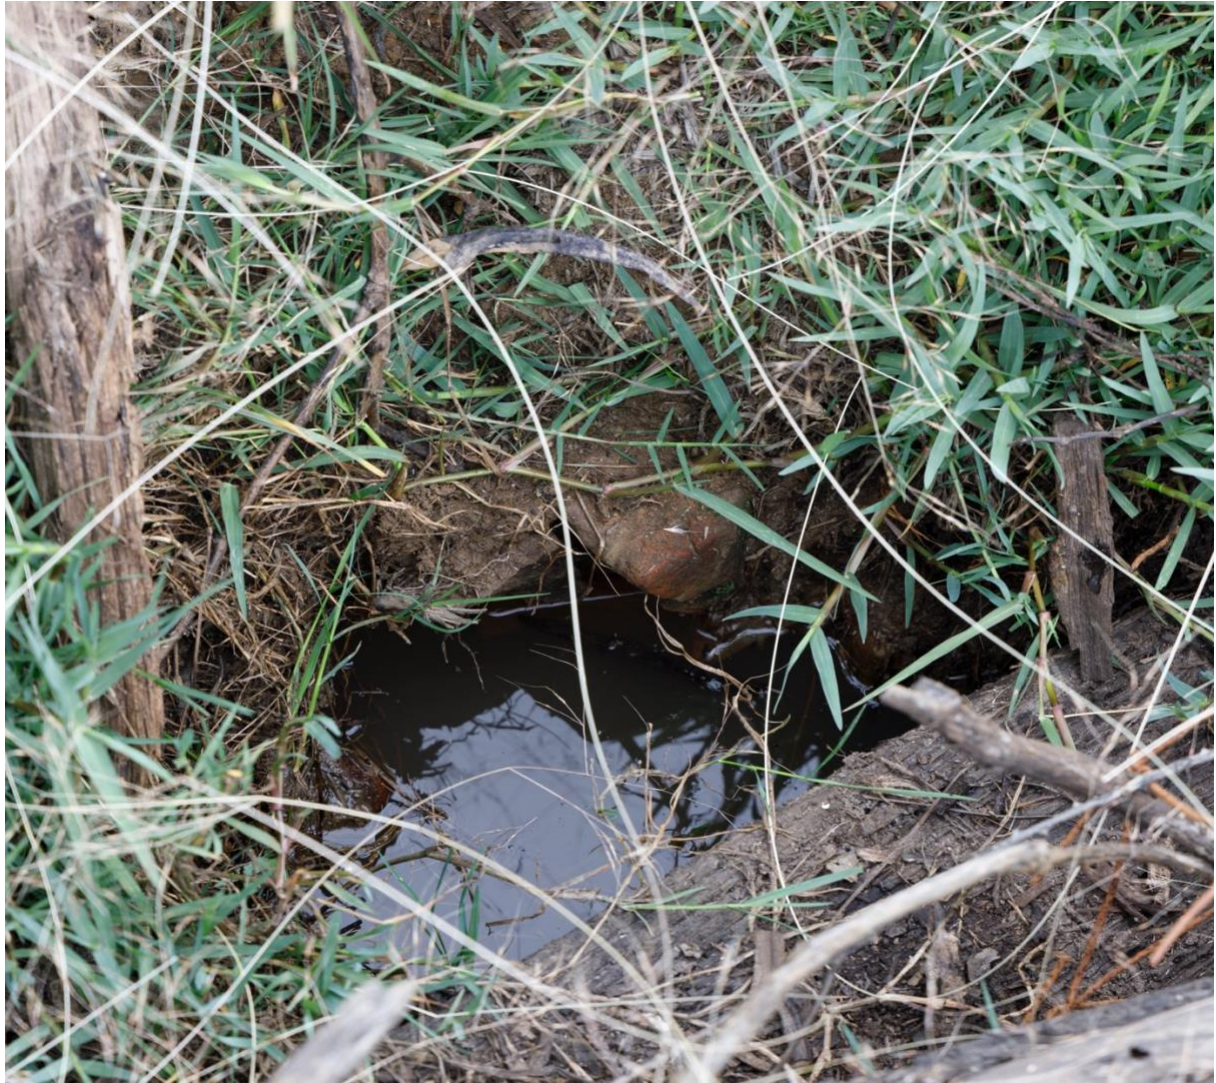
Figure 7. Well at south western side of homestead, Willow Run (no. 32)

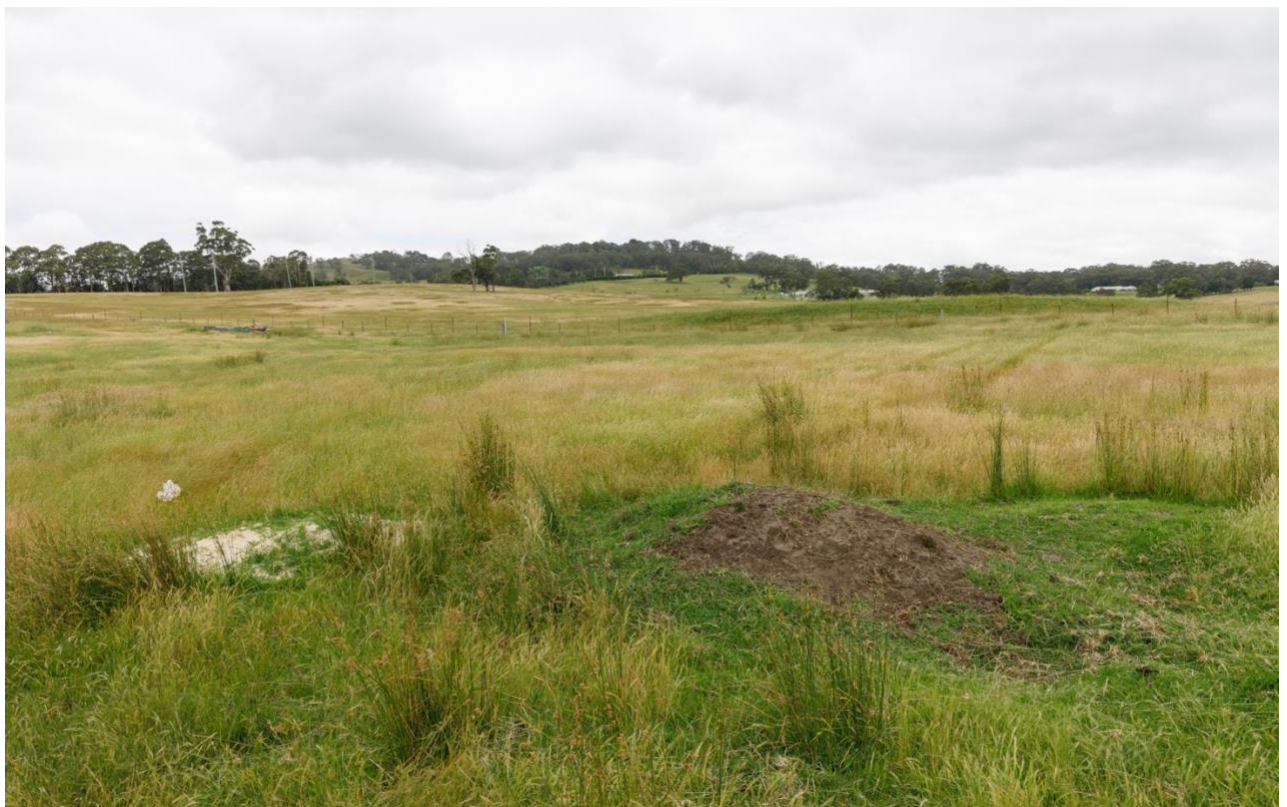
Figure 8. Well (filled in) at south eastern side of homestead, Willow Run (no. 14)

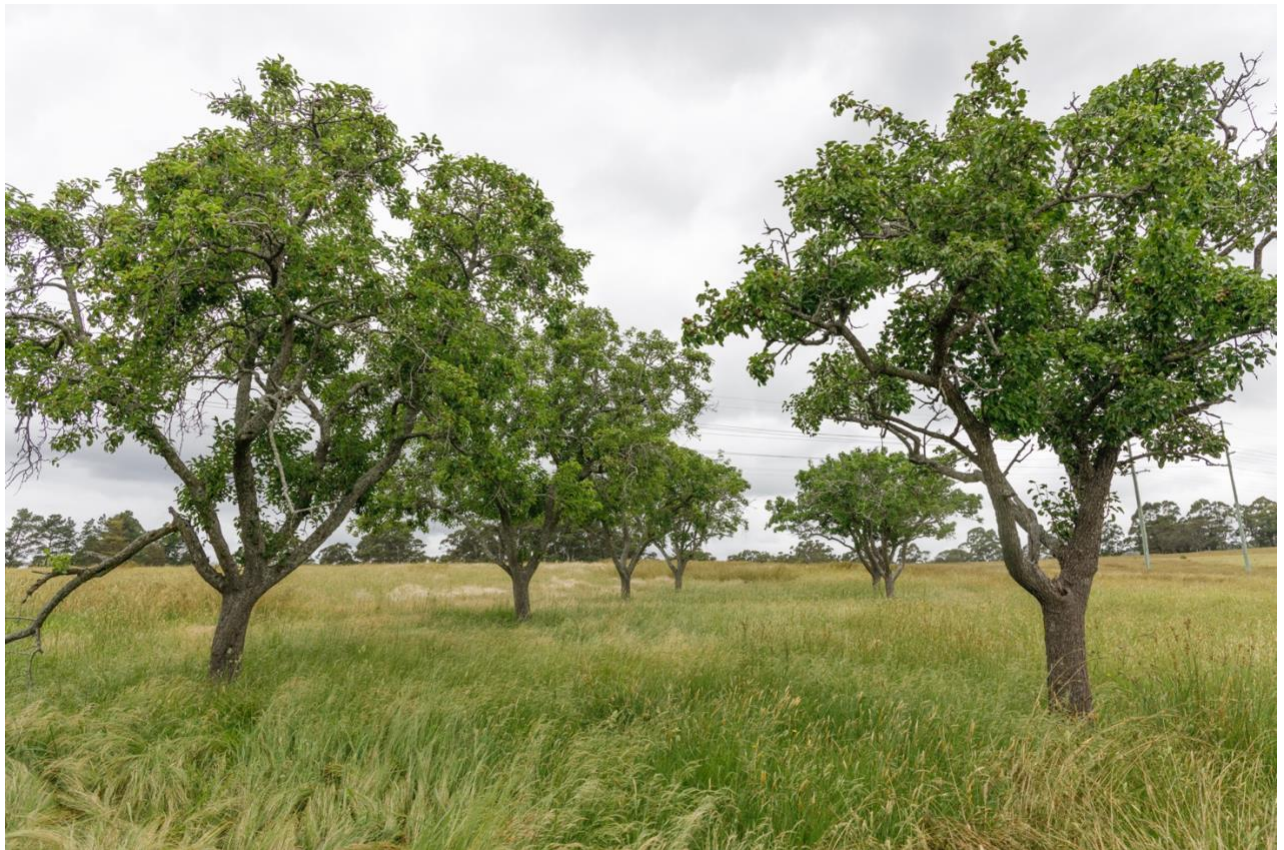
Figure 9. Orchard, located north-east of homestead, Willow Run (no. 19)

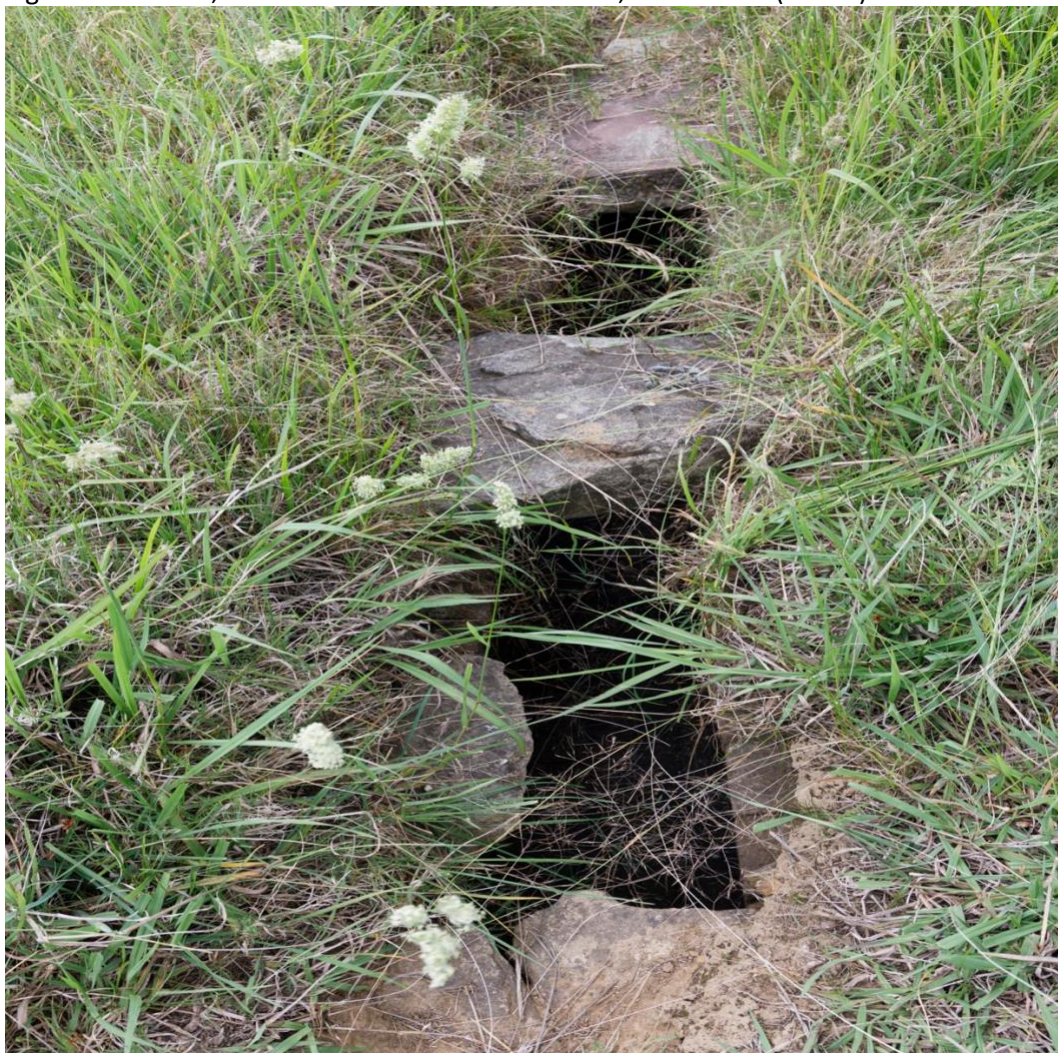
Figure 10. Drainage channel, located north-west of orchard, Willow Run (no. 16)

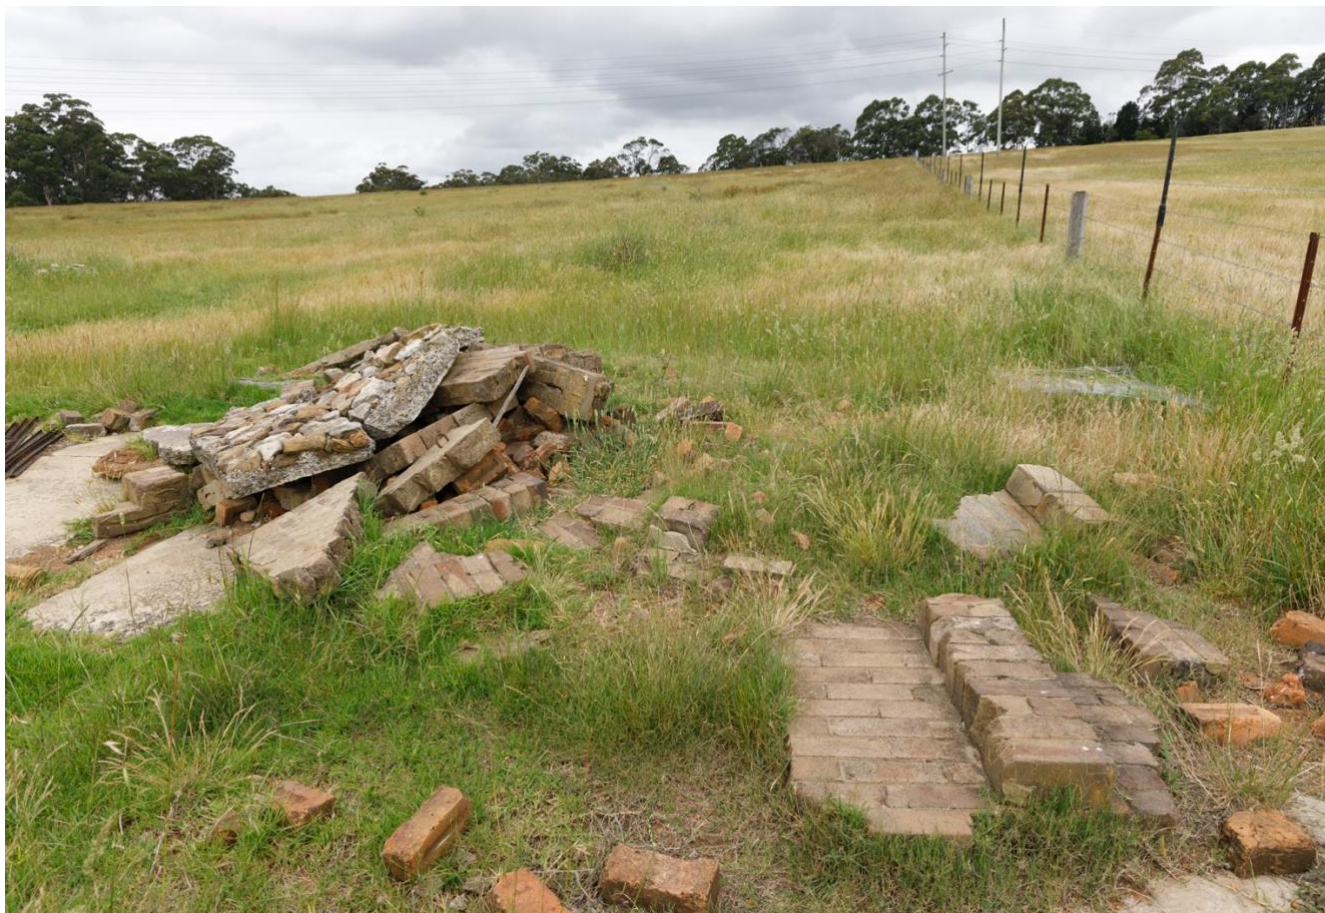
Figure 11. Site of former dairy buildings, located south-east of homestead, Willow Run (no. 25)

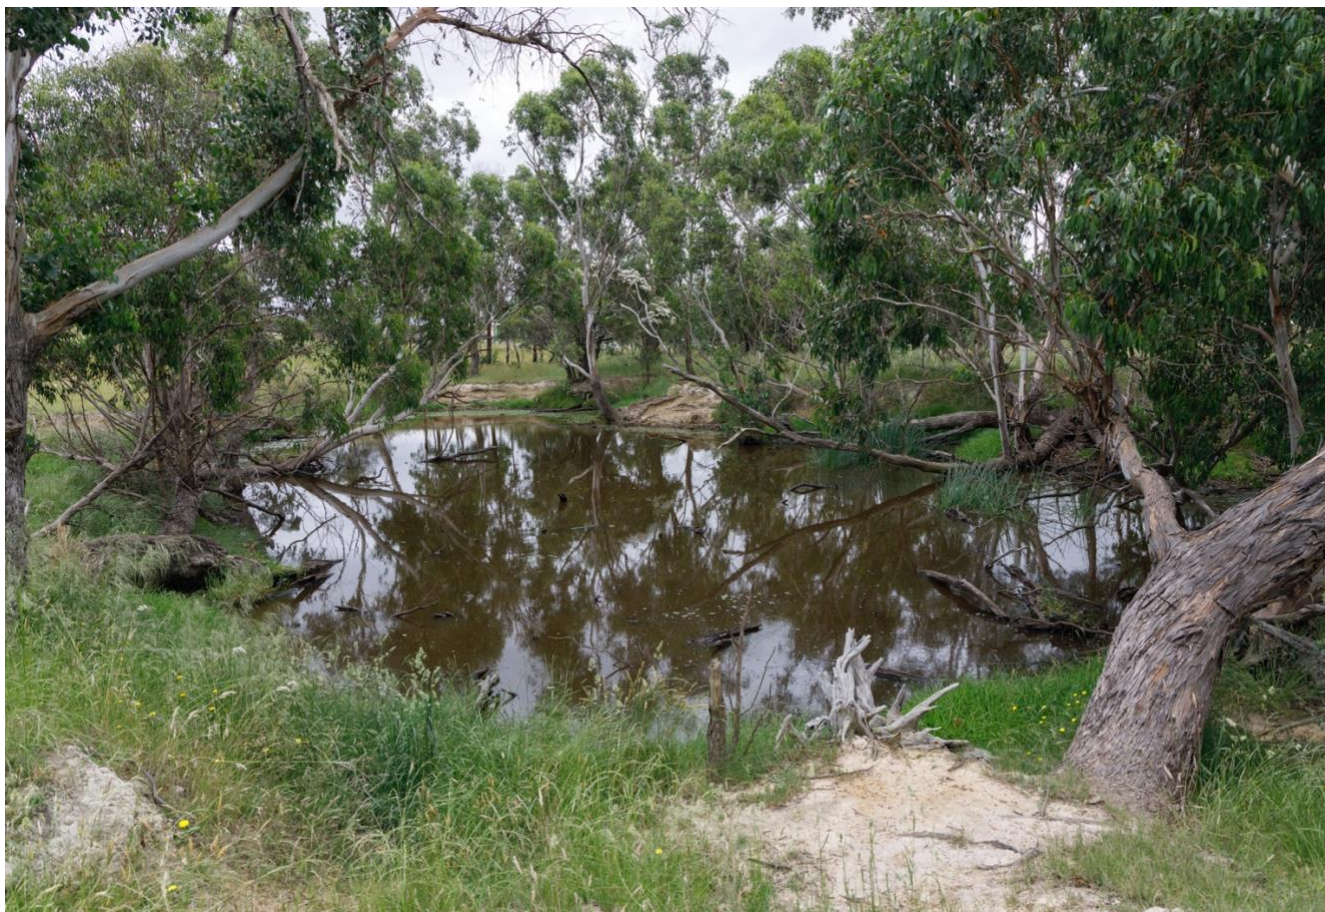
Figure 12. Site of former brickpit, located north-west of homestead, Willow Run (no. 34)

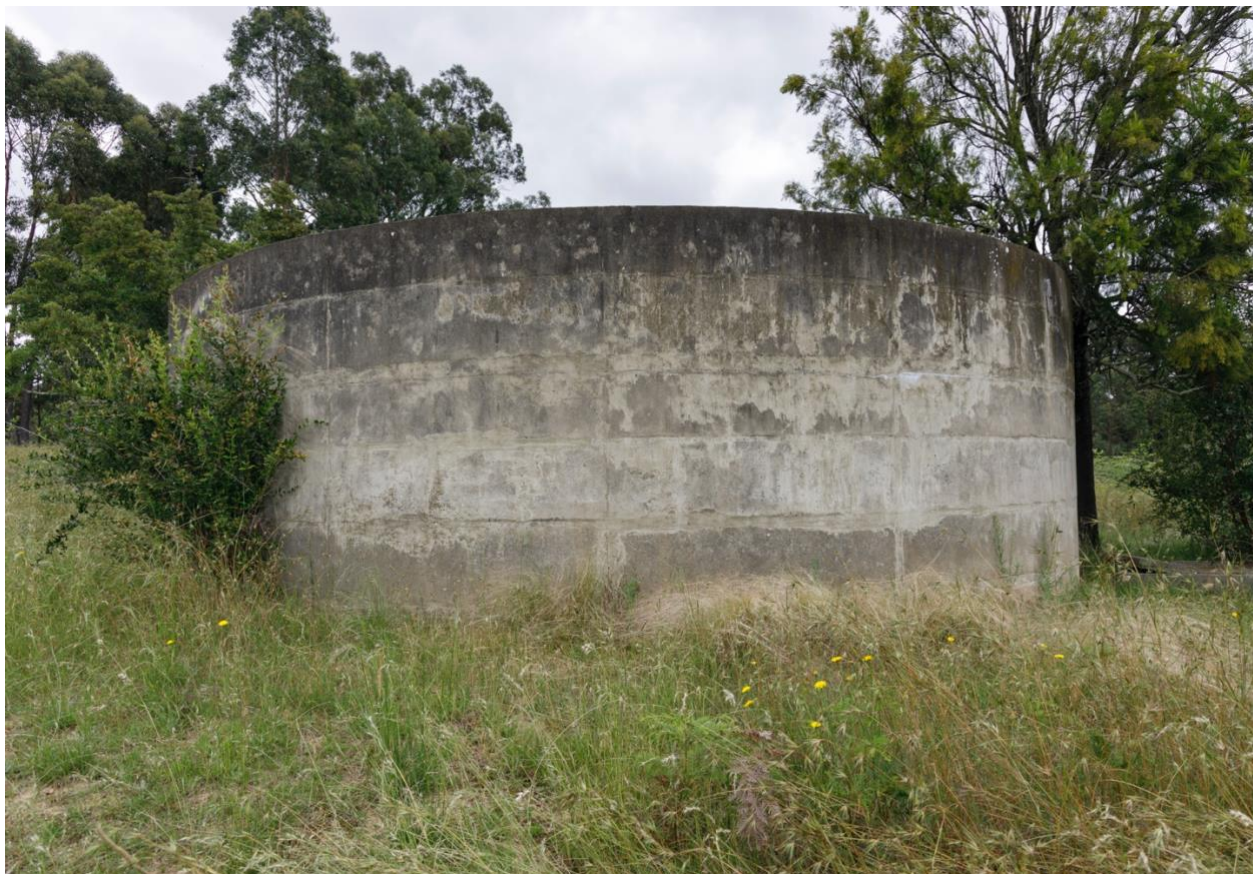
Figure 13. Water tank used as service reservoir, located on Council land, within area proposed for exclusion from existing property, Willow Run (no. 36)

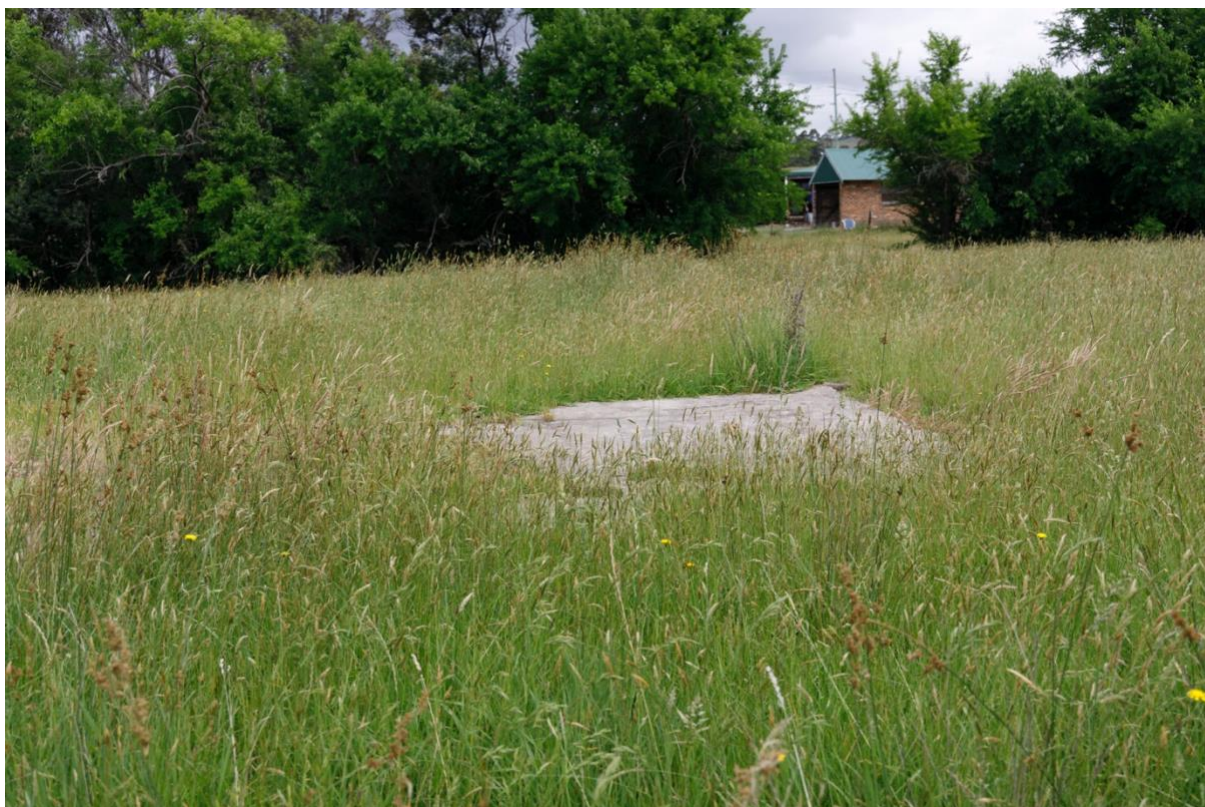
Figure 14. Concrete floor, site of former slaughterhouse, Willow Run (no. 46)

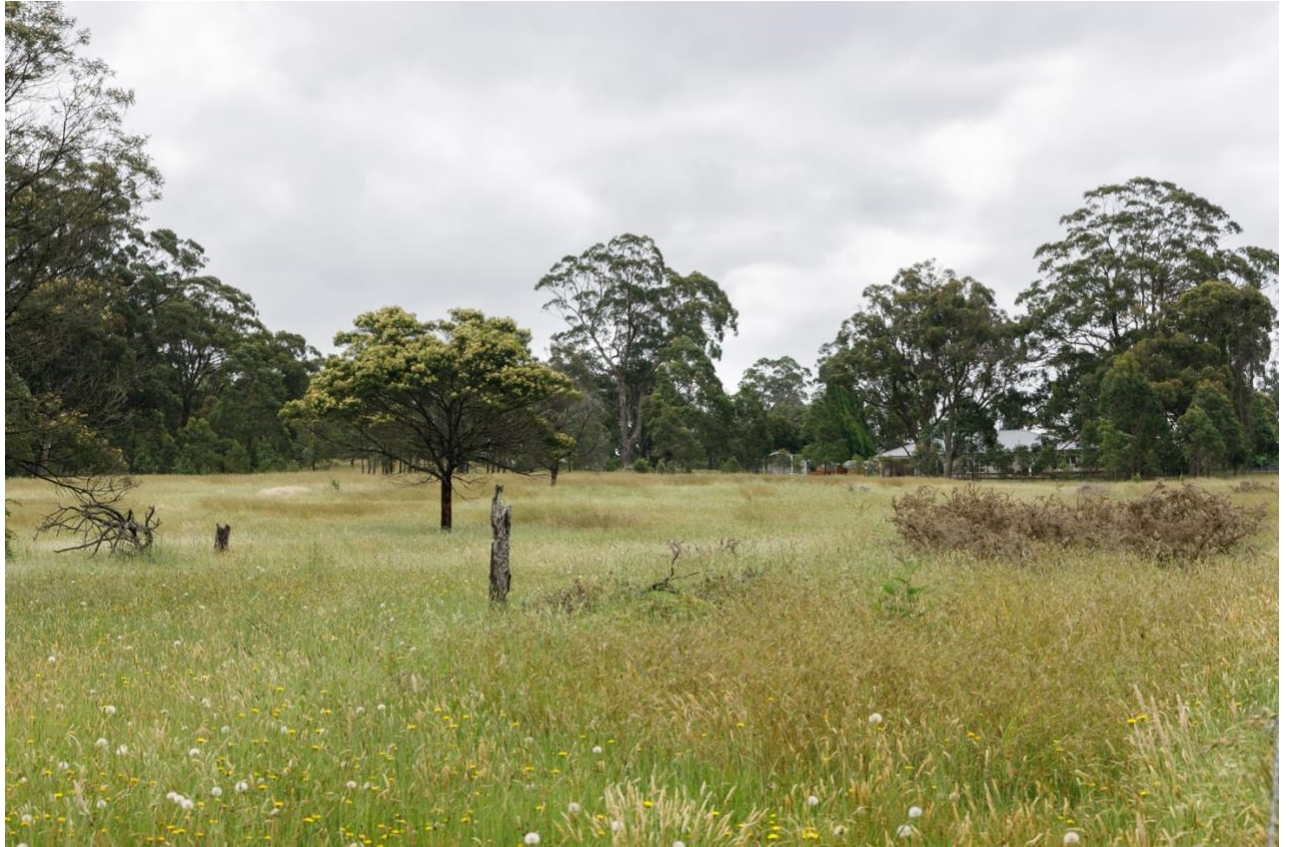
Figure 15. Pockets of significant vegetation within area proposed for exclusion from existing property, Willow Run (residence is on separate lot) (no. 52)

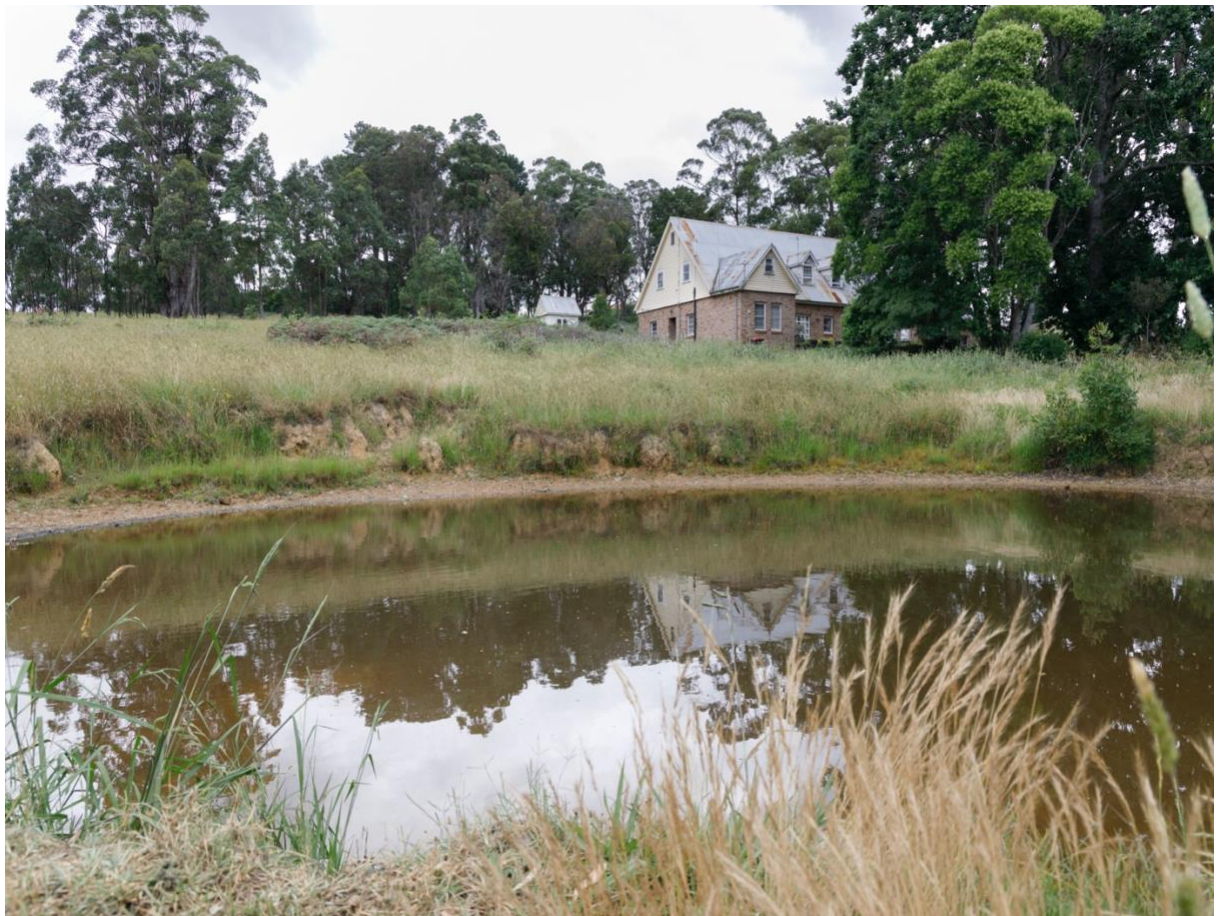
Figure 16. Dam at far north-west of existing lot, within area proposed for exclusion from existing property, Willow Run (residence is on separate lot) (no. 54)

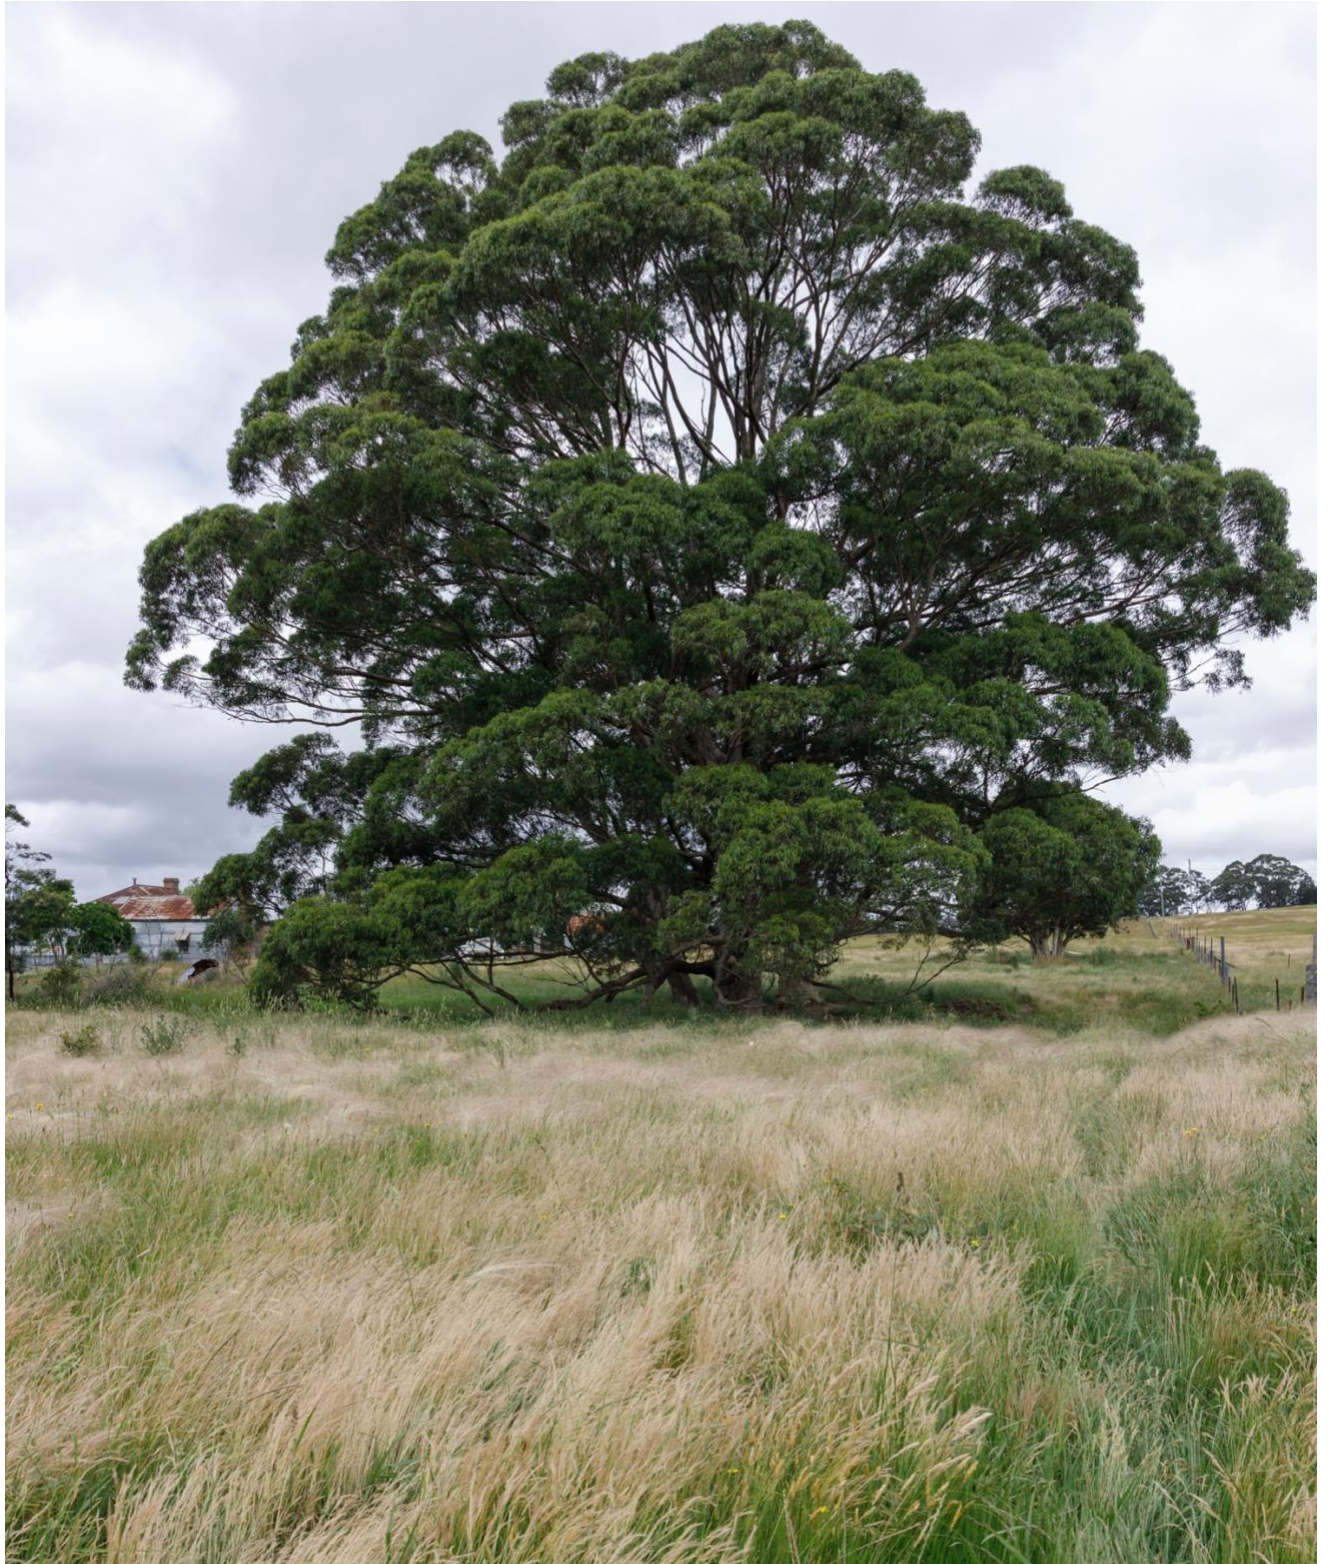
Figure 17. Significant tree: probably Apple Box (*Eucalyptus bridgesiana*) to south-west of existing property, Willow Run (no. 41)
