HERITAGE ASSESSMENT, WILLOW RUN, 105-119 BONG BONG ROAD, MITTAGONG

ATTACHMENT 1. CURRENT PHOTOGRAPHS. All photographs: Paul Wallace.

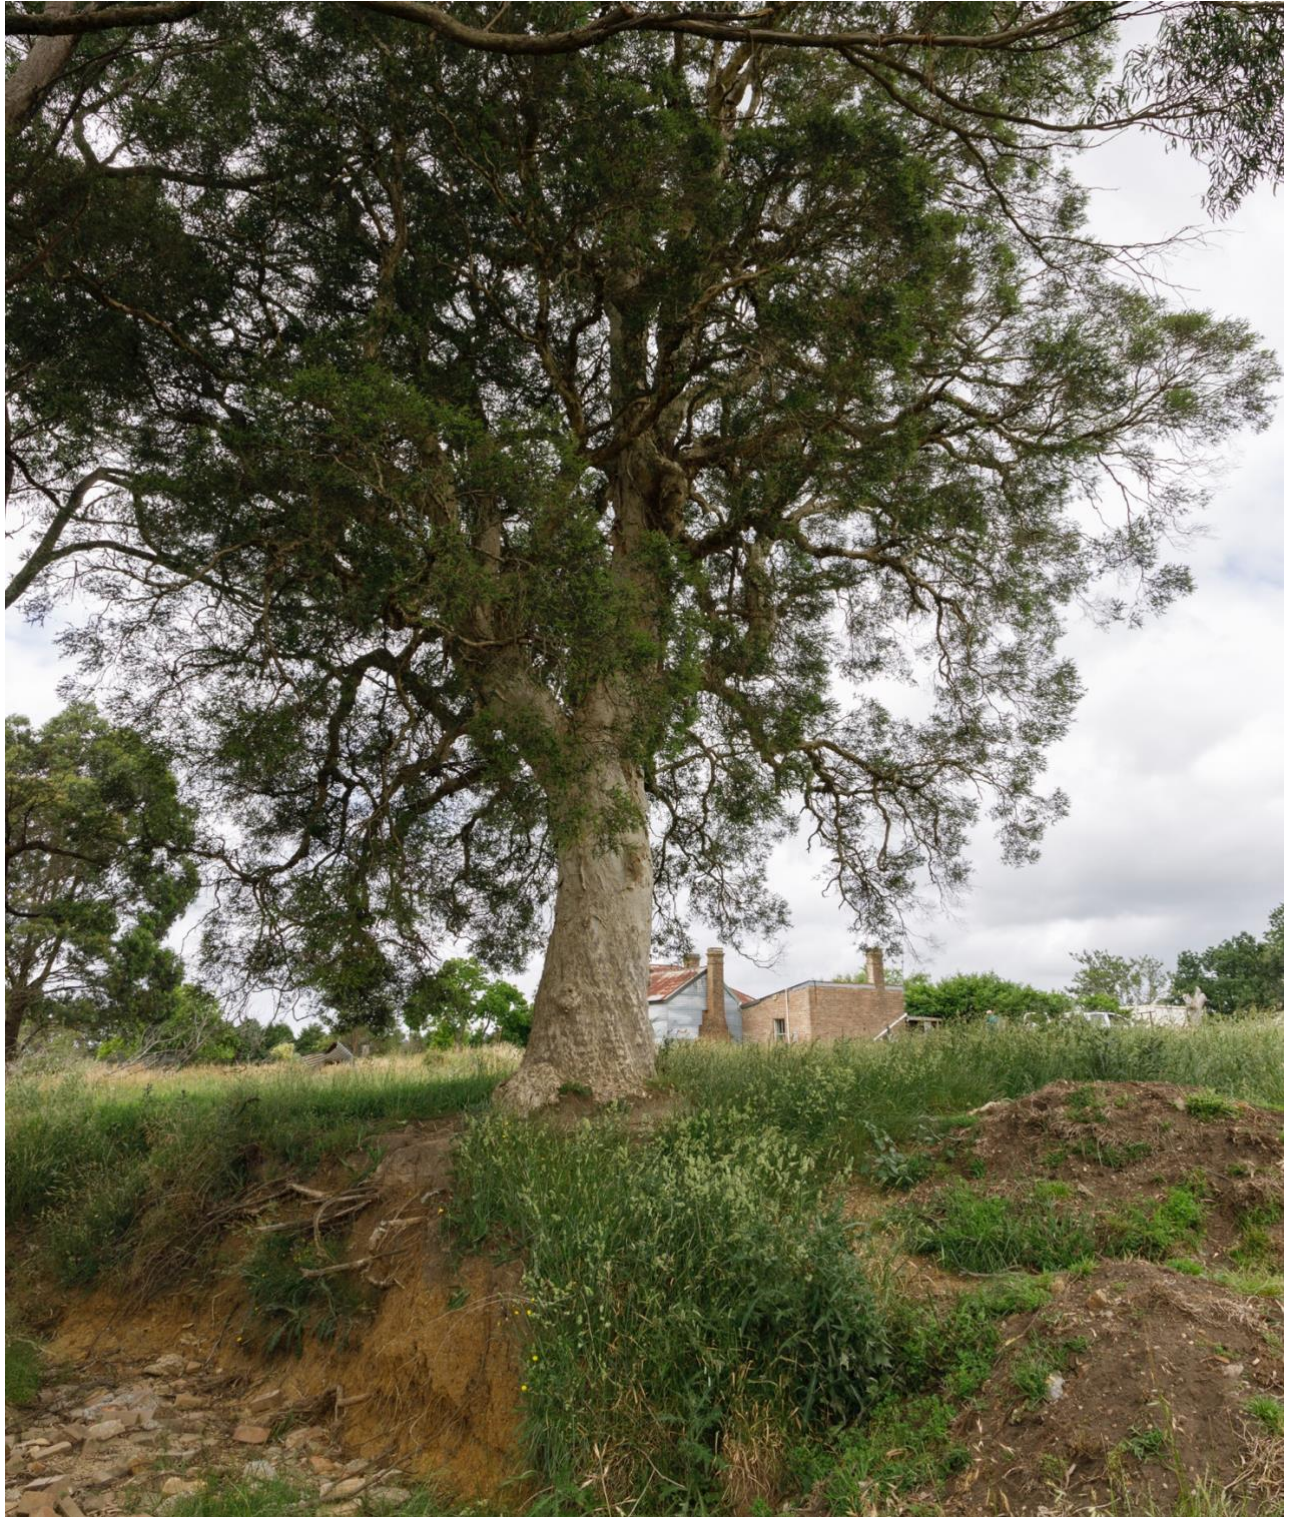
Figure 18. Significant tree: Paperbark (*Melaleuca Quinquenervia*) to south-west of existing property, Willow Run (no. 42)

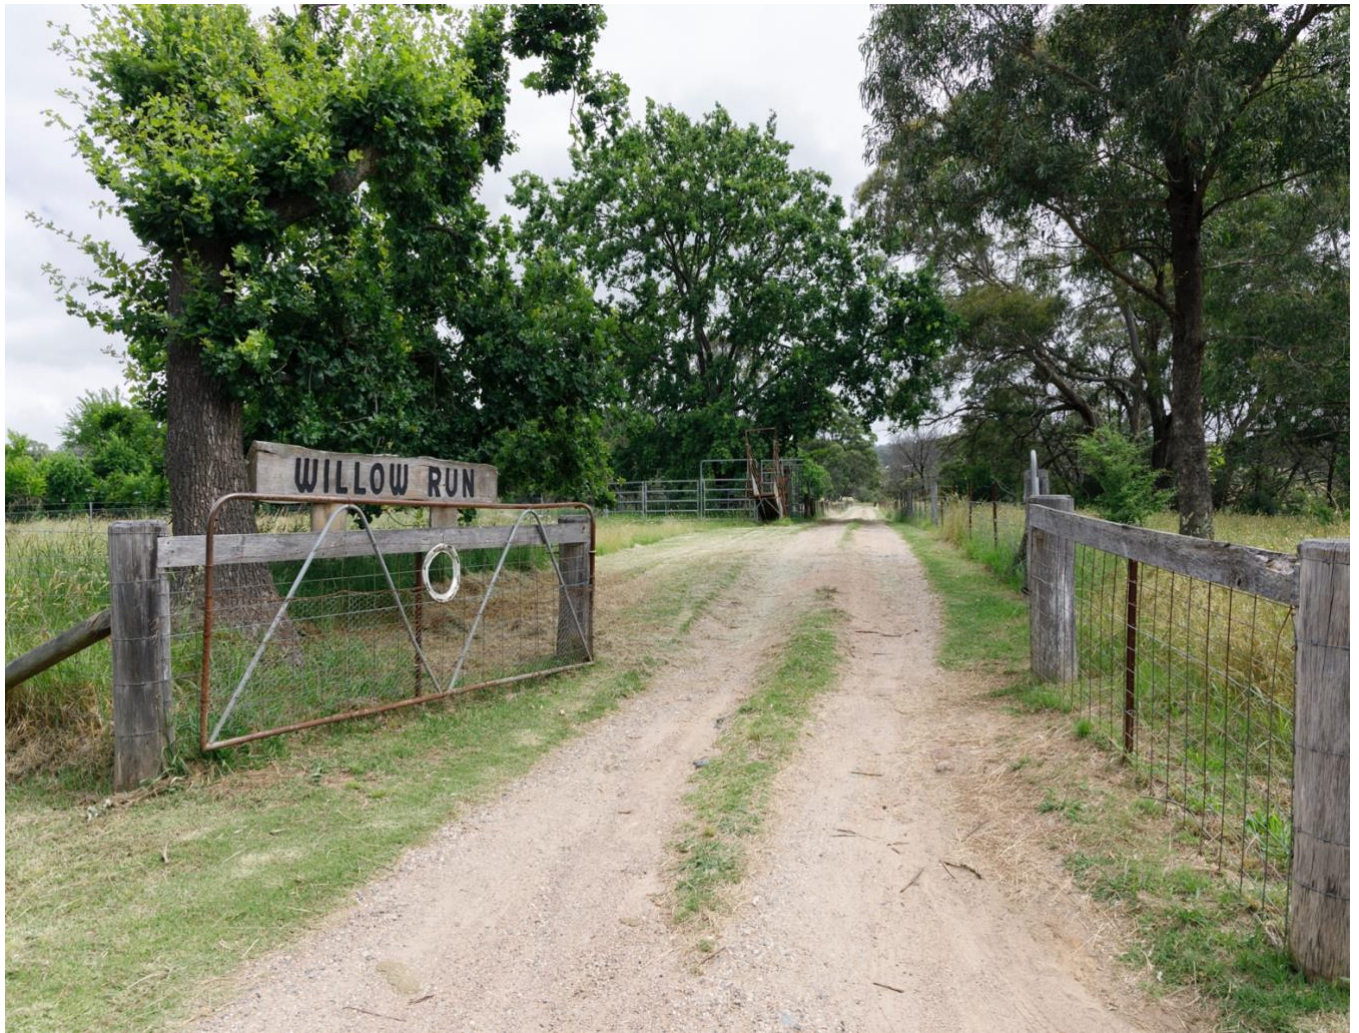
Figure 19. Entry gate and driveway, Willow Run (no. 48)
