## LANDSLIDE RISK ASSESSMENT REPORT

**PROJECT:** 30-32 Telfer Road, Castle Hill, NSW  
2154

**DATE:** 26 September 2019

**REPORT NO:** NE568

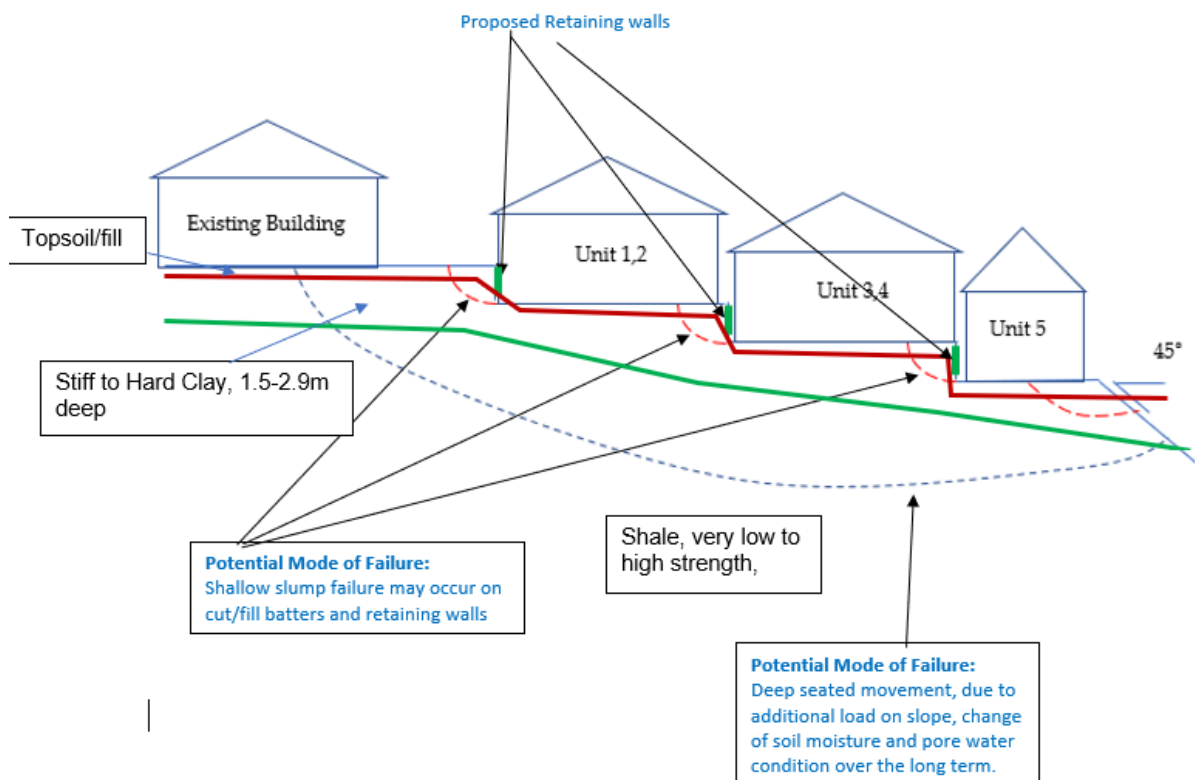
**Figure 5. Cross Sections of the proposed subdivision plan and Potential Mode of Failure (not to scale)**

**Mode 1: A shallow slump** (earth slide or earth flow) involving the natural slope, cuts and man-made fill. This mode of failure may occur in the area surcharged with uncontrolled fill or subject to additional loading from the new constructions or steep cut batters;

**Mode 2: Deep seated failure** (rotational or translational landslide) that involves the underlying fill, natural soil and rock in steep slope. The area subject to this failure could be identified from the presence of steep slopes combined with additional load on the slope.

The sketch of the slope cross section illustrating the potential modes of instability is shown in Figure 5.

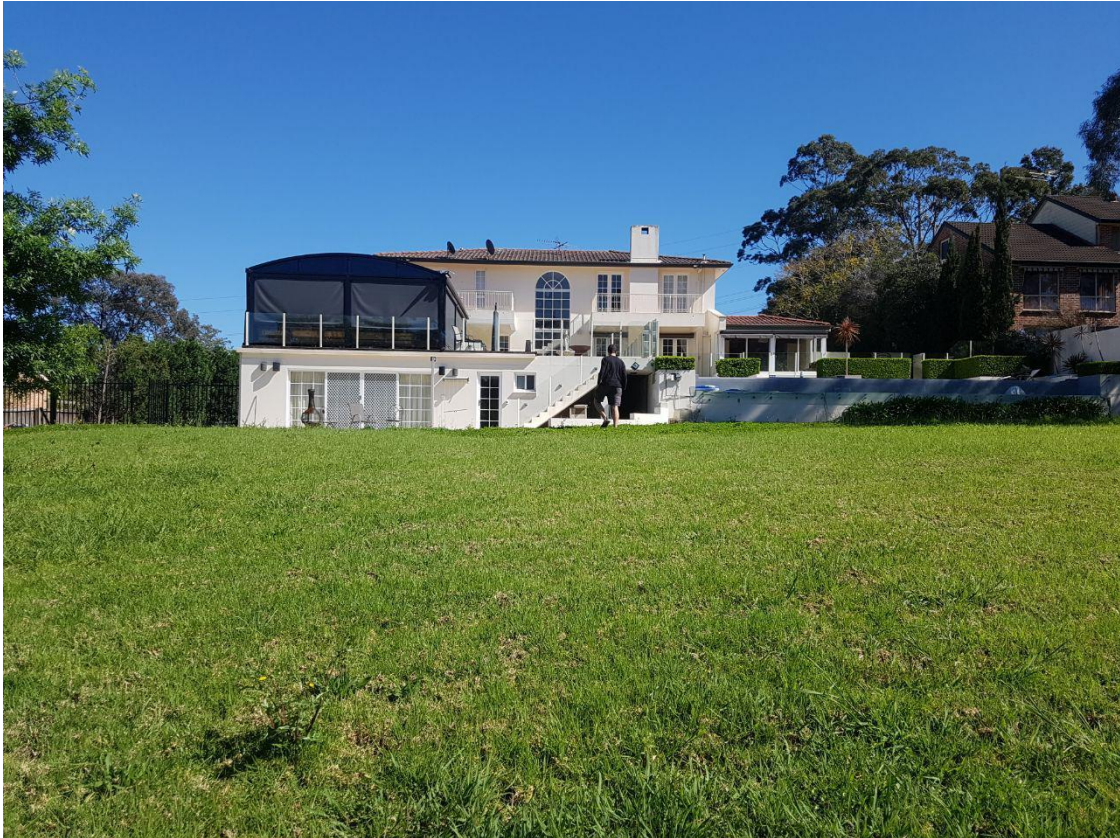
View of the dwelling, looking west

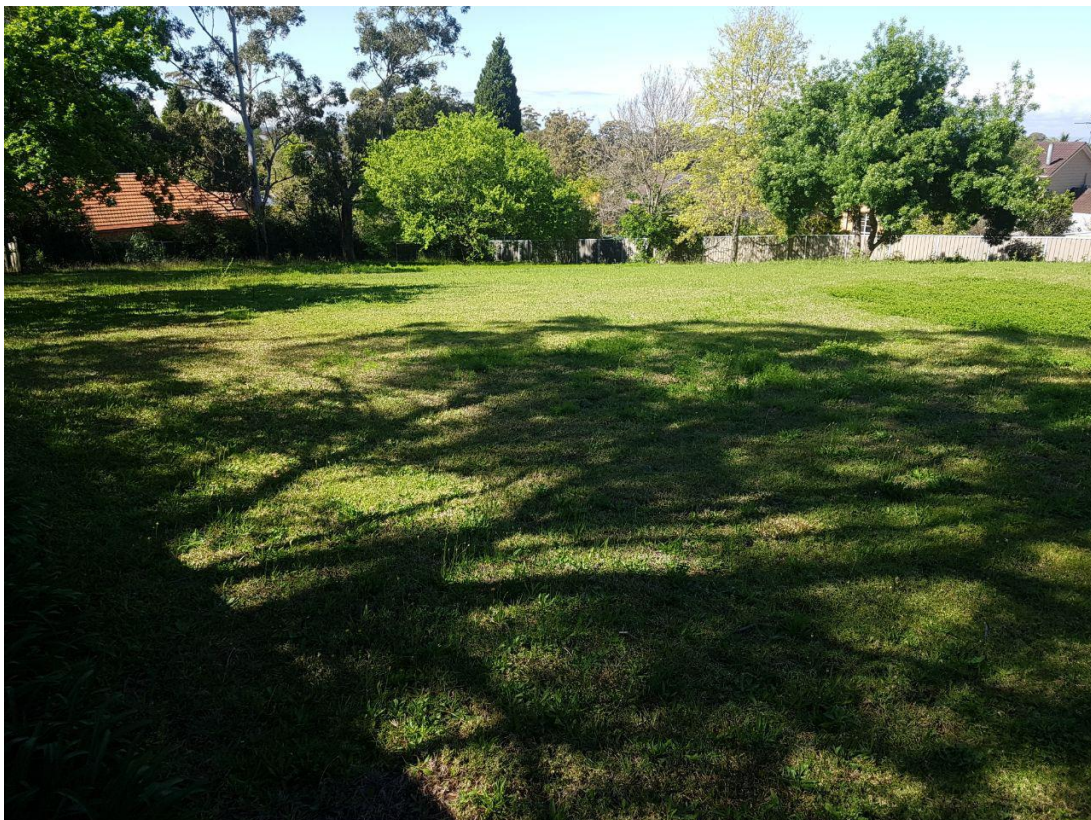
View of the site, looking south-east

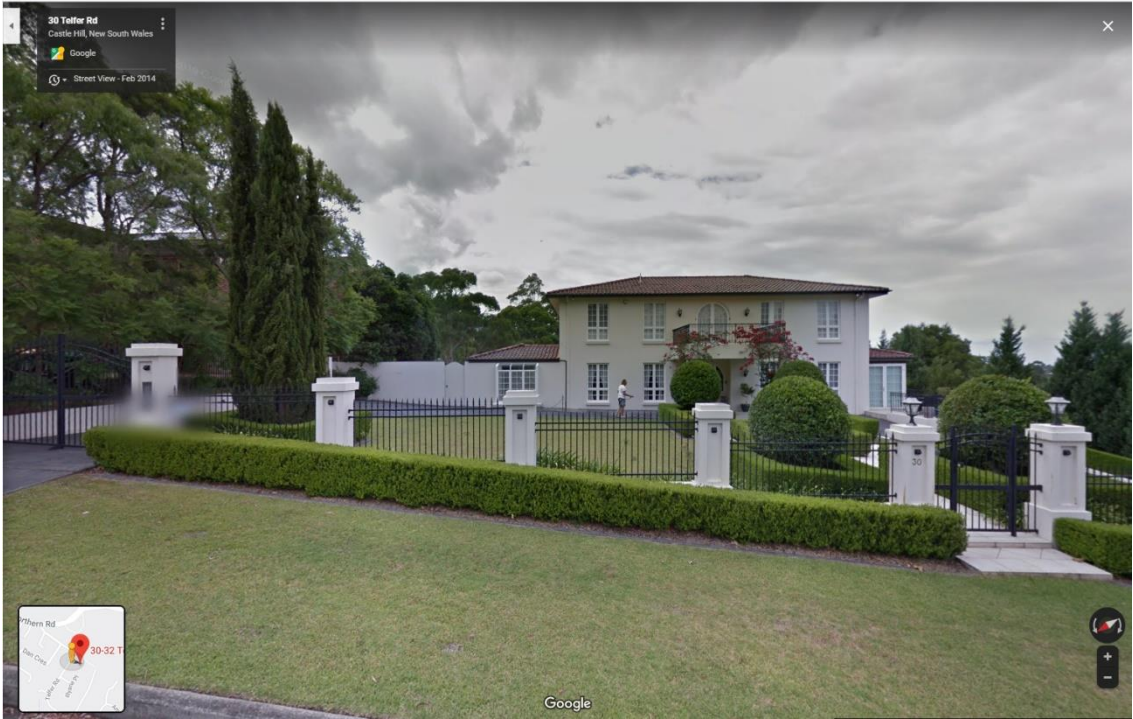
View of the dwelling, looking east
