**SEASONED TREE  
CONSULTING**

## **ARBORICULTURAL IMPACT ASSESSMENT REPORT**

Site address  
**30 - 32 Telfer Road,  
Castle Hill**

| <u>Date</u> | 22 July 2022 |

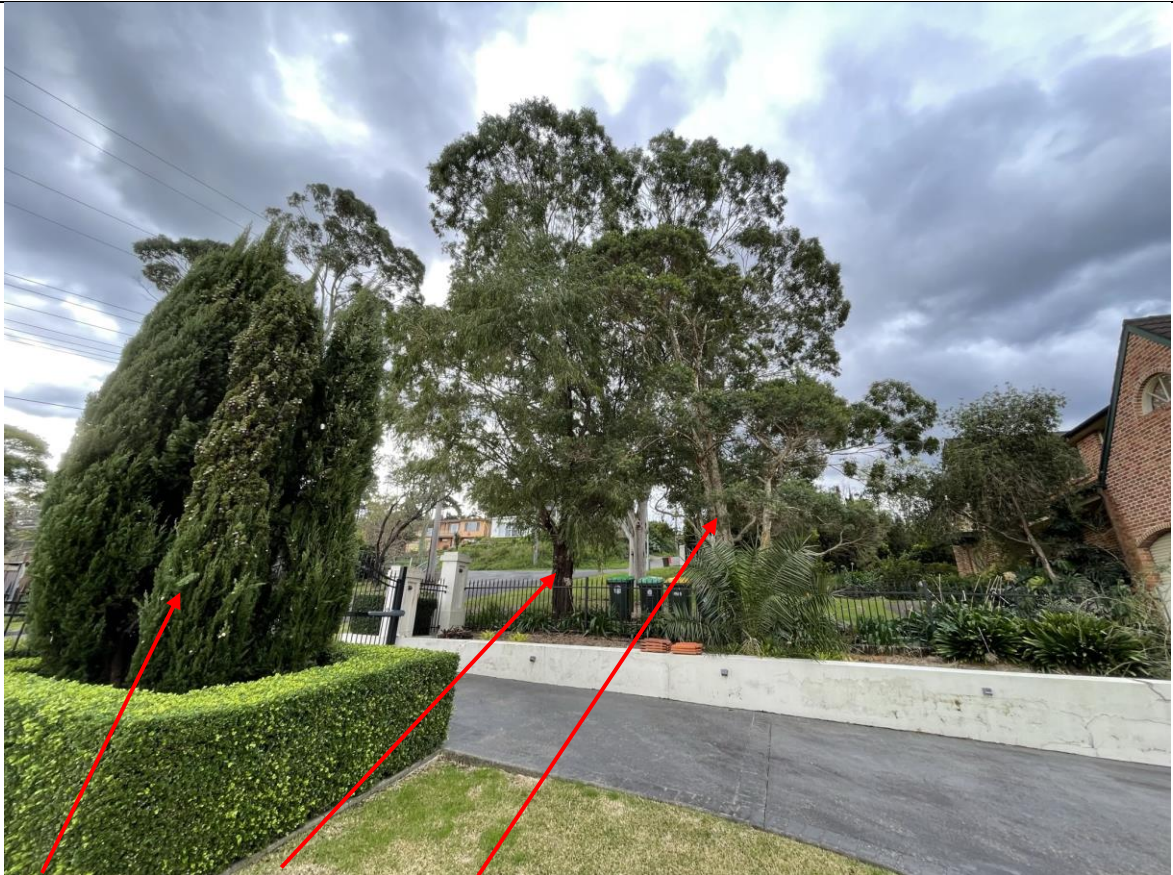
| Tree ID | Common name | Retention value | TPZ radius (m) | SRZ Radius (m) | TPZ Area (sq m) | TPZ Encroachment<br>See Appendix 1A | Discussion/ Conclusion | Recommendation |
|---|---|---|---|---|---|---|---|---|
| 1 | <i>Agonis flexuosa</i> , West Australian Peppermint | A1 | 4.8 | 2.4 | 72.4 | Nil | Tree is located within the northern neighbours front yard and is in good overall condition.<br><br>There is no encroachment from proposed plans. The tree should be retained and protected. | Retain. |
| 2 | <i>Melaleuca linariifolia</i> , Snow-in-summer | A2 | 5.28 | 2.4 | 87.6 | Nil | Tree is located within the northern neighbours front yard and is in good overall condition.<br><br>There is no encroachment from proposed plans. The tree should be retained and protected. | Retain. |

Image a: T3,

T1,

T2,

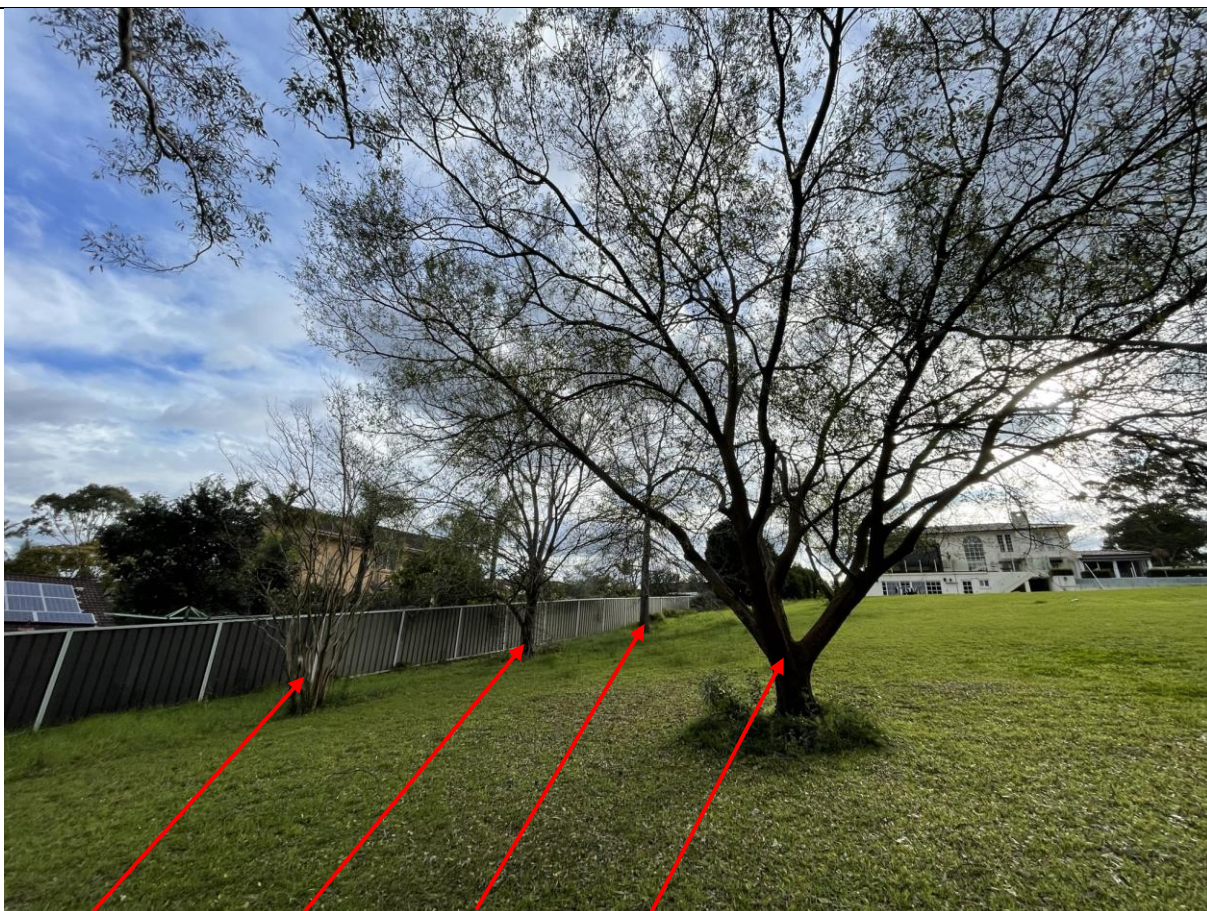
| Tree ID | Common name | Retention value | TPZ radius (m) | SRZ Radius (m) | TPZ Area (sq m) | TPZ Encroachment<br>See Appendix 1A | Discussion/ Conclusion | Recommendation |
|---|---|---|---|---|---|---|---|---|
| 8 | <i>Nyssa sylvatica</i> ,<br>Black Tupelo | A1 | 4.56 | 2.4 | 65.3 | Footprint. | Tree is located within the footprint of the proposed right of way driveway and would be required to be removed to facilitate this subdivision development. | Remove and replace. |
| 9 | <i>Fraxinus sp.</i> ,<br>Ash | A1 | 4.08 | 2.4 | 52.3 | Footprint. | Tree is located within the footprint of the proposed right of way driveway and would be required to be removed to facilitate this subdivision development. | Remove and replace. |
| 10 | <i>Lagerstroemia indica</i> , Crepe myrtle | A2 | 3 | 1.8 | 28.3 | Footprint. | Tree is located within the footprint of the proposed right of way driveway and would be required to be removed to facilitate this subdivision development. | Remove and replace. |

Image e: T10, T9, T8, T11

- 10.4 It is recommended that **Trees numbered T8, T9, T10 (total of 3 trees) be approved for removal** to cater for the subdivision development of the right of way driveway.

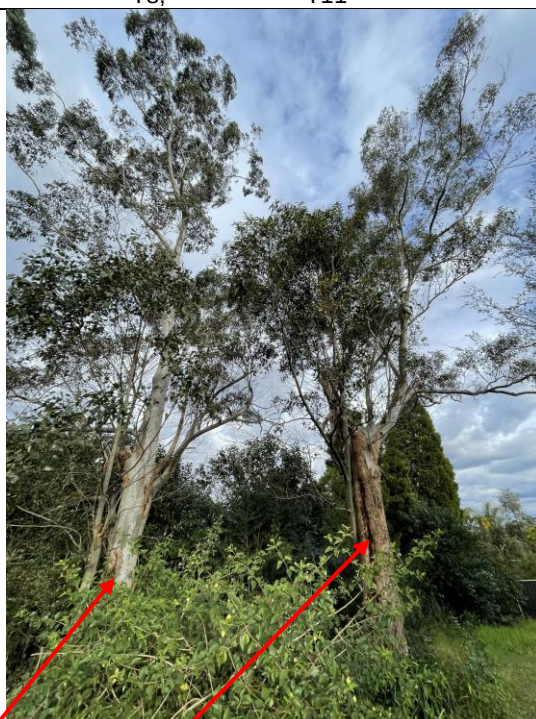
Image f: T14, T12,

| Tree ID | Common name | Retention value | TPZ radius (m) | SRZ Radius (m) | TPZ Area (sq m) | TPZ Encroachment<br>See Appendix 1A | Discussion/ Conclusion | Recommendation |
|---|---|---|---|---|---|---|---|---|
| 12 | <i>Eucalyptus saligna</i> ,<br>Sydney blue gum | Z5 | 8.4 | 3 | 221.7 | Nil | Tree is in poor condition with multiple bracket fungi, a secondary leader has failed years ago and has internal brown rot.<br><br>At this stage the tree can be retained but will be recommended for removal once a DA is lodged for a house on this subdivided block of land. | Retain. |

| Tree ID | Common name | Retention value | TPZ radius (m) | SRZ Radius (m) | TPZ Area (sq m) | TPZ Encroachment<br>See Appendix 1A | Discussion/ Conclusion | Recommendation |
|---|---|---|---|---|---|---|---|---|
| 14 | <i>Eucalyptus saligna</i> ,<br>Sydney blue gum | Z5 | 7.8 | 2.9 | 191.1 | Nil | Tree is in poor condition with internal decay, a large wound close to ground with multiple bracket fungi.<br><br>At this stage the tree can be retained but will be recommended for removal once a DA is lodged for a house on this subdivided block of land. | Retain. |

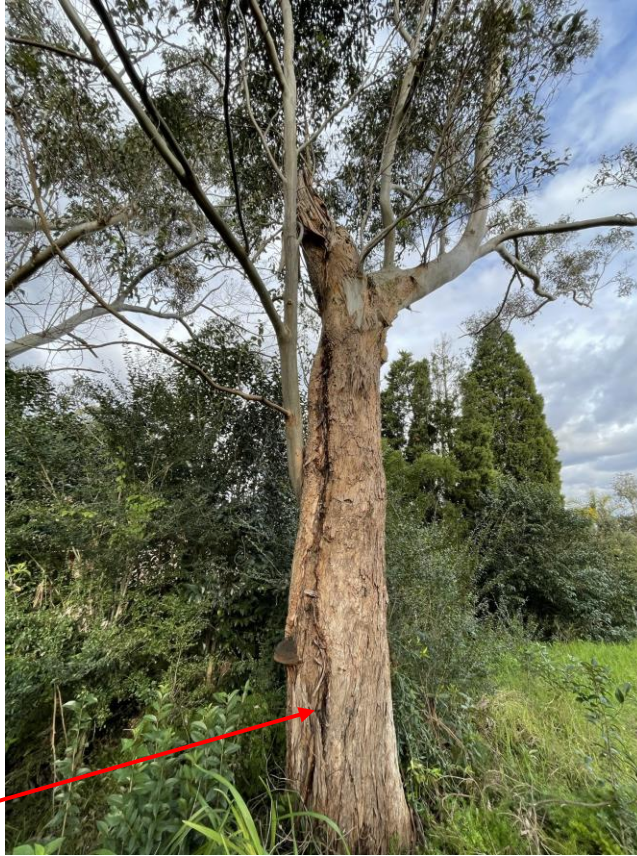
Image g: T12

| Tree ID | Tree Species | DBH (CM) | TPZ radius (M) | TPZ Area (Sq.M) | DAB (CM) | SRZ radius (M) | Height (M) | Spread (M) | Age Class | Health | Structure | Amenity value | SULE (yrs.) | TreeAZ retention Value | Comments |
|---|---|---|---|---|---|---|---|---|---|---|---|---|---|---|---|
| 12 | <i>Eucalyptus saligna</i> , Sydney blue gum | 70 | 8.4 | 221.7 | 80 | 3 | 18 | 14 | Mature | Good | Poor / fair | High | <5 | Z5 | Multiple bracket fungi, secondary leader has failed years ago. Internal brown rot, Epicormics |

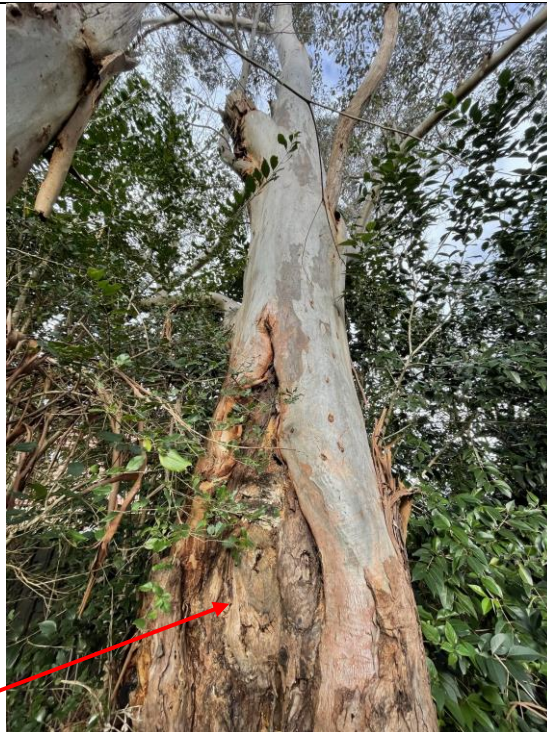
Image h: T14,

| Tree ID | Tree Species | DBH (CM) | TPZ radius (M) | TPZ Area (Sq.M) | DAB (CM) | SRZ radius (M) | Height (M) | Spread (M) | Age Class | Health | Structure | Amenity value | SULE (yrs.) | TreeAZ retention Value | Comments |
|---|---|---|---|---|---|---|---|---|---|---|---|---|---|---|---|
| 14 | <i>Eucalyptus saligna</i> , Sydney blue gum | 65 | 7.8 | 191.1 | 75 | 2.9 | 18 | 11 | Mature | Good | Poor / fair | High | 5 > 15 | Z5 | Internal decay; large wound close to ground with multiple bracket fungis |

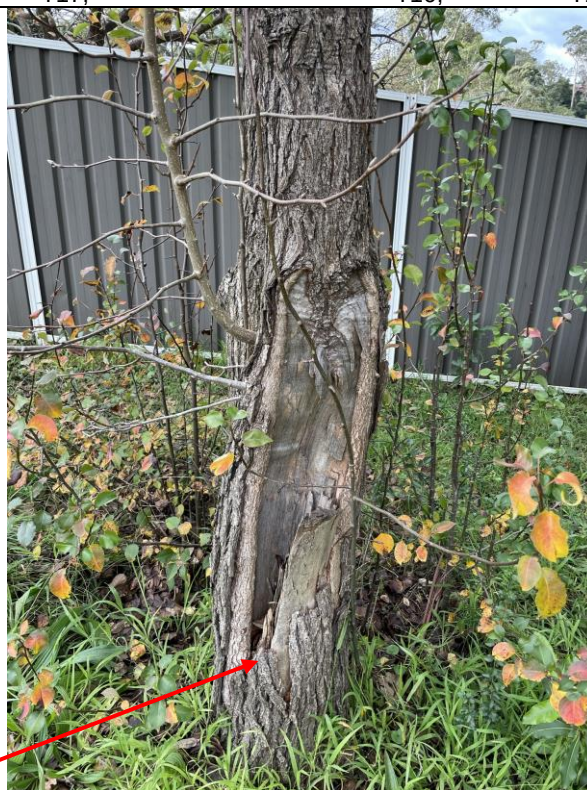
Image i: T21

| Tree ID | Common name | Retention value | TPZ radius (m) | SRZ Radius (m) | TPZ Area (sq m) | TPZ Encroachment<br>See Appendix 1A | Discussion/ Conclusion | Recommendation |
|---|---|---|---|---|---|---|---|---|
| 21 | <i>Pyrus calleryana</i> ,<br>Callery pear | Z5 | 3.48 | 2.2 | 38 | Nil | Tree is in poor condition with a large wound from a codminant trunk failure.<br><br>At this stage the tree can be retained but will be recommended for removal once a DA is lodged for a house on this subdivided block of land. | Retain. |

| Tree ID | Tree Species | DBH (CM) | TPZ radius (M) | TPZ Area (Sq.M) | DAB (CM) | SRZ radius (M) | Height (M) | Spread (M) | Age Class | Health | Structure | Amenity value | SULE (yrs.) | TreeAZ retention Value | Comments |
|---|---|---|---|---|---|---|---|---|---|---|---|---|---|---|---|
| 21 | <i>Pyrus calleryana</i> , Callery pear | 22*19 (=29) | 3.48 | 38 | 36 | 2.2 | 7 | 5 | Mature | Good | Poor | Medium | <5 | Z5 | Large failure close to ground, hollow |

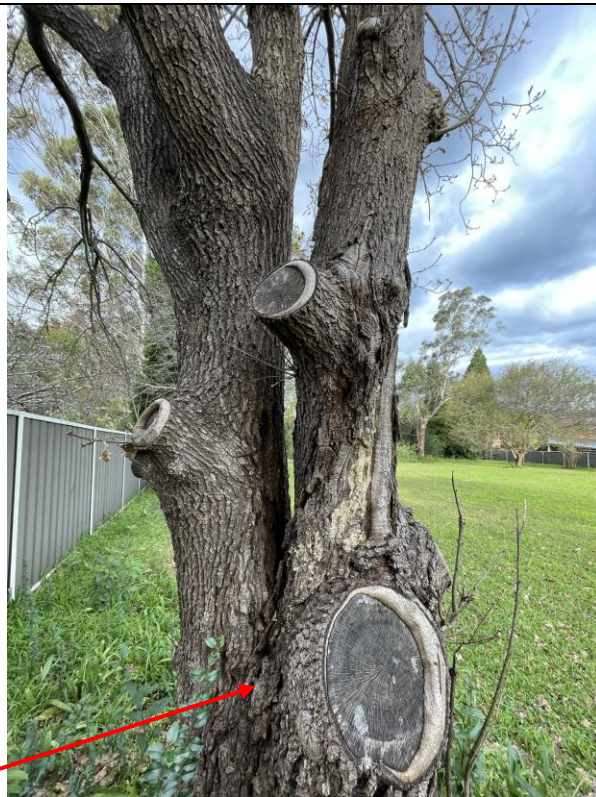
**Image j: T22**

| Tree ID | Common name | Retention value | TPZ radius (m) | SRZ Radius (m) | TPZ Area (sq m) | TPZ Encroachment<br>See Appendix 1A | Discussion/ Conclusion | Recommendation |
|---|---|---|---|---|---|---|---|---|
| 22 | <i>Quercus robur</i> ,<br>English oak | Z10 | 6 | 2.7 | 113.1 | Nil | Tree is in poor condition with being codominant from 1.5m in height with internal decay. There are structural roots that have been heavily scalped, the internal heartwood as been exposed and fungi is present.<br>At this stage the tree can be retained but will be recommended for removal once a DA is lodged for a house on this subdivided block of land. | Retain. |

| Tree ID | Tree Species | DBH (CM) | TPZ radius (M) | TPZ Area (Sq.M) | DAB (CM) | SRZ radius (M) | Height (M) | Spread (M) | Age Class | Health | Structure | Amenity value | SULE (yrs.) | TreeAZ retention Value | Comments |
|---|---|---|---|---|---|---|---|---|---|---|---|---|---|---|---|
| 22 | <i>Quercus robur</i> , English oak | 32*39 (=50) | 6 | 113.1 | 61 | 2.7 | 10 | 8 | Mature | Fair | Fair | Medium | 5 > 15 | Z10 | Codominant from 1.5m, with internal decay. Structural roots scalped, heartwood exposed and fungi present see photos in poor condition |

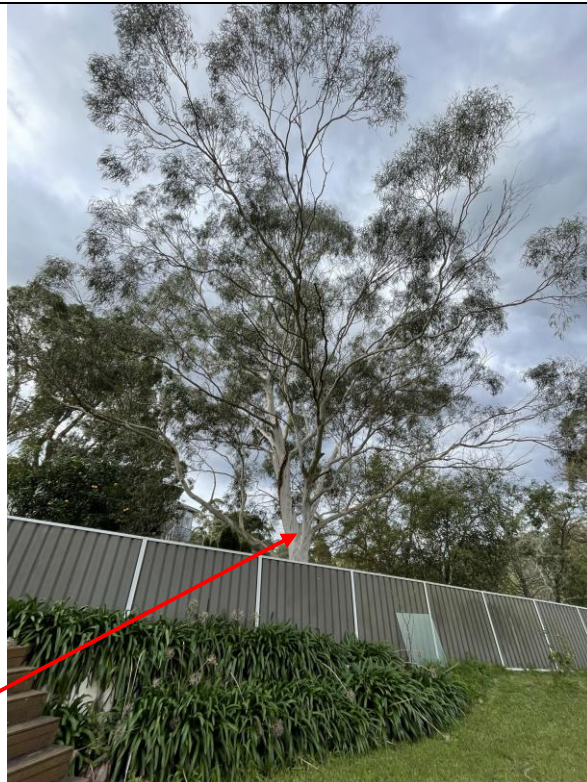
**Image K: T23**

| Tree ID | Common name | Retention value | TPZ radius (m) | SRZ Radius (m) | TPZ Area (sq m) | TPZ Encroachment<br>See Appendix 1A | Discussion/ Conclusion | Recommendation |
|---|---|---|---|---|---|---|---|---|
| 23 | <i>Eucalyptus scoparia</i> ,<br>Wallangarra white gum | A2 | 7.8 | 2.8 | 191.1 | Nil | Tree is located within the northern neighbours back yard and is in good overall condition.<br><br>There is no encroachment from proposed plans.<br>The tree should be retained and protected. | Retain. |
