Slope Risk Assessment

Proposed Subdivision - 18 Winterlake
Road, Warners Bay

CGS2708

July 2015

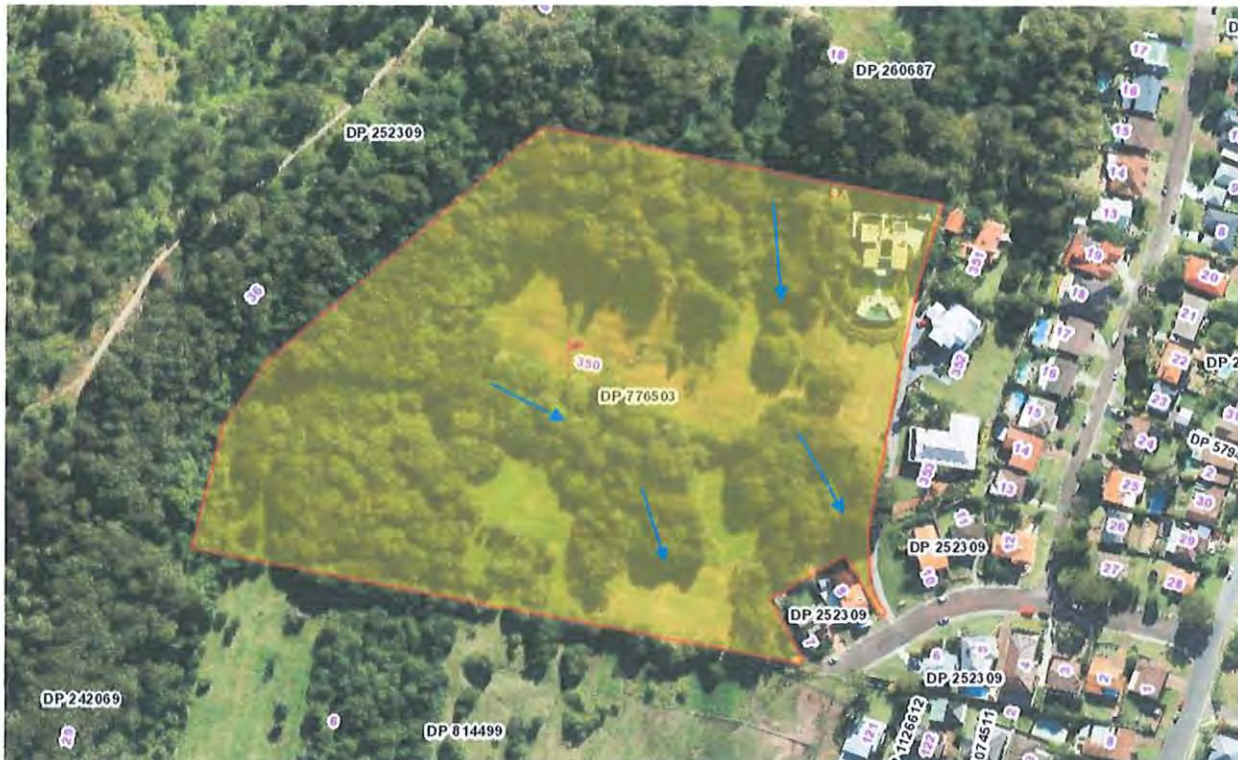
Drainage - Drainage within the site is generally by sheet flow into two gullies, the northern gully draining southward toward Winterlake Drive and the southern gully draining generally eastward across Lots 1 and 2 toward the adjacent property to the south. The flanks of the gullies were measured at up to approximately 60°. Evidence of old soil slips and soil creep was observed in both of the gullies including old scarps and tree trunk bowing.

Figure 1: Site location, courtesy of Six Maps (maps.six.nsw.gov.au). Approximate location of the two drainage gullies is indicated with blue arrows.

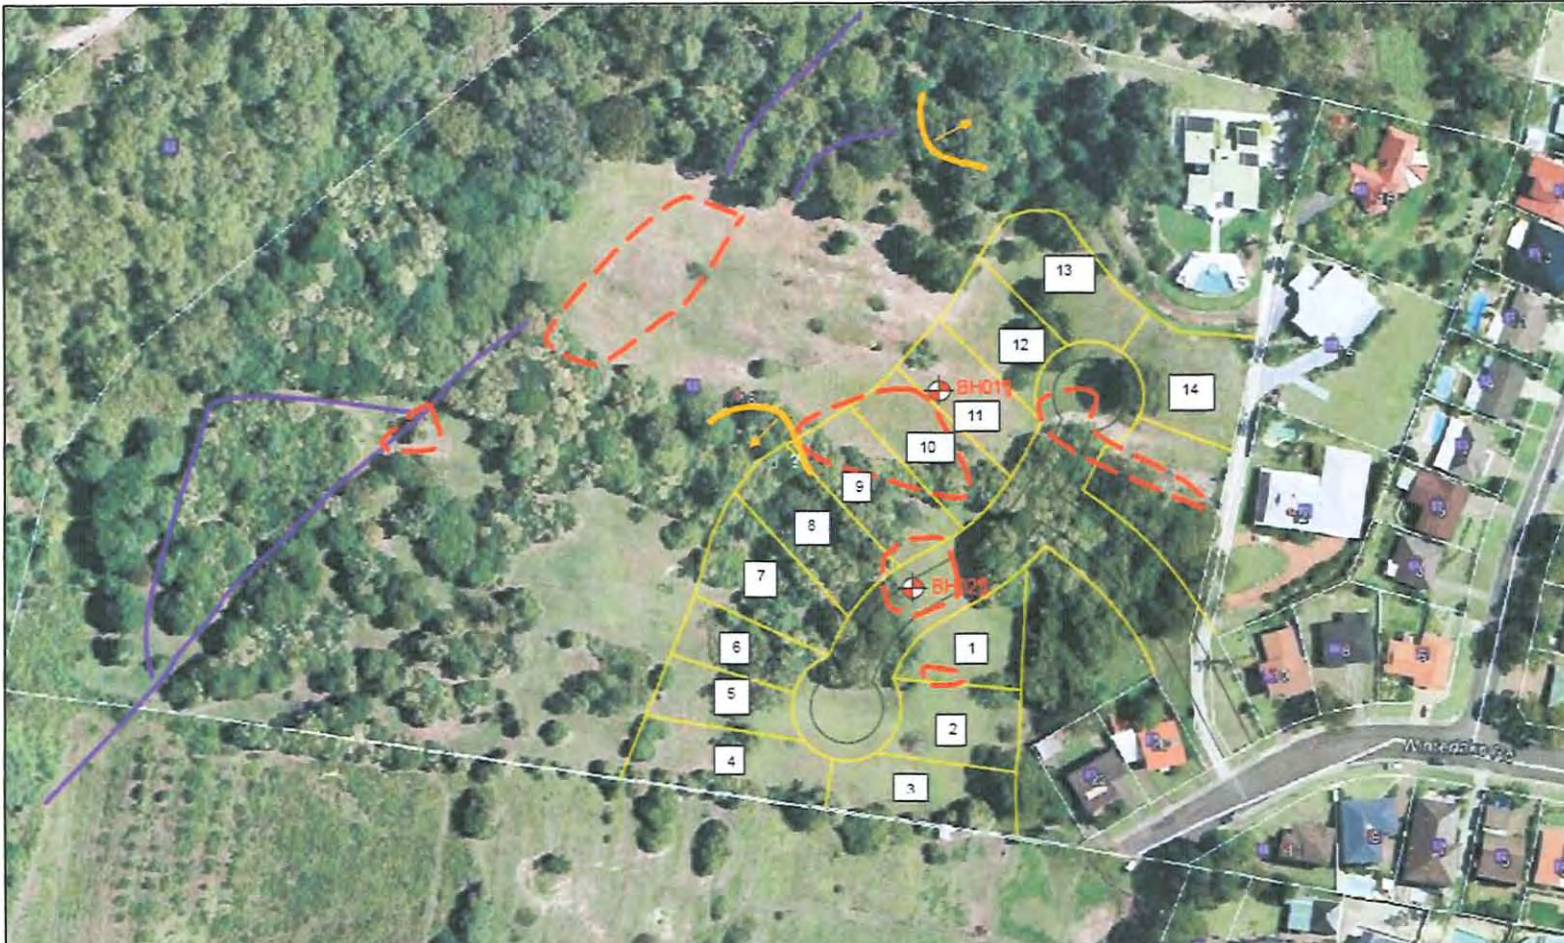
Surficial slips and evidence of ongoing soil creep were noted in both of the steep sided gullies. The slip in the south gully appears to involve natural soils and uncontrolled fill that has been tipped into the gully. The slip in the north gully involves colluvial soils. The instability appears to be confined to the gullies, and no scarps, tension cracks, or disturbed ground that could not be attributed to past earthworks were noted outside the gully areas.

Both of these slips are located predominantly out of the proposed building envelope area. The slip in the northern gully is located approximately 50m northwest of Lot 13, and is not deemed to pose a hazard to future development. The slip in the south gully shall be entirely removed as unsuitable soil as a part of the gully filling operation that is anticipated. After filling, the slip in the south gully would have no impact on future development.

Orange indicates approximate location of slips.

- > Remedial earthworks to remove small slips present in the gullies prior to filling;
- > Managing / redirecting surface drainage from above the building envelopes through use of appropriately designed and constructed cut-off drains or similar;
- > Controlling surficial drainage within the lots, including installation of roof gutters;
- > Founding structures in controlled fill or beneath the surficial soils into rock; and
- > Incorporating retaining structures as elements of the footing system for future structures.
