**Proposed Residential Subdivision
Rayford Street and Daydawn Avenue, Warners Bay**

Slope Stability Assessment

Report No. RGS01426.1-AE

30 May 2017

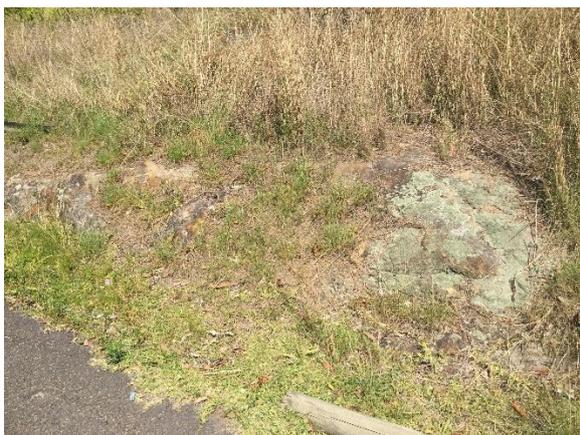
Conglomerate outcrop adjacent to existing house in southeast corner of site.

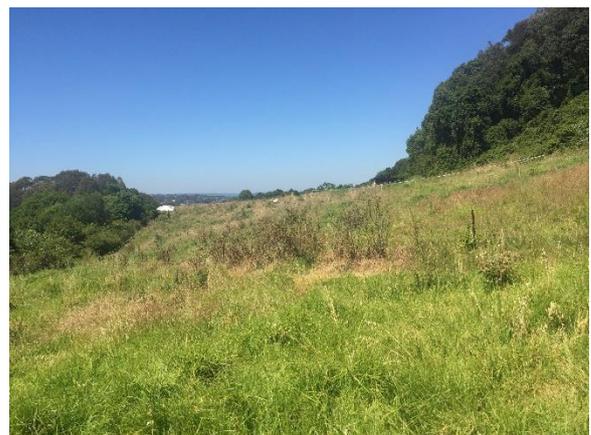
Upper bench area in western third of site

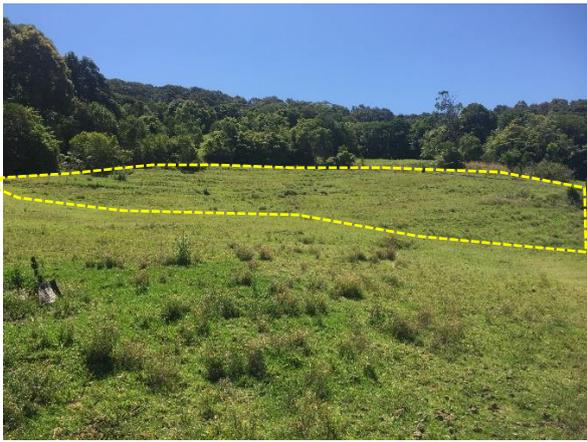
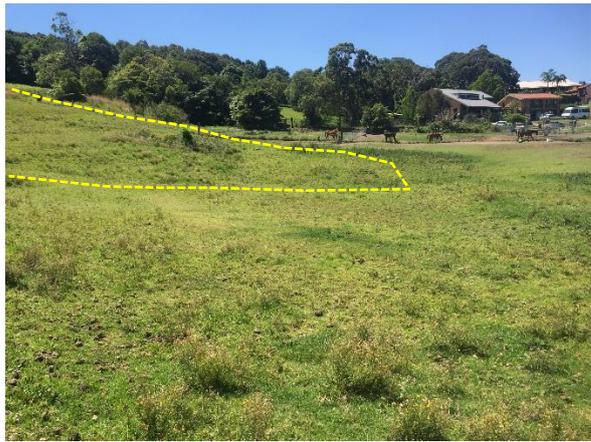
An area of recently active landslide was identified on the upper to mid slopes of the northern end of the site, with a lobe of resultant debris having travelled onto the lower, footslope area. Development should be avoided on the active part of the landslide on the upper slopes. This area is identified and delineated in the report.

<p><i>Zone of recent landslide activity at north end of site viewed from footslope. Note hummocky, benched ground conditions</i></p>	<p><i>Lobe of landslide debris deposits on footslope at northern end of site.</i></p>

Prior to development of the footslopes below the identified landslide zone on Figure 8, it is recommended that remedial measures be implemented within the identified active landslide zone above. Such measures are likely to involve:

- Installation of drainage measures such as subsoil drains or horizontal drains to promote drainage of the slope and prevent buildup of pore water pressures within the slope;
- Regrading of the failed outer slope to allow control of erosion and remove soils that appear prone to short term onset of instability;
- Installation of mesh, topsoil, and anchors to stabilise the disturbed soil mantle directly upslope of the development area.

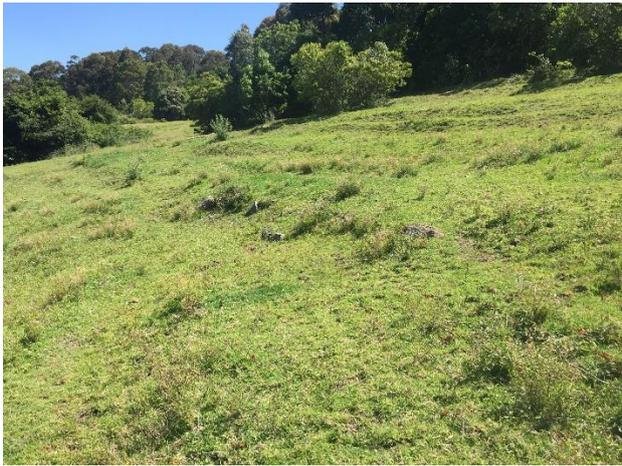
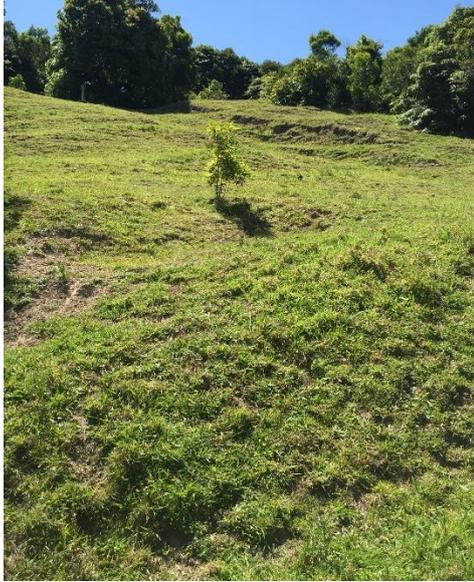
<p><i>Disturbed ground indicative of landslide activity near northern end of site</i></p>

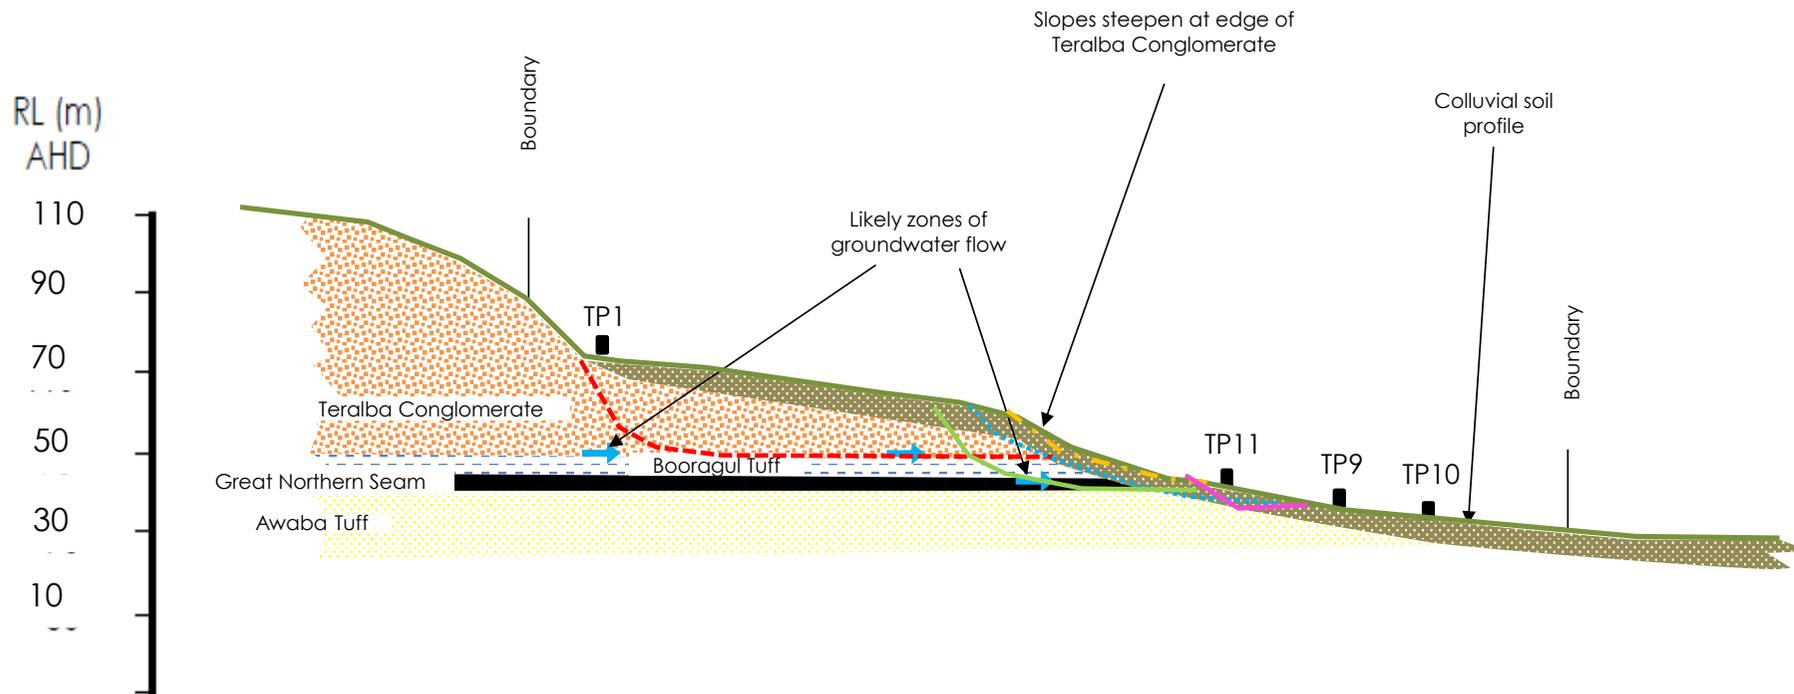
Client	Pulver Cooper & Blackley		Job No.	RGS01426.1	
	Project:	Residential subdivision Geotechnical Assessment		Drawn By:	SRM
		19 Daydawn Avenue & 40 Rayford Street, Warners Bay		Date:	30-May-17
	Title:	Identified Landslide Hazards		Drawing No	Figure 7

- Hazard 1:** Large scale translational slide of conglomerate blocks over saturated Booragul Tuff causing debris flow (>100m³). Such a failure could cause complete destruction or large scale damage of several structures within a typical residential subdivision;

- Hazard 2:** Translational or rotational slide through colluvial and residual soil profile. Should such a failure occur it could potentially cause extensive structural damage and require large scale, costly repairs, and possibly temporary evacuation of a typical residential building until repairs are complete. Maintaining good slope drainage to prevent buildup of water pressures within the profile is recommended;

- Hazard 3:** Soil creep. Creep is an imperceptibly slow movement that takes place on sloping soil sites. It is an ongoing, natural slope process involving the progressive downslope movement of soils over the underlying rock profile. Creep will occur within the soil profile overlying weathered rock at this site, and will require management by undertaking good hillside construction practice as recommended in this report;

- Hazard 4:** Translational slide of soil and weathered rock profile on outer edge of profile resulting from ongoing stress relief due to erosion and valley formation processes on the outer slope. The existing slides in the northern part of the site and at 19 Daydown Avenue are examples of this type of failure. Should such a failure occur it could potentially cause extensive structural damage and require large scale, costly repairs, and possibly temporary evacuation of buildings until repairs are complete. Maintaining good slope drainage to prevent buildup of water pressures is recommended, together with remedial works to reinstate the existing failures. Planning of subdivision layouts to avoid siting residential structures over these areas is recommended, to limit potential consequences;

Hazard 5: Small scale slide (<100m³) due to failure of unsupported cuts and fills or poorly designed, constructed, or otherwise inadequate retaining walls. Such a failure could cause localised damage requiring moderate repairs to part of the structure.

- - - / HAZARD H1 - Large scale translational slide of conglomerate blocks over saturated Booragul Tuff causing debris flow
- HAZARD H2 - Translational or rotational slide through colluvial and residual soil profile
- . - . HAZARD H3 - Ongoing soil creep in colluvial soil profile
- HAZARD H4 - Translational slide in weathered rock and soil profile - existing slides in northern part of site & southern end (off Daydawn Ave)
- / HAZARD H5 - Rotational Failure in unsupported or inadequately retained cuts or fills

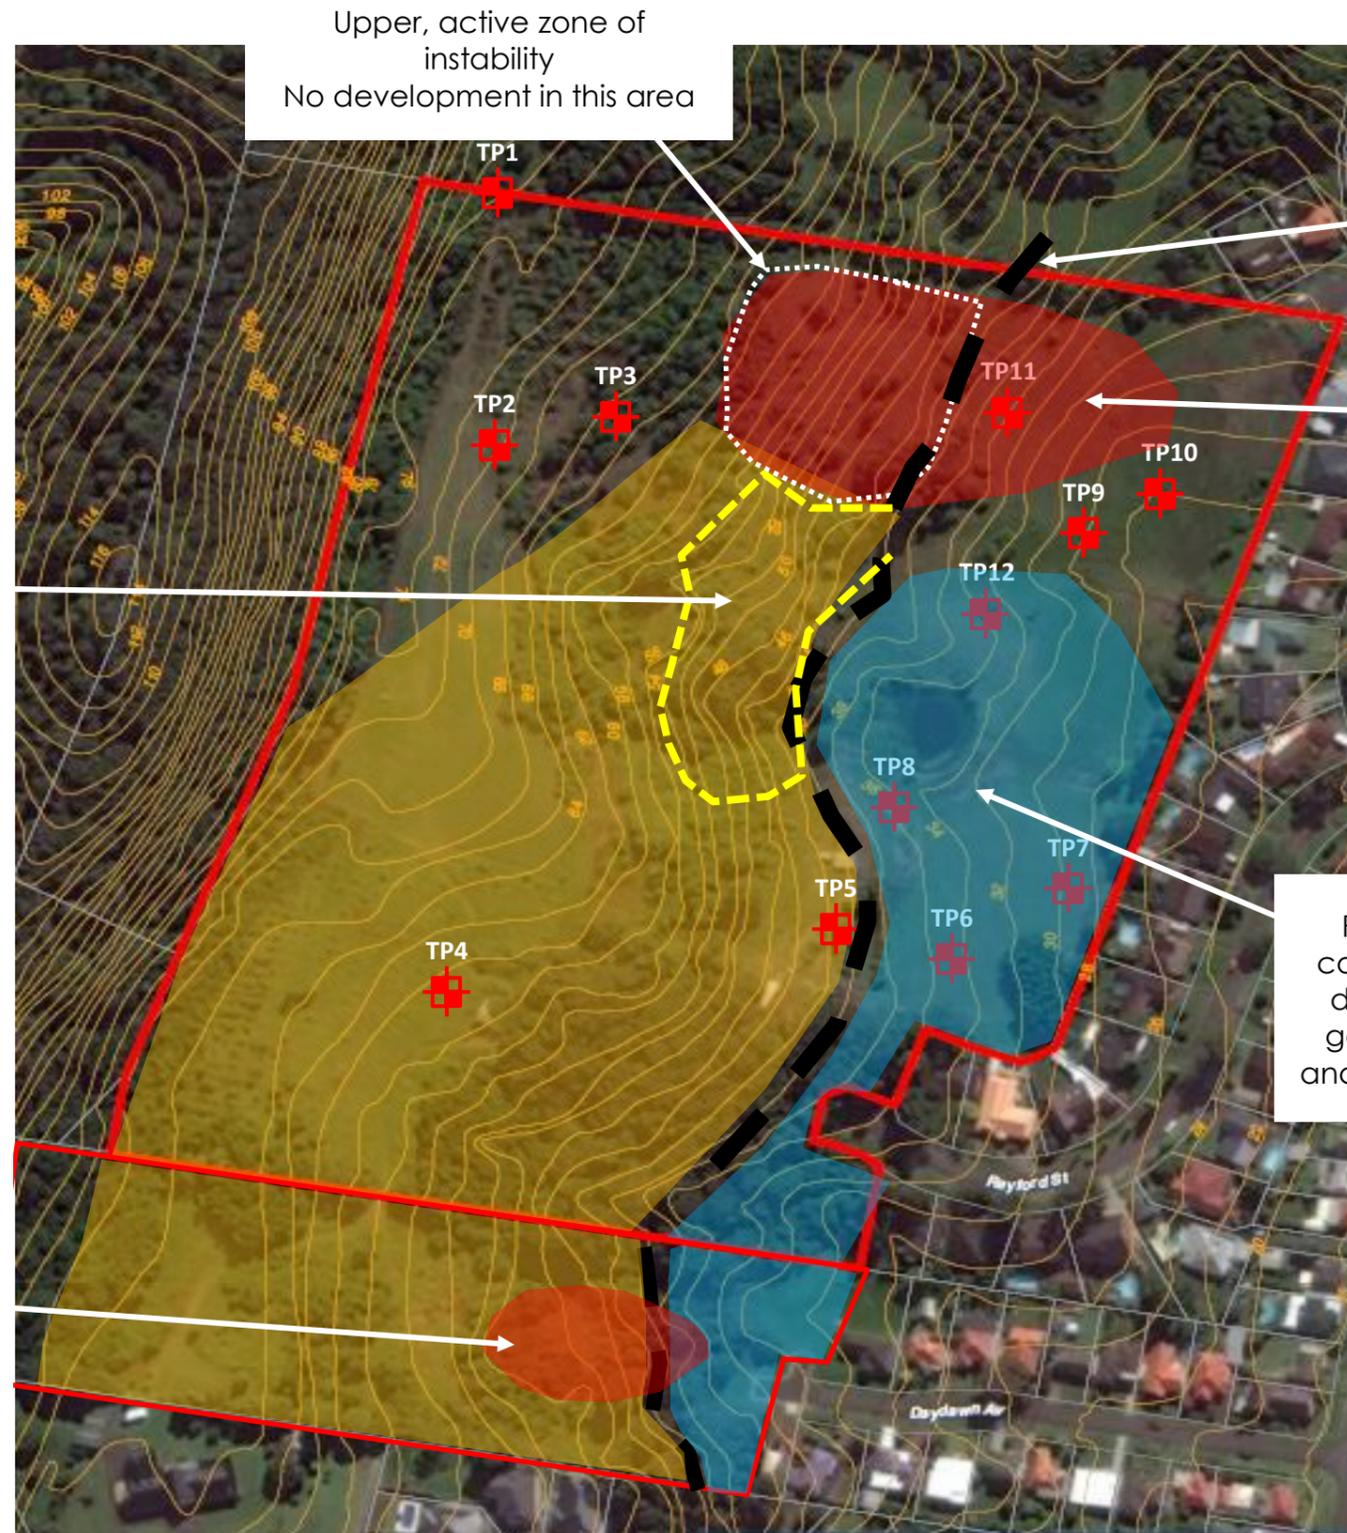
The assessment indicates the risk of slope instability to be **High to Very High** in the areas affected by previous landslide activity at the northern end of the site and off the end of Daydown Avenue. The **Very High** rating applies to the active landslide zone on the upper slopes of the northern failure. It is recommended that development be avoided in this area. Remedial measures are proposed that would reduce the likelihood of further re-activation of the landslide, but the remedial works proposed would not reduce the risk of instability to a level whereby development of the active slide area itself would be feasible.

As shown in Table 1, by adopting the recommendations of this report, the risks can be reduced to **Low** for a large proportion of the site. Based on the assessment presented in Table 1 and the proposed remedial measures, the risk of slope instability and potential development areas available at the site are presented on Figure 8.

Should development be proposed in the colluvial midslopes near the centre of the site (delineated in yellow on Figure 8), it is important that measures be taken to prevent water travelling through the weathered rock profile from becoming trapped beneath the low permeability colluvial clay soils that cover the slope. To assist in preventing buildup of water pressures beneath the slope profile, it is recommended that a series of subsoil drains be installed within the proposed building area.
