**Proposed Residential Subdivision  
Rayford Street and Daydawn Avenue, Warners Bay**

**Additional Geotechnical Assessment**

Report No. RGS01426.1-AGrev2

29 March 2019

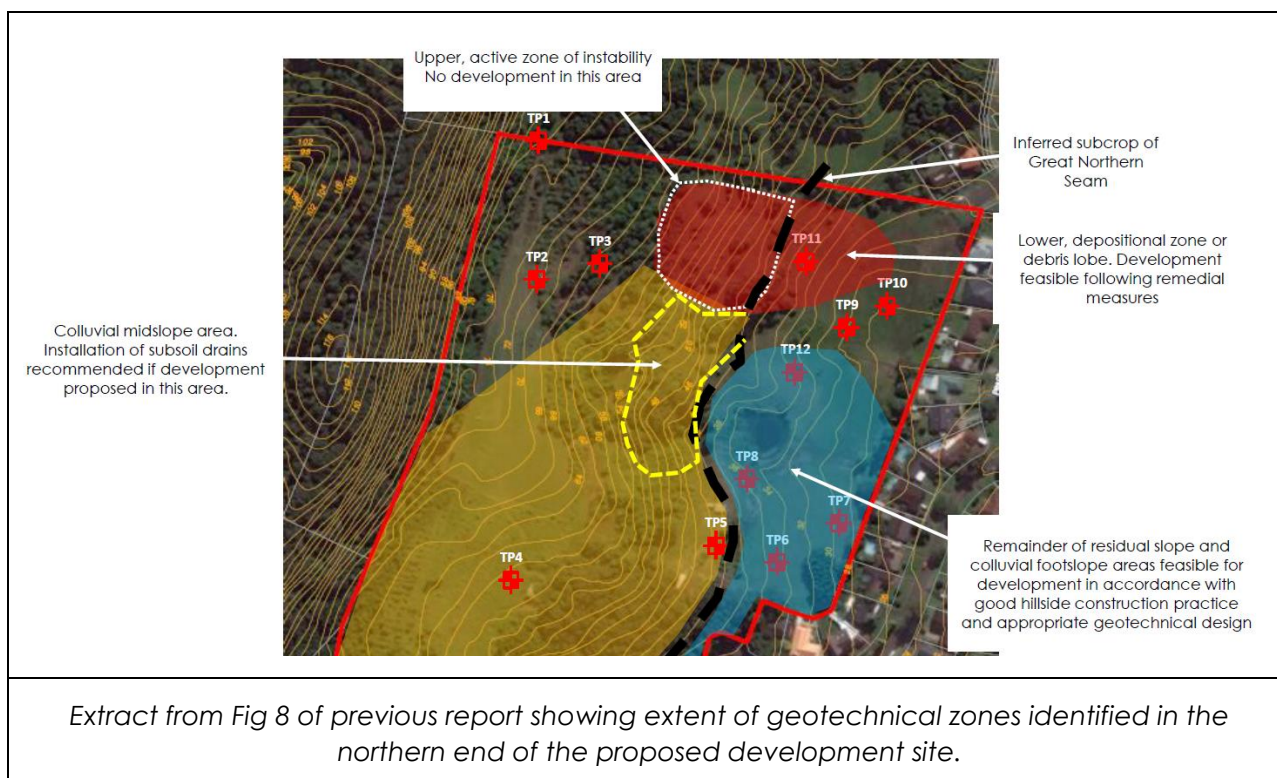
The previous investigations identified a zone of active slope instability at the northern end of the site, surrounded by colluvial deposits that were remnants of flows or ancient mass movement. The areas were plotted into broad zones as shown on the figure reproduced below from report ref.RGS01426.1-AE.

Upper, active landslide zone (shaded red with white dashed outline) – No development

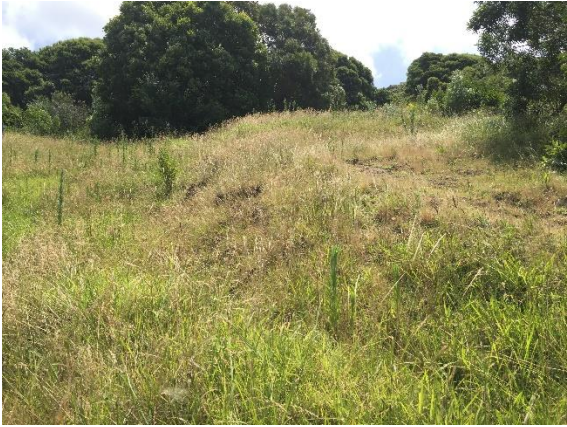
<p><i>Zone of active slope instability in northwestern corner of site</i></p>	<p><i>Irregular slope with features indicative of past disturbance or mass movement on slope behind TP107.</i></p>

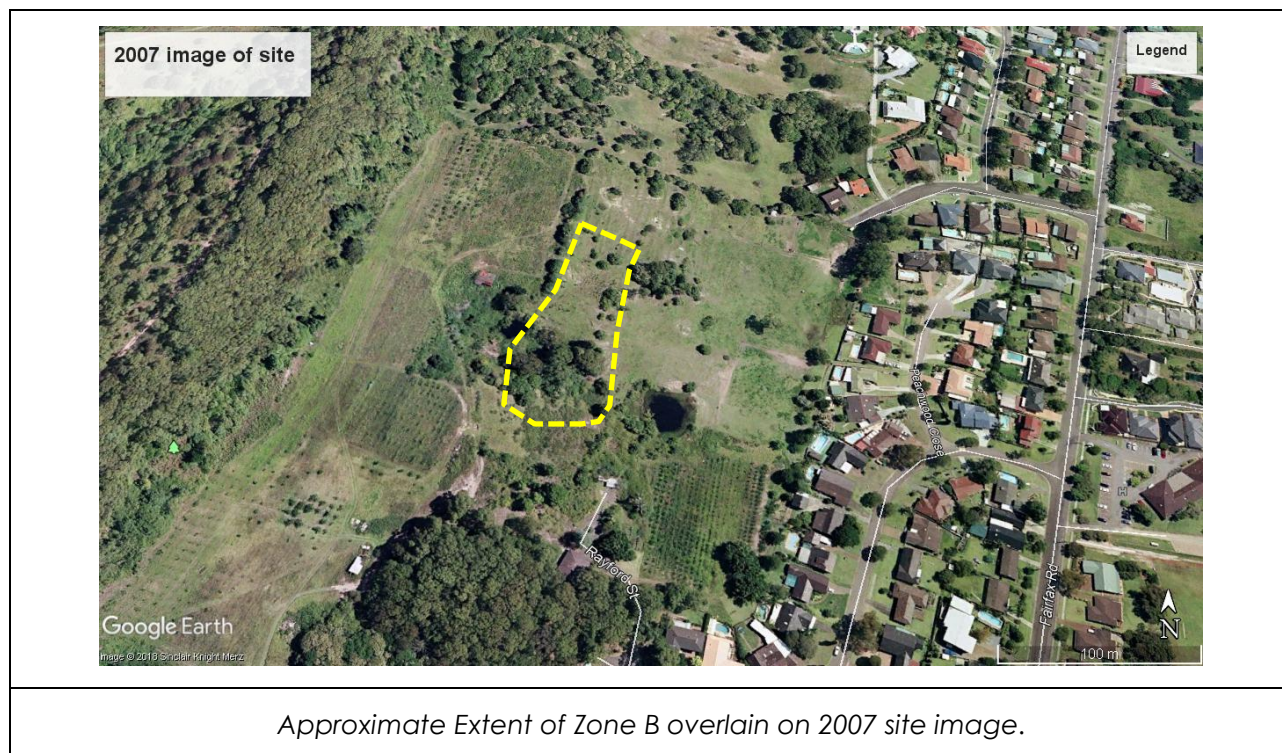
related to mass movement, or near surface disturbance associated with past use of this part of the site for orcharding. A 2007 Google Earth image of the site (shown below) shows remnant orchards on the slope currently delineated as Zone B. It also shows an area of possible localised slope movement.

Residential development of the Zone B area will require extensive geotechnical investigation, design, and remedial works.

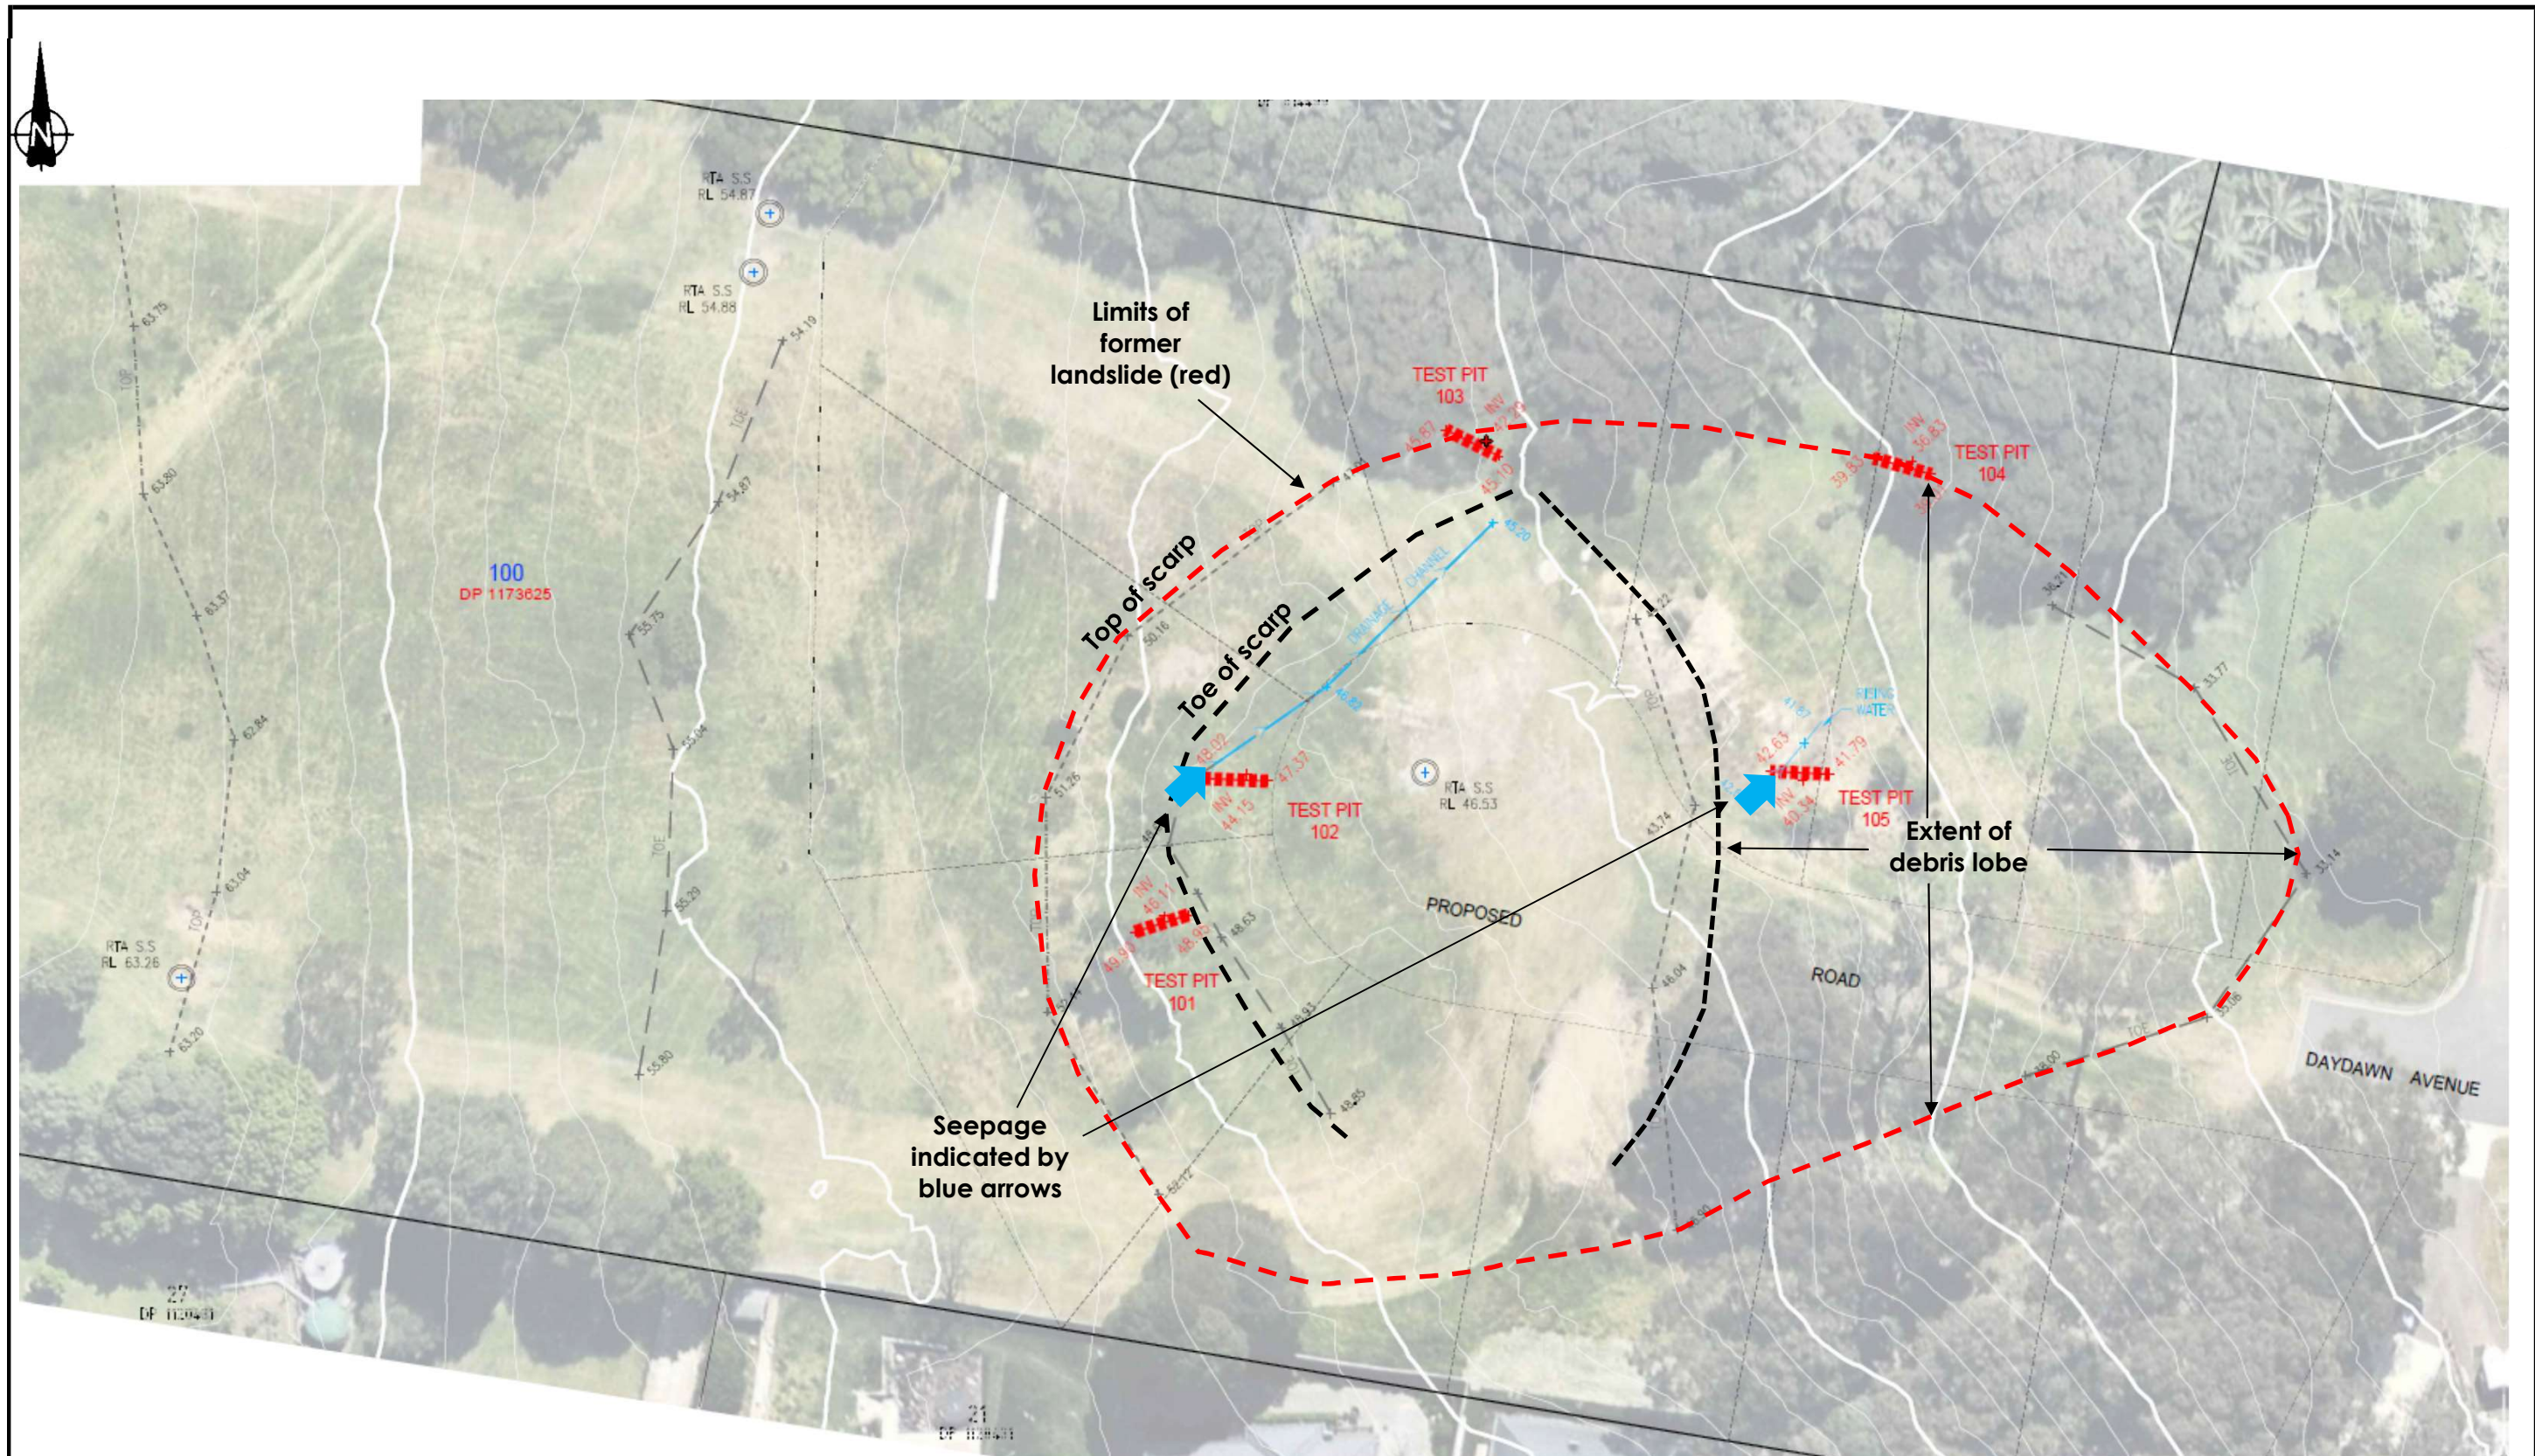
- Visible seepage from the disturbed zone was observed in two locations that are marked on Figure 1;
- A coal seam and overlying low strength tuffaceous soils were encountered in TP103 on the northern edge of the disturbed area;

The recent test pitting investigation indicated that the disturbed ground extends onto the front of the majority of the lots surrounding the cul-de-sac. Previous remediation concepts discussed included installation of subsoil drains that could be located on property boundaries, to assist in alleviating pore water pressures within the landslide area. This would improve drainage, however, the highly disturbed ground would remain within the proposed building areas of the lots and this is not recommended.

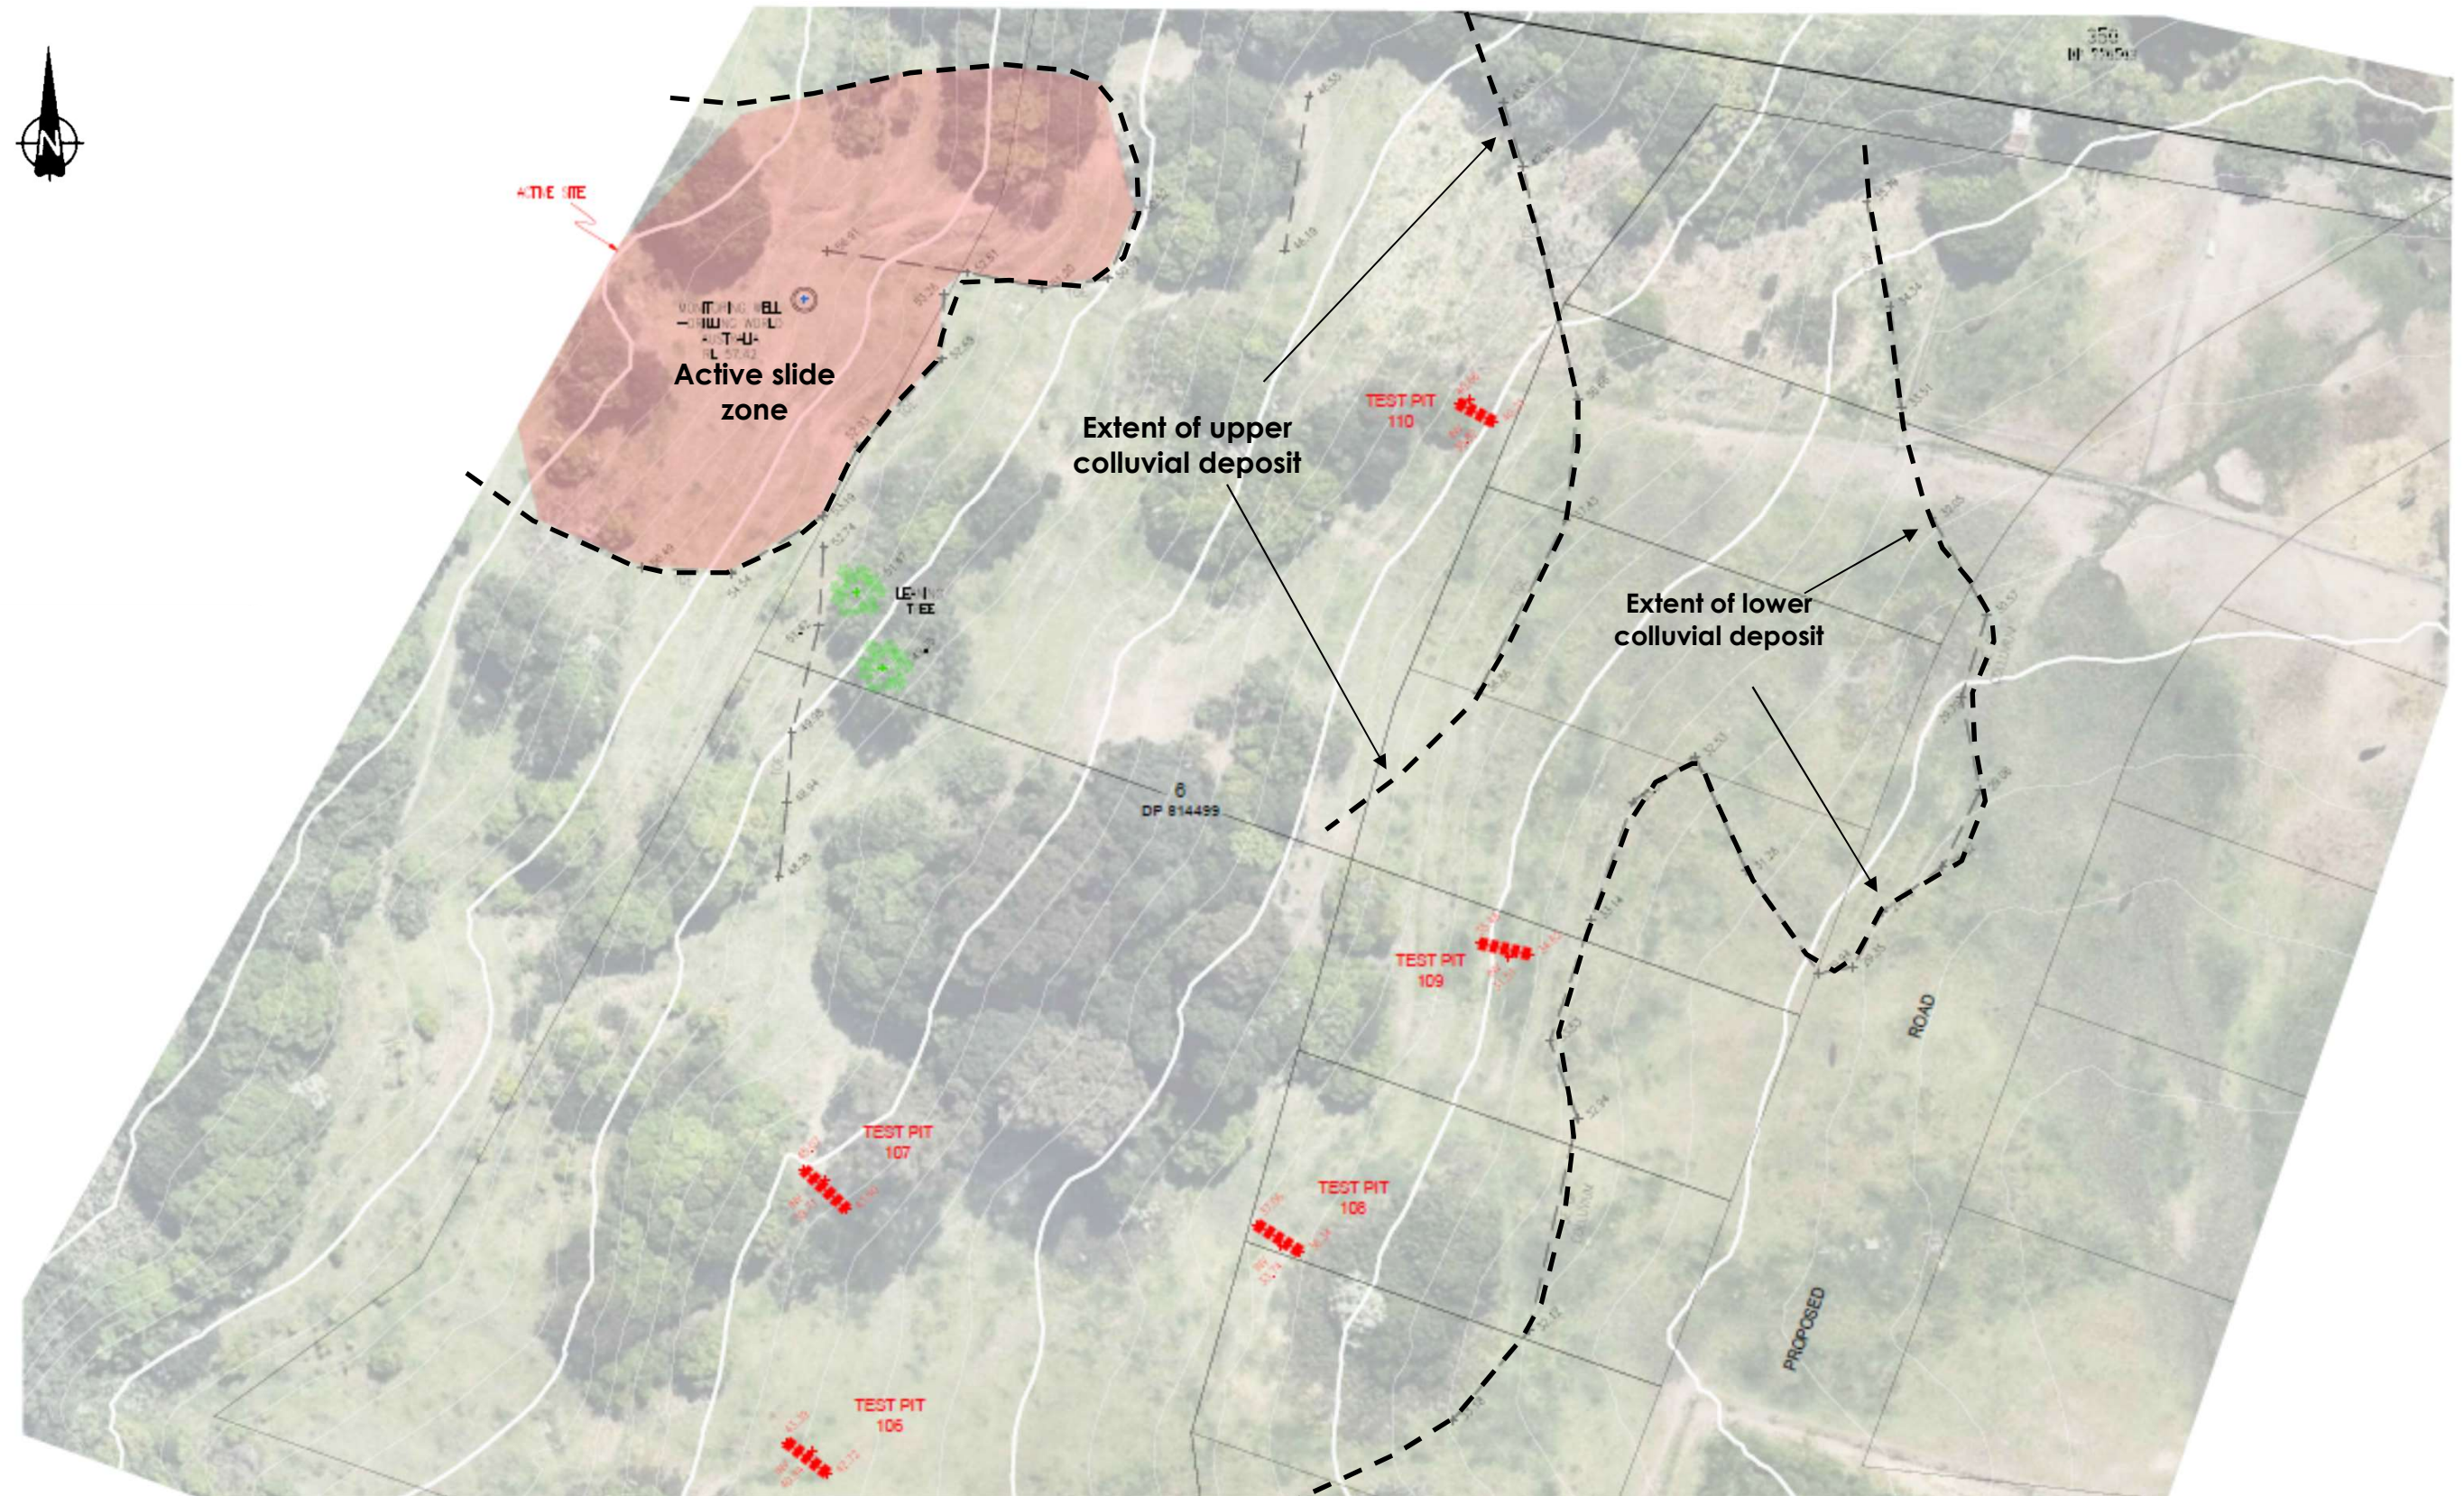
<b>Client</b>	Pulver Cooper Blackley Pty Ltd	Job No.	RGS01426.1
	Residential Subdivision Geotechnical Assessment	Drawn By:	SRM
	19 Daydown Ave and 40 Rayford Street, Warners Bay	Date:	15-Jan-19
	Extent of Landslide Affected Area - Northern Landslide Area	Drawing No.	<b>Figure 2</b>

- Deep colluvial deposits in test pit TP106 and TP107 support the previous identification of colluvial slopes in this area;
- Since the previous assessment, clearing of thick vegetation on the slope behind the TP106/107 area revealed an irregular surface with some features indicative of past disturbance or movement;
- Colluvial deposits were shallower in the lower slopes that encroach onto the rear of proposed residential lots. The colluvium in test pits TP108 and TP109 was underlain by residual soils and weathered rock at 2.4 and 2.2m respectively;
- Evidence of active movement at the northern end of the site was observed and the visible extent delineated by survey.
