**Geotechnical Slope Risk Assessment**

**Proposed Subdivision**

**18 Winterlake Road, Warners Bay**

Report No. RGS02268.1-ABrev1

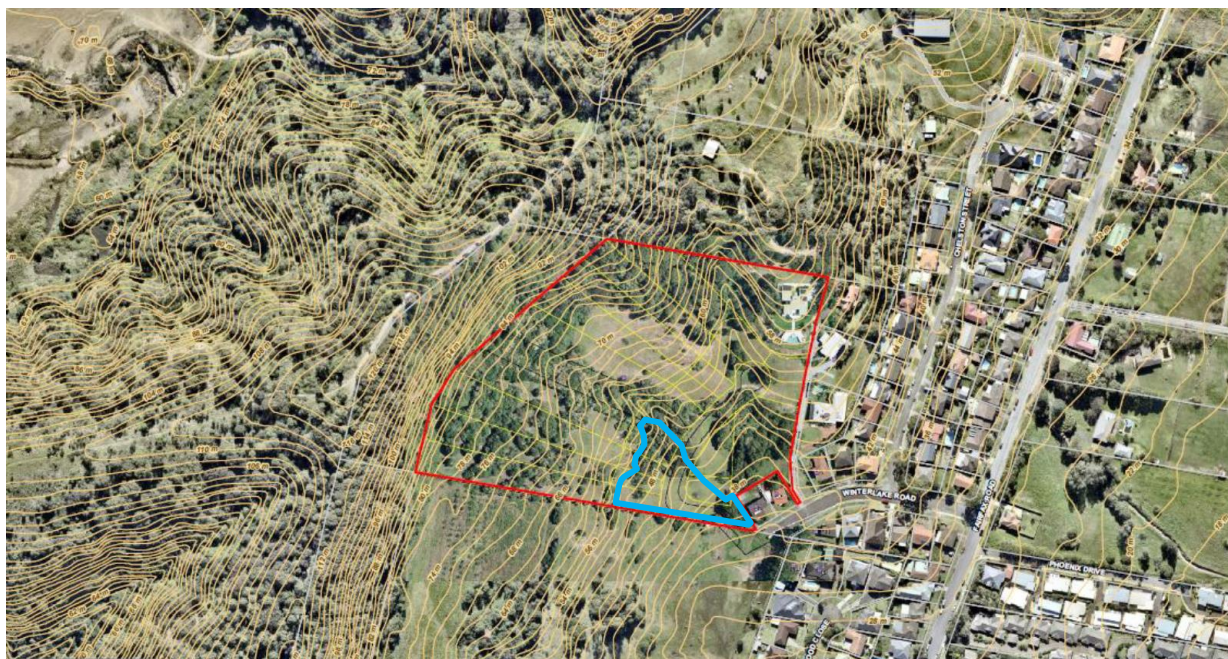
**Plate 1.** Total property area of No. 18 Winterlake Road shown in red outline. Proposed residential development area shown in blue.

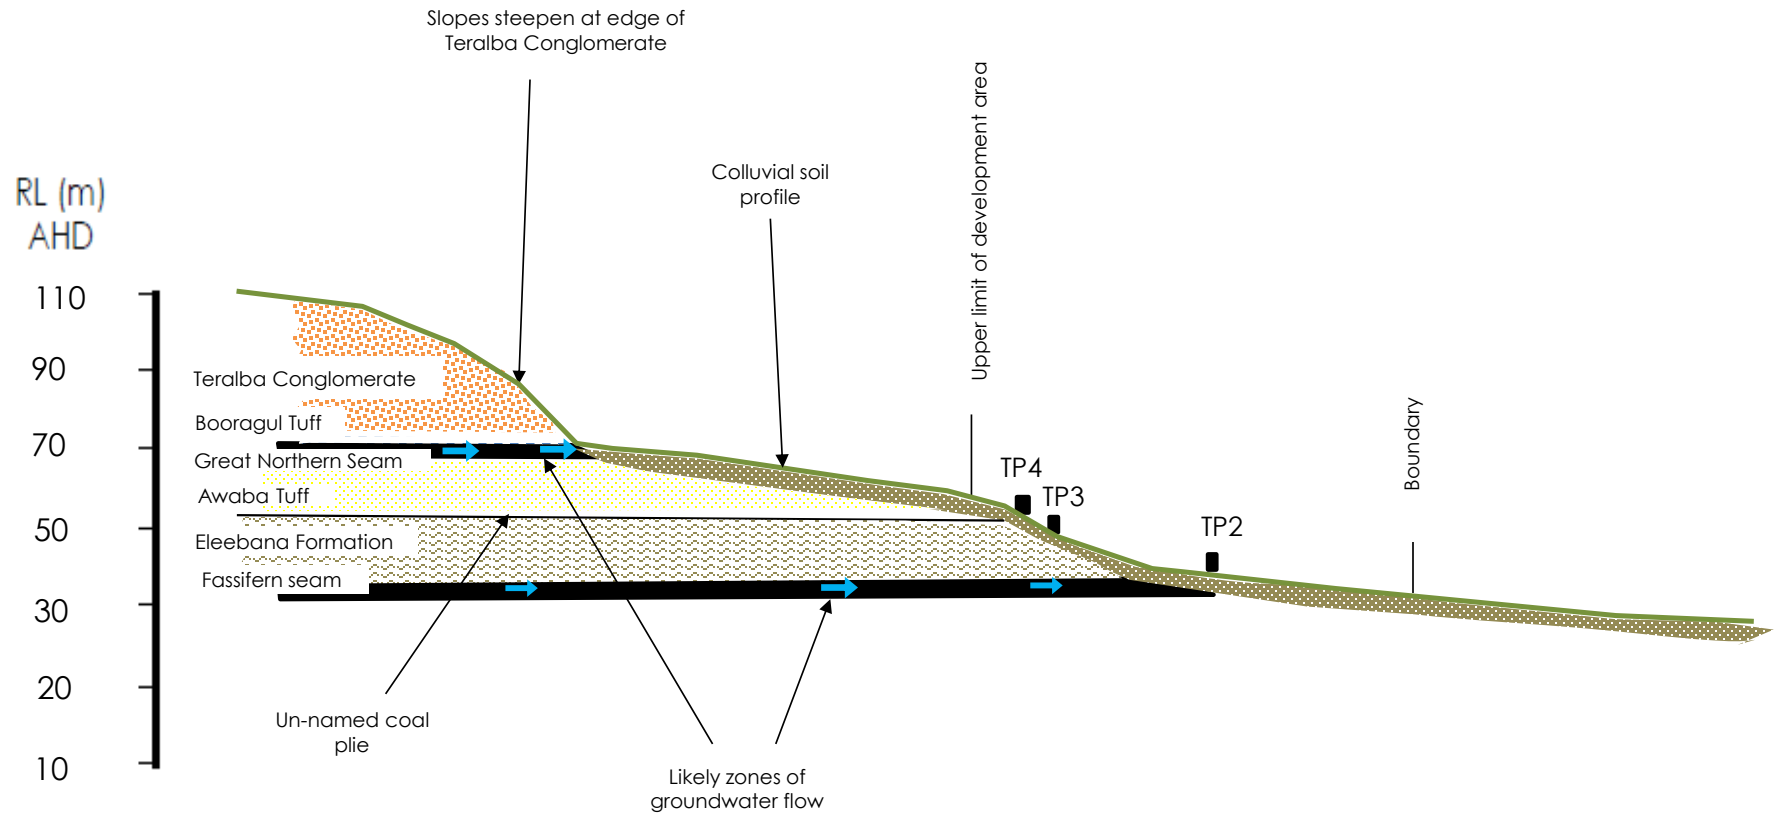
<b>REGIONAL GEOTECHNICAL SOLUTIONS</b>	<b>Client</b>	Valley Planning Pty Ltd	Job No.	RGS02268.1
	<b>Project:</b>	Proposed residential subdivision 18 Winterlake Road, Warners Bay	Drawn By:	SRM
	<b>Title:</b>	Interpreted Geological Cross Section	Date:	31-Jan-20
			Drawing No	<b>Figure 5</b>

The following points are noted from Figure 5 and the subsurface conditions encountered by this and previous investigations:

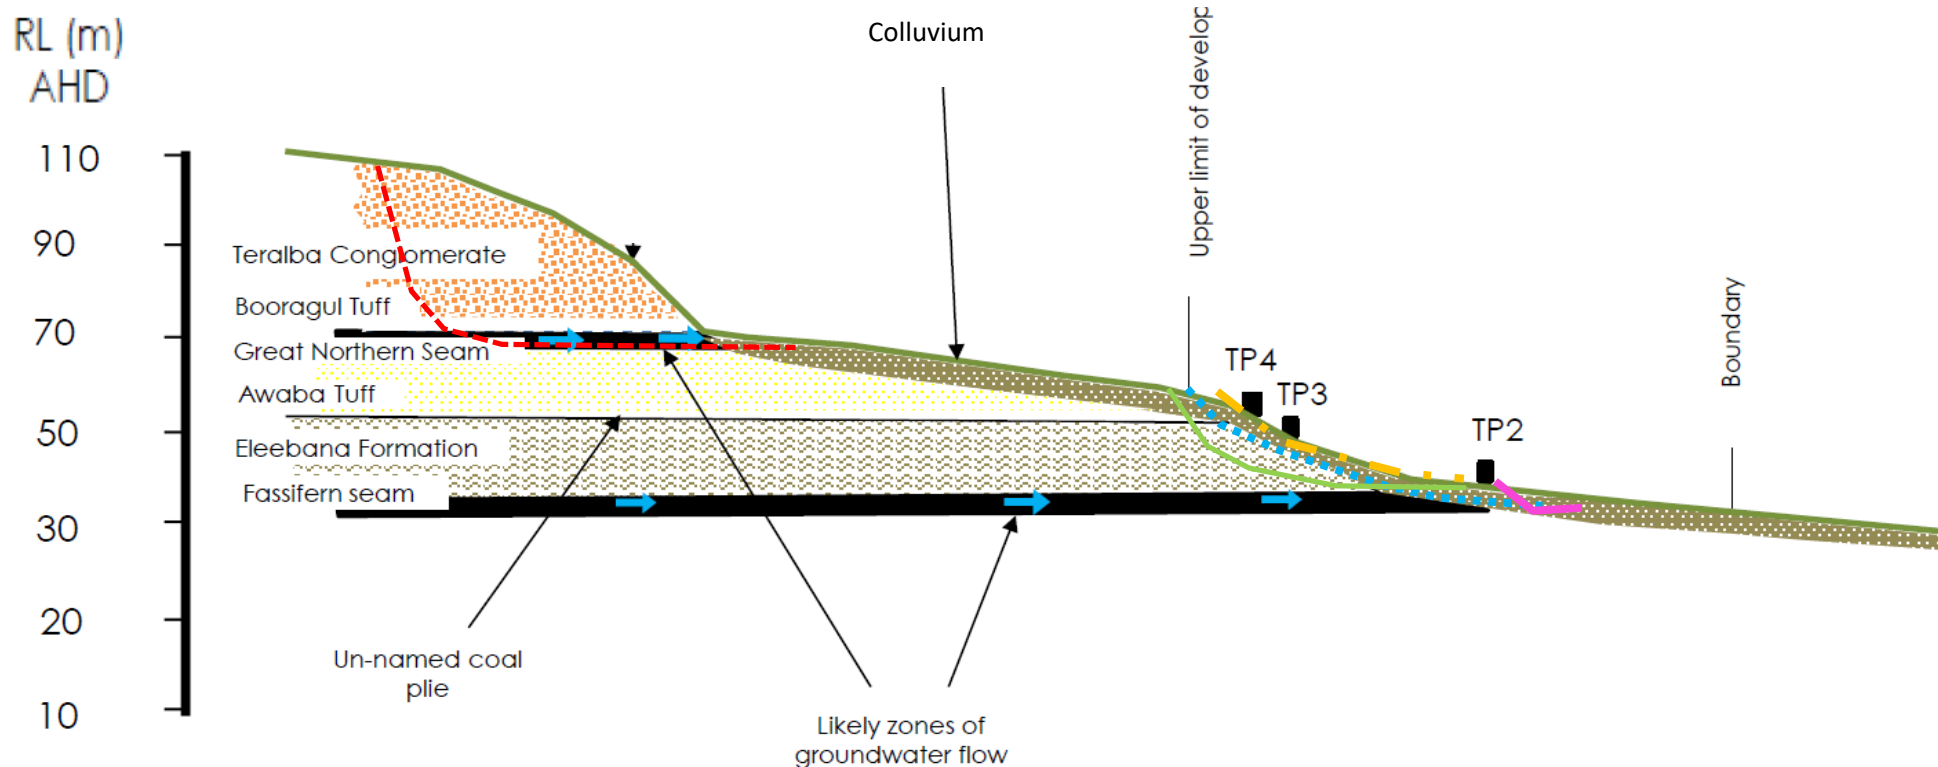
<b>REGIONAL GEOTECHNICAL SOLUTIONS</b>	<b>Client:</b>	Valley Planning Pty Ltd	Job No.	RGS02268.1
	<b>Project:</b>	Proposed residential subdivision	Drawn By:	SRM
		18 Winterlake Road, Warners Bay	Scale:	NTS
	<b>Title:</b>	Identified Landslide Hazards	Date:	30-Jan-20
			Drawing No.	<b>Figure 6</b>

**Hazard 1:** Large scale translational slide of conglomerate blocks over saturated tuffaceous claystone layers large movements and possible debris flow and involving more than  $>100\text{m}^3$  of material. Such a failure could cause complete destruction or large scale damage of several structures within a typical residential subdivision;

**Hazard 2:** Translational or rotational slide through the colluvial and residual soil profile. Should such a failure occur it could potentially cause extensive structural damage and require large scale, costly repairs, and possibly temporary evacuation of a typical residential building until repairs are complete. Maintaining good slope drainage to prevent buildup of water pressures within the profile is recommended;

**Hazard 3:** Soil creep. Creep is an imperceptibly slow movement that takes place on sloping soil sites. It is an ongoing, natural slope process involving the progressive downslope movement of soils over the underlying rock profile. Creep will occur within the soil profile overlying weathered rock at this site, and will require management by undertaking good hillside construction practice as recommended in this report;

**Hazard 4:** Translational or rotational slide of soil and weathered rock profile resulting from ongoing stress relief due to erosion and valley formation processes on the outer slope. Should such a failure occur it could potentially cause extensive structural damage and require large scale, costly repairs, and possibly temporary evacuation of buildings until repairs are complete.

**Hazard 5:** Small scale slide ( $<100\text{m}^3$ ) due to failure of unsupported cuts and fills or poorly designed, constructed, or otherwise inadequate retaining walls. Such a failure could cause localised damage requiring moderate repairs to part of the structure.

Each of the identified hazards is illustrated on Figure 6.

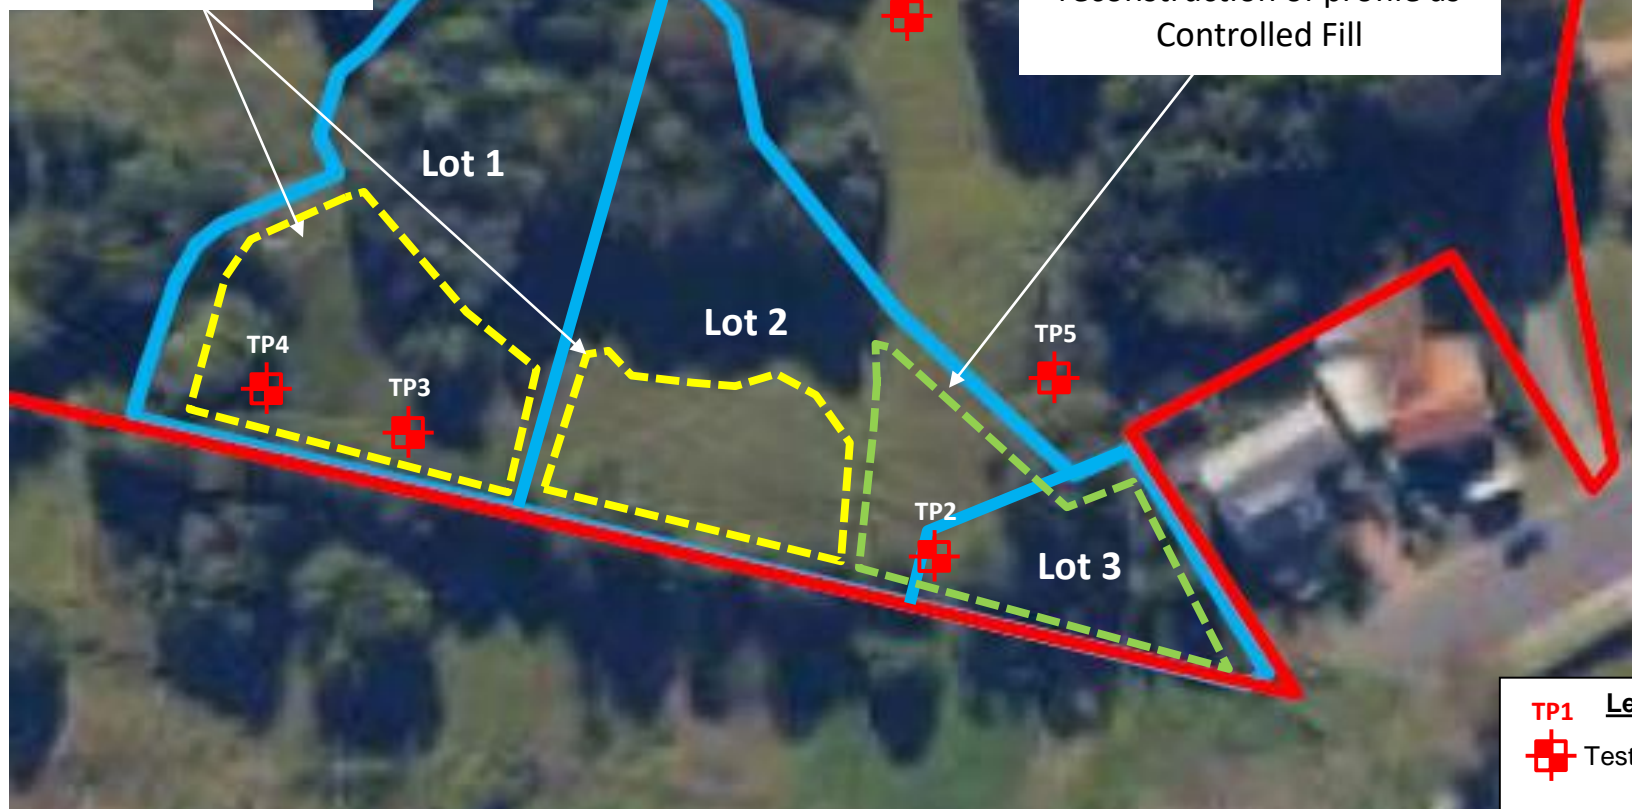
<b>Client:</b>	Valley Planning Pty Ltd	Job No.	RGS02268.1
<b>Project:</b>	Proposed residential subdivision	Drawn By:	SRM
	18 Winterlake Road, Warners Bay	Scale:	NTS
<b>Title:</b>	Potential Building Areas and Geotechnical Requirements	Date:	30-Jan-20
		Drawing No.	<b>Figure 7</b>

Yellow outlines - potential building areas, pending detailed geotechnical investigation, deep subsoil drainage, regrade of slope and piled foundations as per report

Green outline - potential building areas pending detailed geotechnical investigation, excavation of existing profile, placement of rock drainage blanket and reconstruction of profile as Controlled Fill

For development on the mid to upper slope areas of Lot 1 and Lot 2 (delineated in yellow on Figure 7), it is important that measures be taken to prevent water travelling through the soil and weathered rock profile from becoming trapped beneath the low permeability colluvial clay soils that cover the slope. To assist in preventing buildup of water pressures beneath the slope profile, it is recommended that a series of subsoil drains be installed within the proposed building area.
