Hazardous Materials Survey

Peat Island & Adjoining Land
Mooney Mooney NSW

Hazardous Materials Survey Report

January 2013
JBS 42531-53106 (Rev 0)
JBS Environmental Pty Ltd

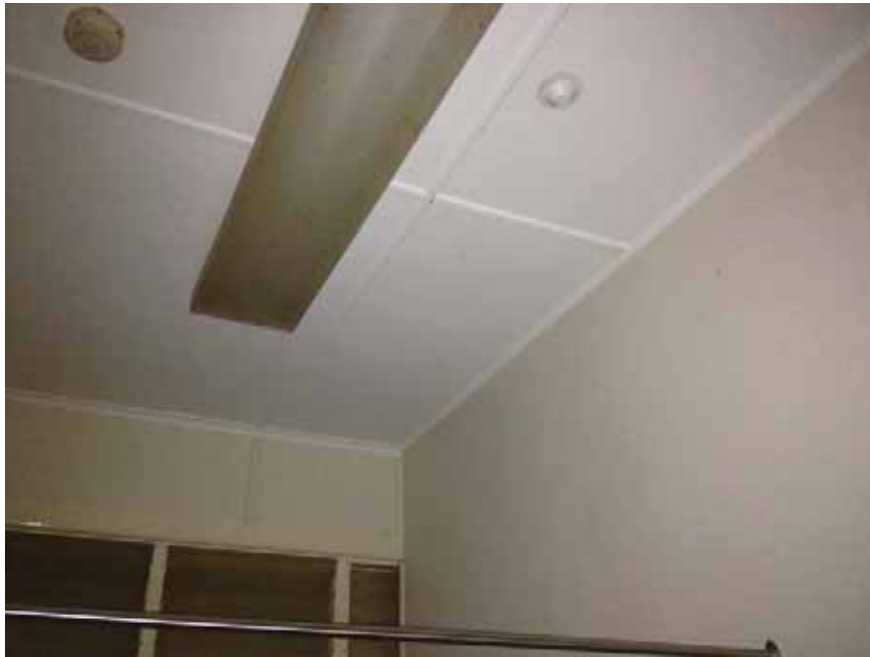
With the exception of the two shower rooms in Building 1 hazardous materials were not observed in any of the rooms. Ceiling linings in the shower rooms were constructed of suspected ACM and sample M1 (Chrysotile, Amosite and Crocidolite asbestos detected) was collected. The ceiling linings in the shower rooms were in good condition and covered an area of approximately 11.5 m².

Photograph 01 – Building 1, Asbestos containing flat sheet ceiling lining within interior shower rooms

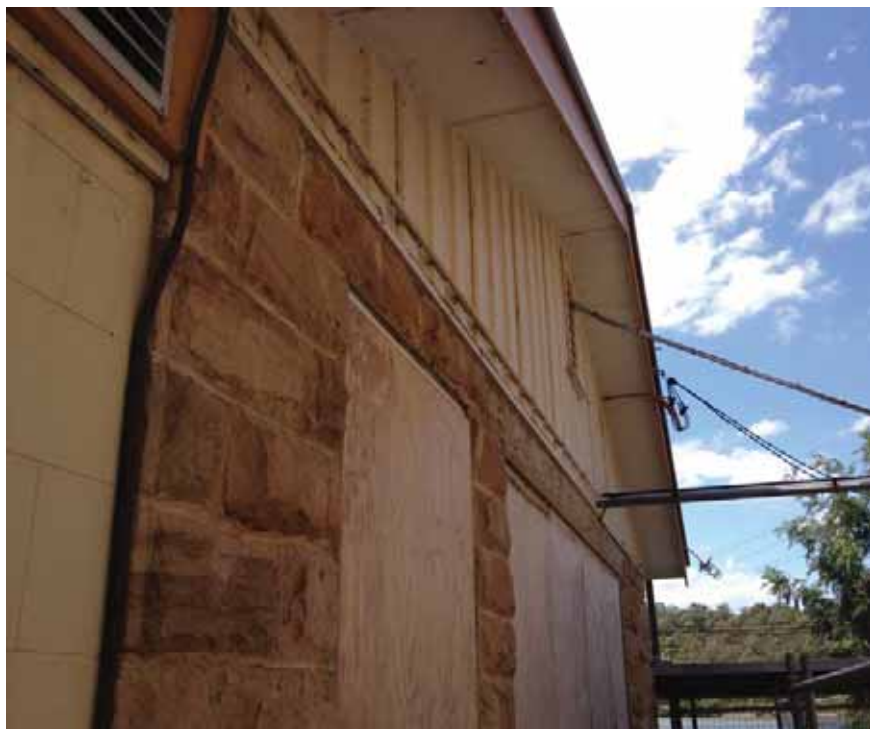
Building 2 was a single storey building of sandstone and brick construction with a corrugated iron roof. The fascia on the east and west exterior of the sandstone portion (NE) of the building was of suspected ACM covering an area of approximately 25 m² and in very good condition. The eaves of the building were of suspected ACM in good condition and a sample (M6 - Chrysotile, Amosite and Crocidolite asbestos detected) was collected for analysis.

Photograph 02 – Building 2, Asbestos containing flat sheet eaves and fascia cladding

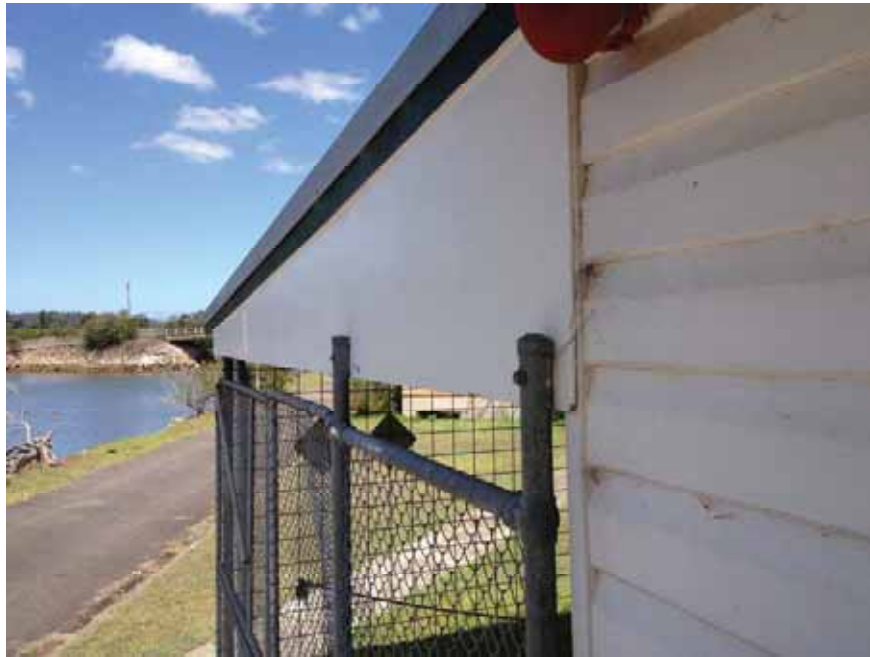
Building 3 was clad with weatherboard with a suspected ACM fascia board on the building and the garage. The suspected ACM was in good condition and had an approximate area of 4 m². Sample M4 (Chrysotile asbestos detected) was collected for analysis.

Photograph 03 – Building 3, Asbestos containing flat sheet garage fascia board

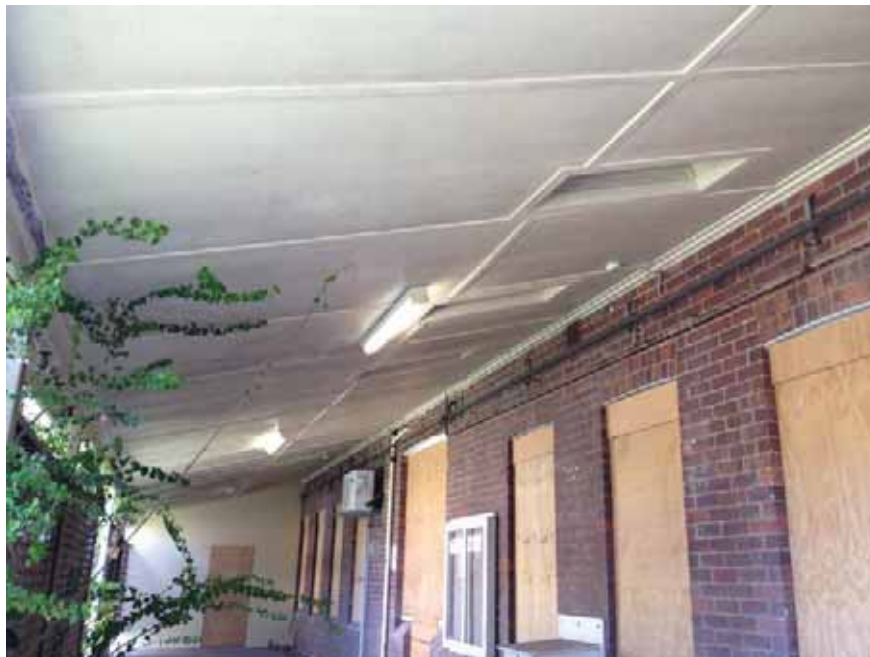
Building 4 was constructed of brick with a steel sheet roof and had two storeys. The eaves and the ceiling lining to the entrance porch were of suspected ACM in good condition with an area of approximately 100 m². Sample M8 (Chrysotile asbestos detected) was collected for analysis.

Photograph 04 – Building 4, Asbestos containing flat sheet porch ceiling lining

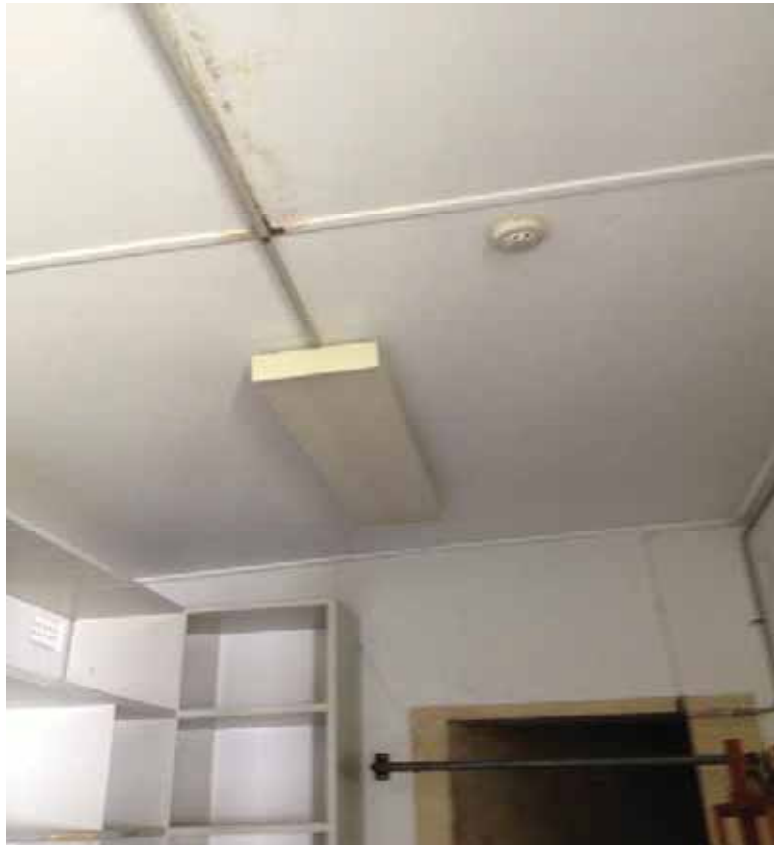
Photograph 05 – Shed adjacent to Building 4, Presumed asbestos containing ceiling lining

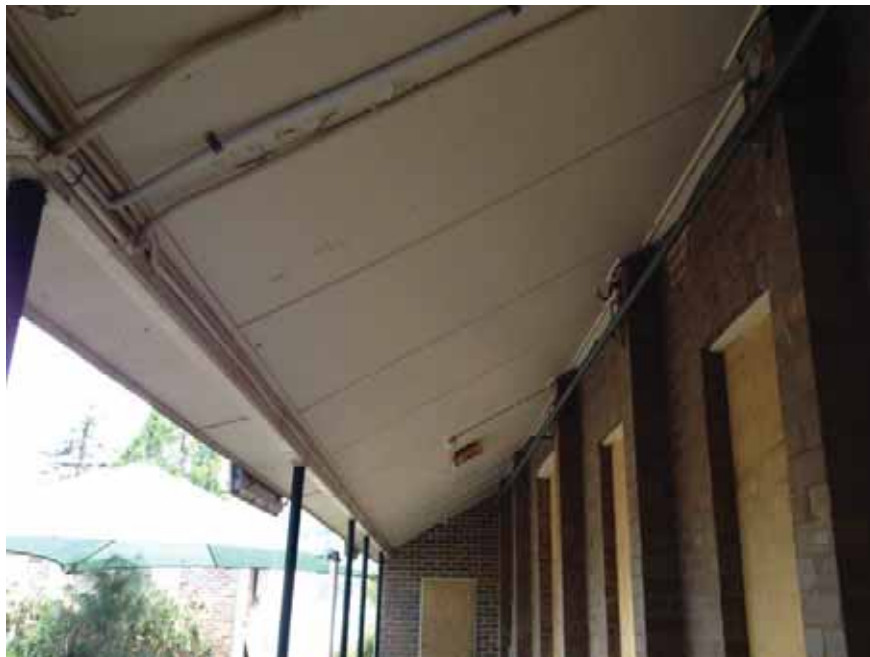
Photograph 06 – Building 5, Presumed asbestos containing flat sheet porch ceiling lining

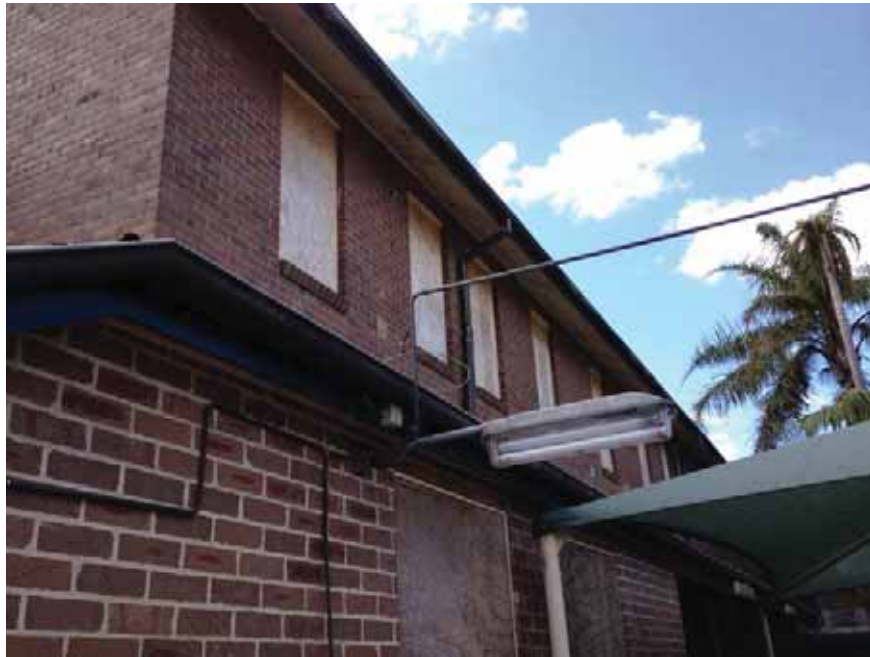
Photograph 07 – Building 5, Presumed asbestos containing flat sheet eaves

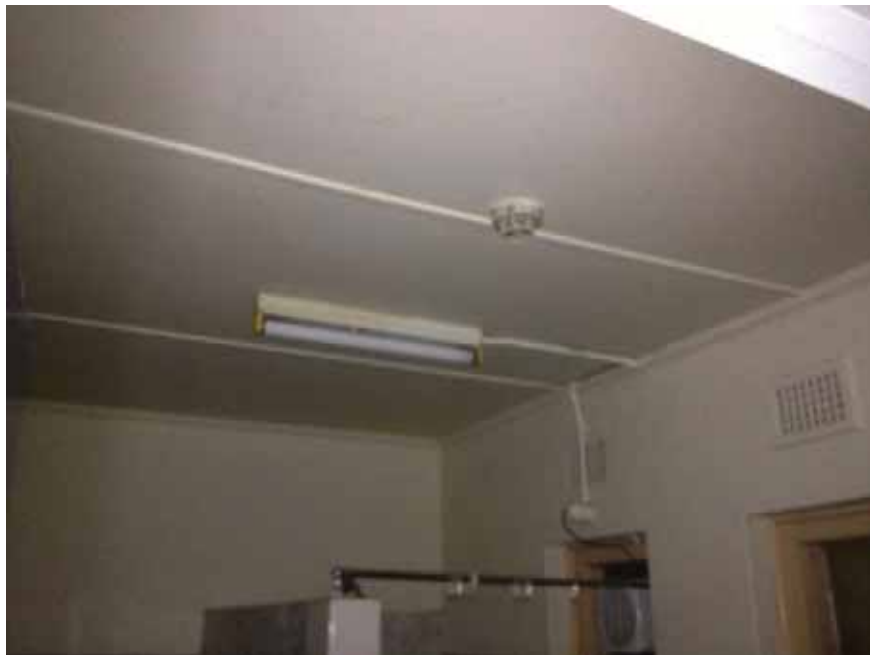
The ceiling lining in the bathroom at the southern end of the ground floor of Building 5 was of suspected ACM. The ceiling was in good condition and covered an area of approximately 8 m². The dining room, also in the southern portion of the ground floor had vinyl tiles to the floor suspected of containing asbestos. The tiles were in good condition and covered approximately 80 m². Sample M10 (Chrysotile asbestos detected in tile, none in adhesive) was collected from the tiles for analysis. The ceiling lining of the kitchen and storage rooms located at the northern end of Building 5 was of suspected ACM in good condition and had a total area of approximately 80 m². The ceiling lining of the stairway leading to the first floor was of suspected ACM, which was in good condition and covered an area of approximately 20 m².

Photograph 08 – Building 5, Presumed asbestos containing flat sheet ceiling lining in ground floor (southern) bathroom

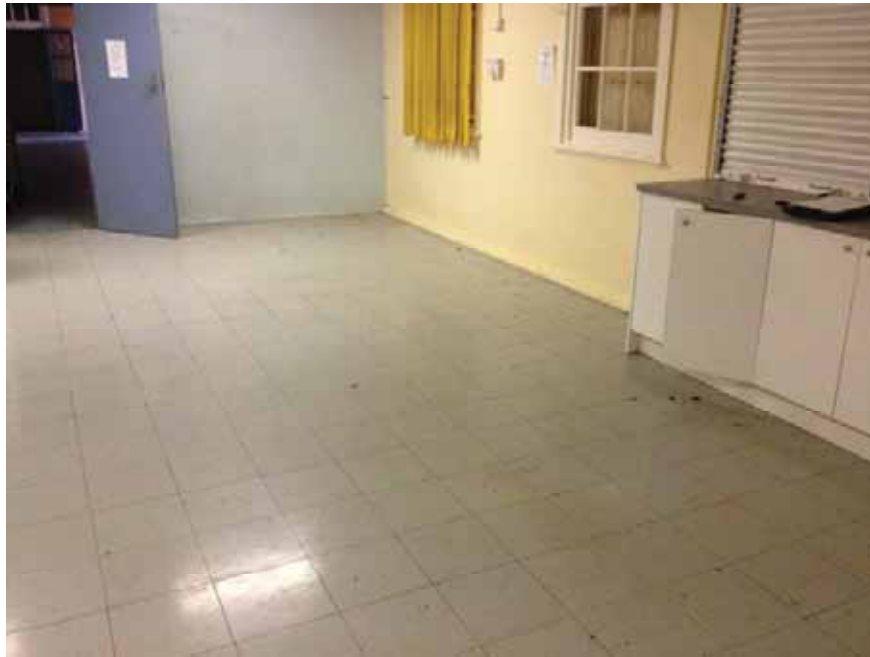
Photograph 9 – Building 5, Asbestos containing vinyl floor tiles in kitchen

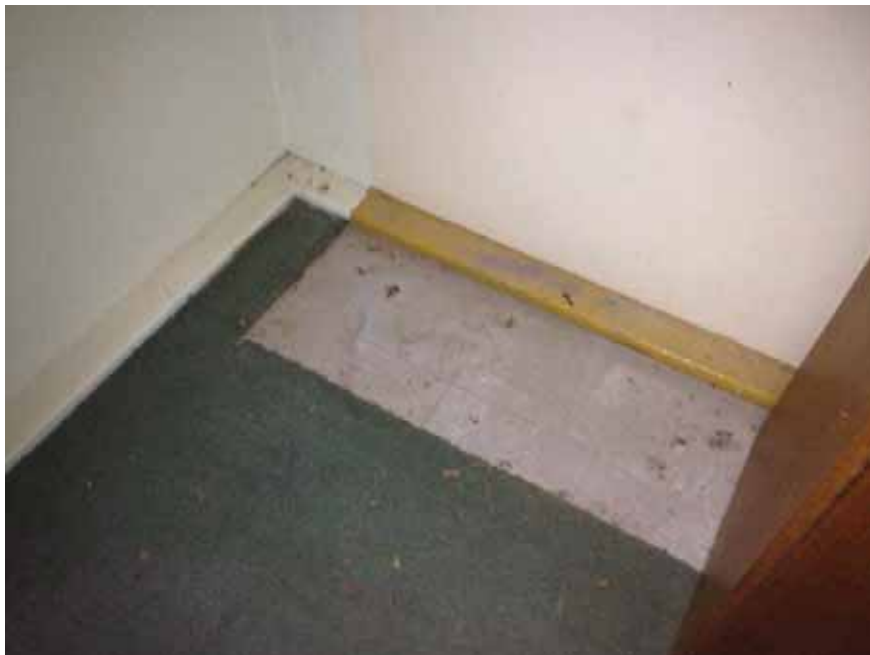
Vinyl floor tiles consistent with those observed in the kitchen on the ground floor were present in the twelve offices on the first floor. Each office had a floor area of 10 m² resulting in approximately 120 m² of tiles suspected of containing asbestos in good condition.

Photograph 10 – Building 5, Presumed asbestos containing vinyl floor tiles beneath carpet in first floor office areas

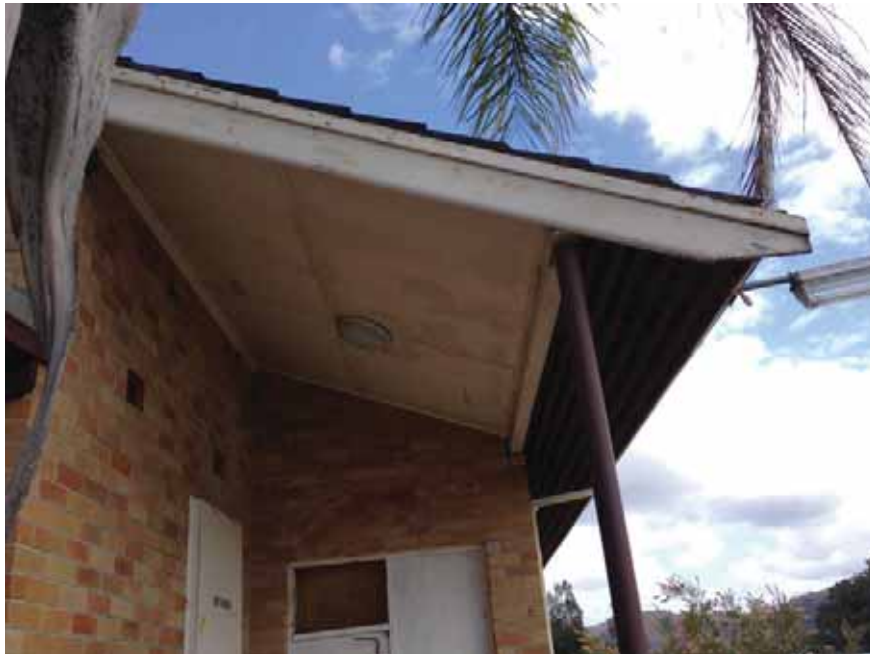
Building 6 was a single storey building constructed of brick with concrete tiles to the roof and timber lined eaves. The lining of the ceiling of the porch on the north eastern corner of the building was of suspected ACM, which was in good condition and had an area of approximately 6 m². With the exception of the laundry, no hazardous materials were observed inside the building. Yellow vinyl floor tiles under the sink in the laundry in the south western corner of the building were suspected on containing asbestos and had an area of approximately 2 m². A sample of the yellow tiles (M15 - *Chrysotile asbestos detected*) was collected for analysis.

Photograph 11 – Building 6, Presumed asbestos containing flat sheet porch ceiling lining (NE corner)

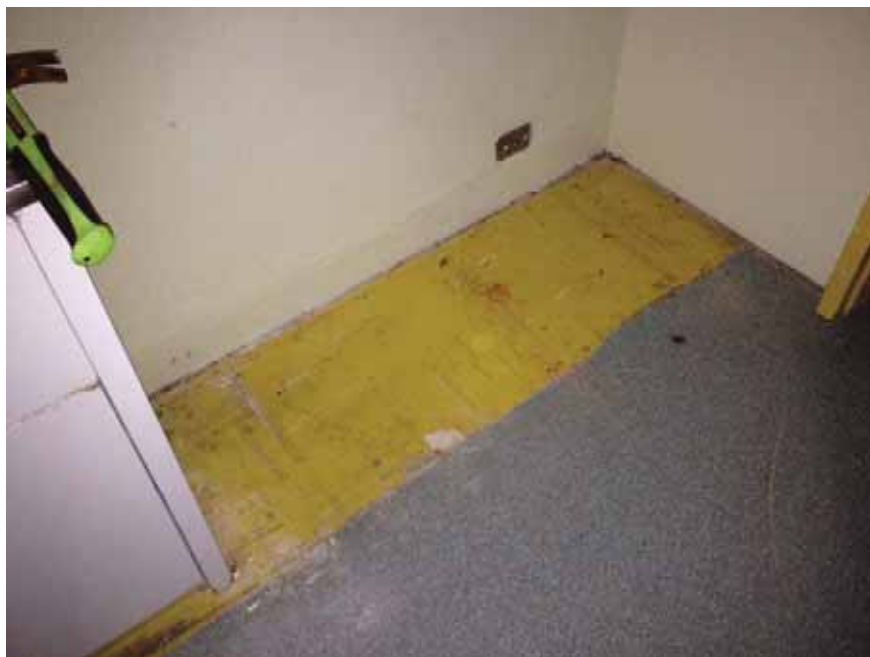
Photograph 12 – Building 6, Asbestos containing vinyl floor tiles in laundry

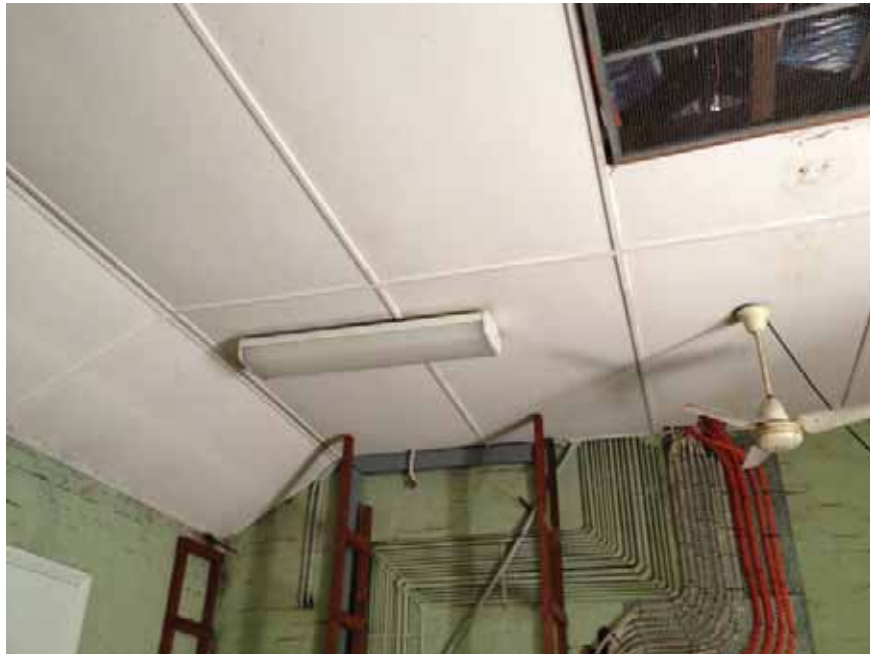
The ceiling lining of the utility room at the northern end of the building was of suspected ACM. The ceiling had an area of approximately 45 m² and was in good condition. Sample M11 (Chrysotile asbestos detected) was collected from the ceiling lining material. Vinyl floor tiles in the northern most utility room were suspected of containing asbestos. The tiles covered an area of approximately 8 m² and were in good condition. Sample M12 (Chrysotile asbestos detected in tile, none in adhesive) was collected from the tiles.

Photograph 13 – Building 9, Asbestos containing flat sheet ceiling lining in utility room.

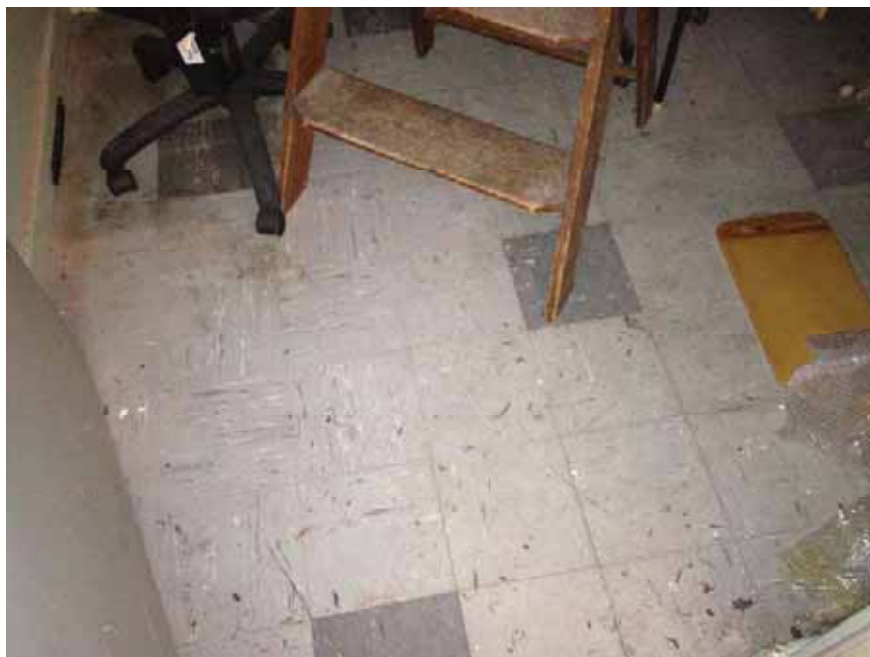
Photograph 14 – Building 9, Asbestos containing vinyl floor tiles in utility room

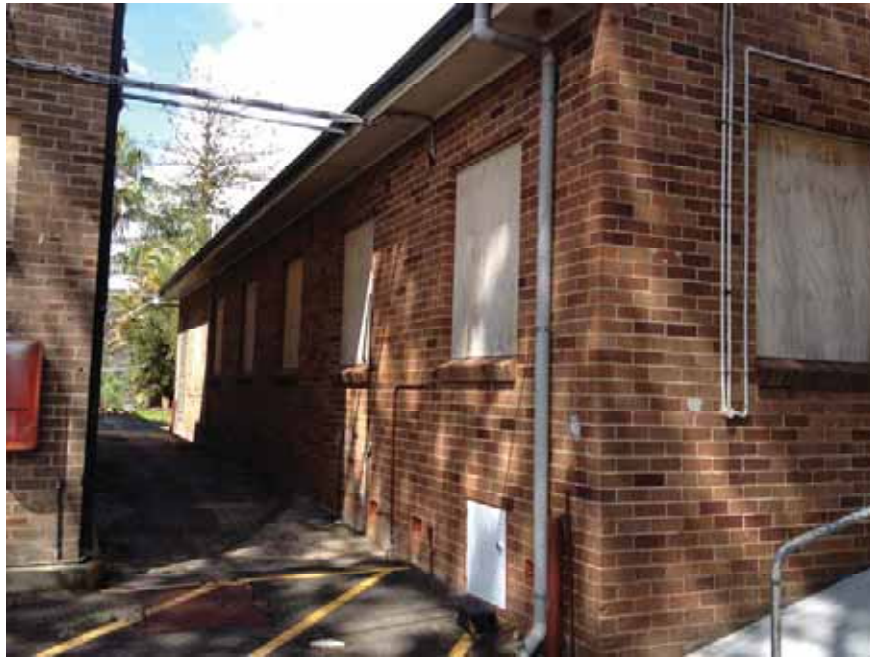
Building 10 was a single storey building constructed of brick with a sheet steel roof. The eaves were of suspected ACM with an area of approximately 20 m² and in good condition.

Photograph 15 – Building 10, Presumed asbestos containing flat sheet eaves

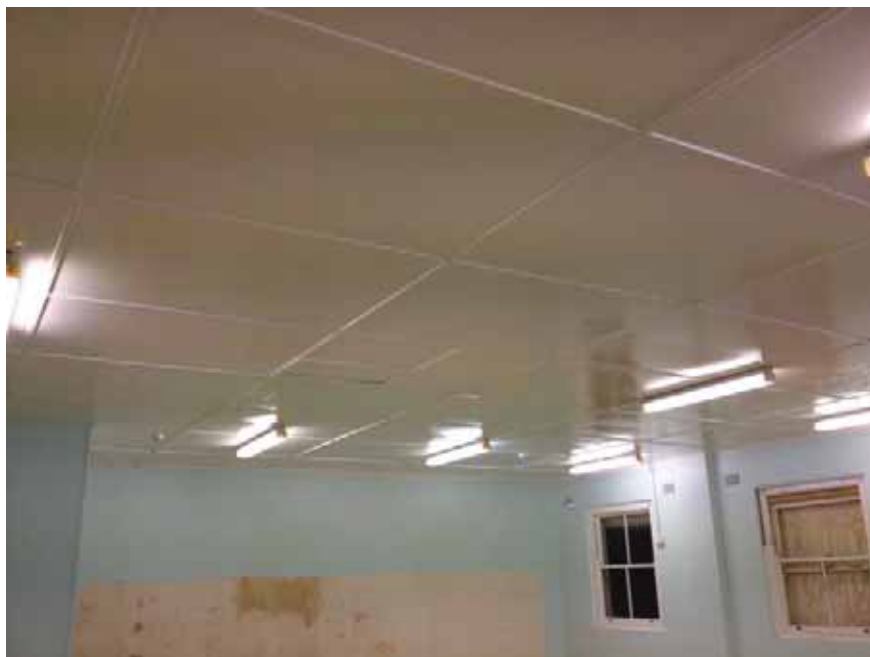
Photograph 16 – Building 10, Presumed asbestos containing flat sheet interior ceiling lining

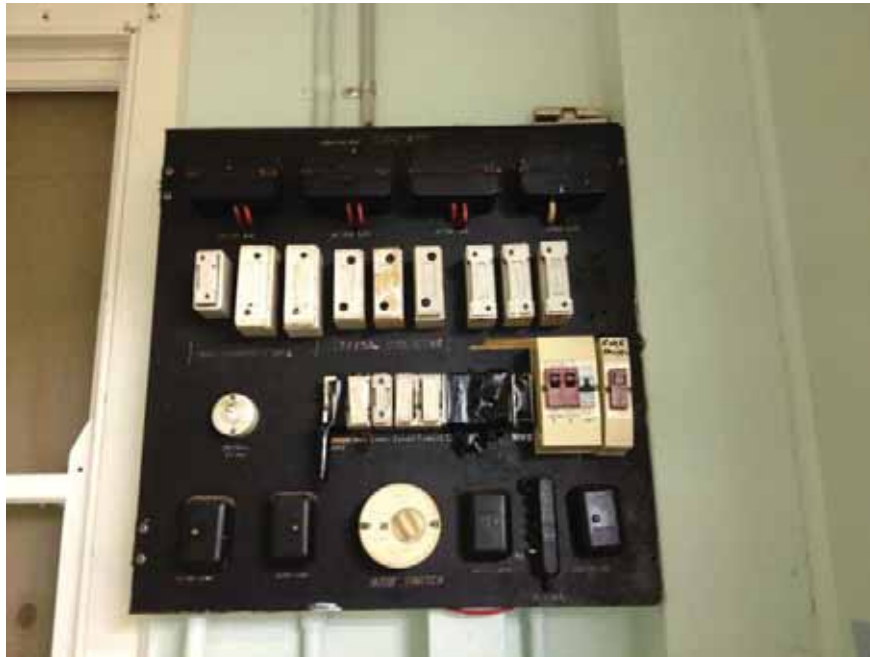
Photograph 17 – Building 10, Presumed asbestos containing 'zelemite' backing board

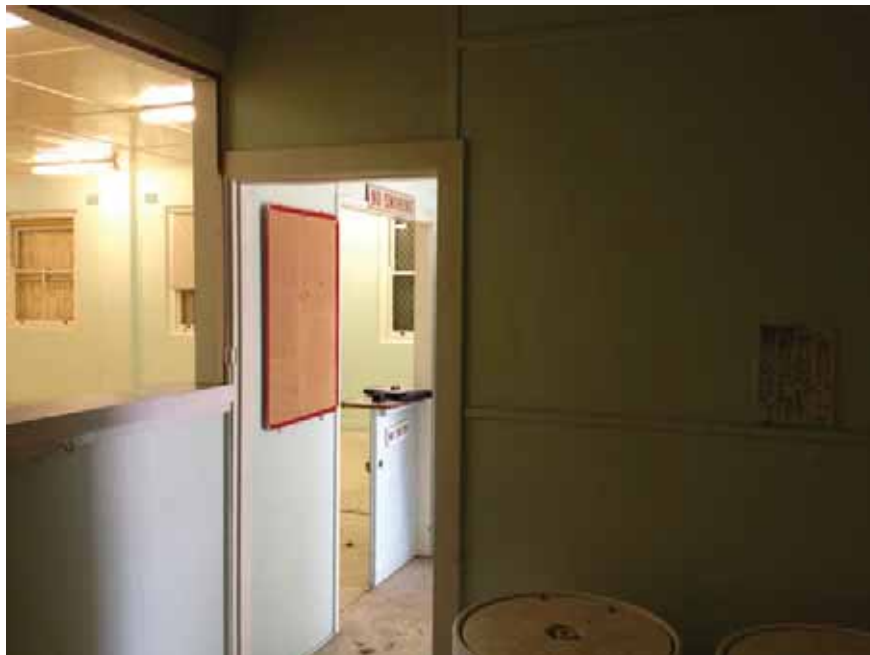
Photograph 18 – Building 10, Asbestos containing flat sheet wall linings

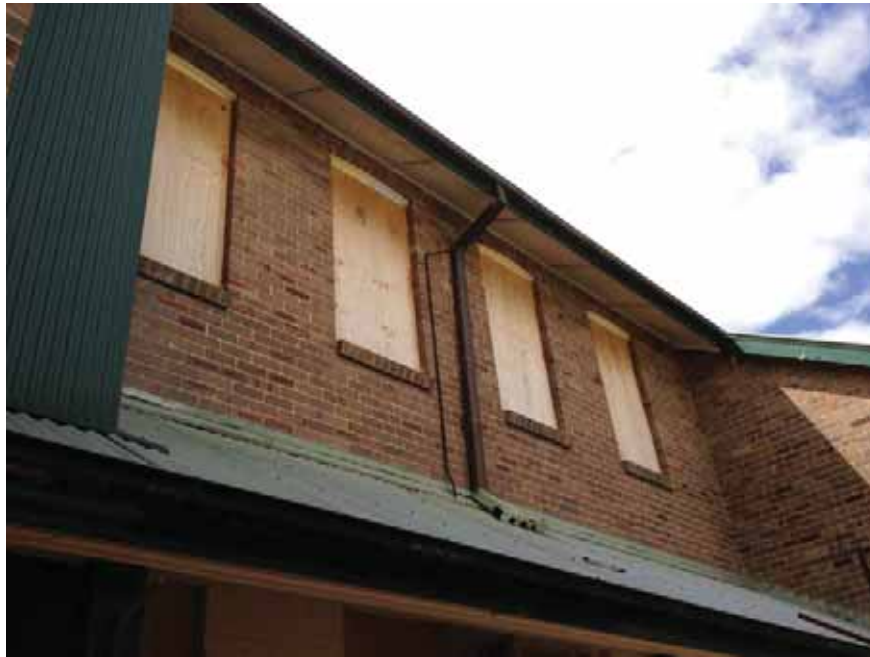
Photograph 19 – Building 11, Presumed asbestos containing flat sheet eaves

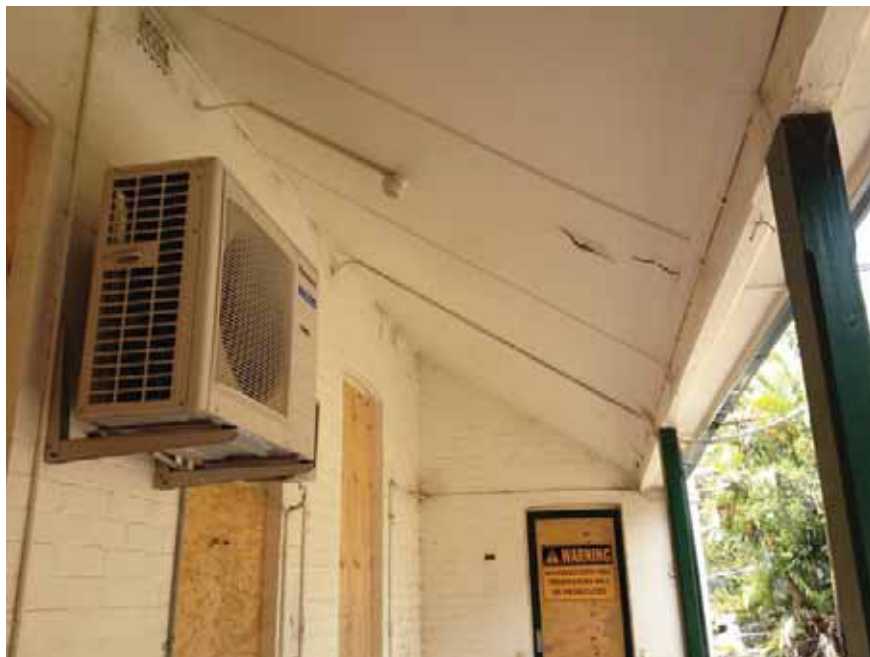
Photograph 20 – Building 11, Asbestos containing flat sheet porch ceiling lining

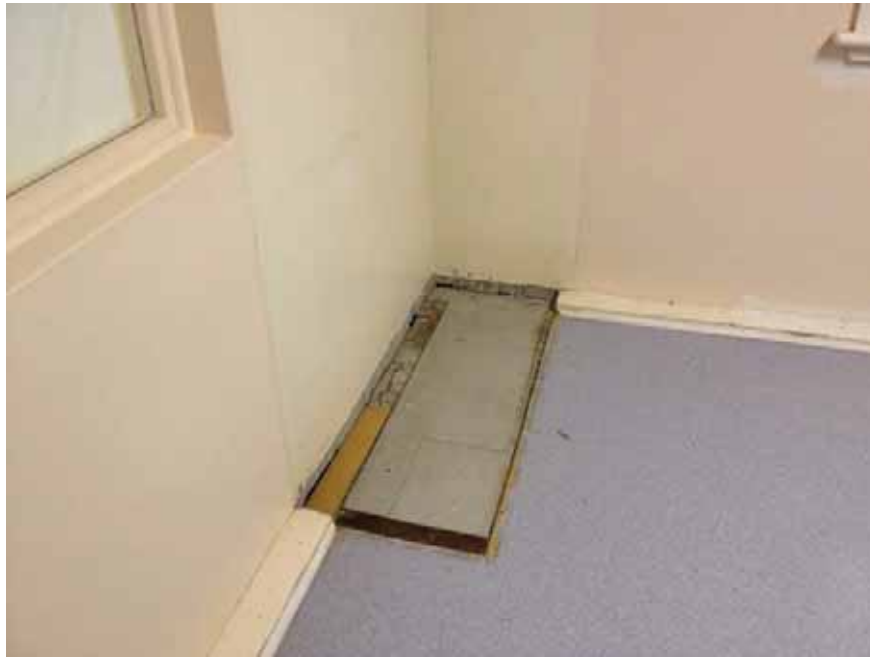
Approximately 15 m² of suspected ACM ceiling lining was observed in the stairway leading to the first floor. Blue vinyl floor tiles, suspected of containing asbestos, had been exposed when a cupboard had been removed from one of the office. The exposed tiles had an area of approximately 1 m² and it is suspected that similar patches of tiles are present under cupboards in the other eleven offices on the first floor of Building 11. Consequently, it is assumed that approximately 12 m² of blue vinyl tiles, suspected of containing asbestos are present on the first floor of the building. Sample M19 (*Chrysotile, asbestos detected in the tile, none in the adhesive*) was collected from the exposed area of tiles.

**Photograph 21 – Building 11, Asbestos containing vinyl floor tiles
beneath office area cupboards on first floor**

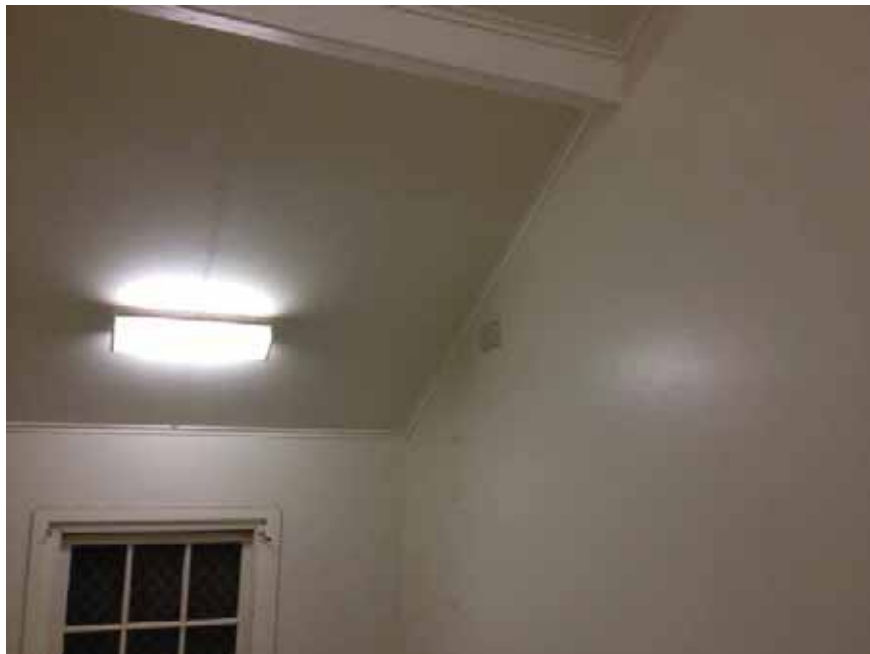
**Photograph 22 – Building 11, Presumed asbestos containing flat sheet
stairwell ceiling lining**

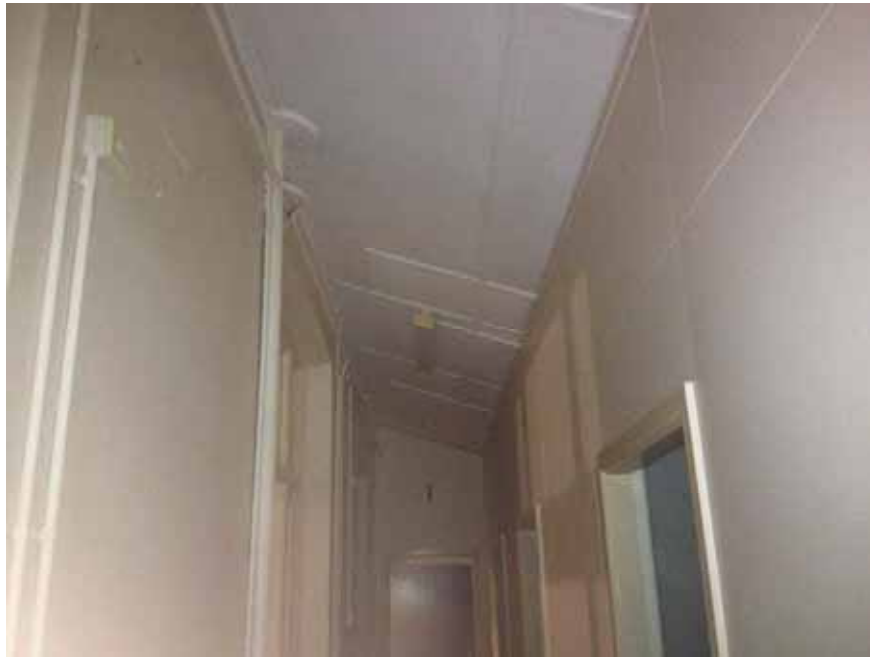
The ceiling linings in rooms along the eastern portion of the ground floor of the building were suspected ACM and sample M27 (*Chrysotile and Amosite asbestos detected*) was collected. These ceiling linings had a total area of approximately 117 m² and were in good condition. The ceiling linings in the bathroom in the southern portion of the building had an area of approximately 6 m² and were consistent with those in the eastern portion, as represented by sample M27. Approximately 10 m² of suspected ACM sheets in good condition were present as the ceiling lining in the stairway leading to the first floor.

Photograph 23 – Building 12, Asbestos containing flat sheet ground floor ceiling lining

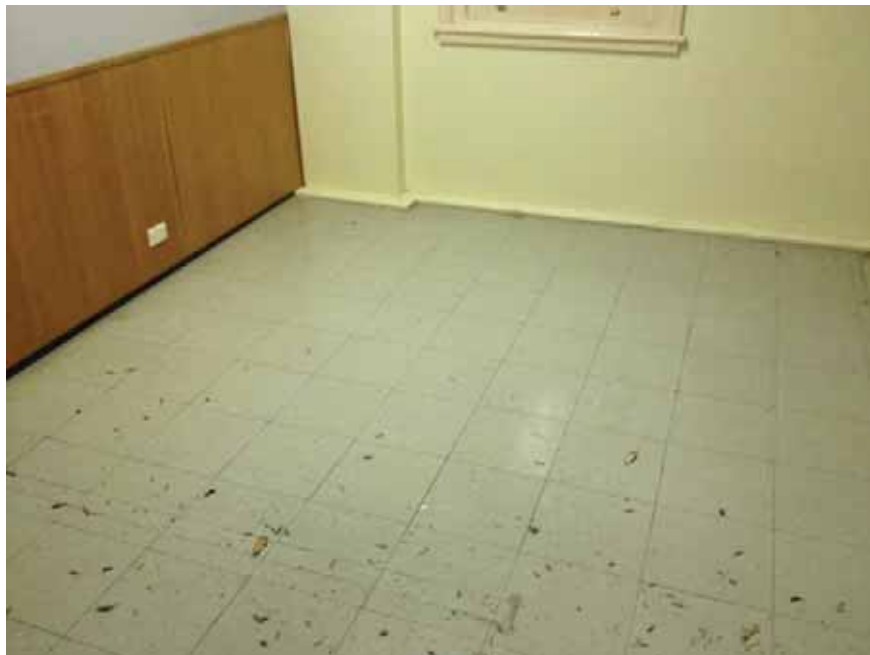
Grey vinyl tiles, suspected of containing asbestos, covered the entire floor area (approximately 465 m²) of the first floor. The tiles were in good condition and sample M28 (*Chrysotile asbestos detected in the tile, none in the adhesive*) was collected for analysis.

Photograph 24 – Building 12, Asbestos containing first floor vinyl floor tiles

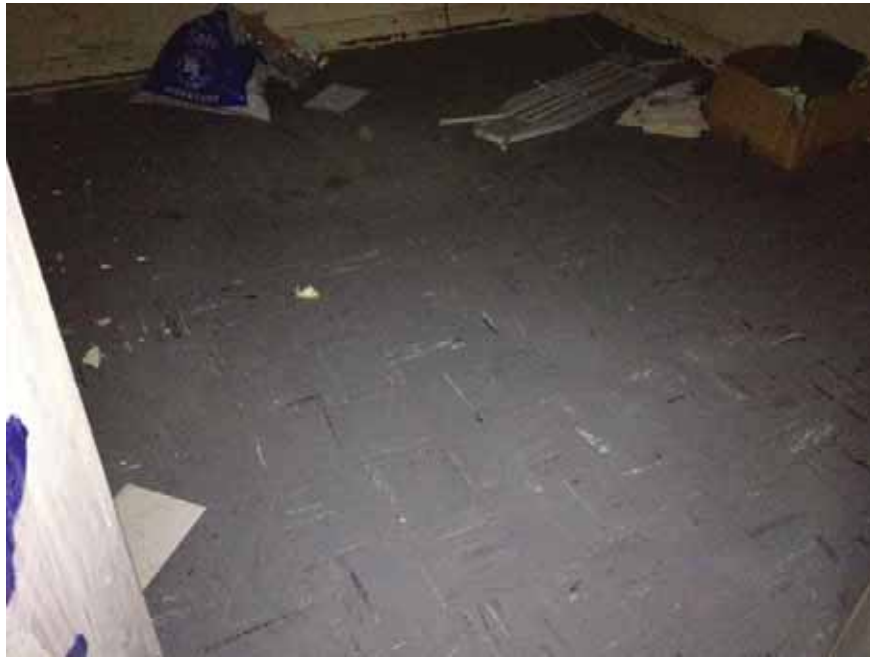
Photograph 25 – Building 13, Asbestos containing blur vinyl floor tiles

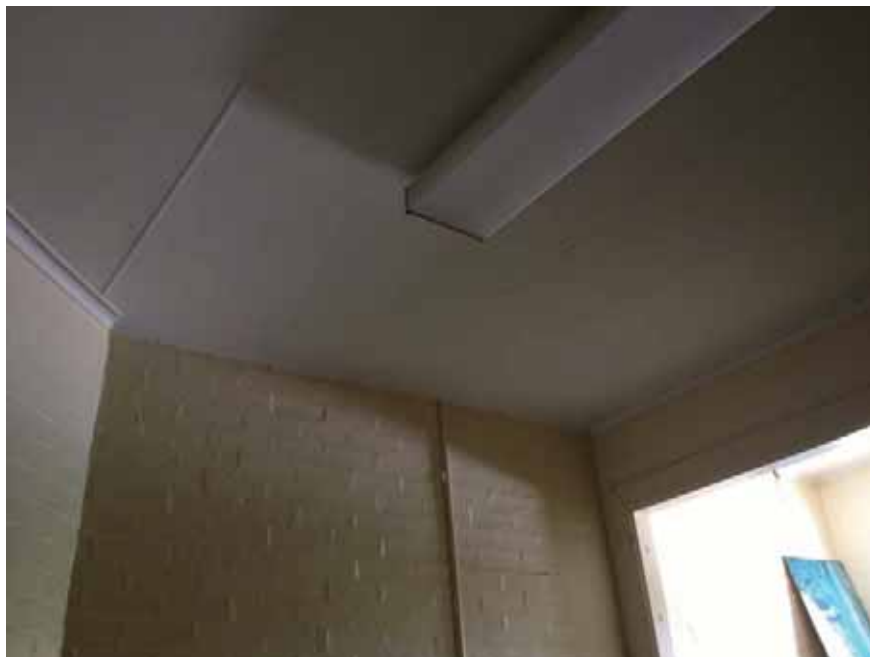
Building 14 was a single storey building constructed of weatherboard and brick with a steel sheet roof. Ceiling linings throughout the building were of suspected ACM and covered an area of approximately 200 m². The linings were in good condition. Sample M26 (*Chrysotile and Amosite asbestos detected*) was collected from the ceiling linings.

Photograph 26 – Building 14, Asbestos containing flat sheet ceiling lining

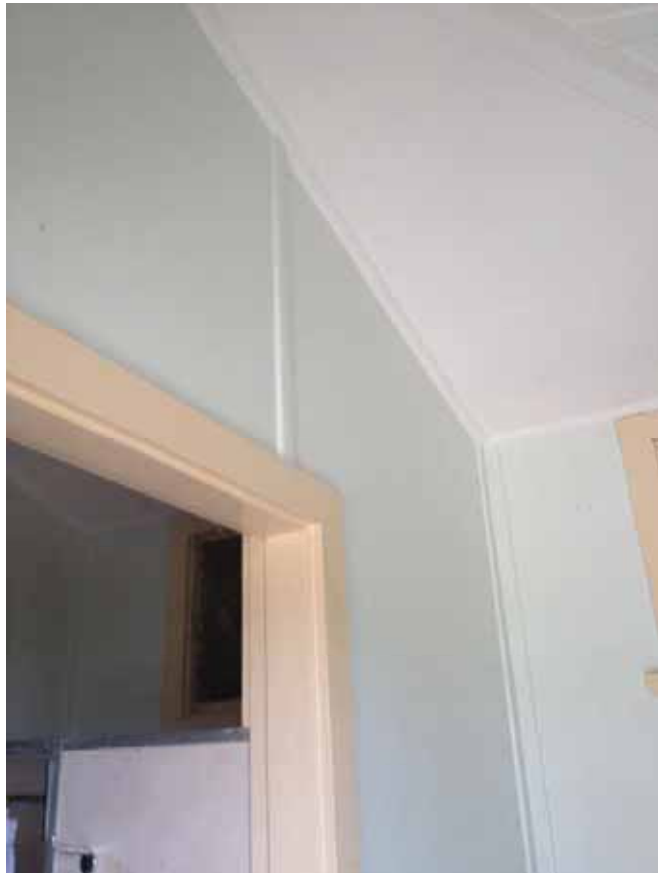
The interior of Building 15 was divided into two main rooms with a bathroom located in the northern corner of the building. The ceiling lining was observed to be consistent with the ceiling lining on the entry porch and suspected ACM in good condition with an area of approximately 10 m². Wall linings in the bathroom were also of suspected ACM in good condition with an area of approximately 25 m². Sample M32 (*Chrysotile and Amosite asbestos detected*) was collected from the material in the wall linings.

Photograph 27 – Building 15, Asbestos containing flat sheet bathroom wall lining

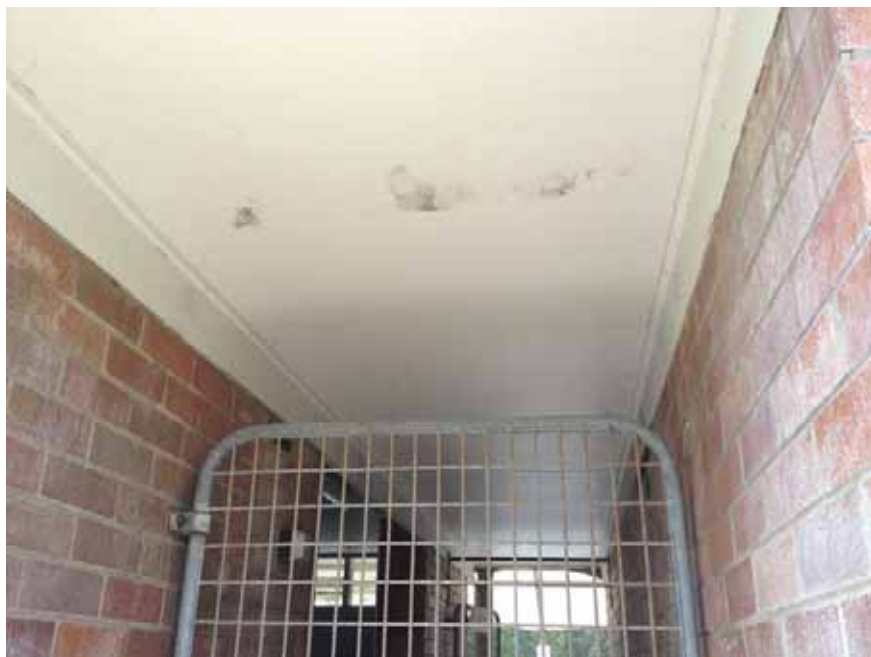
were of suspected ACM in good condition and an area of approximately 56 m². Samples M30 (*Chrysotile asbestos detected*) was collected from the lining material.

Photograph 28 – Building 18, Asbestos containing flat sheet ceiling lining

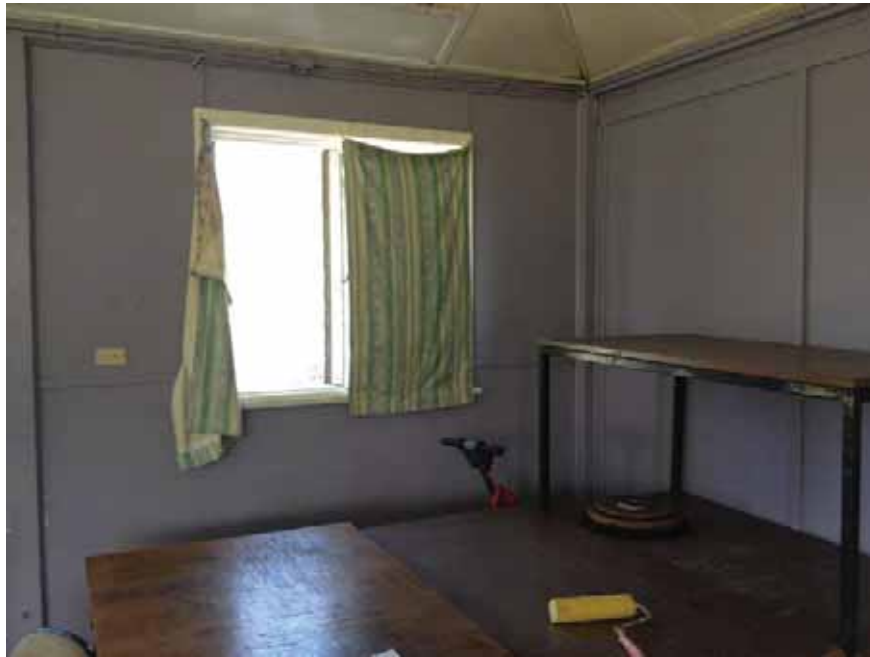
Photograph 29 – Building 20, Presumed asbestos containing flat sheet wall lining

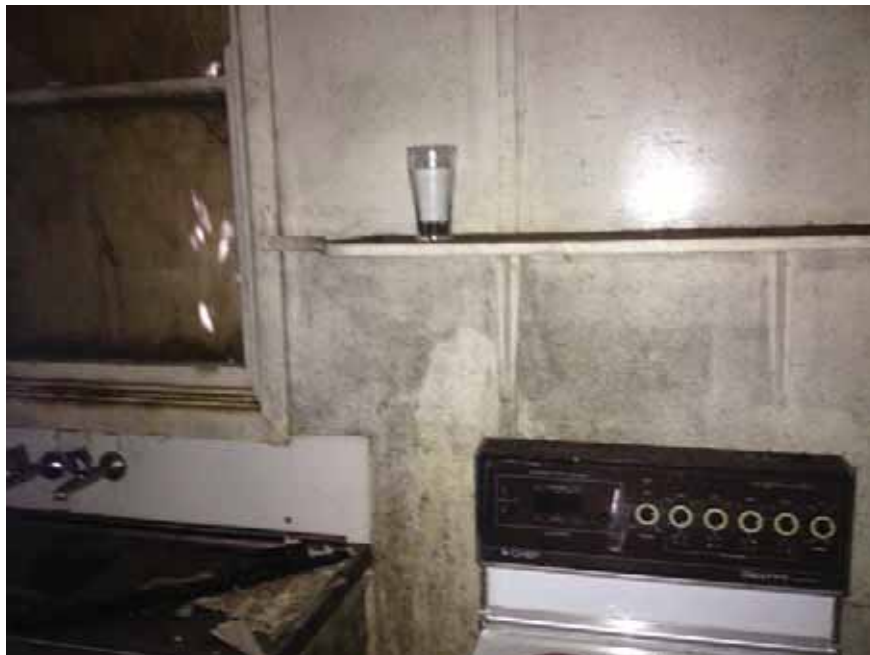
Photograph 30 – 65 Kowan Rd, Asbestos containing wall lining in kitchen

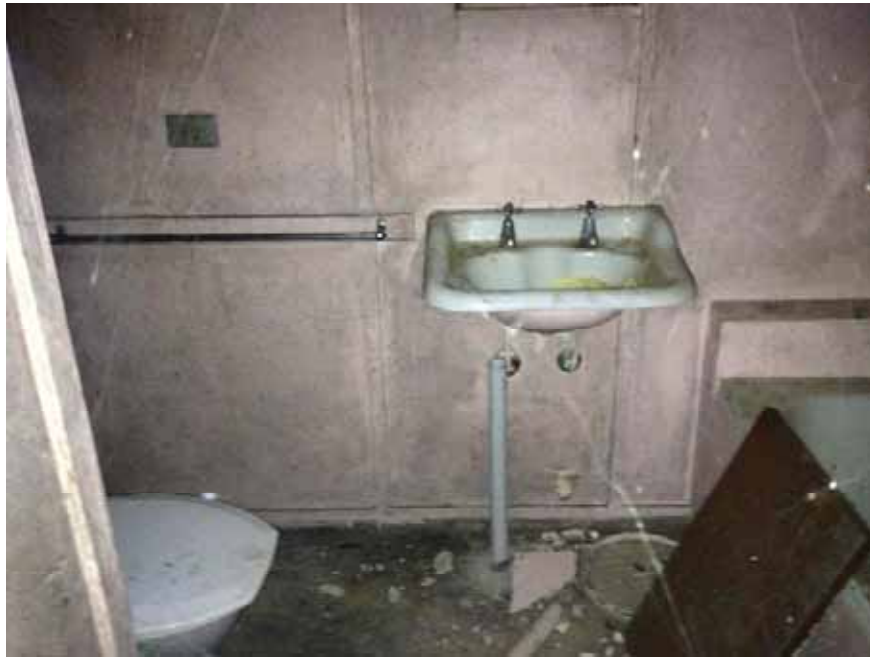
Photograph 31 – 65 Kowan Rd, Asbestos containing flat sheet bathroom wall linings

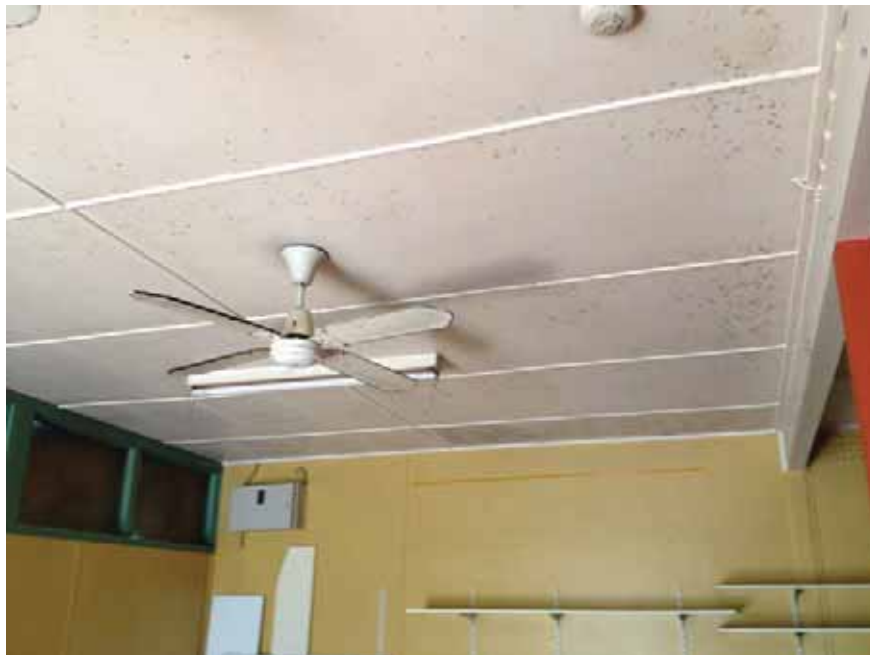
Photograph 32 – Service station, Asbestos containing flat sheet ceiling lining

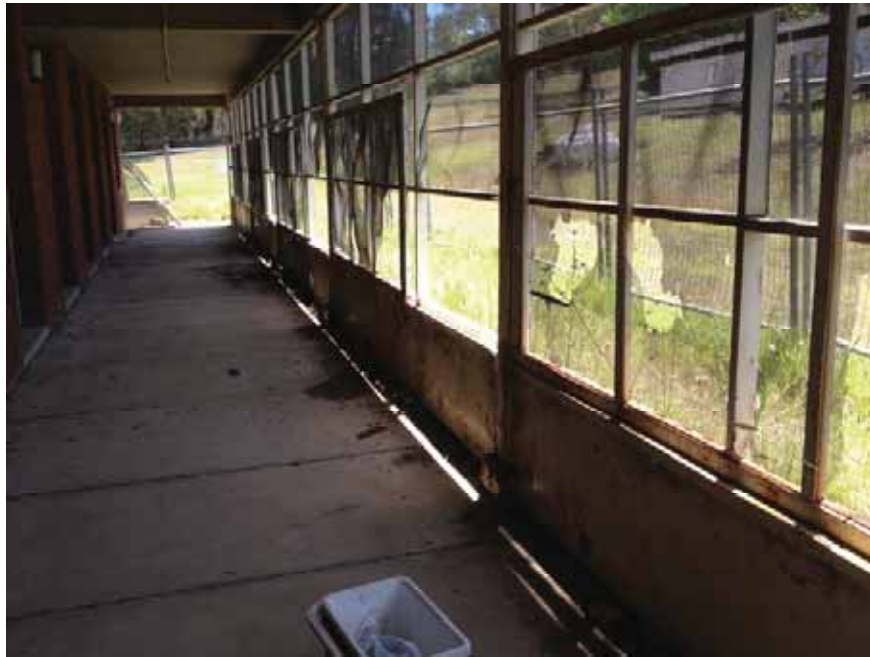
Photograph 33 – Nurses Dormitory, Asbestos containing flat sheet in fill panels beneath porch windows

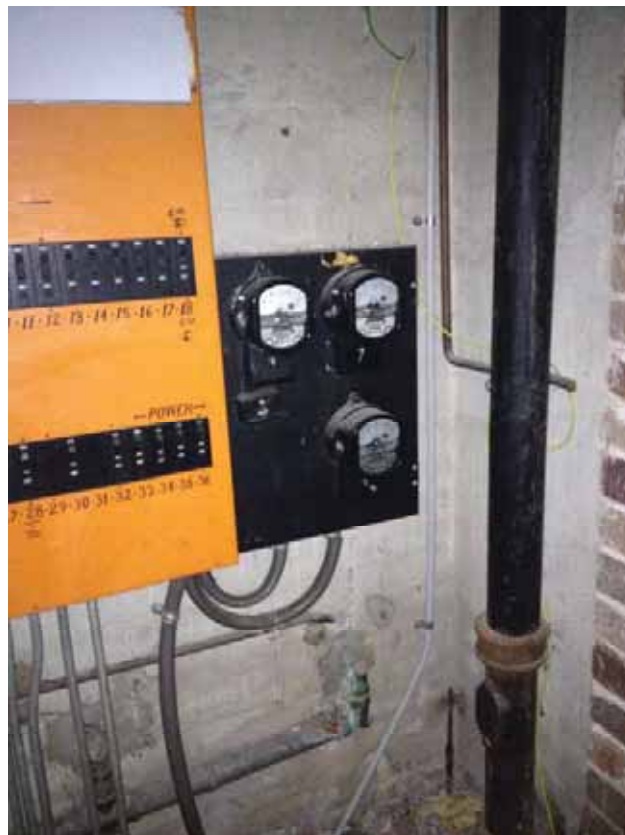
Photograph 34 – Nurses Dormitory, Asbestos containing 'zelemite' backing board (ground floor)
