# ROAD SAFETY AUDIT

## EXISTING ROAD

McAuleys Lane, Myocum

September 2020

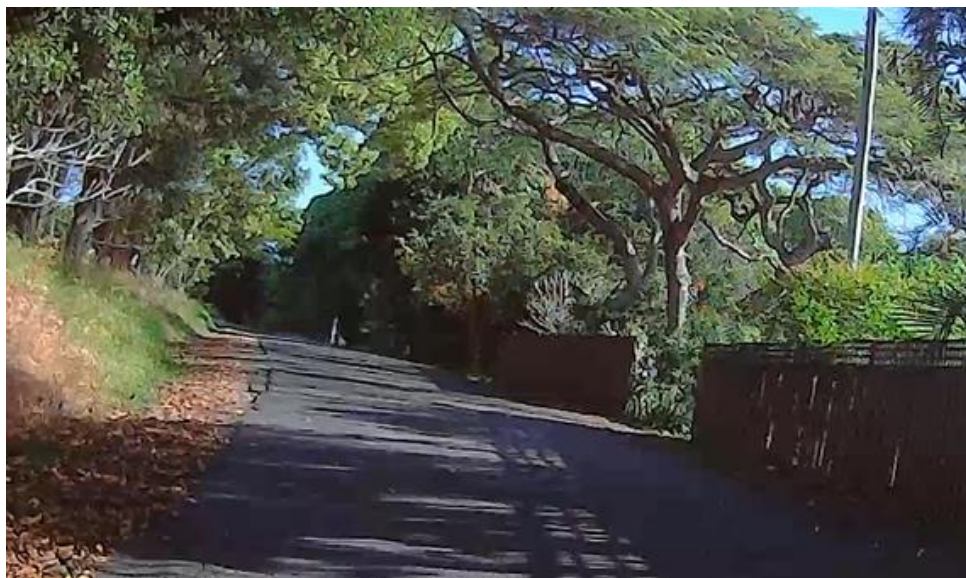
08	<p><b>Concealed Driveways/Sight Distance from Driveways</b></p> <p>There are many concealed driveways along the road. Sight distances are sometimes reduced by the road alignment, roadside vegetation, or fencing. There is only one 'Concealed Driveways' sign – additional signs may be warranted.</p> <p>There is a risk that vehicles entering or leaving these driveways may be struck by through traffic.</p> <p><i>Refer to Photo 11, 12</i></p> <p><i>Location: Numerous</i></p>	<p>Frequency: Improbable</p> <p>Severity: Serious</p> <p>Risk: <b>Medium</b></p>
09	<p><b>Confusing Road Alignment at Ch. 2575</b></p> <p>The travel path through the bend is not well defined – looks a bit like an intersection. There are several driveways on the bend. From the west the road looks like it goes straight ahead (up a driveway). Drivers may not correctly anticipate the road alignment.</p> <p>There is a risk that a driver could be confused by the layout and head up the driveway, then make a last minute correction back onto McAuleys Lane. This could result in the driver losing control and colliding with an oncoming vehicle or a roadside hazard.</p> <p><i>Refer to Photo 13</i></p> <p><i>Location: Ch. 2575</i></p>	<p>Frequency: Improbable</p> <p>Severity: Serious</p> <p>Risk: <b>Medium</b></p>

**Photo 11: Concealed driveway – driveway through fence at shoulder edge**

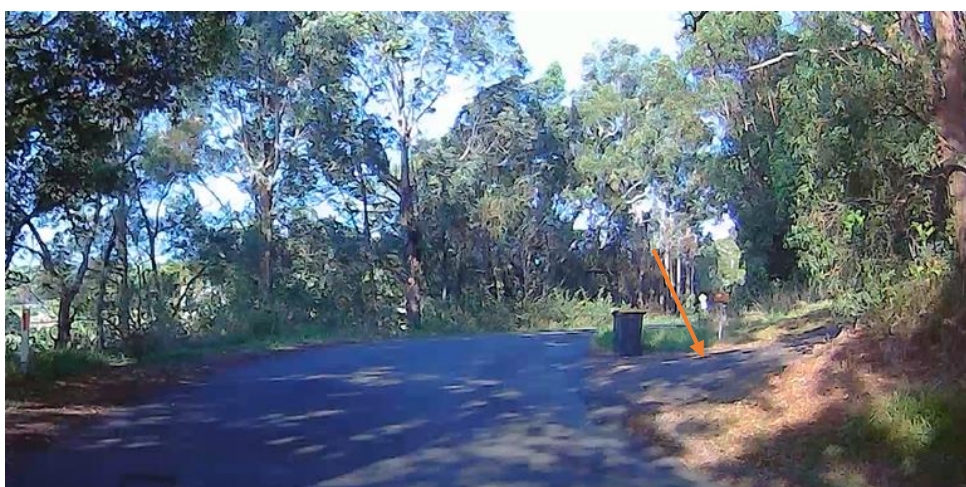
**Photo 12: Example of concealed driveway**

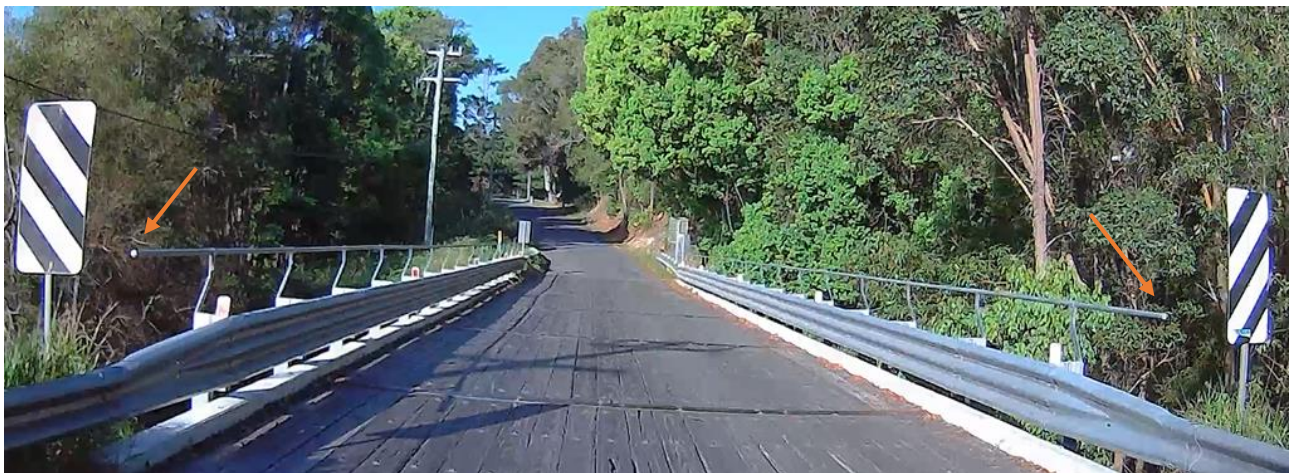
20	<p><b>Possible Spear Hazard from Upper Rail on Bridge at Ch. 2375</b></p> <p>There is a thin tubular rail located above the bridge safety barrier. The rail ends are unprotected. An impact with the end of this rail during a crash may increase the severity of the crash.</p> <p>There is risk of a driver or passenger being “speared” by the rail during a run-of road crash.</p> <p><i>Refer to Photo 20</i></p> <p><i>Location: Bridge at Ch. 2375</i></p>	<p>Frequency: Improbable</p> <p>Severity: Serious</p> <p>Risk: <b>Medium</b></p>
21	<p><b>Provision for Cyclists</b></p> <p>There is no provision for cyclists or pedestrians along the road (i.e. non-existent or narrow shoulders). There are a few ‘Cyclists’ and ‘Pedestrians’ warning signs.</p> <p>There is a risk of a collision between a vehicle and cyclist/pedestrian, or a head-on collision between two vehicles if one driver swerves to avoid a cyclist/pedestrian.</p> <p><i>Location: Most of road length</i></p>	<p>Frequency: Improbable</p> <p>Severity: Serious</p> <p>Risk: <b>Medium</b></p>

**Photo 20: Potential spear hazard?**
