**PROPOSED RESIDENTIAL SUBDIVISION  
LOT 1 IN DP781781 & LOT 100 IN DP 1063277  
WYALLA ROAD,  
JAMBEROO**

**STAGE 1  
CONTAMINATION ASSESSMENT**

**REPORT WO7/1910-Ar AUGUST 2012**

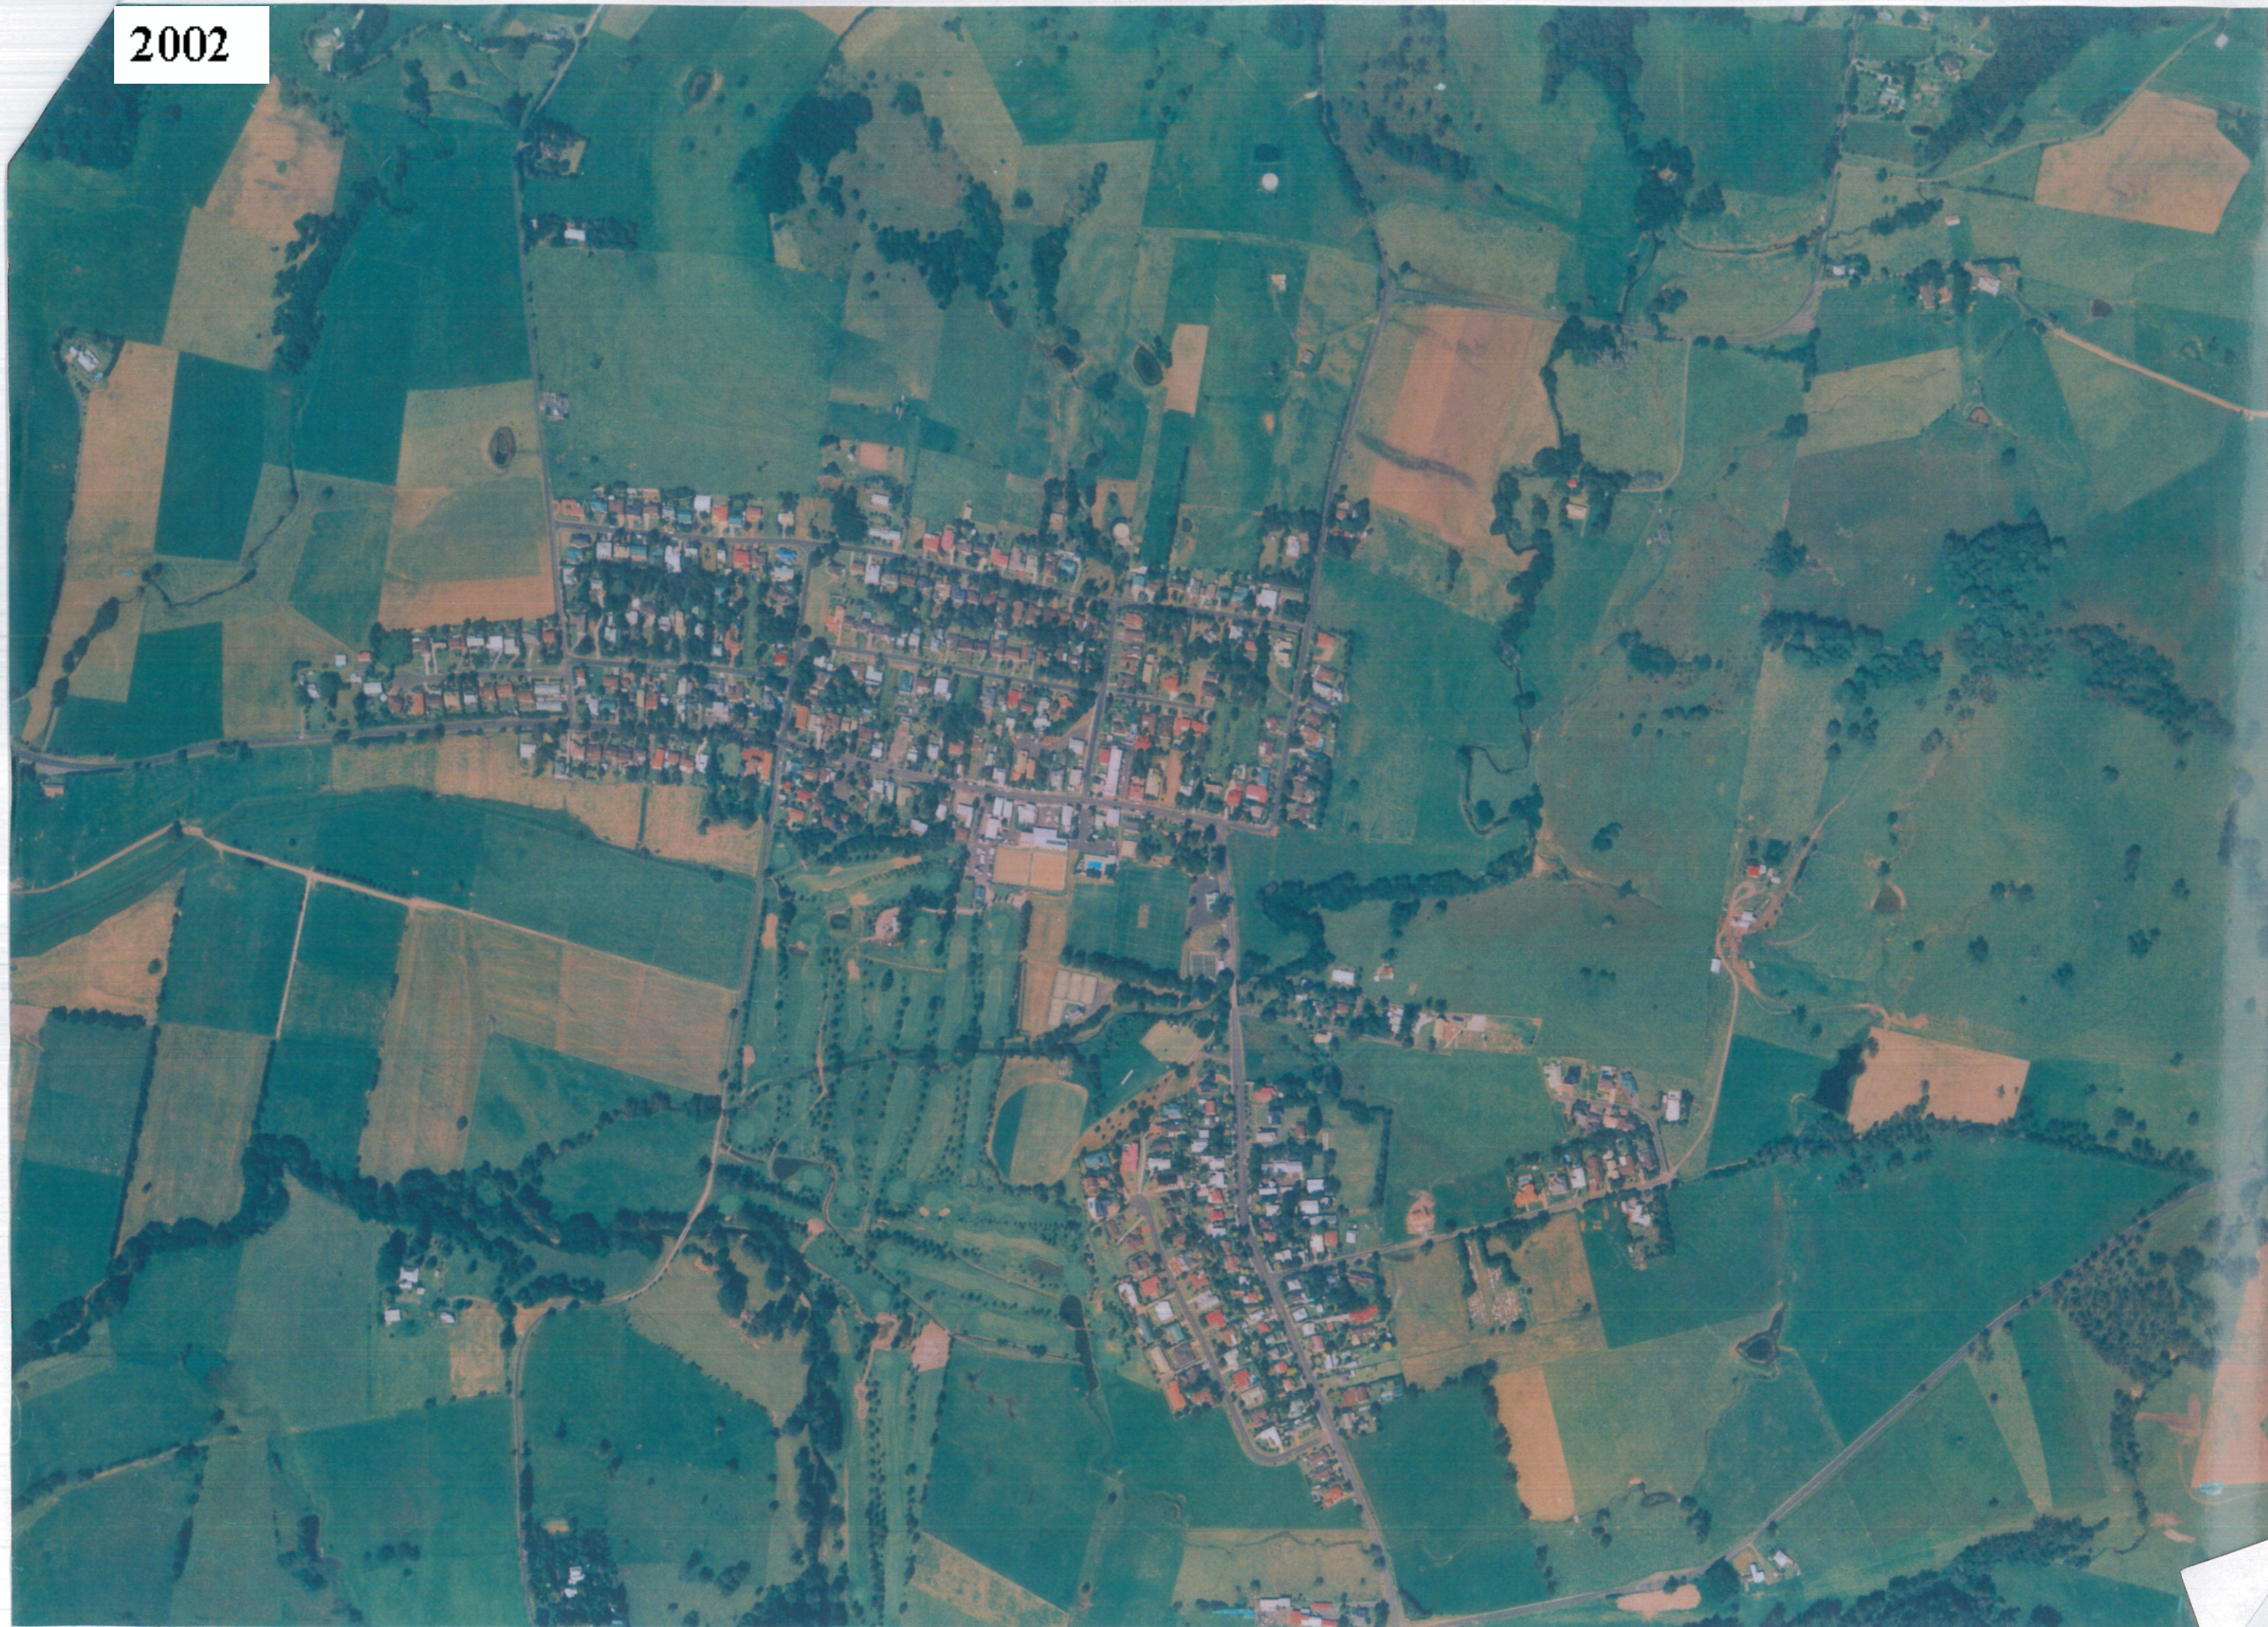
| 2002 | 1:25000 | Colour | <ul style="list-style-type: none"> <li>No other obvious change</li> </ul> |

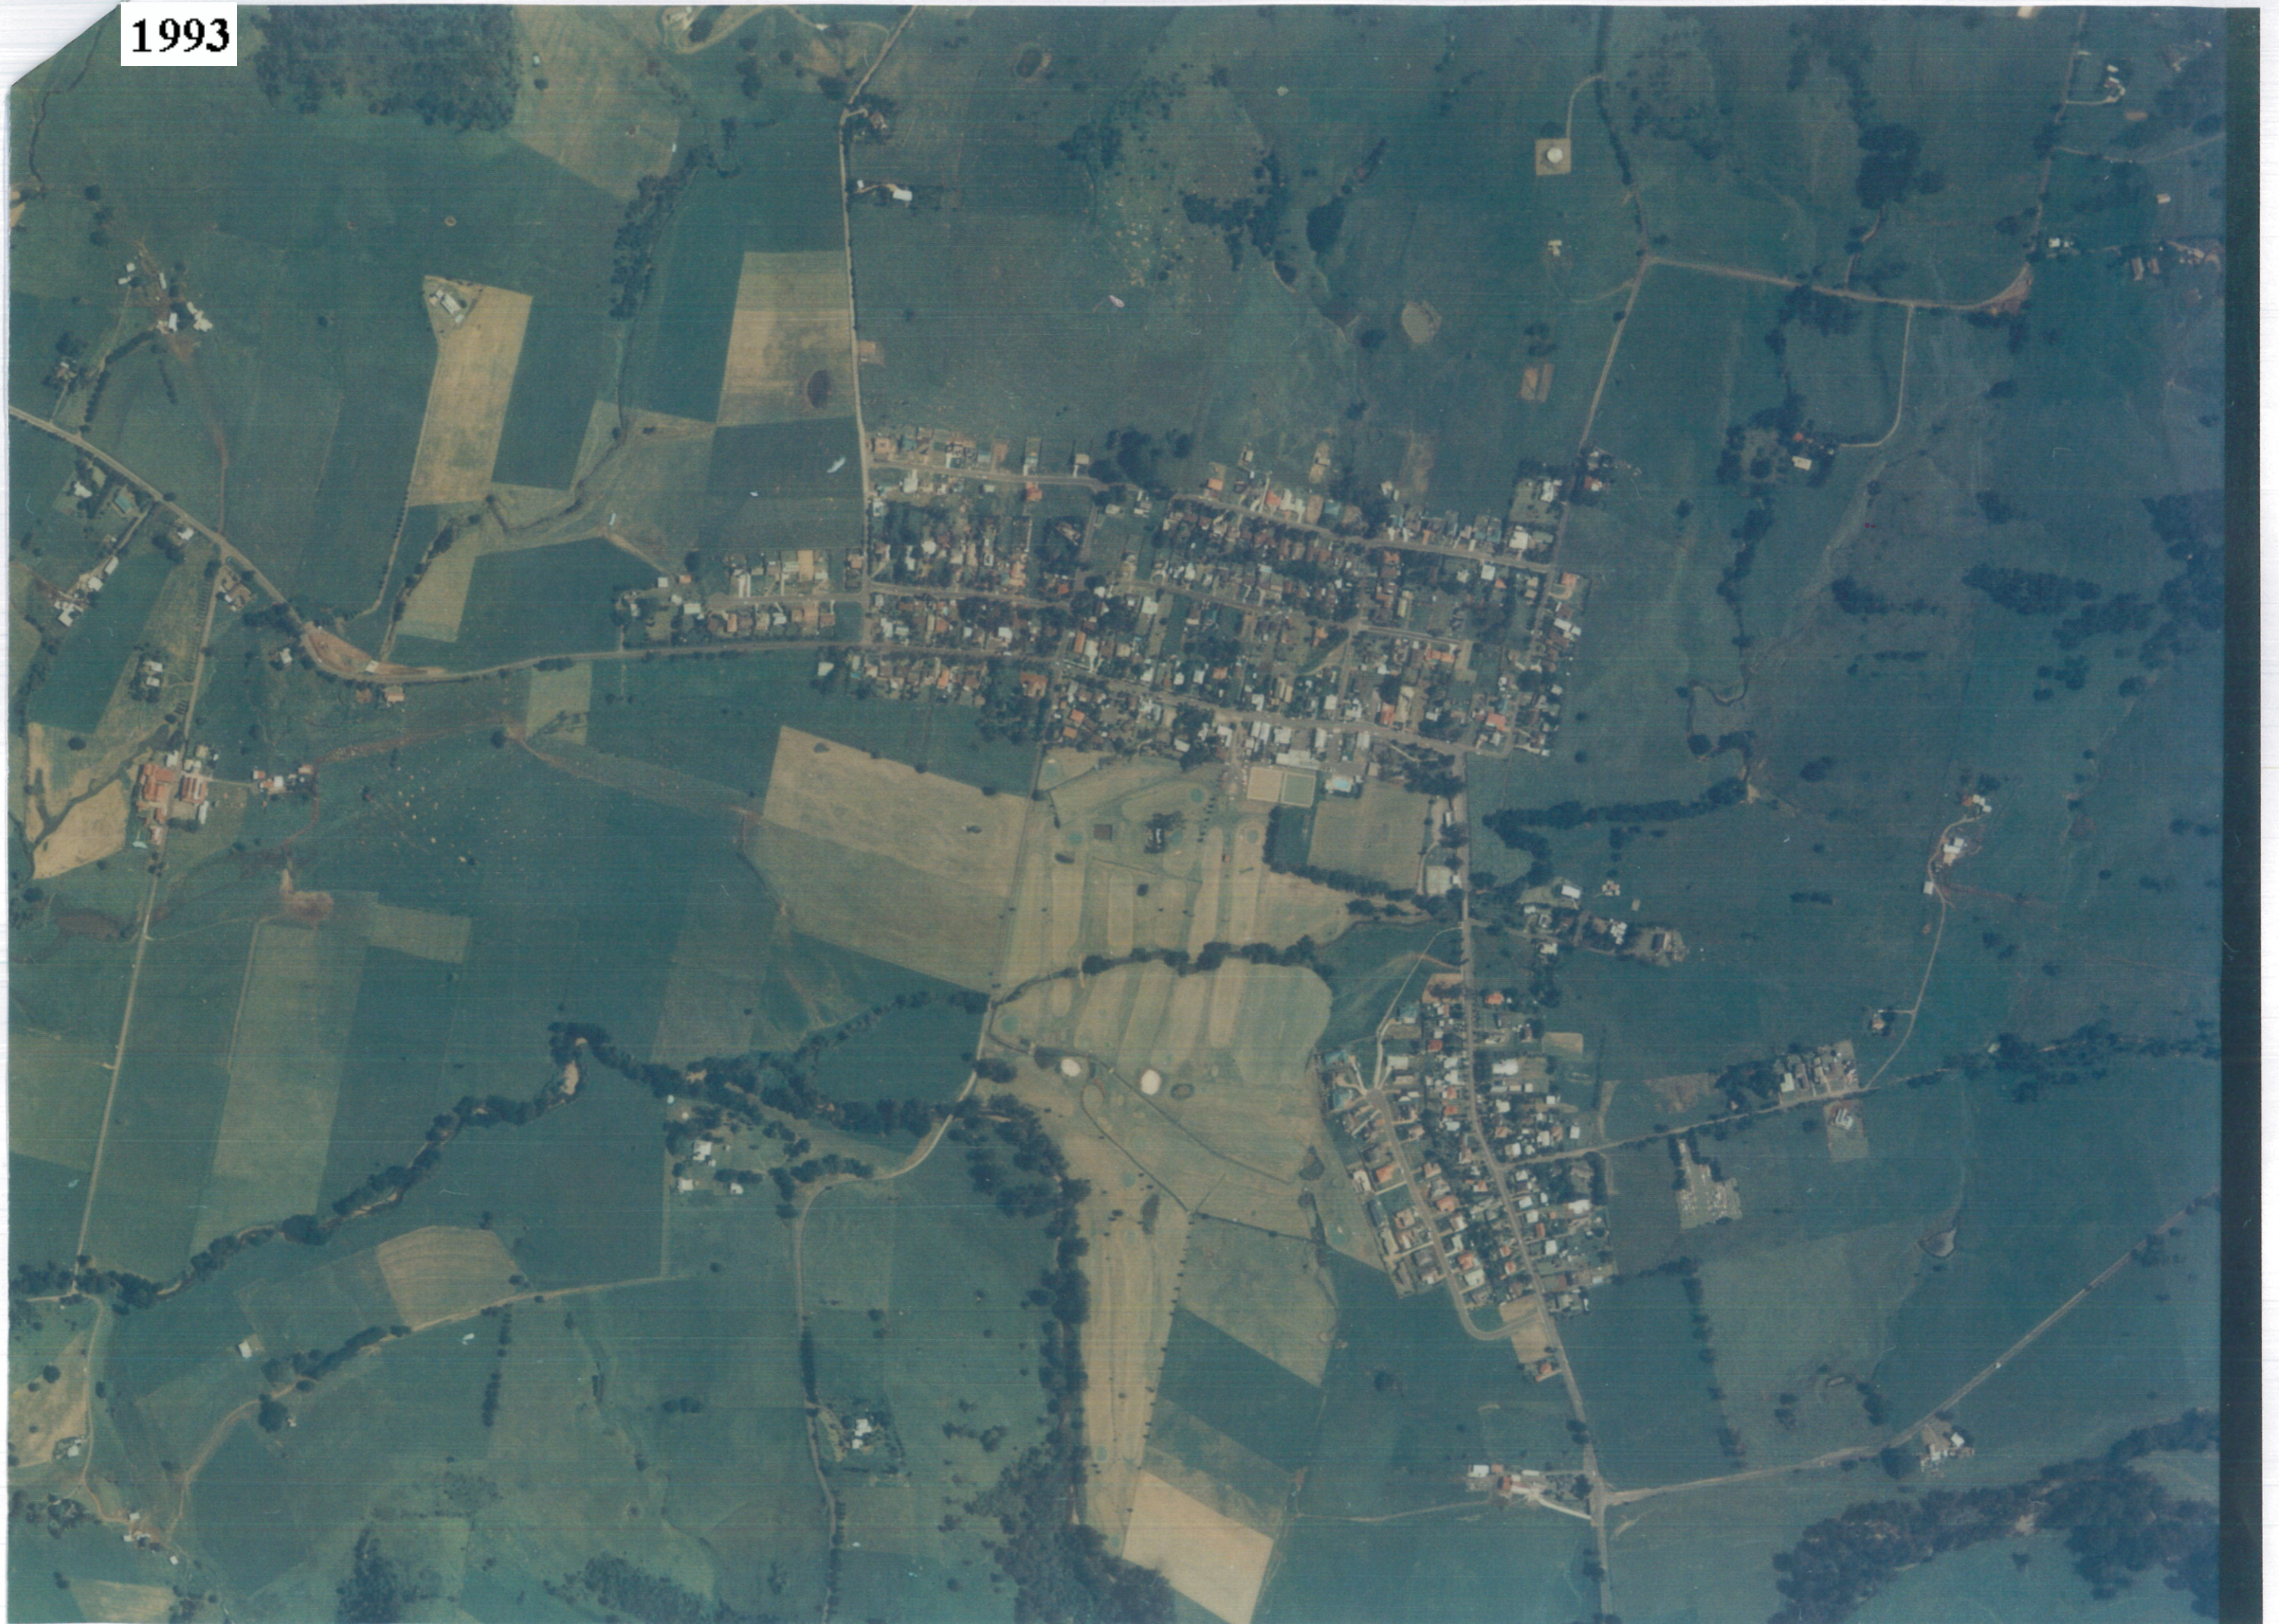
| 1993 | 1:25000 | Colour | <ul style="list-style-type: none"> <li>More residences along Wyalla Road.</li> </ul> |

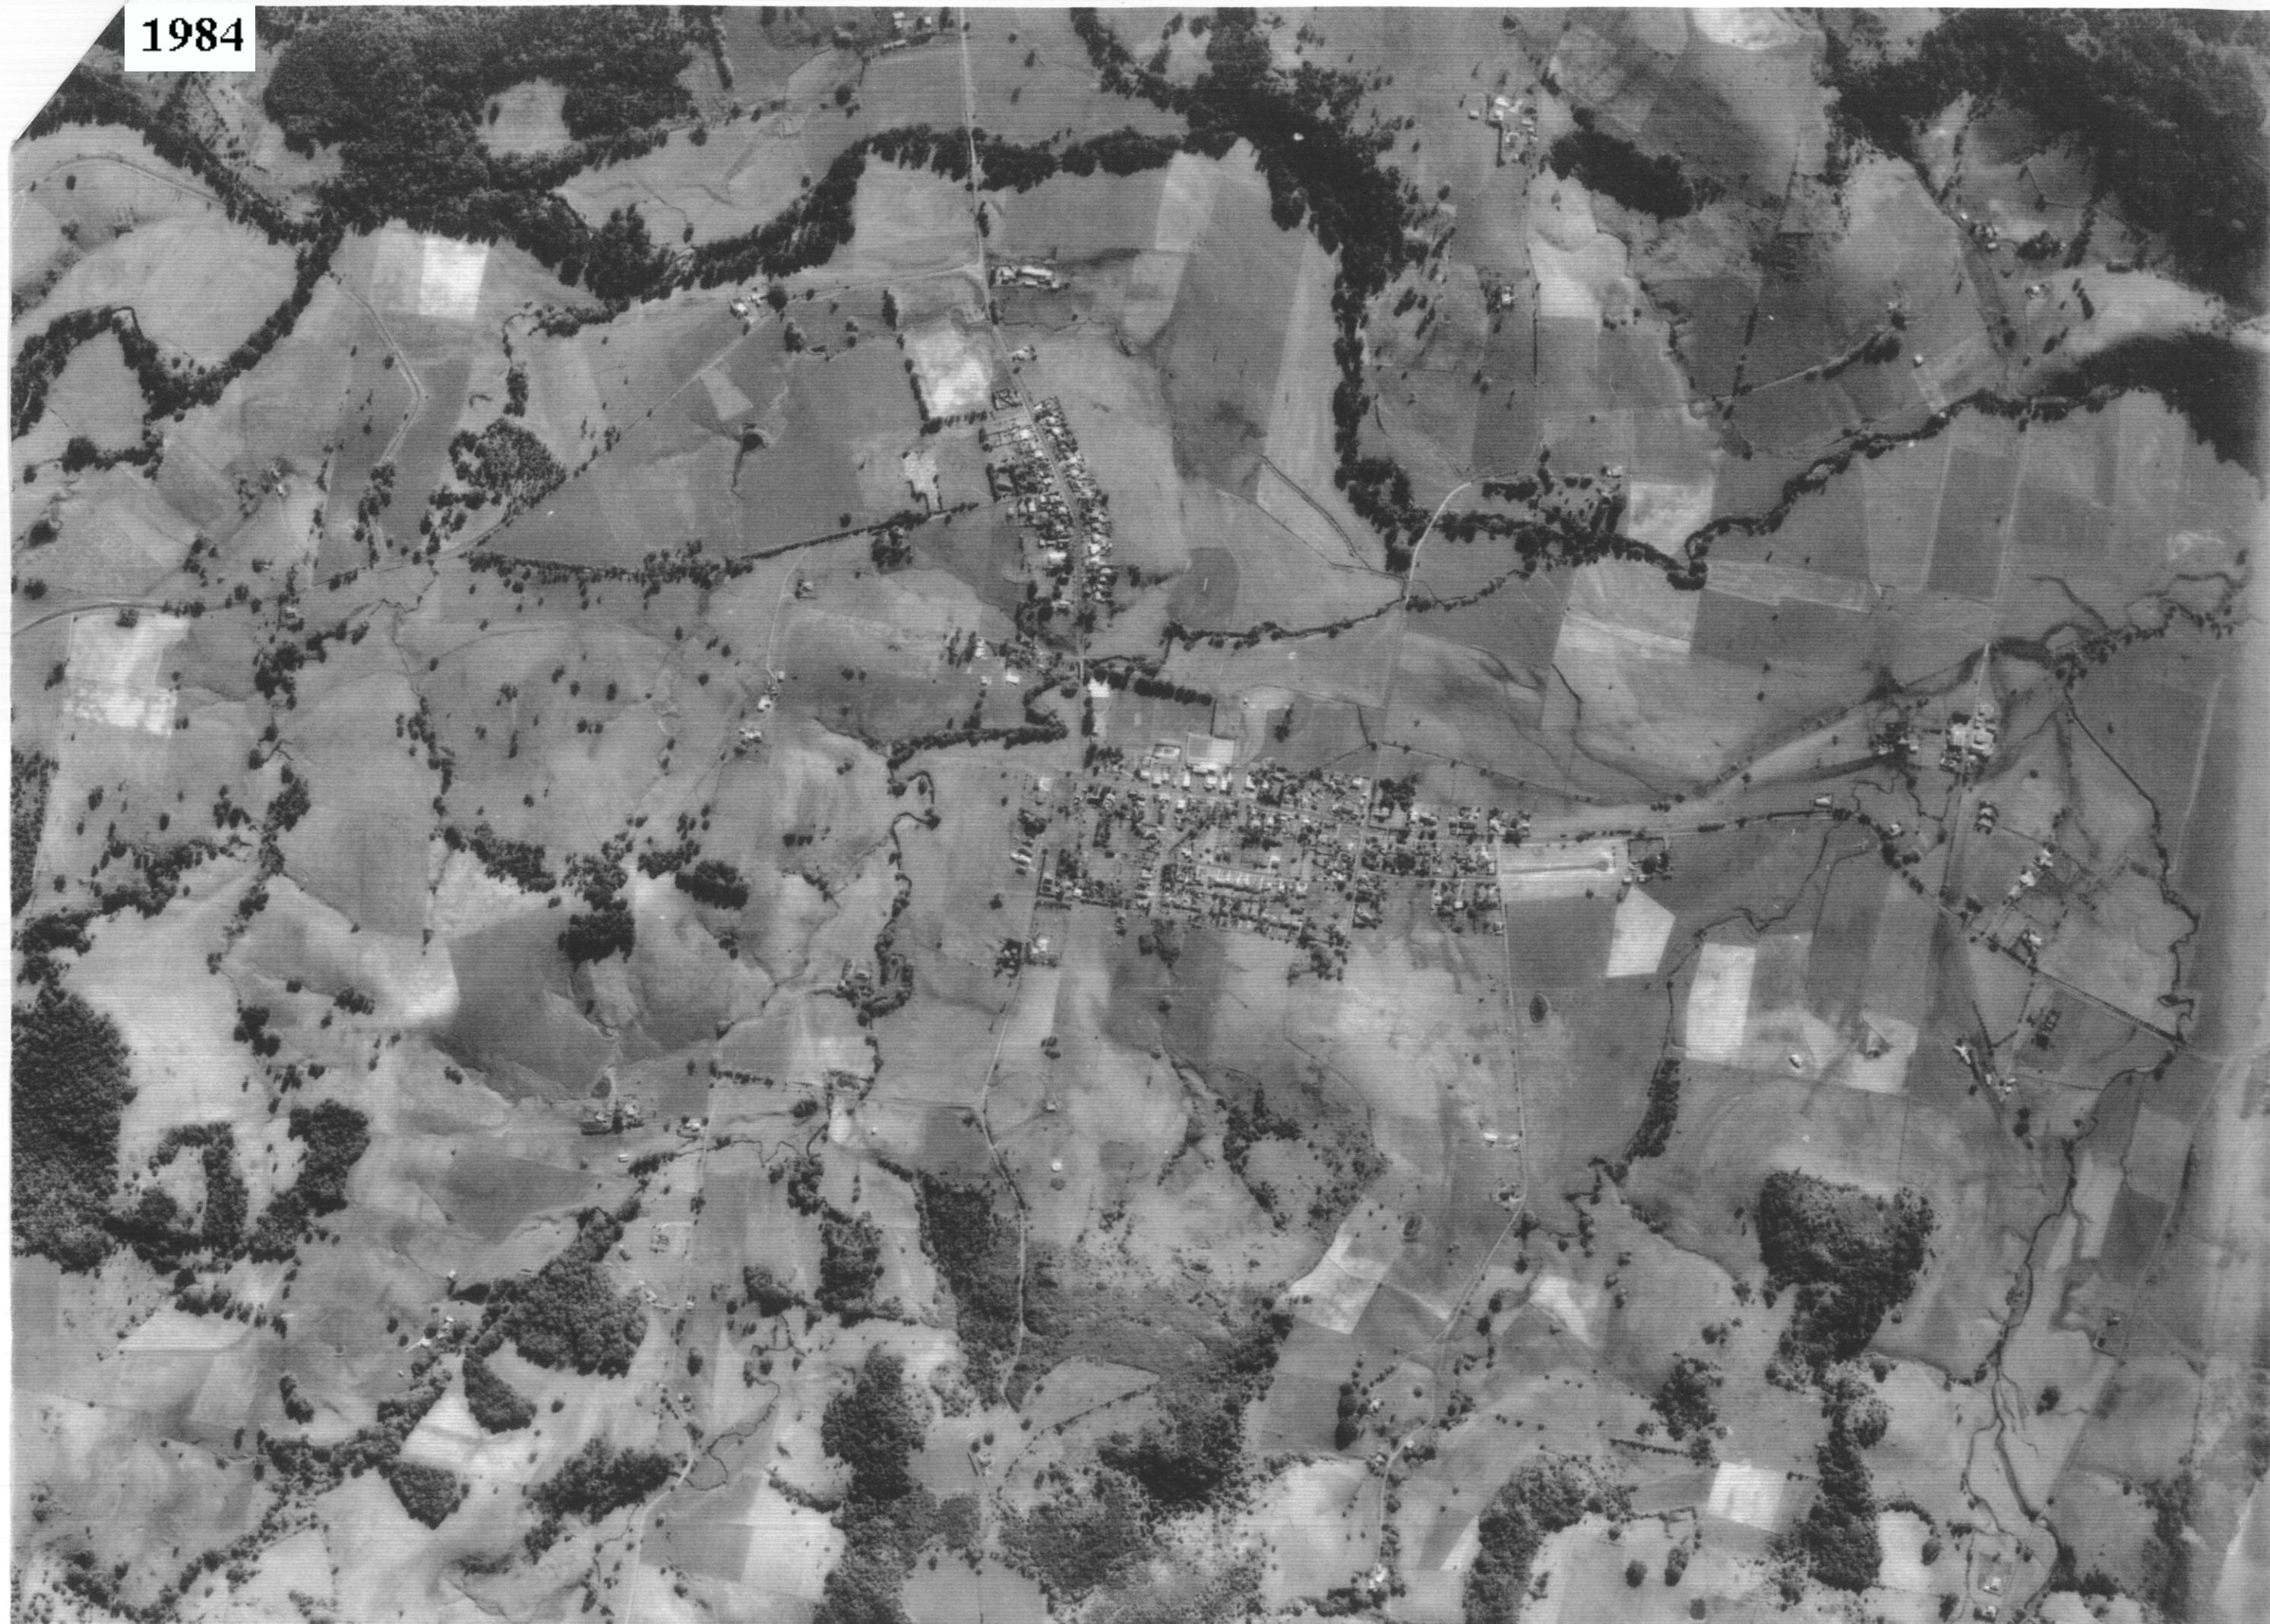
| 1984 | 1:40000 | Black & White | <ul style="list-style-type: none"> <li>No visible change to site</li> <li>Residential properties present in the eastern boundary.</li> </ul> |

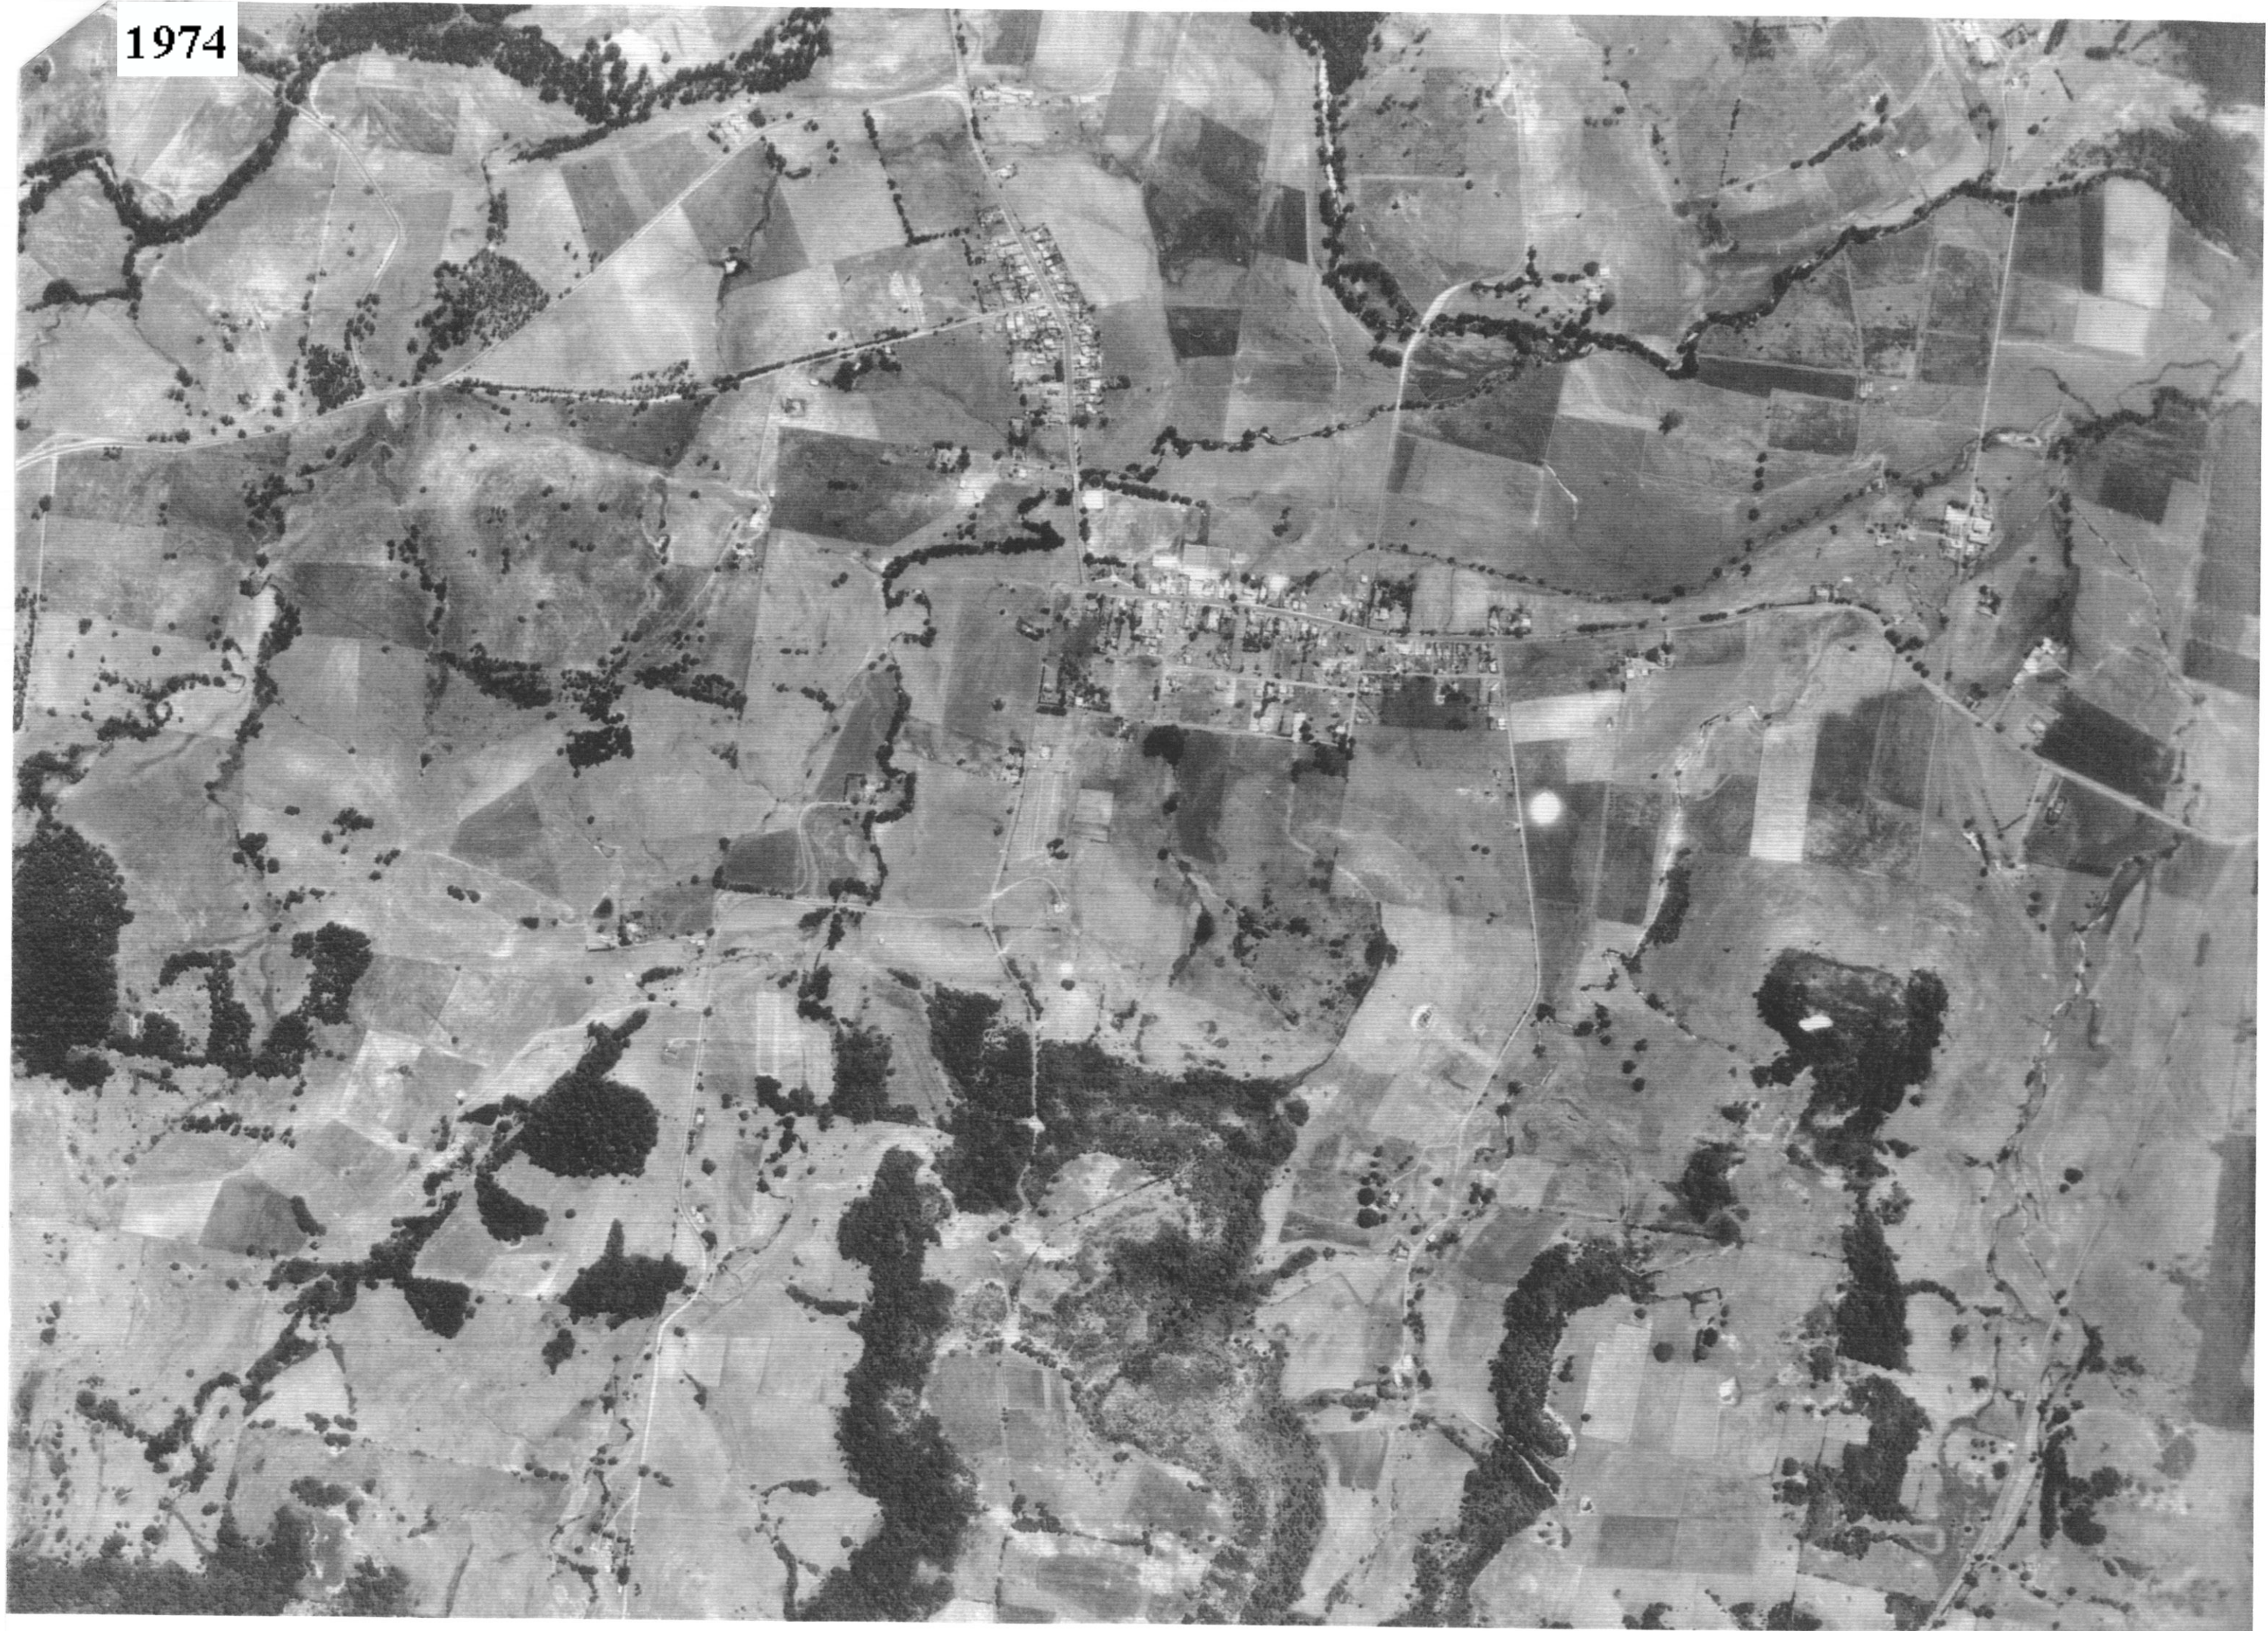
| <b>Year of Photo</b> | <b>Scale</b> | <b>Colour</b> | <b>Site Description</b> |
|---|---|---|---|
| 1974 | 1:40000 | Black & | <ul style="list-style-type: none"> <li>No visible change.</li> </ul> |

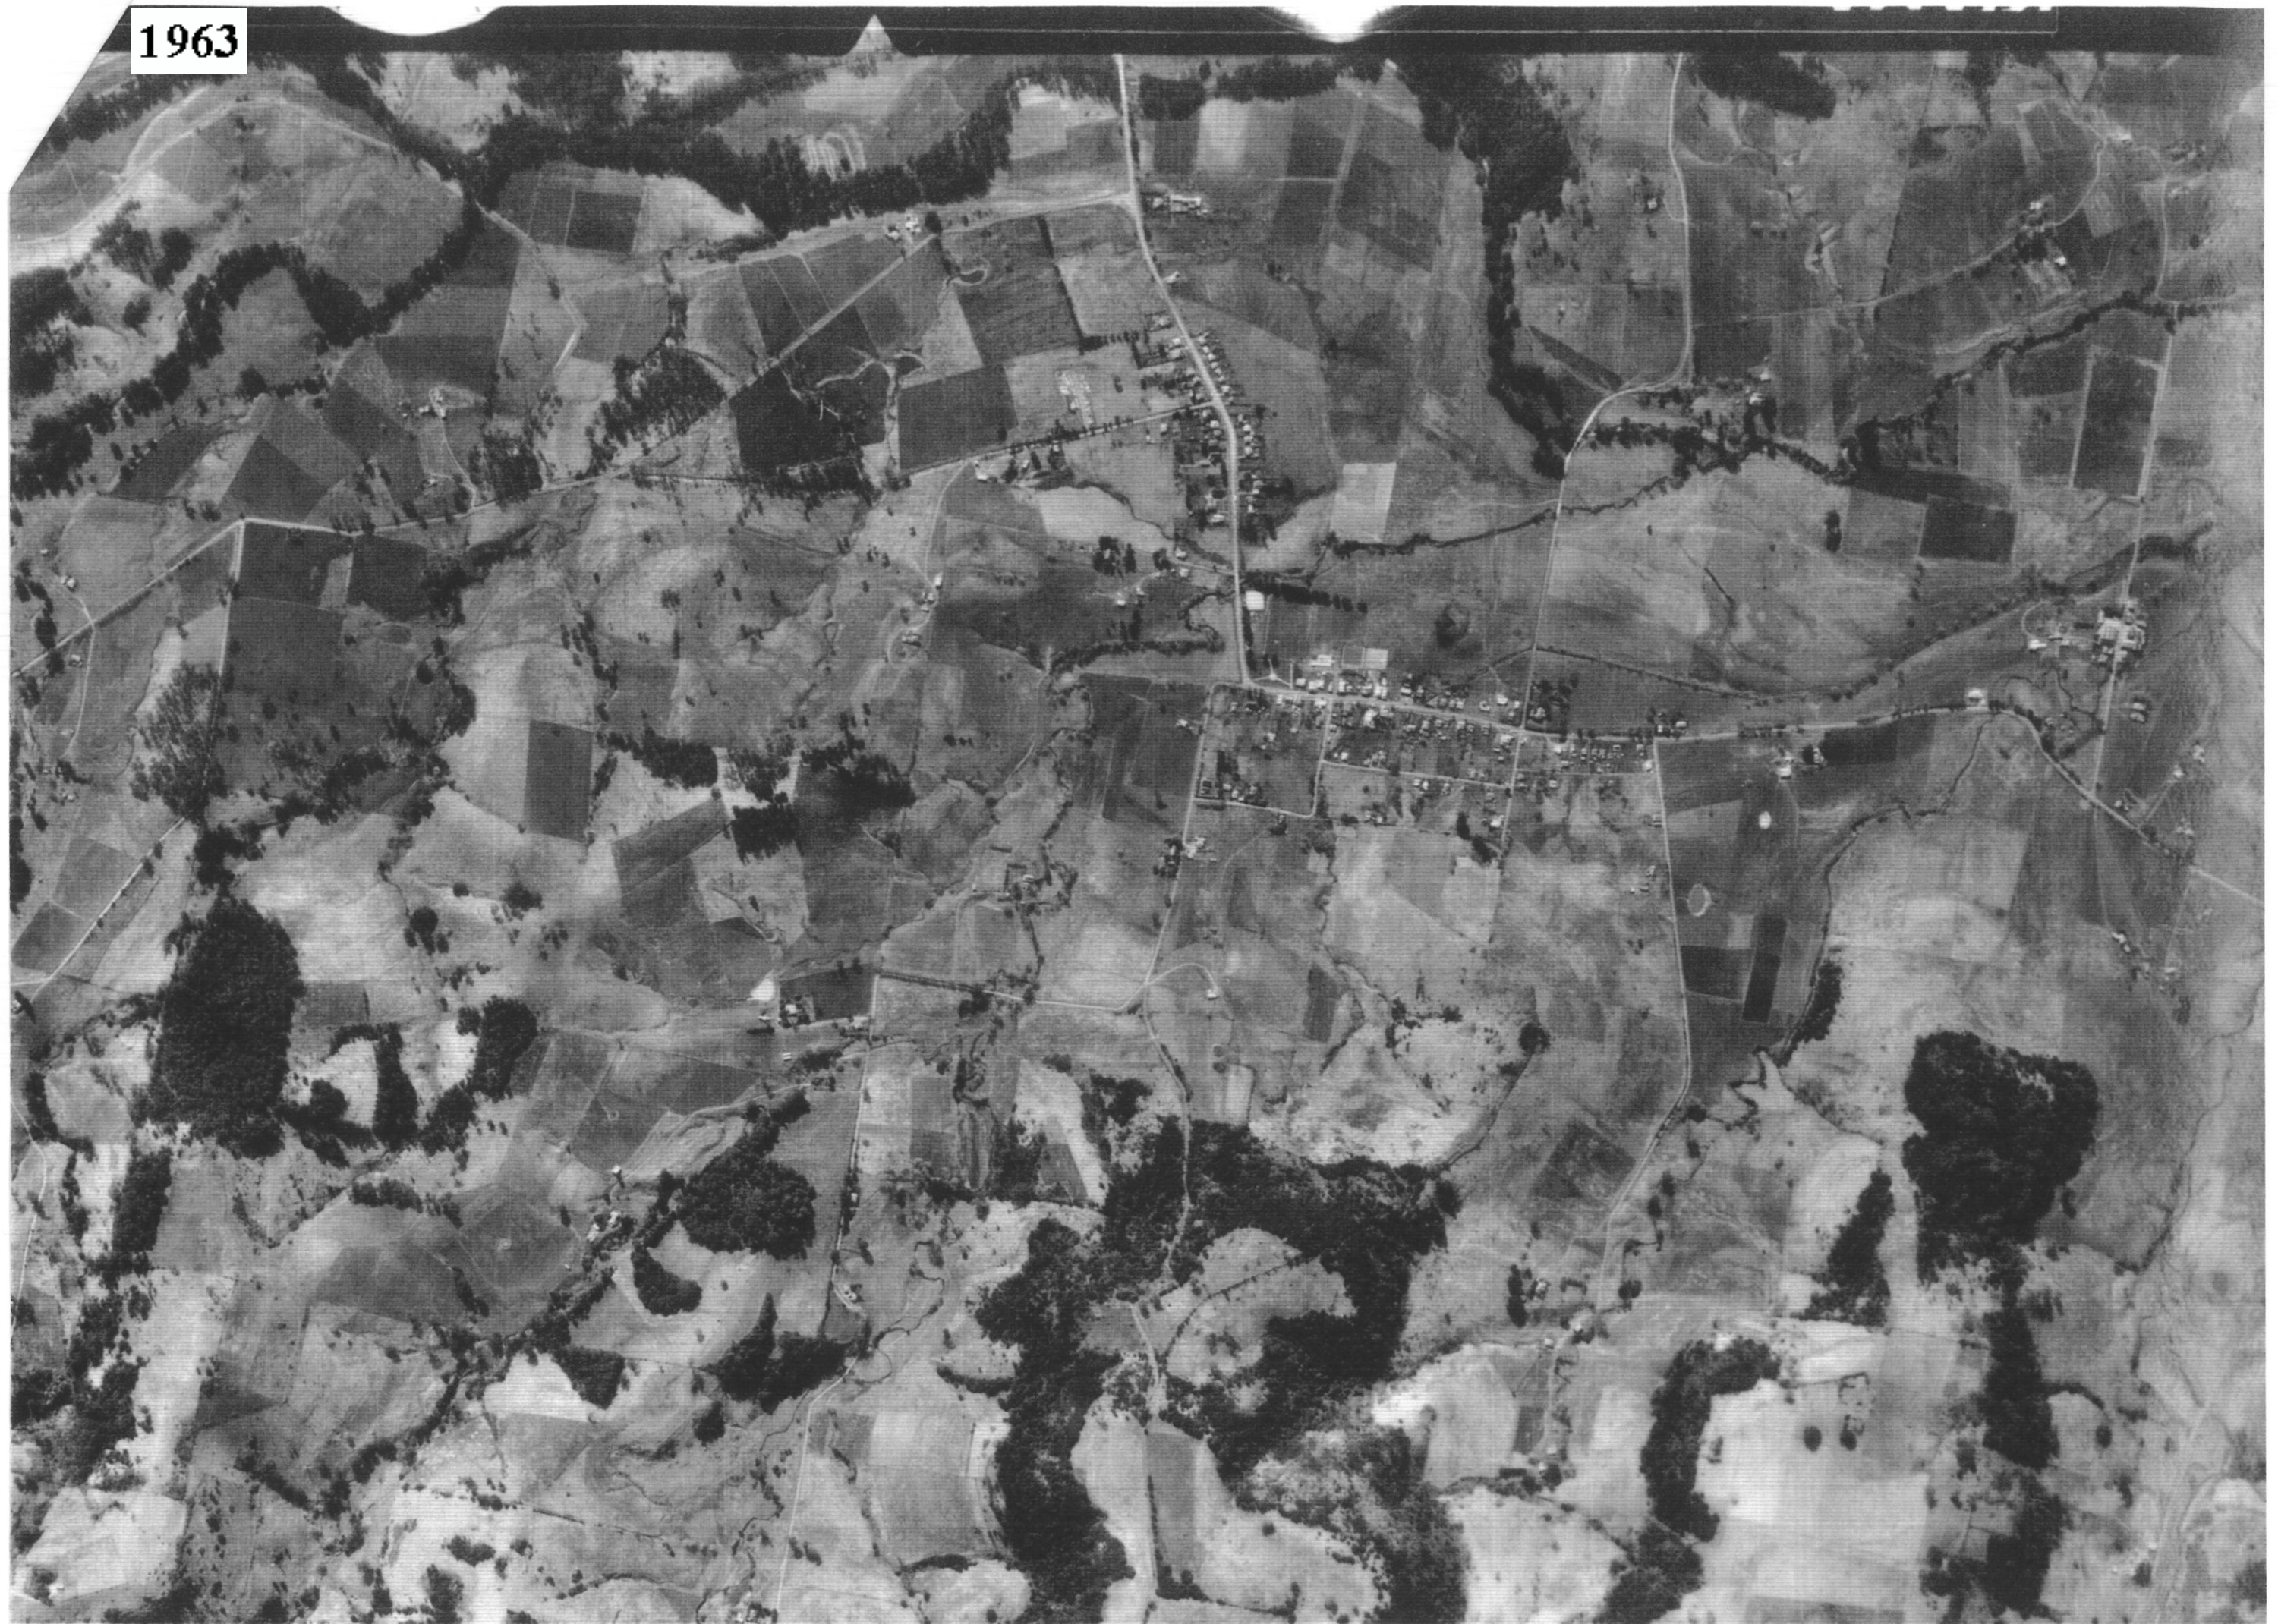
| <b>Year of Photo</b> | <b>Scale</b> | <b>Colour</b> | <b>Site Description</b> |
|---|---|---|---|
| 1963 | 1:40000 | Black & White | <ul style="list-style-type: none"> <li>No visible change apart from a shed or similar on Wyalla Road boundary at the northern corner of Lot 100.</li> </ul> |

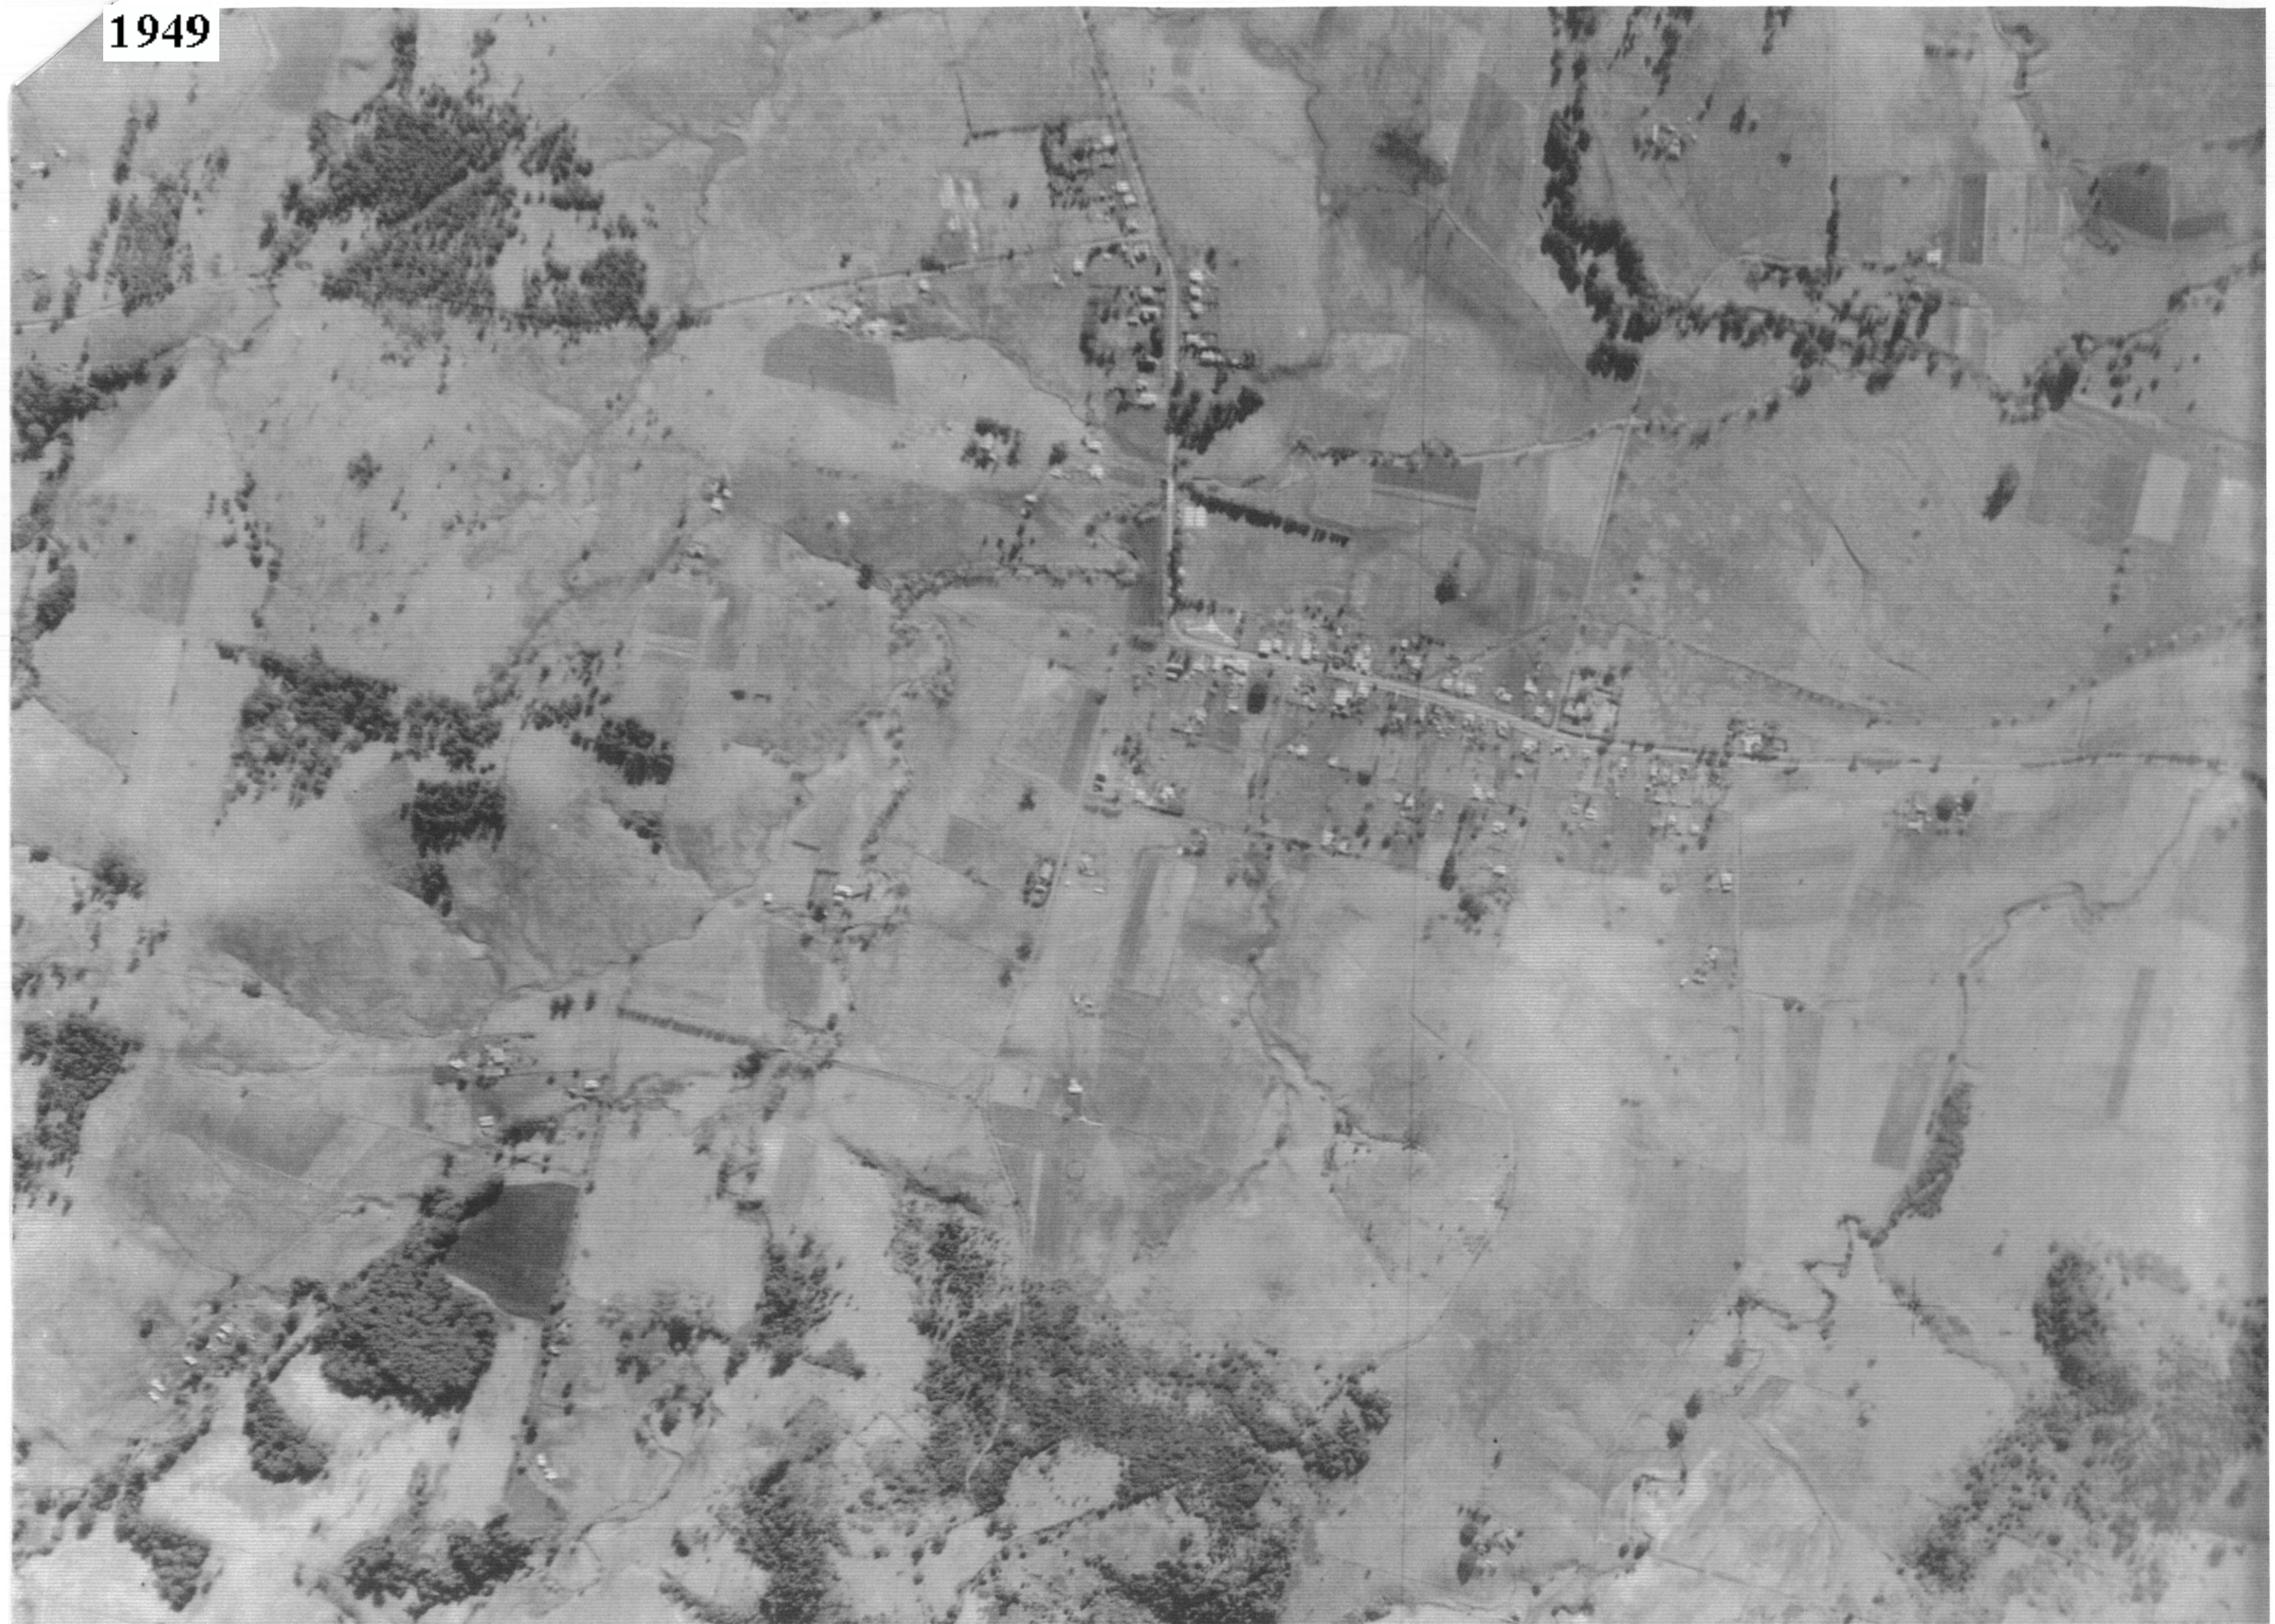
| <b>Year of Photo</b> | <b>Scale</b> | <b>Colour</b> | <b>Site Description</b> |
|---|---|---|---|
| 1949 | 1:30000 | Black & White | <ul style="list-style-type: none"> <li>A residence or a similar structure at the southeast corner of Lot1 corresponding to the location of the current residence.</li> <li>Hyams Creek running along the western boundary, flowing from south to north-east.</li> <li>No residences along Wyalla Road.</li> <li>Lot 100 completely clear of trees</li> </ul> |
