**PROPOSED RESIDENTIAL SUBDIVISION  
LOT 1 IN DP781781 & LOT 100 IN DP 1063277  
WYALLA ROAD,  
JAMBEROO**

**STAGE 1  
CONTAMINATION ASSESSMENT**

**REPORT WO7/1910-Ar AUGUST 2012**

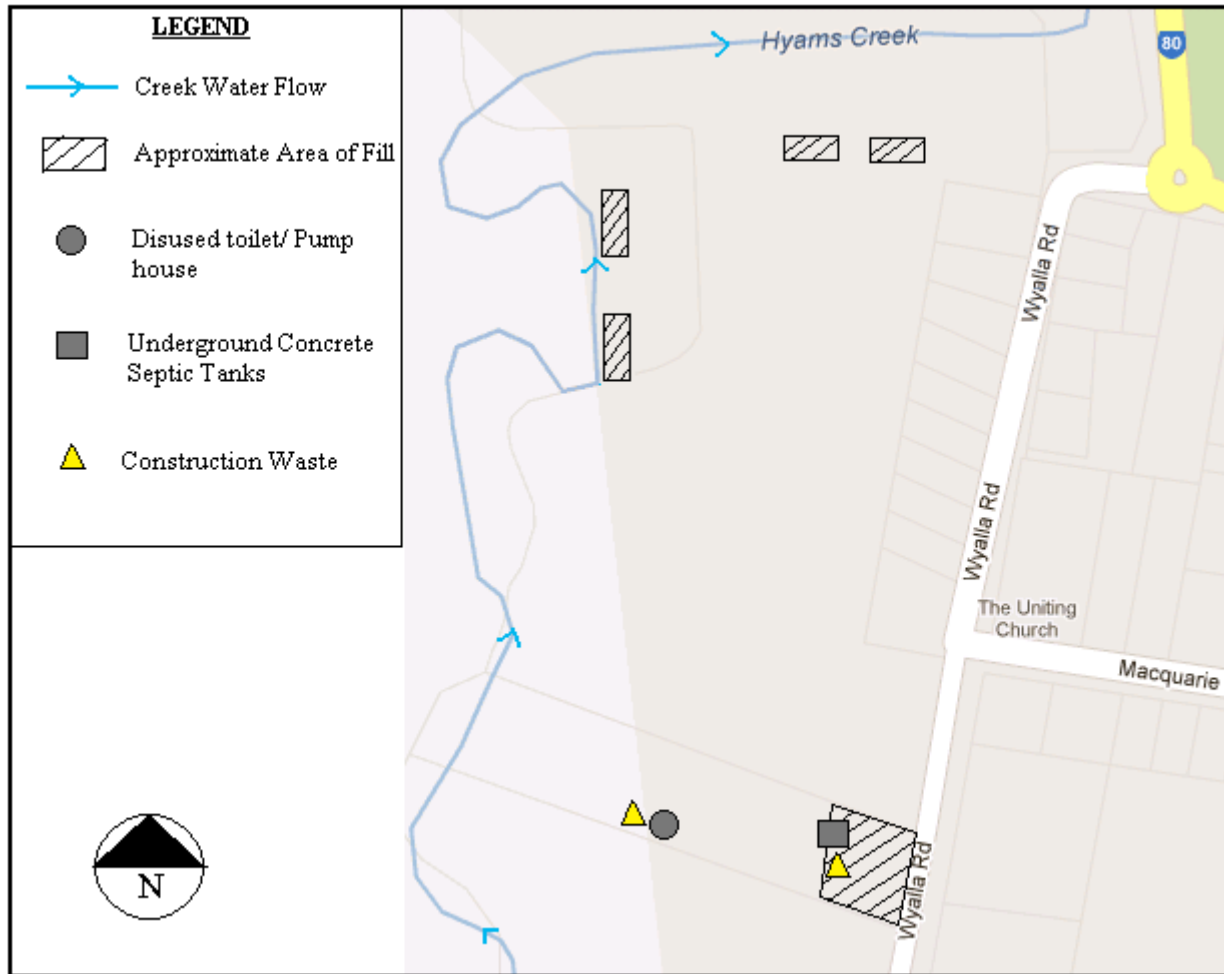
**SITE PLAN**

During the site visits on 13<sup>th</sup> and 31<sup>st</sup> July, 2012 the following observations were made. The features observed were measured with a hand held GPS as shown on the attached Drawing W07/1910-1.

- There was a large rural residence with several out buildings on lot 1 which include separate garages and a metal shed. All buildings appear to be having been placed on cut/ fill platform.
- A retaining wall supports the fill up to about 2m high on the northern side of the drive way in Lot 1.
- The access from Wyalla road to lot 1 comprises pavement covered in a bitumen surface.

- The metal shed in lot 1 has some construction waste next to it, on the western side including scrap metal, rotten treated timber, old PVC pipe and an old rusty barrel.

- The ground surface drops about 2m to 3m behind the sheds.
- Two underground concrete tanks were located on the lower part of Lot1, appears to be septic tanks.

- There are dumped scrap metal and an old stand alone disused toilet or a pump house at the centre of lot 1 in the southern boundary.
- A small fill mound, similar to a BMX bicycle ramp was located in Lot100 close to the creek.

- A series of metal fences on a fill mound was located towards the northern boundary of Lot 100. Several fill mounds were located in this area.
- Majority of the site was covered in grass and appears to have had little disturbance from the remainder of the site.
